EILEAN DONAN CASTLE

ARCHAEOLOGICAL WATCHING BRIEF

MAY 2010

REPORT CODE: FAS2010 454 LDC407

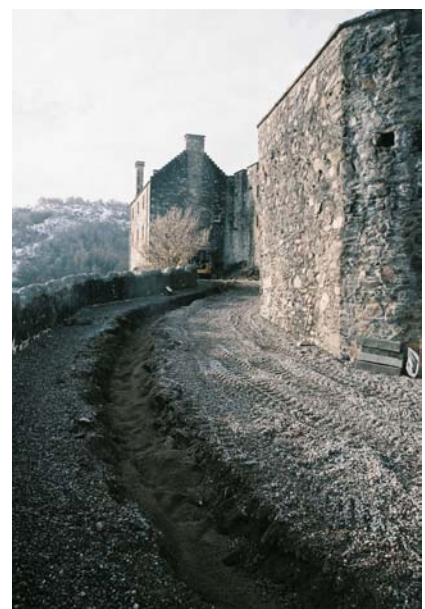
Plate 2 General view of sewer pipe trench looking west

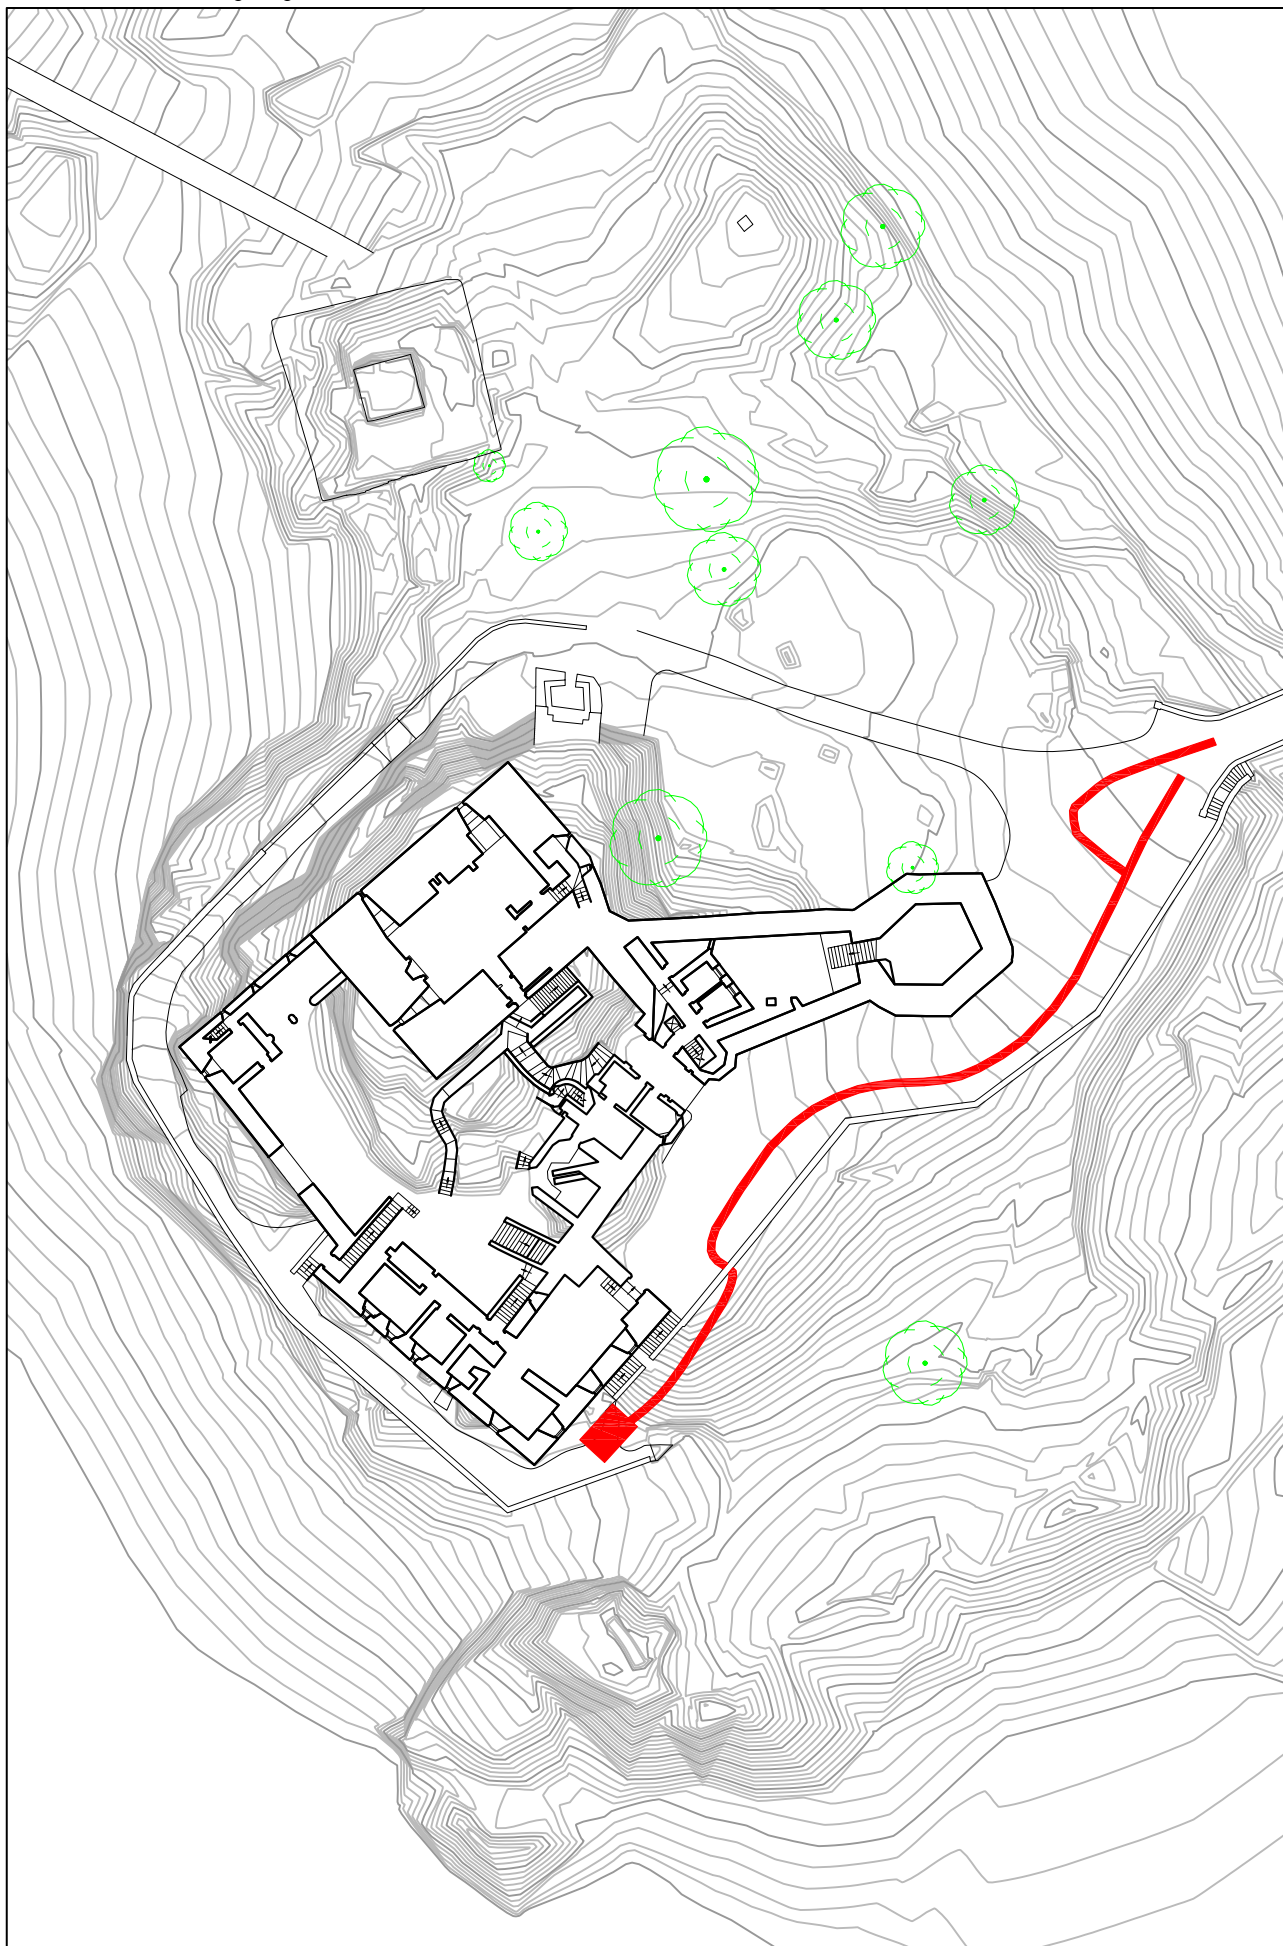
Figure 2

Location of sewer pipe trench

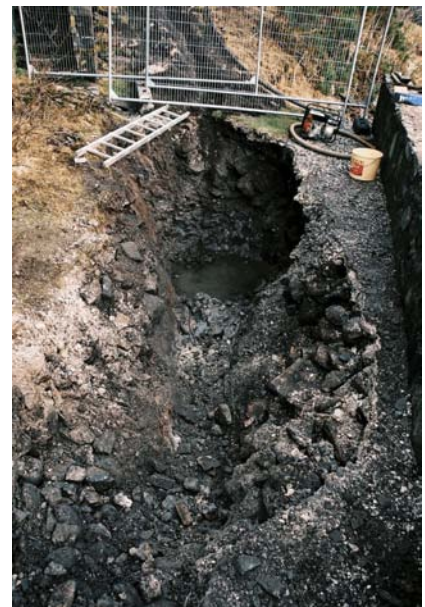
Plate 3 General view of pump location and southwest end of sewer trench

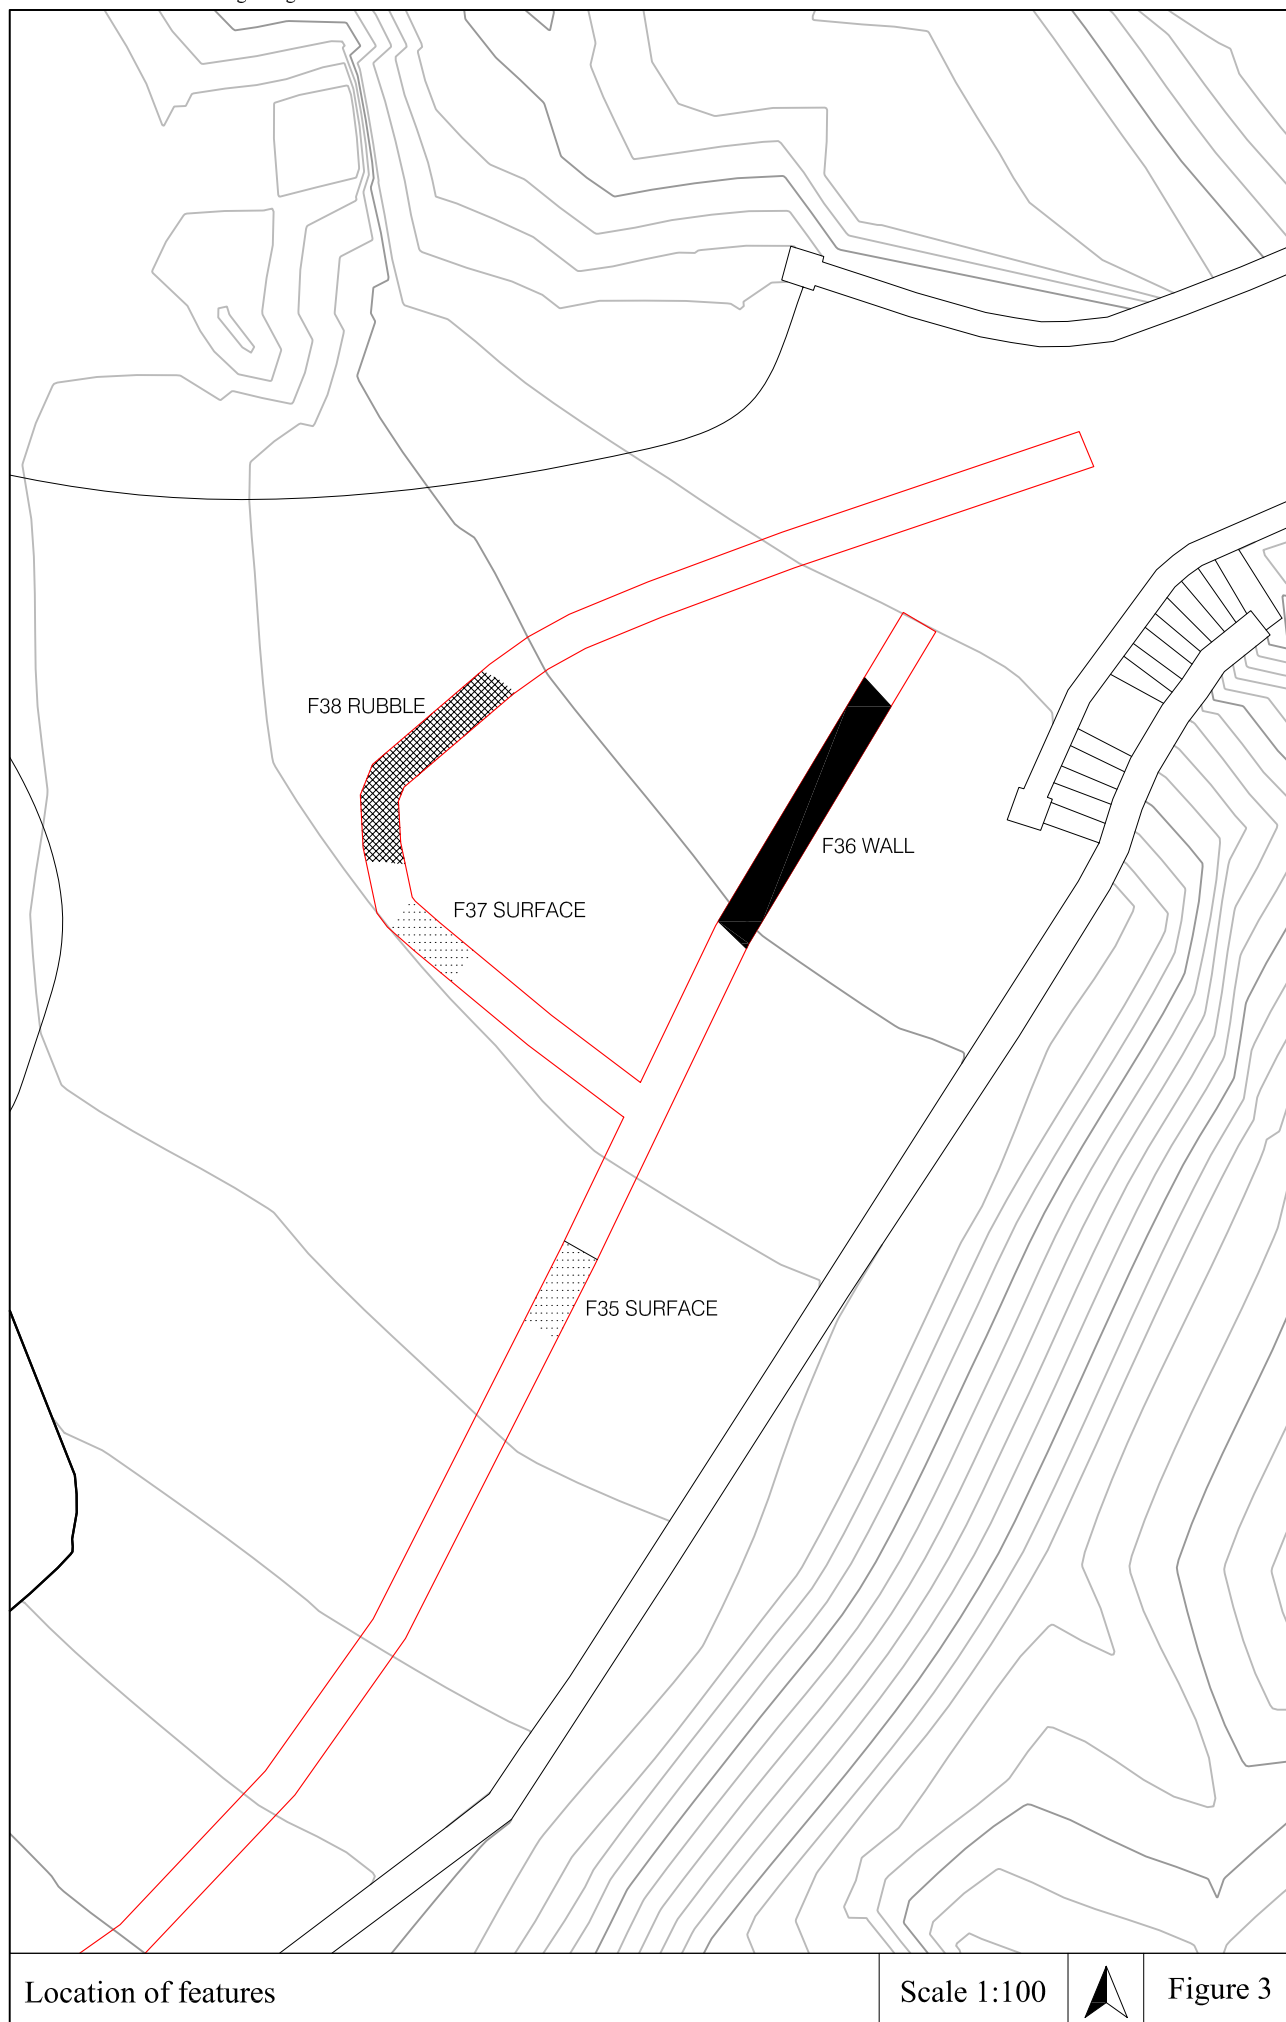
Figure 3

Excavation commenced at the pump chamber which was cut directly into bedrock (Figure 3; Plate 3). The sewer pipe trench travelled broadly northeast from the pump chamber and encountered a sequence of gravel-covered variable topsoil which was not exceeded along a substantial length of the route.

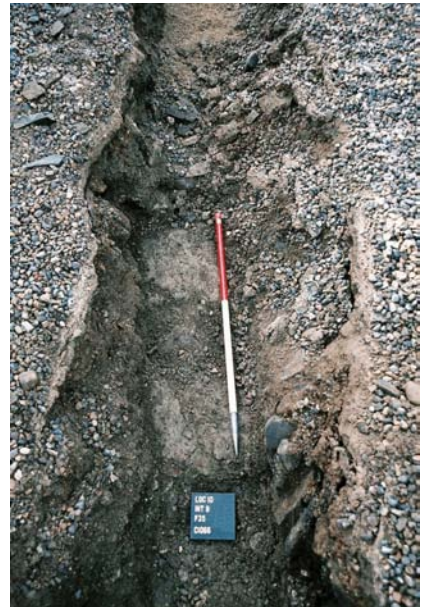
Plate 4 F35 looking NNE (scale 1.0m)

In the vicinity of the modern bridge a number of archaeological features were exposed by the removal of topsoil. The first identified appeared at *c.*0.40m BGL and was identified as an area of compact lime mortar and stone rubble (F35 C1066)(Plate 4). F35 lay at the limit of the required depth and was visible for a length of *c.*1.0m, but is likely to have been more extensive in plan. No further excavation was required and the feature was recorded and reburied.

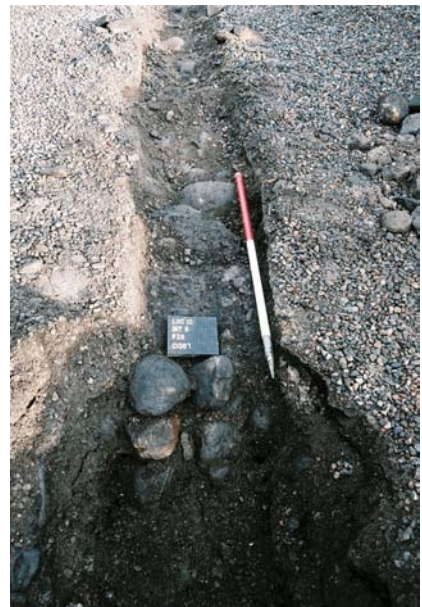
Plate 5 Curtain wall F36 looking NNE (scale 1.0m)

A second feature was encountered 3.5m to the northeast of F35 and allocated F36 (C1067). F36 consisted of densely packed rounded cobbles set in a matrix of clayey silt and lay only 0.10m BGL (Plate 5). The southwestern side of F36 was well-defined and was exposed to three courses and continued beneath the require

trench depth. The northeastern side of the feature was less well defined but the feature appeared to measure *c.*4.0m wide. The feature was readily identified as a portion of medieval curtain wall due to its similarity to lengths exposed within evaluation excavation and open area excavation. Accordingly, the decision was made to divert the trench to the north to avoid impacting the feature. The feature was exposed, recorded and reburied.

The position of curtain wall F36, while glimpsed within the narrow trench, is set further east than has been modelled previously which allows the reconstruction of the castle plan to be further refined (Figure 4). The location of F36 confirmed during the watching brief can be interpreted alongside evidence from evaluation survey. To the southwest of the position of F36 a feature defined by topographic survey has been proposed as a possible length of southern curtain wall (F8). Further information from the contour survey suggests an

Notably the remains of the eastern curtain wall were the most shallow lying almost immediately beneath the gravel and topsoil cover of the west side of the bridge at 0.10m BGL. The route of the trench was diverted during groundwork in order that no impact be made into the remaining make-up of curtain wall F36; the feature was exposed and mapped and then reburied. The depths of all archaeological features encountered and the deposit profile across the length of the trench should be noted for future service infrastructure mitigation strategies.

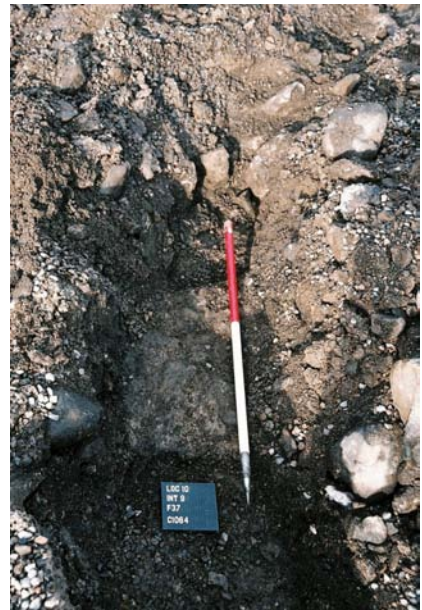
Plate 6 F37 looking NW (scale 1.0m)

Within the length of diverted trench two further features were exposed. F37 lay to the northwest of F36 and represented a further section of lime mortar surface (C1064)(Plate 6). The surface lay at the required trench depth (0.40m BGL, *c.*5.8m AOD) and was not fully exposed and may have been more extensive in plan. F37 was recorded and reburied. To the northeast of F37 a large anomaly was exposed within the trench and assigned F38. F38 consisted of a substantial deposit of building rubble set in a matrix of lime mortar (C1065)(Plate 7). C1065 consisted primarily of disordered rubble and while some fragments remained bonded together no overall coherence could be discerned. F38 seems likely to represent material from the demolition of a lime-mortar bonded stone structure. The material may derive from a medieval or early post-medieval building and F38 has therefore been interpreted as a former building stance. F38 lay at 0.20m BGL and was impacted by *c.*0.20m for the length of the trench.

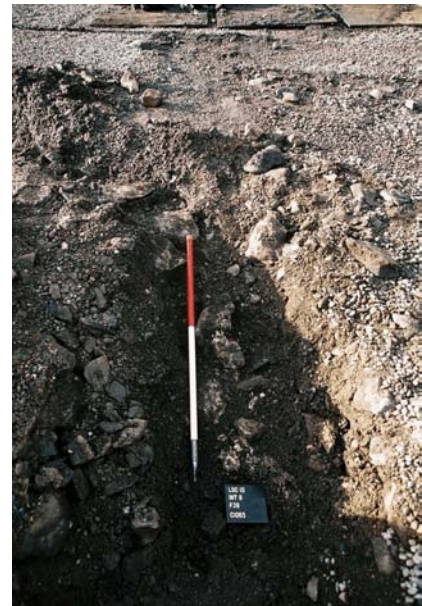
Plate 7 F38 looking NE (scale 1.0m)

The presence of F38 and the location of a previous service trench carrying an electricity cable appear to have either obscured or previously impacted on the remains of F36 in this area.
