TAIN - NEW TOILET BLOCK , REAR OF LOCALITY OFFICE, TAIN.

Department of Libraries & Leisure Services
Highland Regional Council

ARCHAEOLOGICAL ASSESSMENT EXCAVATION NEW TOILET BLOCK SITE REAR OF LOCALITY OFFICE, TAIN

For Ross and Cromarty District Council, Leisure and Recreation Department.

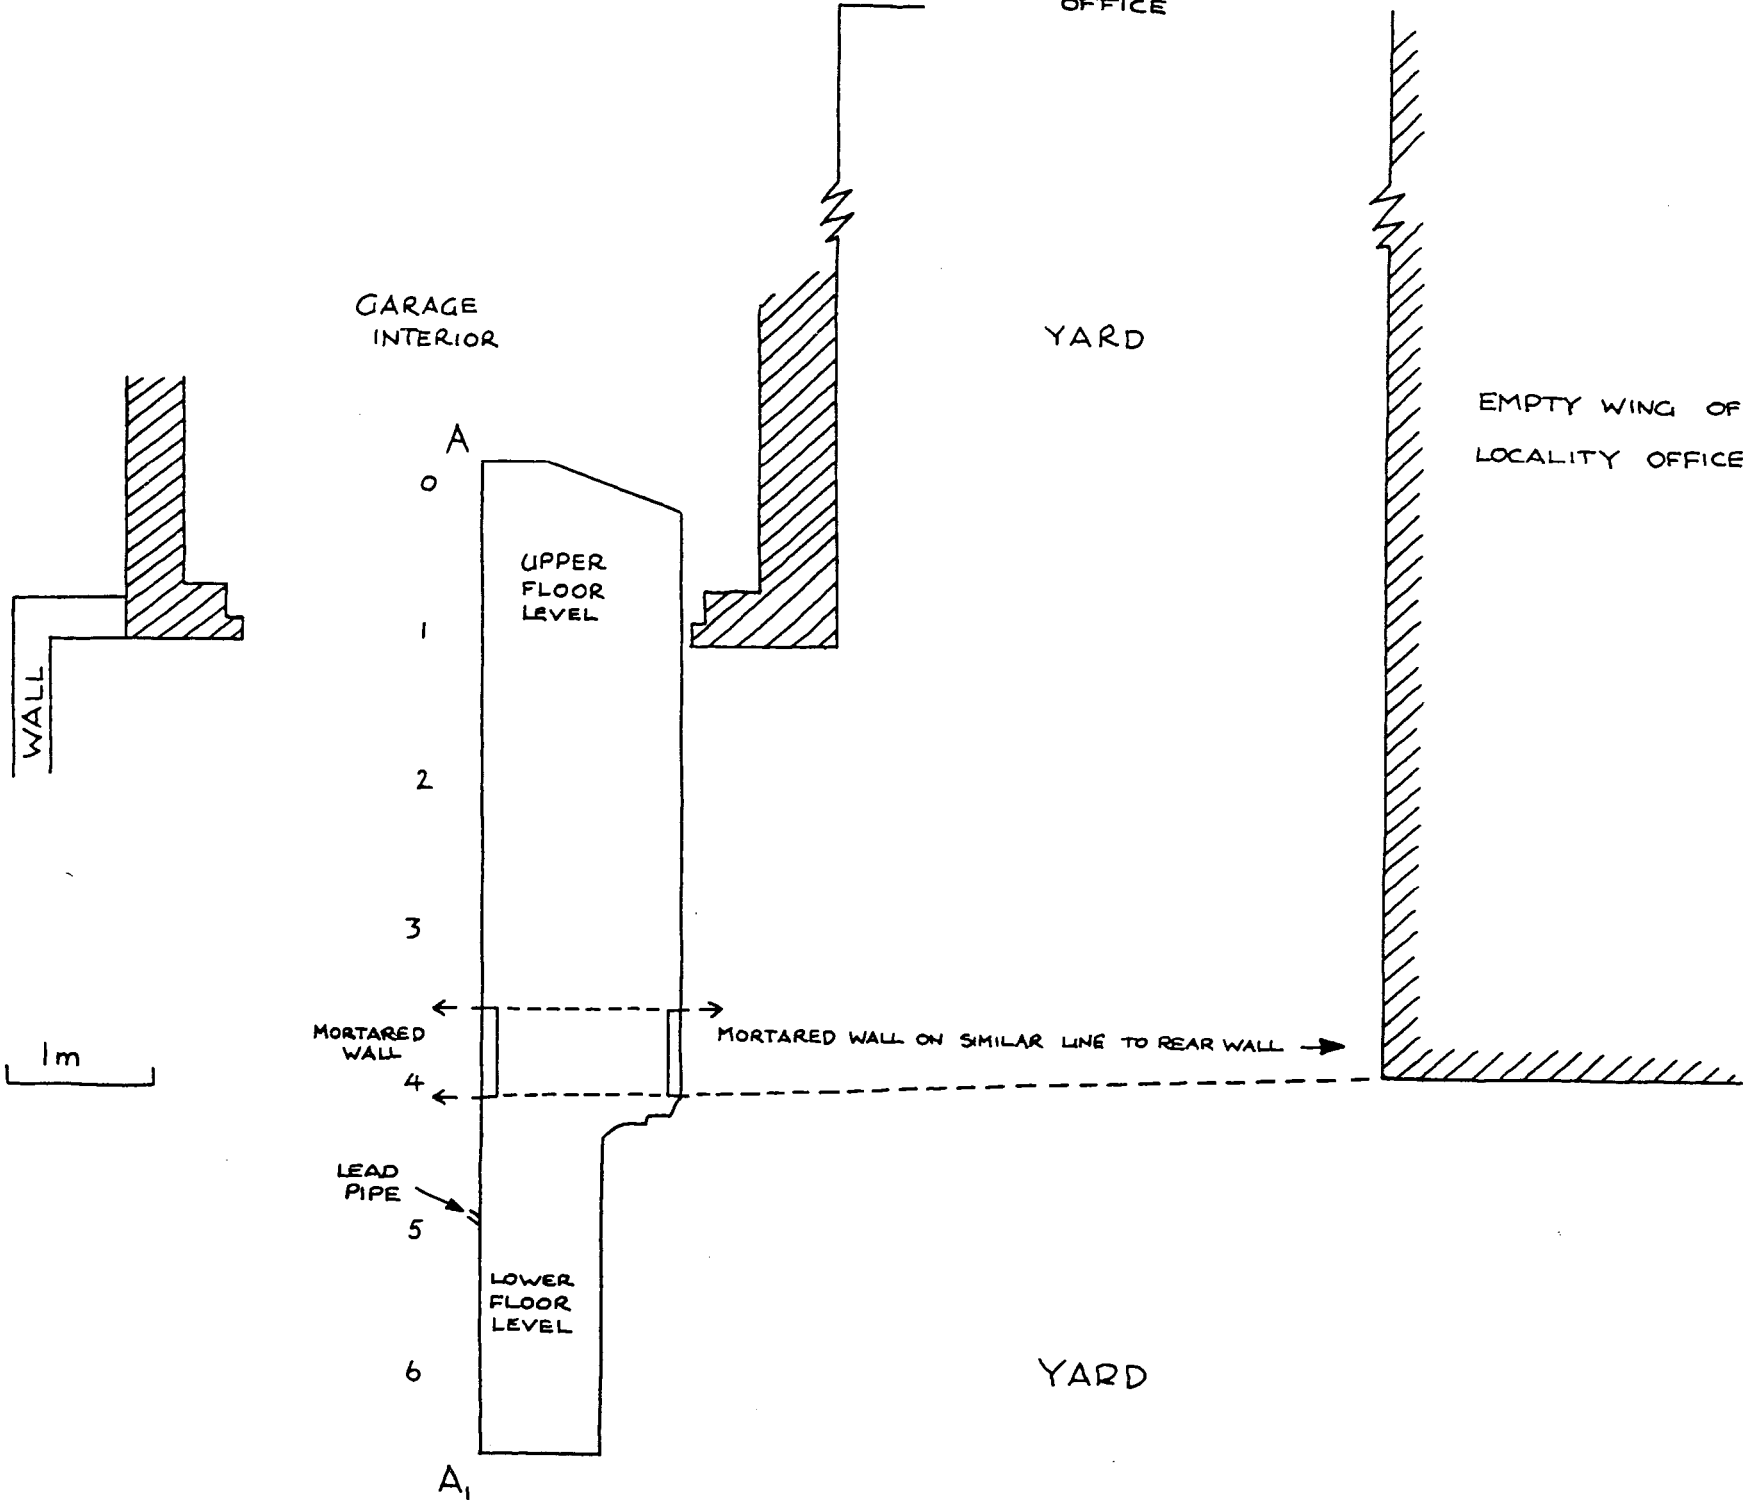
MORTARED WALL ON SIMILAR LINE TO REAR WALL →

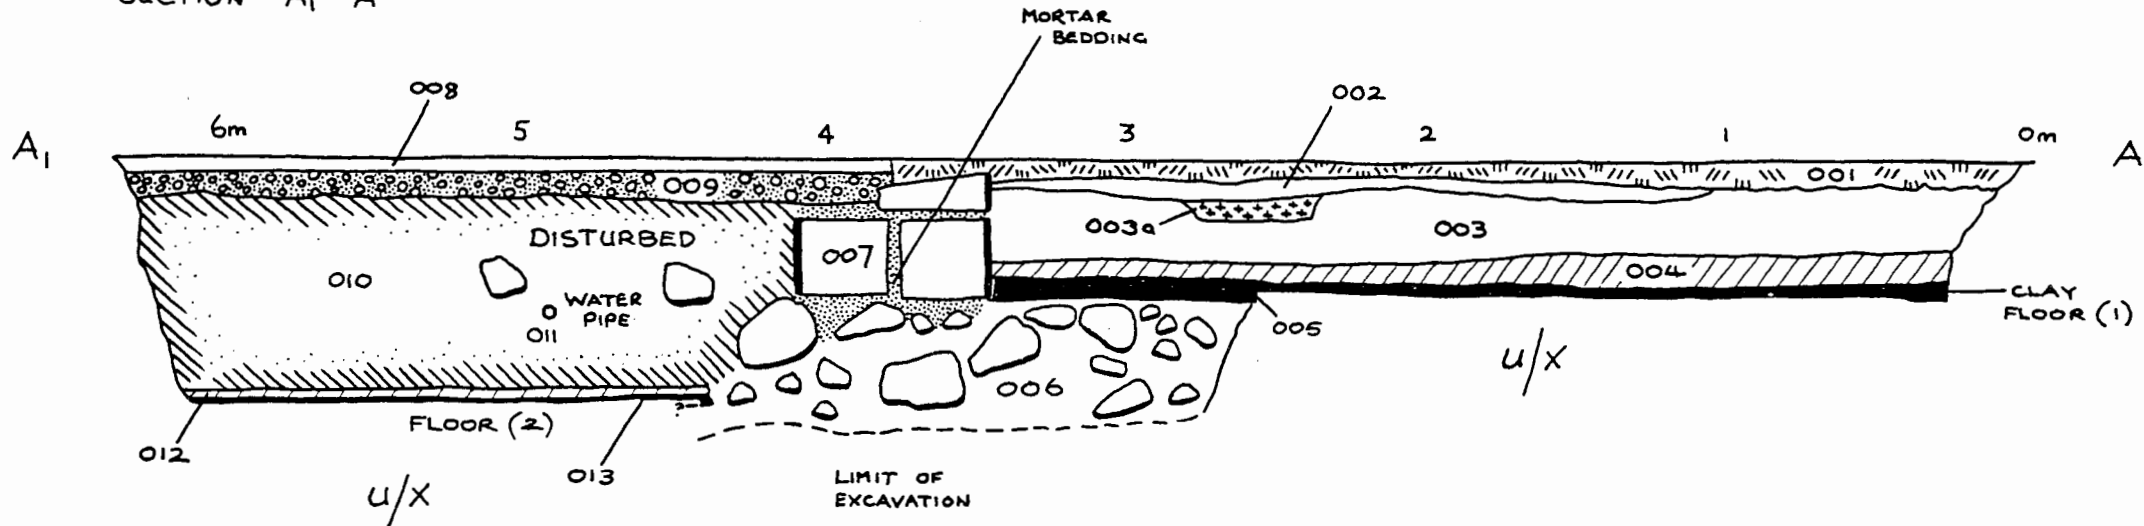
SECTION A₁ - A

Beneath the concrete of the garage floor and yard was a thin layer of brown soil overlying a deep bottoming layer of rubble, brick etc (001-003). This in turn overlay a thin, sticky black layer of humus-rich material directly overlying a flat, beaten clay floor level (004-005). The black material contained only a few fragments of 18th-19th century bottle and window glass - neither particularly diagnostic. Beneath this again was a thick layer of heavily-compacted coarse red sand (006) with a major component of large, water-worn cobbles of varied geological origin, but with fragments of local red sandstone in places. While the mix suggests that this material had been redeposited, its clean nature (no artefacts were recovered and the material was unstained) its compaction argues against this, and it may be the natural sub-soil in this area.

Some 3.5m along the trench, the foundations of a sandstone wall were encountered crossing the trench at right angles. This wall was bound with lime mortar and approximately 50cm thick (007). It appeared to run along the same line as the back extension of the present building, and represents an earlier building of similar dimensions. The clay floor clearly related to this building.

Beyond the wall, the yard covering was of tarmac, again overlying a bedding layer, this time of finer gravel material and clearly of recent origin (008-009). This base overlay a much-disturbed layer of dirty soil with patches of clay, stone, brick, mortar and other recent debris (010). Disturbance may be due to a lead water pipe (011) which cut across the trench at an angle, and which still contained a trickle of clean water. This was severed by the machine during excavation. The only material noted within this layer other than the pipe were small fragments of internal wall-plaster, too fragmented for collection.

Beneath the disturbed layer was another floor of clay similar to that within the building (012) with a very thin layer of black, sticky material (013) similar to (004) within the building. Its date and function are uncertain, but this was again underlain by the curious red sandy material as before (006).
