## **An Archaeological Survey of Balnacruie of Deishar Farm, Boat of Garten**

*with an assessment of the archaeological value of this farm and proposals to improve the management of this archaeological resource.*

**Wordsworth Archaeological Services**  
4 Balbeg, Balnain, Glenurquhart  
Inverness-shire IV3 6XQ  
(tel 01456476 288)

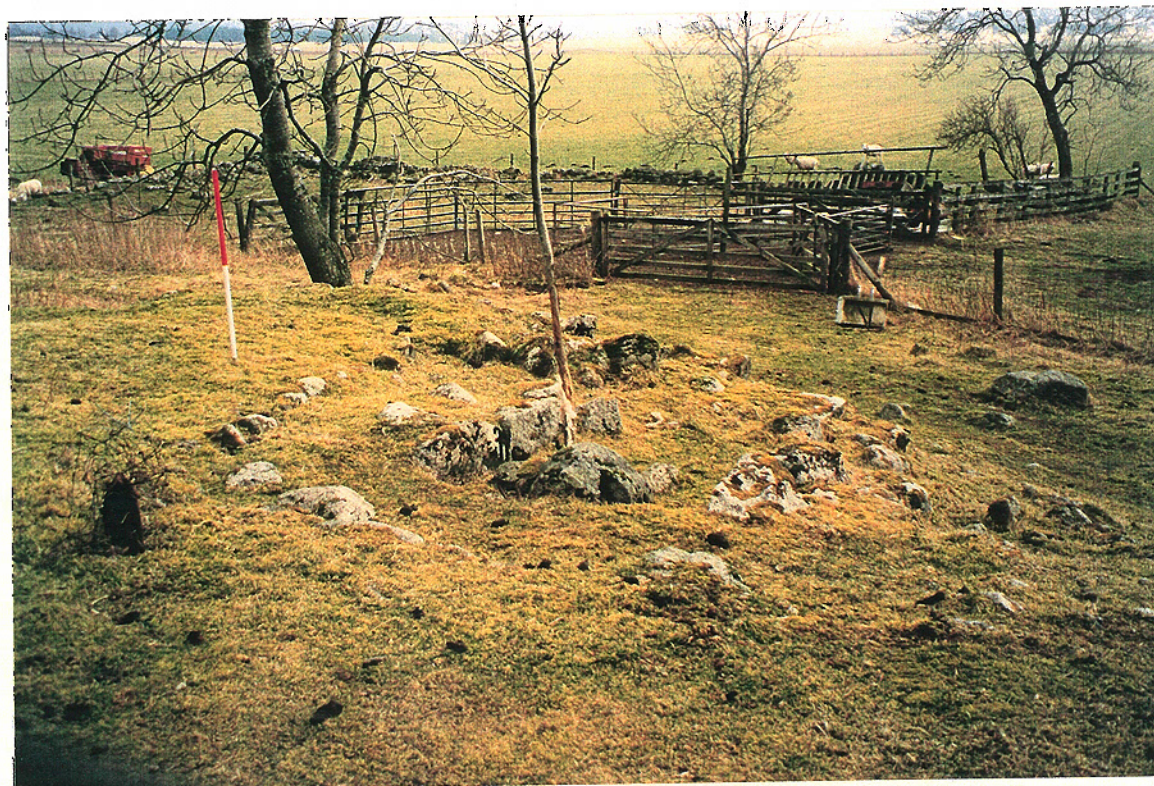
**C** The drystone footings of an oval building 8m by 4+m survive in places here. In the centre is a rectangular hollow 1.2m by 1.5m within another chamber 3m by 3m. It is thought this might be the foundations for a horse mill.

A small tree is growing in the centre of this feature and a larger one is established on the SE side. Between B & C are the remains of a concrete sheep dip now partially decayed

**Fig 5(i) Feature c at Balnacruie - ?Horsemill**  
**Looking South East Note trees growing and adjacent to the site**

**Management Options:** *The surviving buildings to the North of the modern sheep fence should be protected from the dumping of materials and destruction caused by digging or vehicle access. The present grazing regime prevents the site being swamped by regeneration though the trees growing on/near site C should be removed. The site should be monitored for invasion by juniper scrub from the North.*

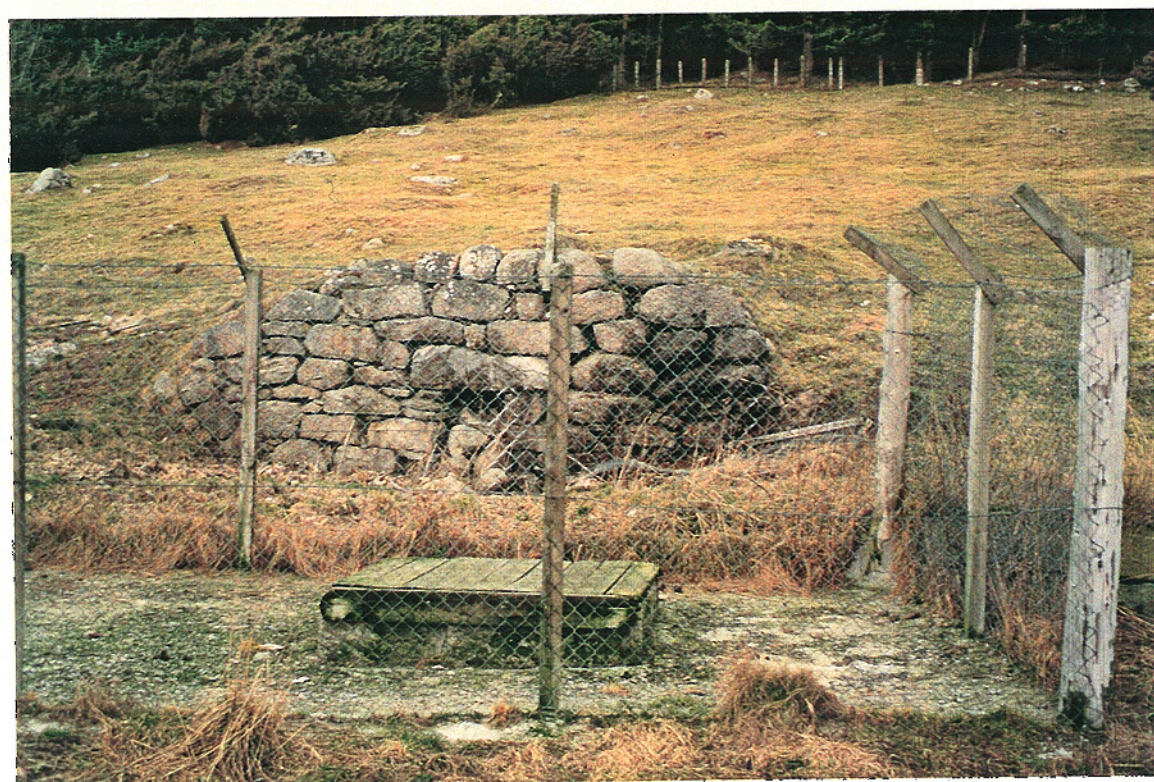
**D** The small kiln located here was not measured due to the hysteria of the dogs kennelled alongside! The kiln has been loosely filled in with stones. It was probably another lime kiln though it is not recorded as such on the OS maps. It is in good condition but a ferret tunnel has been built into the West side of this feature..

**Fig 5 (ii) ?Limekiln, Feature D at Banacruie**  
**Looking North West through fence of dog kennel**

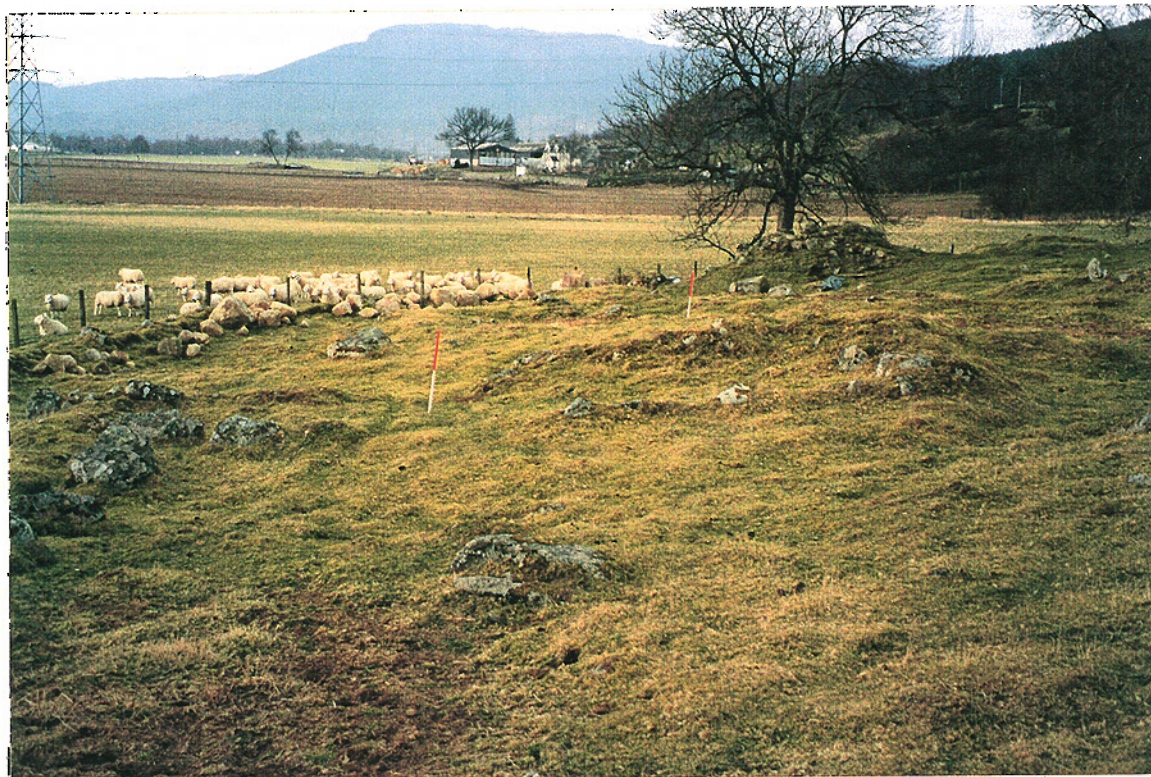
**Description:** The stone footings of two longhouses F & G, 10m by 4m, lie to the South of a rectangular enclosure H, 10m square. The sites of other buildings are suggested by roughly rectangular hollows on both sides of the modern track as shown on Fig 4. The South boundary is formed by an irregular earth and stone dyke as shown on the earlier OS maps. This is partly masked by field clearance stones dumped over the fence.

**Fig 6 (i)** Ranging poles mark sites of Houses F & H Note stone rubble by fence  
Looking South West to Kiln I and Glebe of Deishar Farm

**Management Options:** *This site lies immediately West of the settlement at Balnacruie and should be managed together with it. As with site 1, the present grazing regime is preserving this site. The boulders by the fence should be moved but this would have to be done without damage to the buildings and the enclosure.*

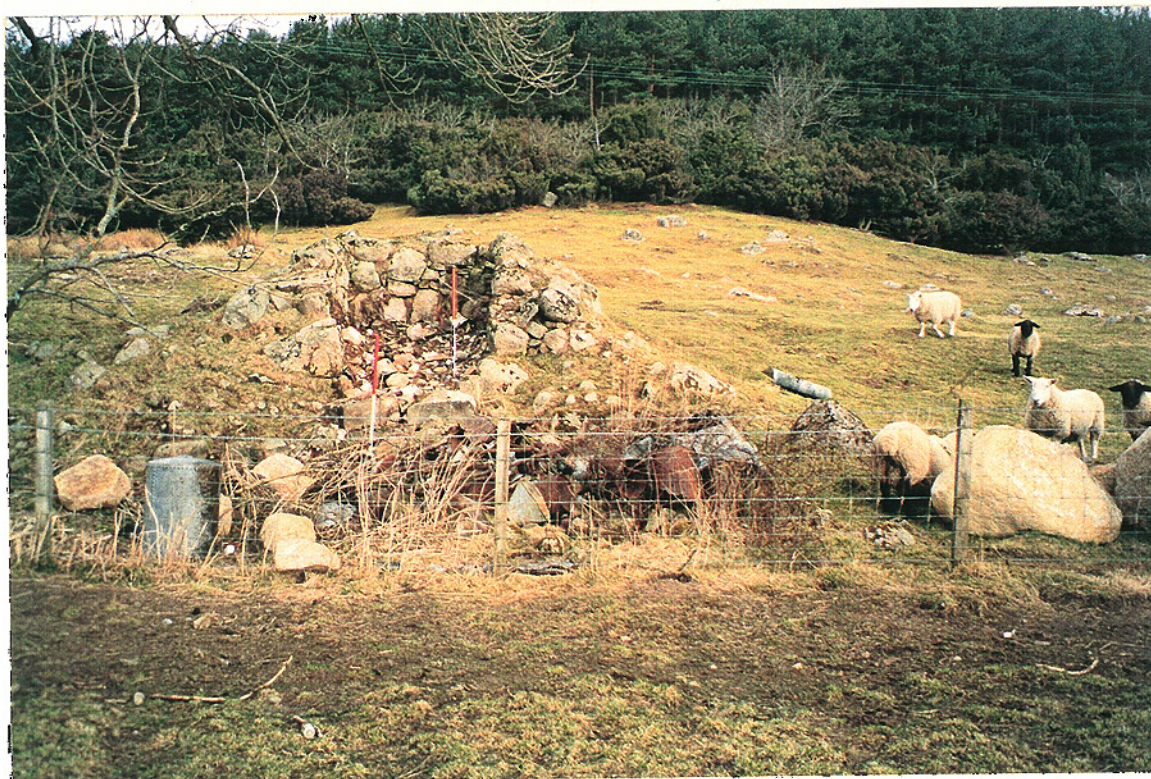
**Description:** As shown on Fig 4, a limekiln, I, appears to separate Ballinluig from the unnamed settlement at site 2. The kiln was a rounded rectangle 1.25m wide by c3m long. As can be seen from the photograph it has been filled in with farm rubbish which has recently been cleared out. The two houses, J, shown to the West on the 1st OS edition, can only be partly traced on the ground, possibly because this is now an access route from the field to the hill behind. There is some vehicle erosion in this area (see photograph).

**Fig 6 (ii)** Limekiln I with associated rubbish  
Looking North

**Management Options:** *As with sites 1 & 2, the present grazing regime is preserving this site from being covered by regeneration. Care must be taken to prevent further damage by vehicle tracks and the dumping of rubbish and stones. The rushes could be burnt to encourage heavier grazing around enclosure K. The rubbish around and within kiln I ought to be cleared away and may in any case be seen as a hazard to stock.*

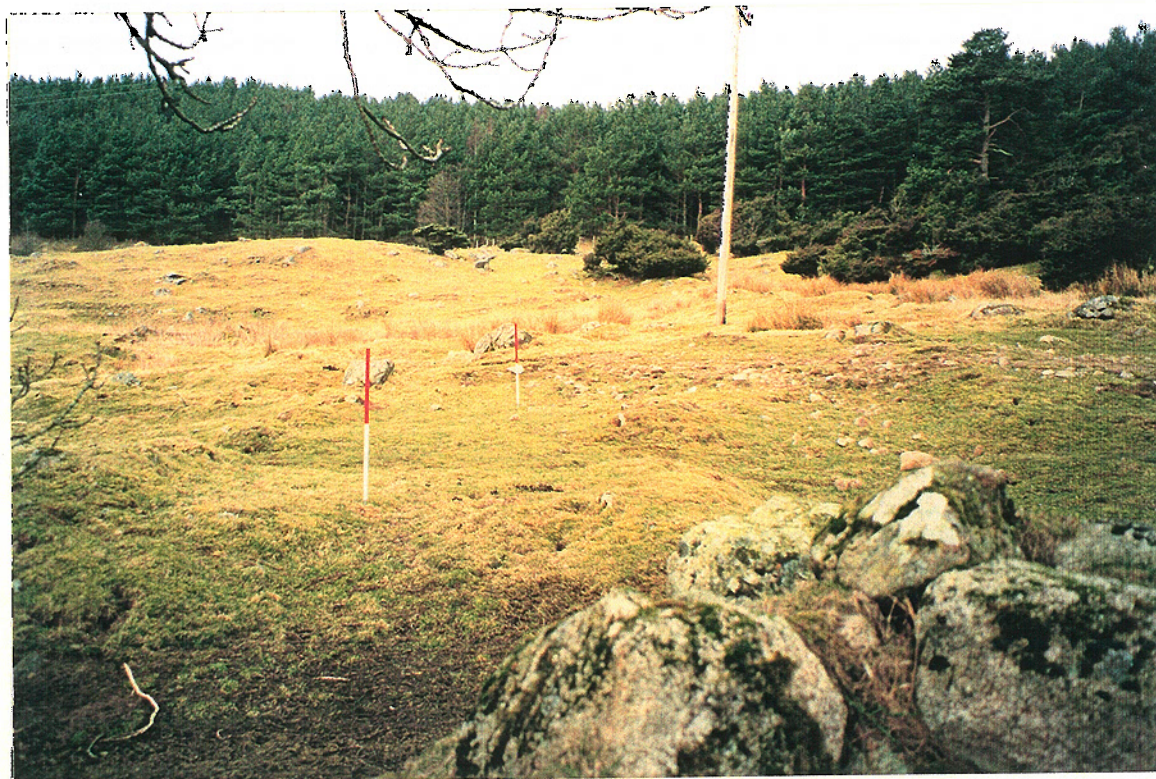
**Fig 7(i)** House site J marked by ranging poles  
Note wear on track in centre right of picture  
Looking North West from Limekiln I

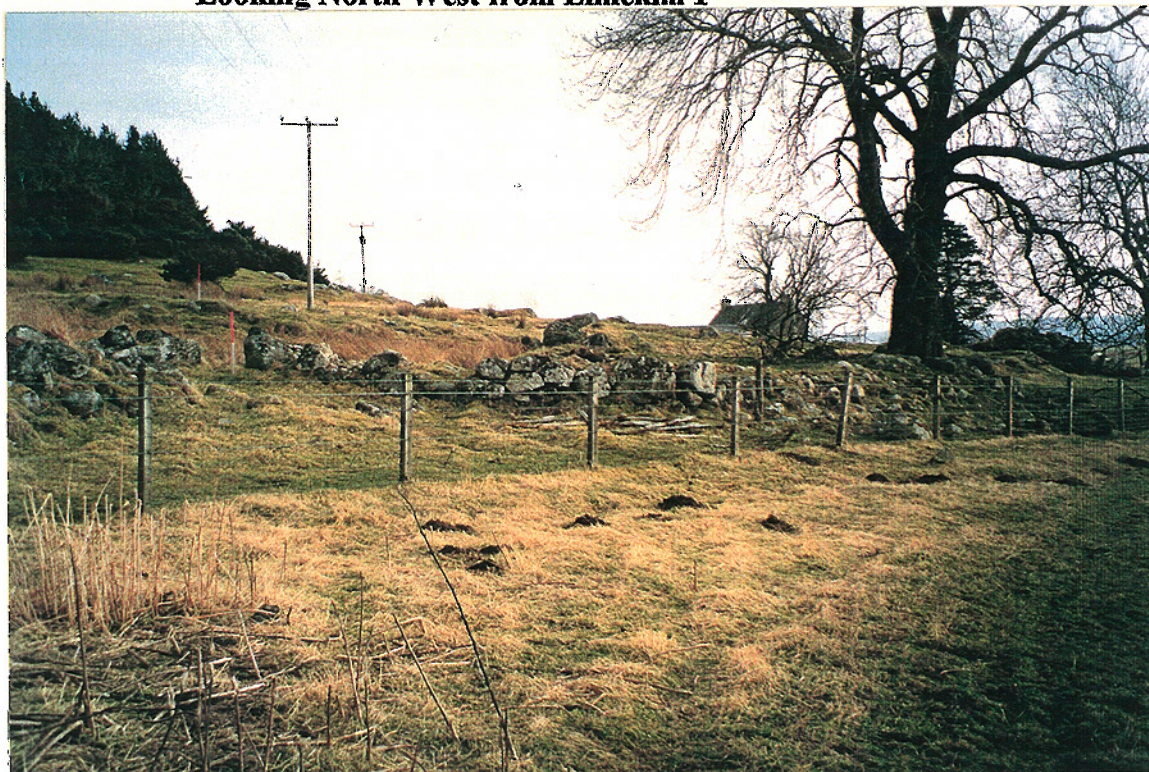
The boundary wall seen at site 2 continues from the kiln to link with a D-shaped enclosure, K, with an entrance to the West as shown. The East side of the appeared to have been partly filled in with stone rubble, though this may only be caused by the collapse of the enclosure wall on this side. There is a dump of mossy wood and strong nettle growth to the North East suggesting there has been some disturbance in this area. On the West side near the entrance some stones from the enclosure wall have been recently dislodged. (see photograph). The base of this enclosure is very wet. If the chapel site is correctly placed on the OS map, this might be the site of the *Fuaran Fiontag*.

**Fig 7 (ii)** Enclosure K with ranging poles at entrance and possible line of East wall.  
Note tree on line of dyke to right of picture  
Looking North East

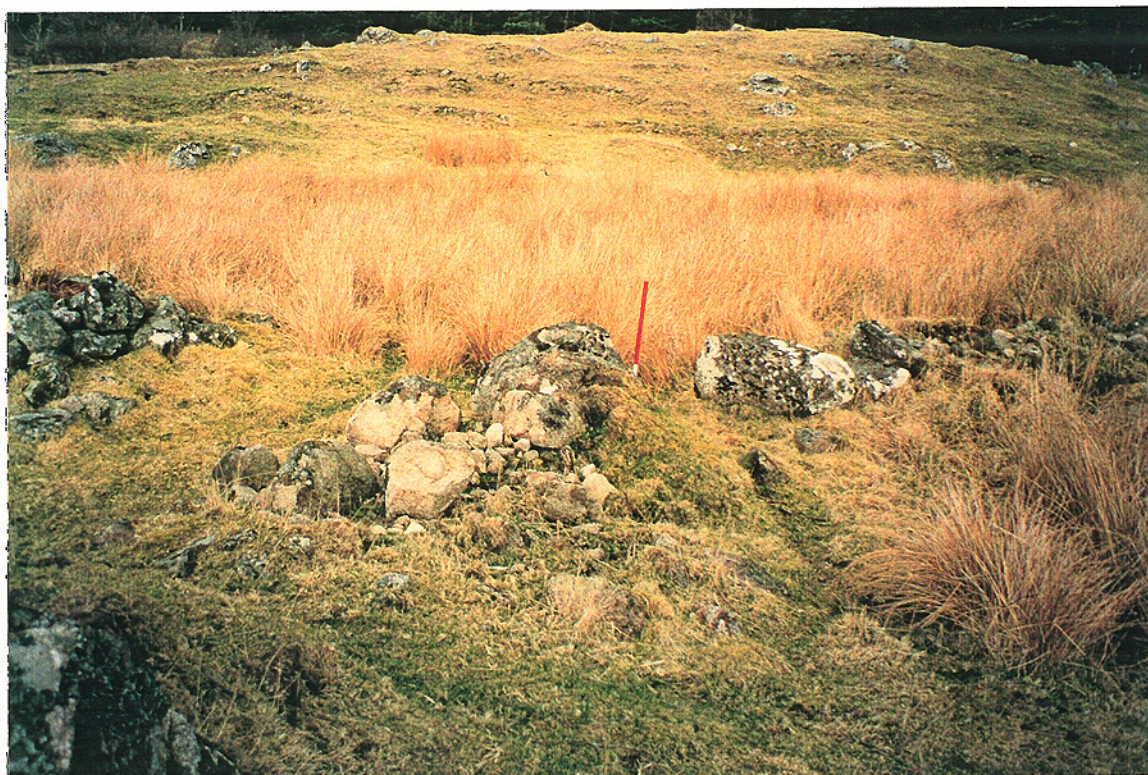
**Fig 8 (i)** Enclosure K with disturbed stones of wall  
Ranging rod marks entrance shown in Fig 7(ii)  
Looking North North West towards House Site L

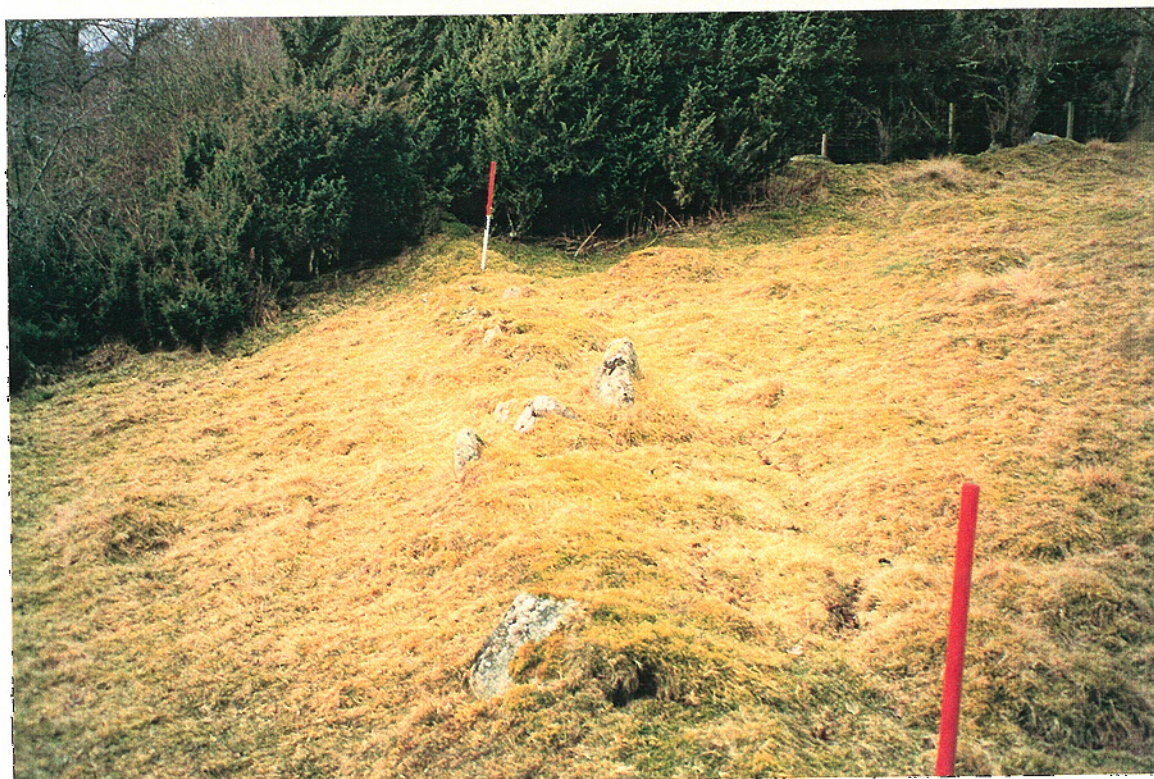
*Description:* This is recorded on all the OS maps as Grave Yard (Remains of and Site of Chapel). As is discussed above there are no remains visible here and it is possible that it should be sited elsewhere. The area around here is heavily overgrown with juniper and birch scrub. There is a boulder and earth dyke as shown on the current OS map extending 30m North East from the present farm boundary and some 60m North of the old boundary wall. Rather than bounding a graveyard, it would appear to mark an enclosure to the North as the ground appears more fertile here.

**Fig 8 (ii)** Dyke at site 4 with juniper scrub  
Looking South West

The old dyke, as can be seen in the photograph, is partly overgrown with juniper scrub and it would be desirable to clear this away from the wall. It is recognised that there may be a conflict with nature conservation interests in this area.

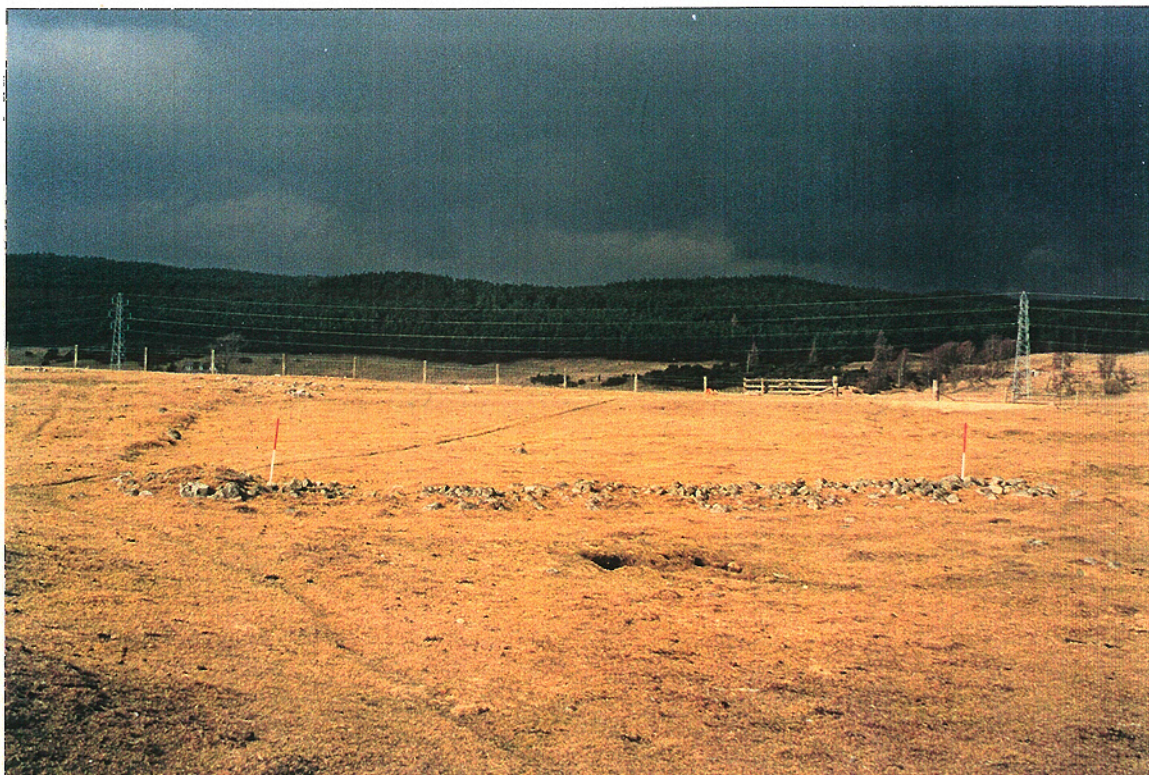
The wall line of the enclosure survives as a thin spread of stones. There are considerable quantities of stones cleared from the field to the North and dumped in the vicinity.

**Fig 9(i)**      **Remnant of Enclosure at site 5**  
**Looking North**      **Note rabbit burrow in front of wall**

*Management Options:* This should be kept clear of future stone dumps. No positive action is suggested here.

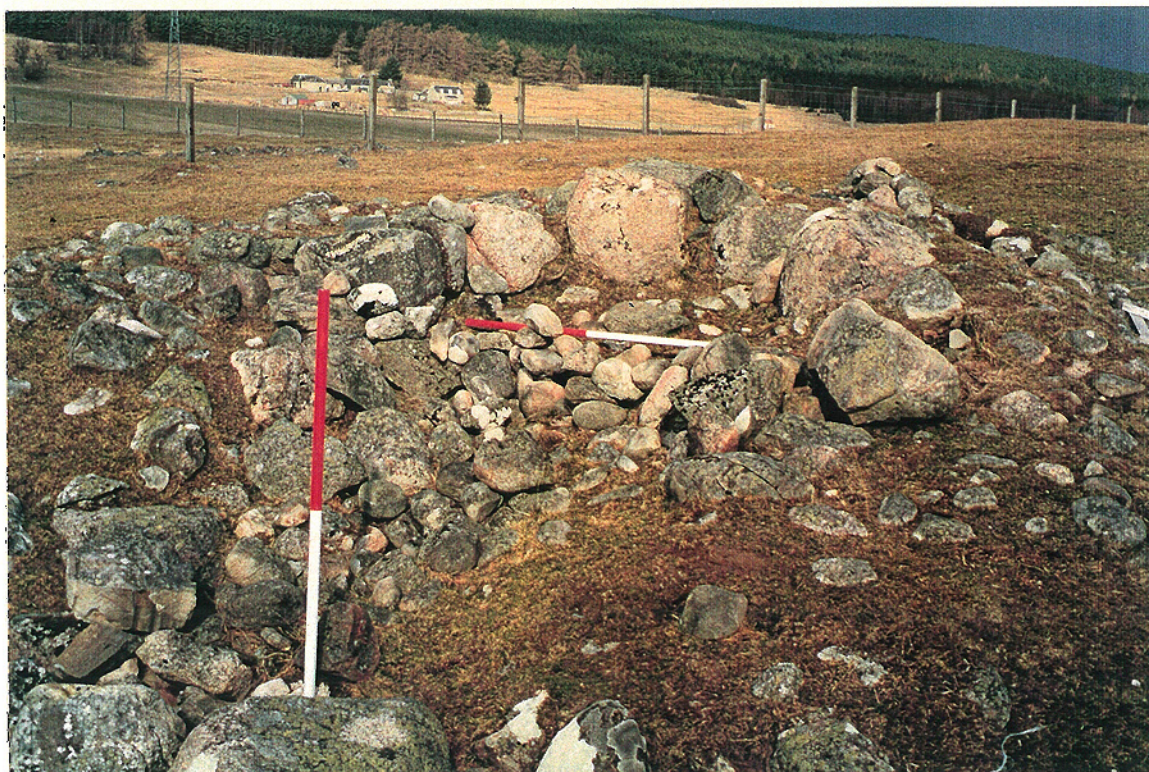
*Description:* A limekiln in rather poor repair is located here. The limekiln is marked but not titled on the earlier OS maps. A gully runs from the kiln but is more probably connected with a drainage channel from the lochan to the West rather than being an integral part of the kiln.

**Fig 9(ii)**      **Limekiln at site 6 as surviving**  
**Looking North East to Dochlaggie Farm**

*Management Options:* This feature should be preserved and it may require some stone clearance to make it more visible. As it is located close to Boat of Garten, it must be considered whether greater exposure would make it more susceptible to vandalism.

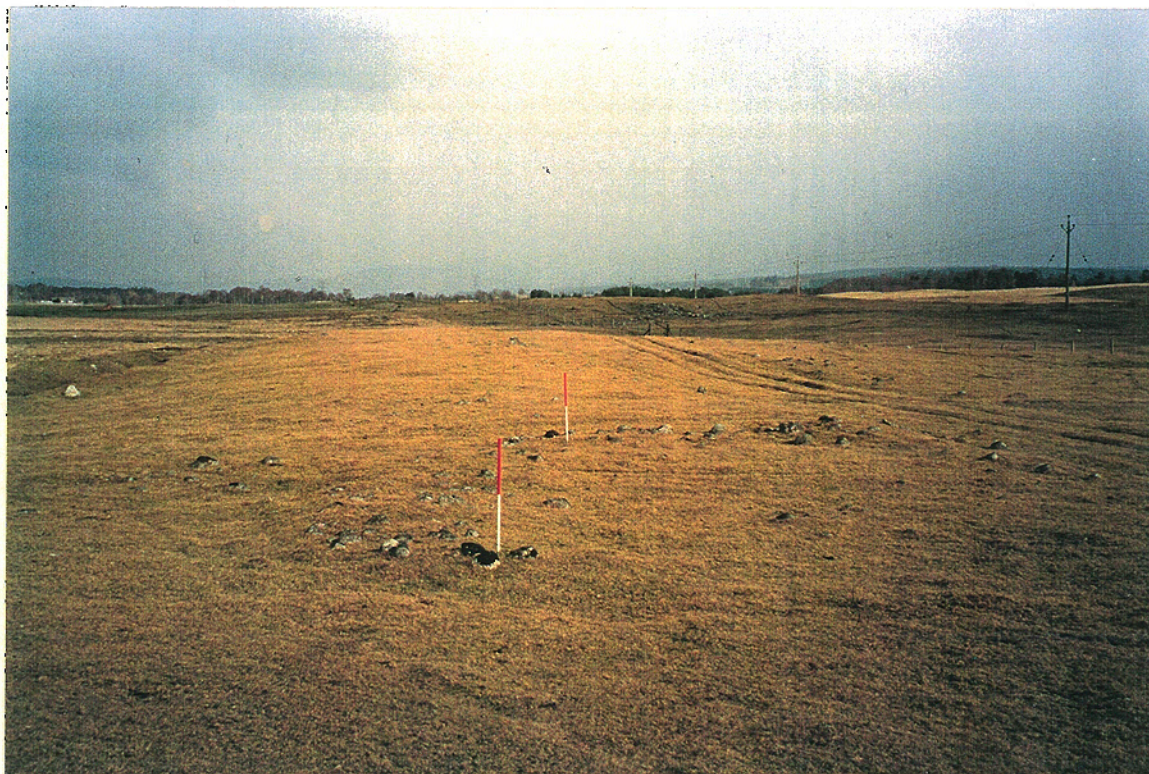
*Description:* An L-shaped rickle of stones 9m long E/W by 6m long N/S may mark the remains of a building or a small enclosure. No feature is recorded here on the earlier OS maps.

Its poor preservation means that it is difficult to interpret this feature.

**Fig 10(i)** Possible house at site 8 with drain from lochan on left and track to right  
Looking South East to Limekiln at site 6

*Management Options:* As this is not an area of active cultivation and well-removed from the usual areas of stone dumping it does not appear to be under any major threat other than vehicles driving over it. Tractors and other vehicles should be encouraged to avoid it.

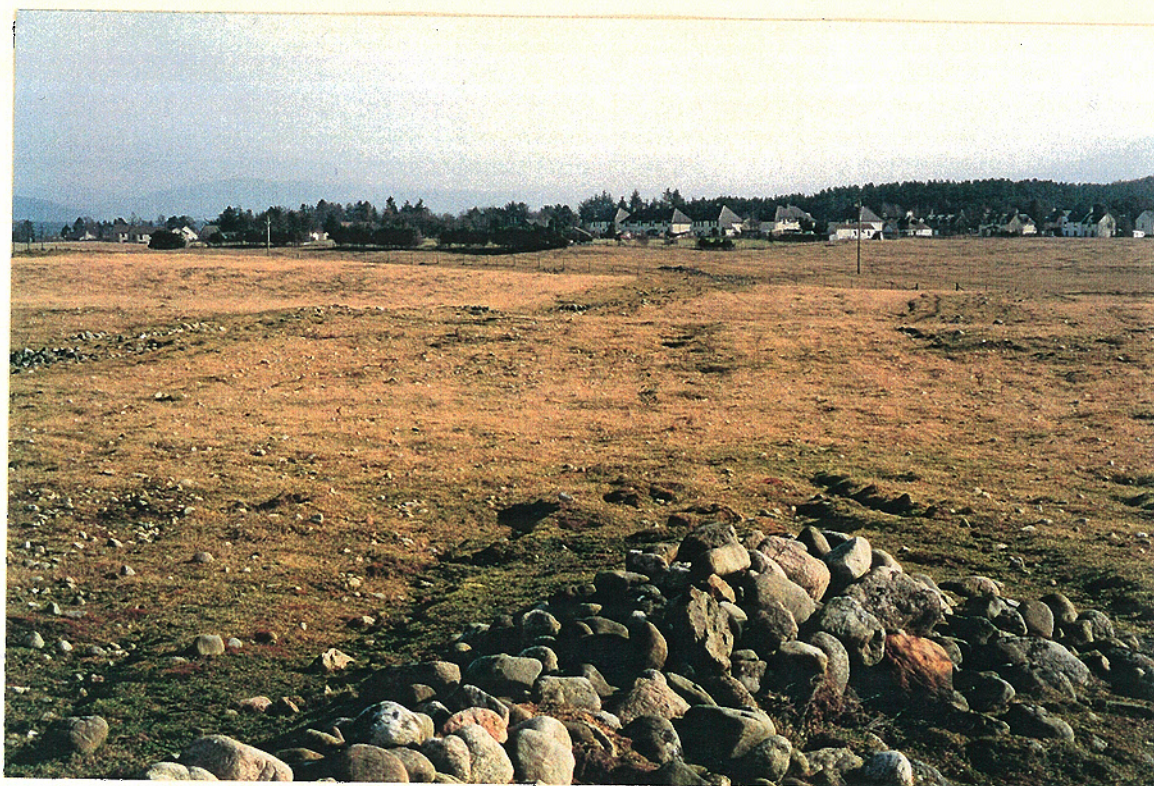
*Description:* A strip of ground to the East of the now drained lochan and North of the former drainage ditch has recently been cultivated as shown in the photograph. Strips left between the ploughings and used to heap field clearance stones may be the residue of a former strip system of cultivation. This is a tentative interpretation but if correct would be an important survival of the field system associated with Ballinluig and Balnacruie. The ground here appears to be stonier than the area to the North which may explain why cultivation was previously abandoned here

**Fig 10(ii)** ?Remnant Field system at site 9  
Looking South to Limekiln at site 6

*Management Options:* This field system could be preserved by following existing ploughing practice and leave the stony headlands unploughed.
