SECOND WORLD WAR AIRFIELDS AT TAIN AND FEARN, EASTER ROSS

A Report to Highland Council by the ASH Consulting Group

July 1999

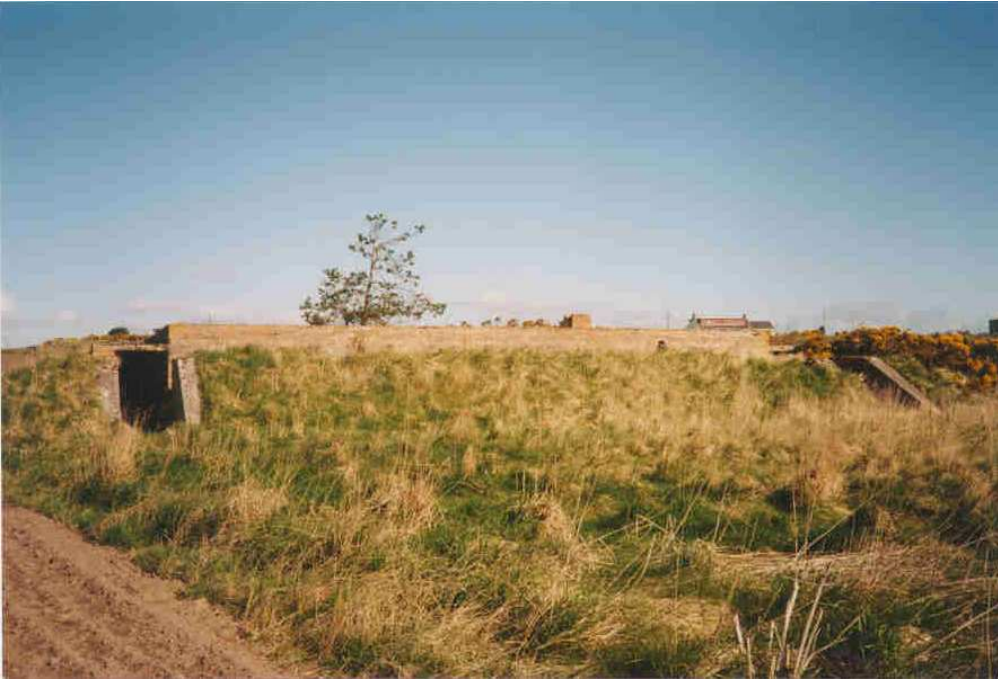
- 10.1 This building is located at OS Reference NH 852763 and was subject of a structural survey by A.F. Cruden Associates in April 1999 is illustrated on photographs numbers 1 and G59. The operations block has been recorded by NMRS and is described as being of concrete and brick construction with two external corridors created in the space between a revetted bank to the north and south. Internally there is a central corridor with a series of offices and rooms set off at right angles. Toilets exist at each end of the corridor. This building is similar to the operations block found at Arbroath (OS ref. NO 64 SW 29). A representative of the Fleet Air Arm Museum has assessed this building as being of significance in the national context but has confirmed that a similar building exists at Arbroath. The FAAM recommendation is that this building should be conserved if possible.

- 10.7 We found no evidence of any settlement or movement of the building. Both external and internal blockwork walls are structurally sound but plaster finishes are in very bad condition. The concrete floor and roof slab are generally sound but damp proof membranes have probably significantly deteriorated. Windows, door, rainwater goods and other fittings and fixtures are missing or smashed.

- 10.8 The following hazards were evident from non intrusive site investigation:
- ◆ Broken drain cover in the floor create a significant tripping hazard.
 - ◆ Asbestos insulation on the boiler installation presents a serious asbestos hazard.
 - ◆ Asbestos cement shelves in several rooms presents a low risk asbestos hazard.

Photo 1
Operations block viewed from the south

- 10.9 This building appears to be in a relatively sound state of repair and could be restored without major structural repairs being required. If the airfield were to be developed as an interpretation centre, this building would be an important feature and could provide a walk through exhibit with the offices on each side of the corridor being restored to their former condition.

- 10.11 In the short term, it is recommended that minor works be undertaken to ensure that the internal and external fabric of the building does not deteriorate further. Such work is likely to include the removal of vegetation from the roof, re proofing of the roof, minor repairs to the roof coping, repairs to drainage runs to clear standing water and securely boarding up window and door openings to prohibit access and to make the building generally wind and watertight.

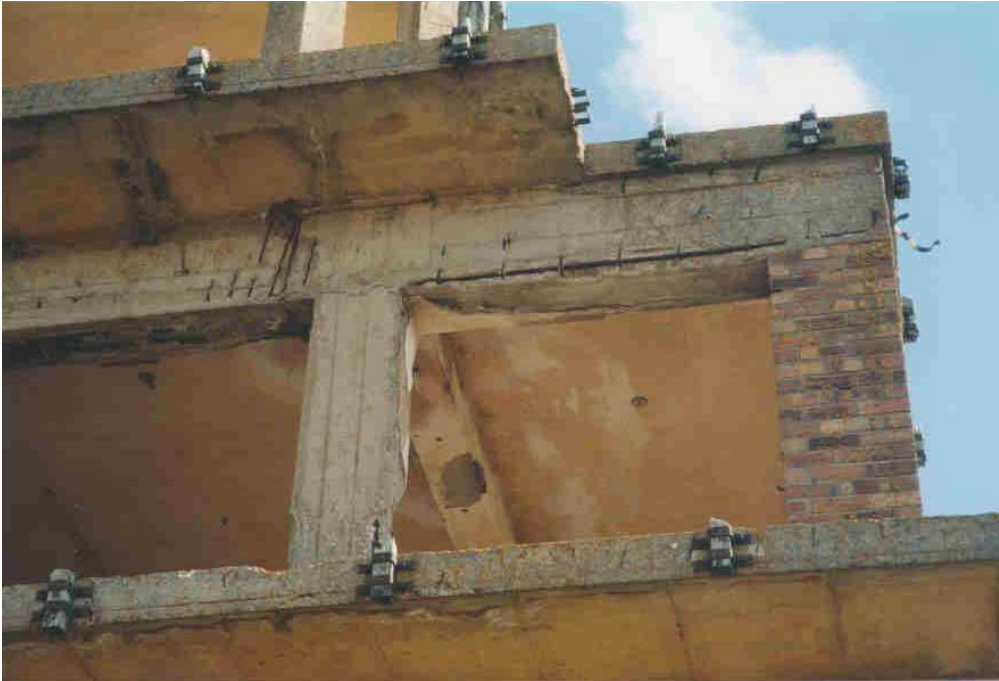
10.16 The reinforced concrete however, is in poorer structural condition with considerable spalling of concrete having exposed areas of reinforcement. (see photographs) This has been caused by carbonation of the concrete (a natural occurrence where carbon dioxide penetrates the concrete and eventually causes corrosion of the reinforcement), and will become progressively much more widespread with time.

- 10.17 Internally the plaster finishes to the walls are in very poor order and again much of the soffit of the concrete floor slabs is affected by spalling concrete.
- 10.18 All window frames and most of the window cills have disappeared from this building, together with most of the other fittings and fitments.

- 10.19 Apart from the obvious risks of falling from unprotected openings in the building, the principal risk is from spalling concrete falling from the balconies or frame.
- 10.20 Some asbestos cement sheets are incorporated into the internal tables and workbenches, and the remains of asbestos cement rainwater pipes lie scattered around the area. These present a low risk asbestos hazard.

Photo 3
Control Tower
concrete deterioration of 2nd floor structure viewed from the south

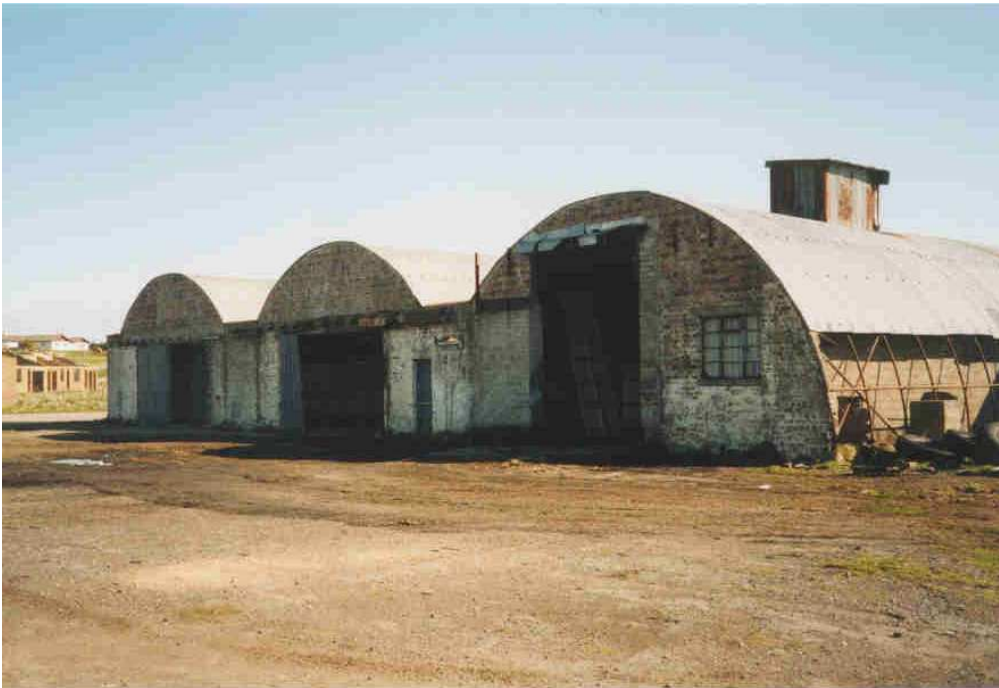
Photo 4
Torpedo sheds viewed from the south

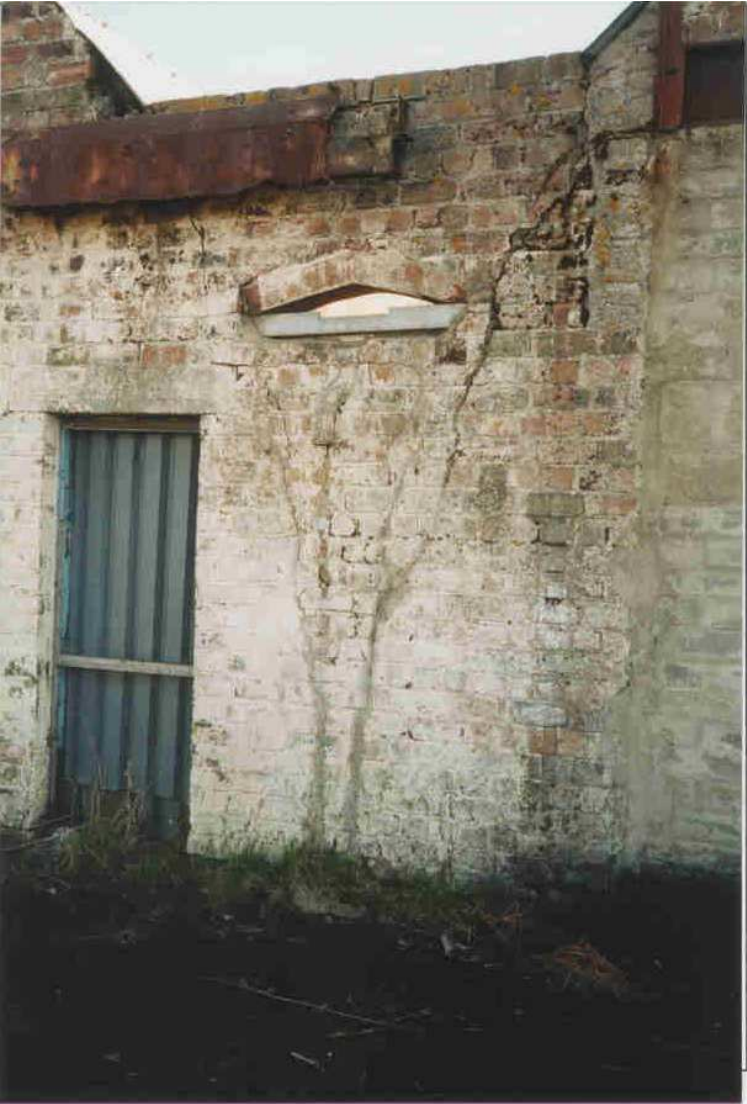
Photo 7
Torpedo sheds
Cracked brickwork on west gable wall at junction with nissen nuts

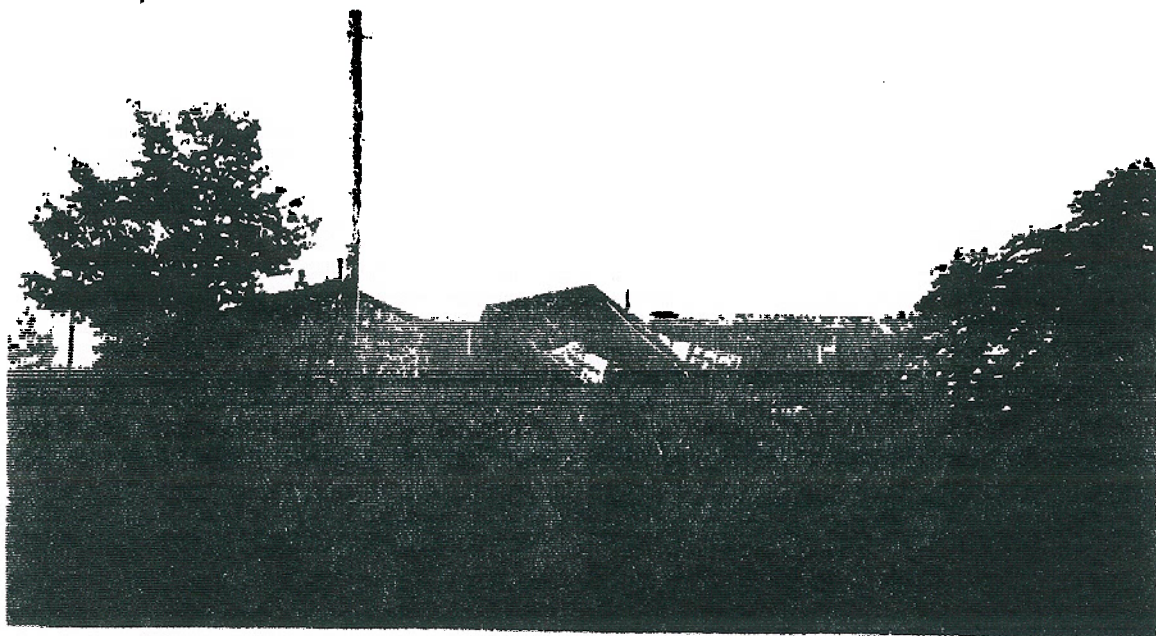
More badly damaged buildings at Lochslin. Some of these are used, however, for storage.

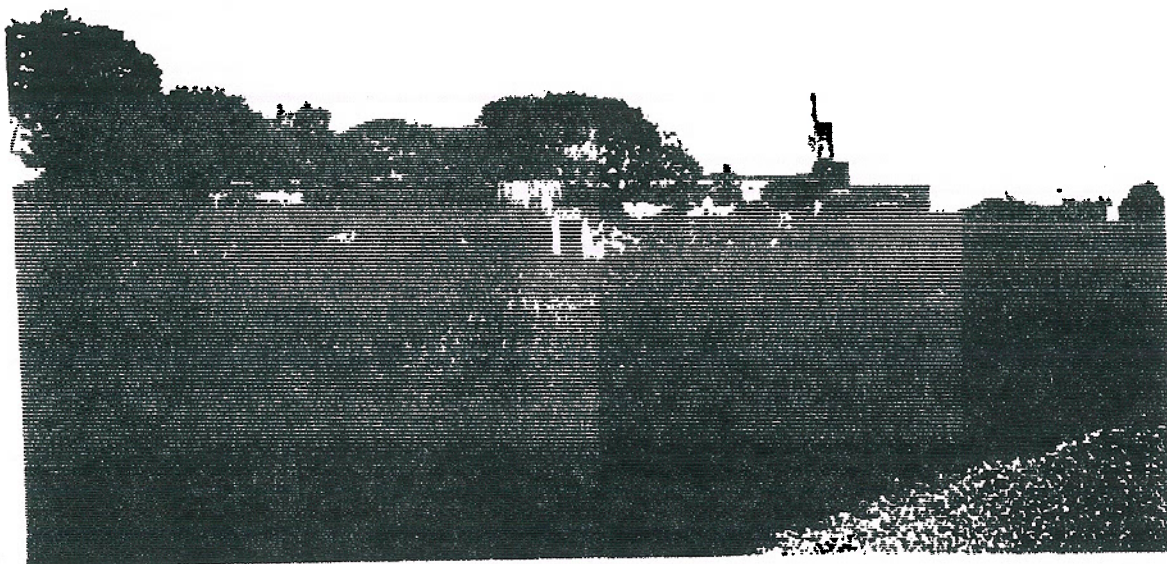
The Operations building on Hunting Hill. This is perhaps the most interesting building to visit as it has retained a considerable atmosphere despite the graffiti. Some old signs can still be found.

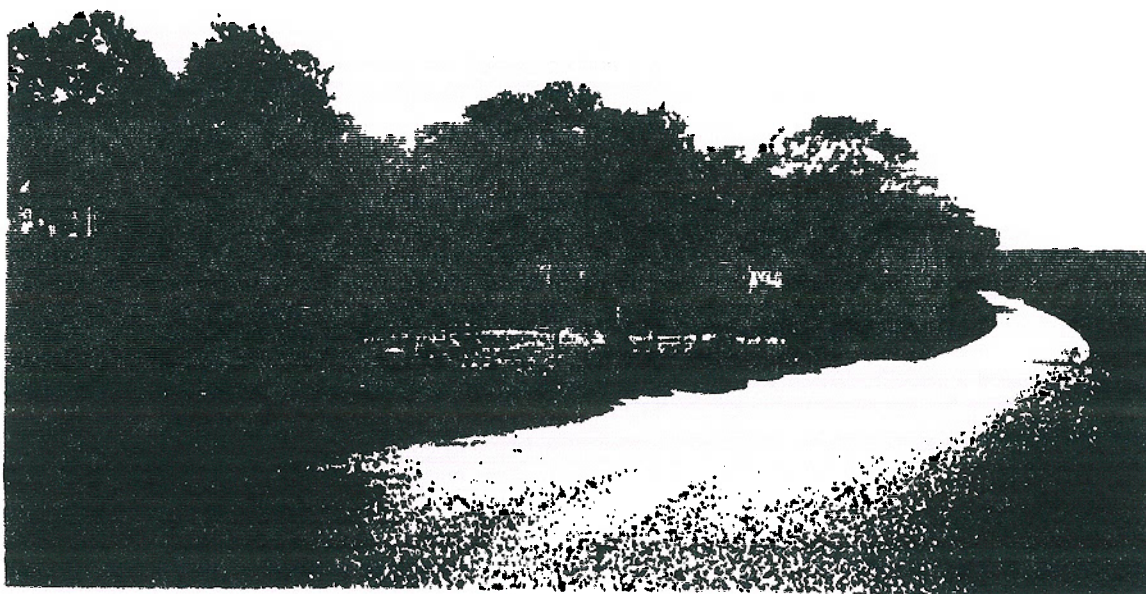
Another overgrown building on Hunting Hill.
