The Highland Council

**The Mackintosh Mausoleum, Petty
Report on collapsed roof**

Part 1 – written report and recommendations

July 2013

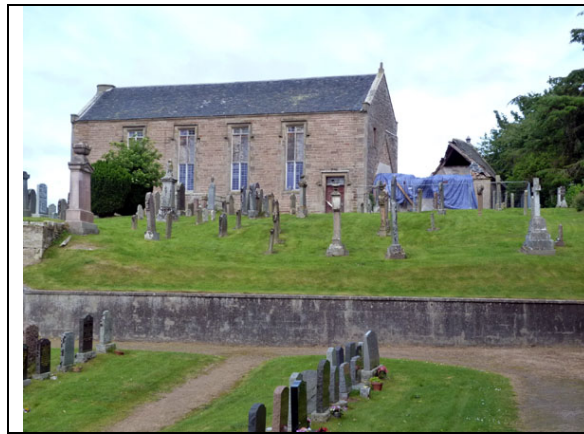
Fig 1 View from the south, from across the graveyard; the collapsed roof of the mausoleum is to the right (east) of the former parish church of St Columba

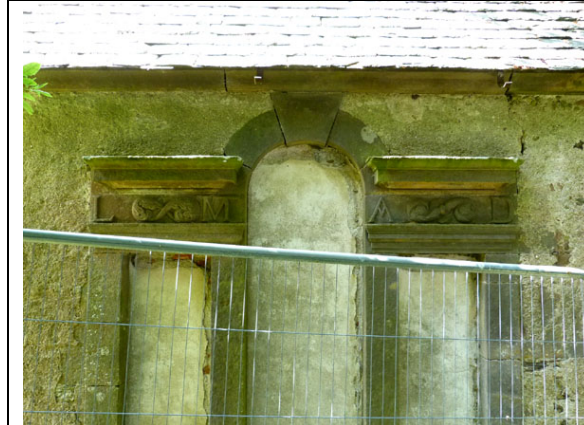
Fig 2 The lintol to the Venetian window on the east elevation which carries the date of 1742 on the keystone, commemorating Lachlan Mackintosh and Anne Duff

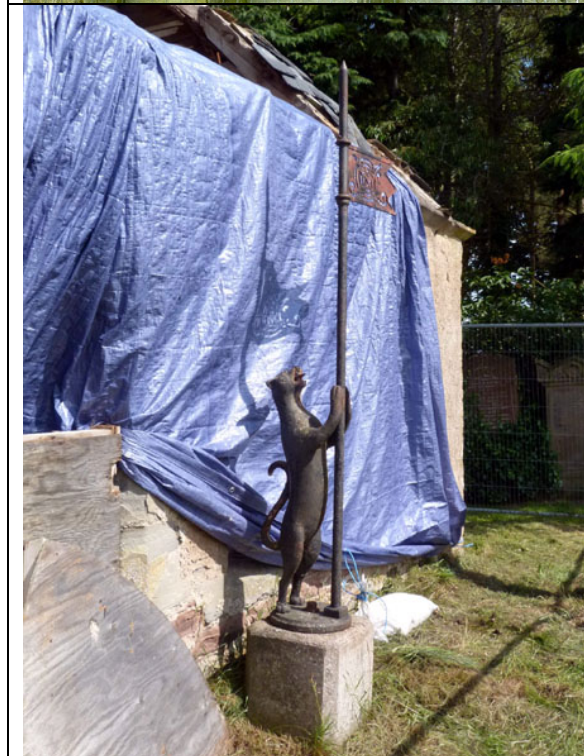
- 6.23 The heraldic cats are formed from two sections of cast-iron with the seam between the two castings pointed up in what might be linseed oil putty, or possibly a pure lime putty mix. Their condition does not give cause for concern, but a report on their condition would be merited from an accredited conservator. The surfaces might be prepared for shot-blasting with a fine grade of material in preparation for the application of a decorative treatment to preserve the life of the statues and the banners they hold.

Fig 3 One of the pair of cast-iron cats symbolising Clan Chattan, carrying banners on poles flanking the entrance to the mausoleum

- 8) An accredited conservator should be commissioned to report on the cast-iron cat statues and on measures to protect them against future decay

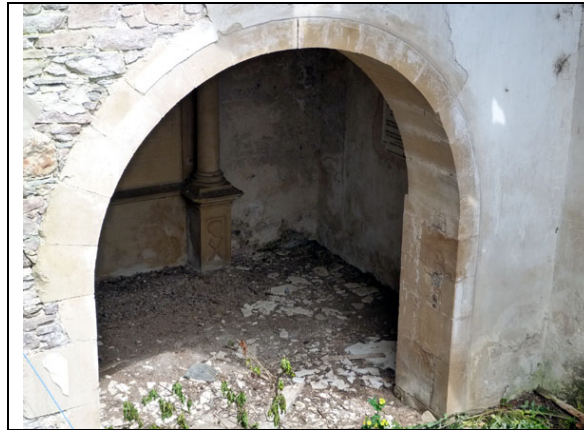
- 2.2 The vault to the north has wall monuments which are partially visible on the north gable and east walls in yellow sandstone and marble respectively (Fig 4). The floor of the mausoleum is finished in sandstone slabs and it is believed that there are burials below this level.

Fig 4 Wall monuments can be glimpsed through the arch at the entrance to the north vault on the north gable and east wall, of yellow sandstone and marble respectively; the panel to the right is believed to have been inserted in 1861 at which time the Venetian window would have been blocked up

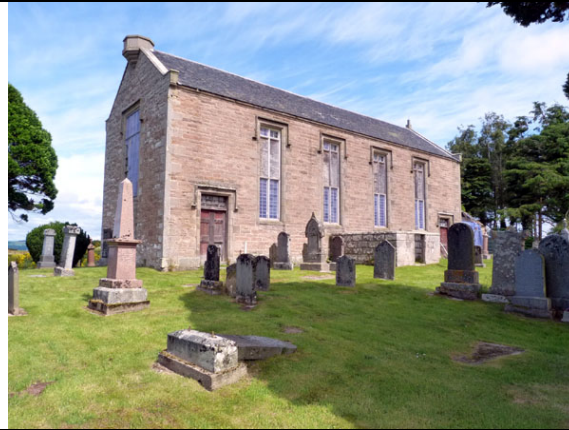
- 2.3 Being unsafe, the property had been boarded up, and for a number of years it had been inaccessible. Together with the adjoining redundant church (which is in private ownership) it has been on the Buildings at Risk since 1990 and the condition of the structures has been monitored on a number of occasions since. Although the mausoleum is in the ownership of Clan Mackintosh, since the mid-1990s the clan has requested that the responsibility for its future care should pass to the Highland Council, with a renewed plea made in 2003. It is understood that the Council served a Dangerous Building Notice on the owners of the adjacent church in April 2013 to make it wind and weathertight. The Council has the responsibility for the maintenance of the graveyard (Fig 5).

Fig 5 View from the southwest of the former parish church of 1839 with the mausoleum beyond; the octagonal bellcote at the west end of the church has been taken down

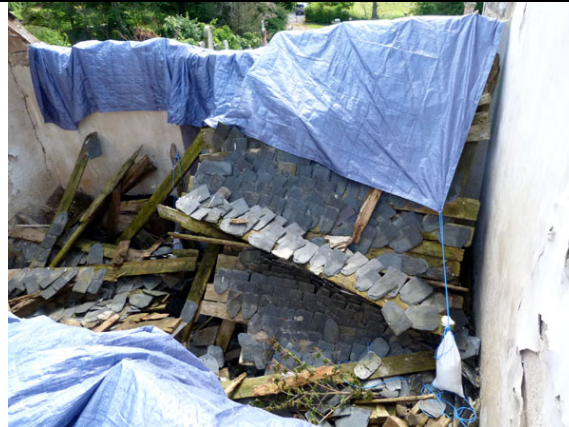
- 2.4 Since the roof collapsed the Council has cordoned off the site with Heras fencing to deter access. Warning signs that the site is unsafe, and that it should not be entered, have still to be posted on the fencing. The Council has protected the exposed wallheads with tarpaulins anchored with sandbags, and invasive vegetation has been removed from the wallheads. In view of the unsafe condition of the overhanging section of roof following the collapse, the property has not been entered for the purposes of undertaking the survey and inspection of the internal fabric of the structure has been restricted to what can be seen from a ladder, and through the aperture of the entrance doorway which is blocked with fallen debris. The interior of the mausoleum is choked with broken rafters, sarking and sections of roof for which the slates have remained intact (Fig 6).

Fig 6 Interior of the mausoleum viewed from the north, showing collapsed sections of roofing with the sarking and slates still intact and the space littered with debris

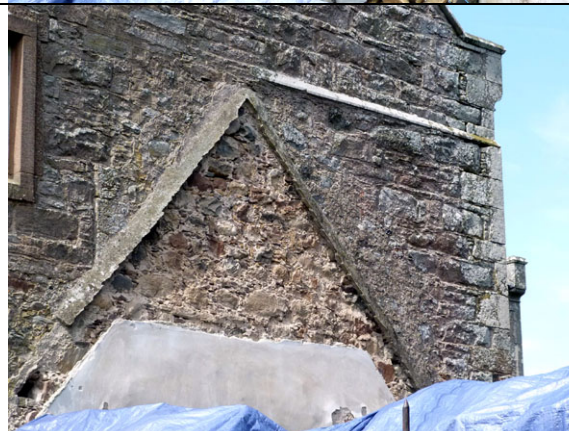
Fig 7 High level stringcourse above the roof ridge of the mausoleum at the east gable of the former church shows evidence a previous building on the site, possibly that of 1767

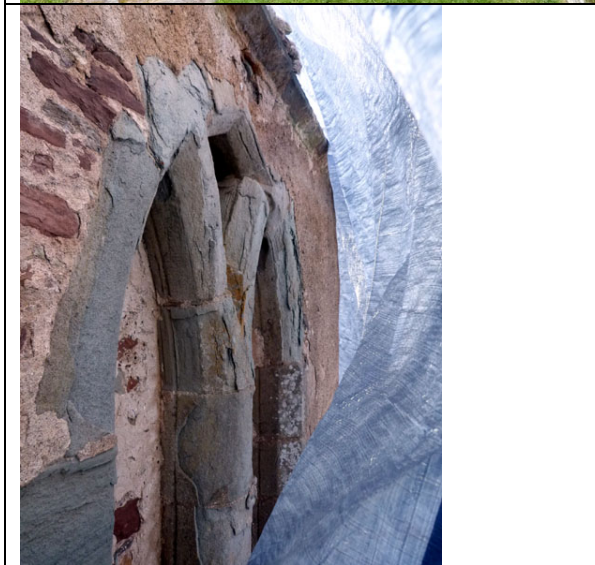
Fig 10 Gothic tracery of c1686 to the windows of the front elevation of the mausoleum, built of mudstone which is exfoliating; the line of the former glazing for leaded lights is visible

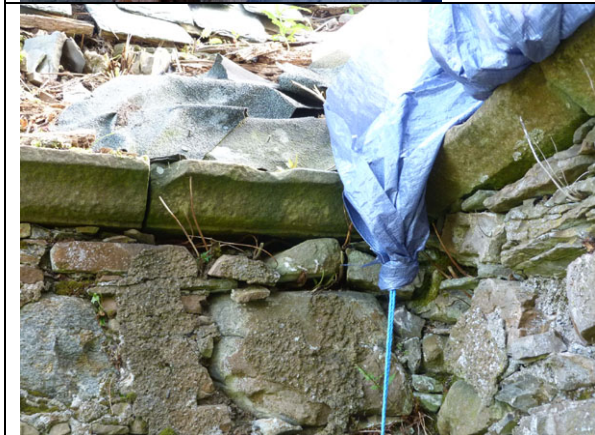
Fig 11 Internal junction between the late 17thc work and the mid-18thc extension to the north shows the differing patterns of wall tabling, from a plain chamfered stone in the earlier work to a more sophisticated cavetto moulding in the work of c1742; the rubble masonry has suffered from constant wetting from the base of the valley gutter and has open joints where the mortar has been lost

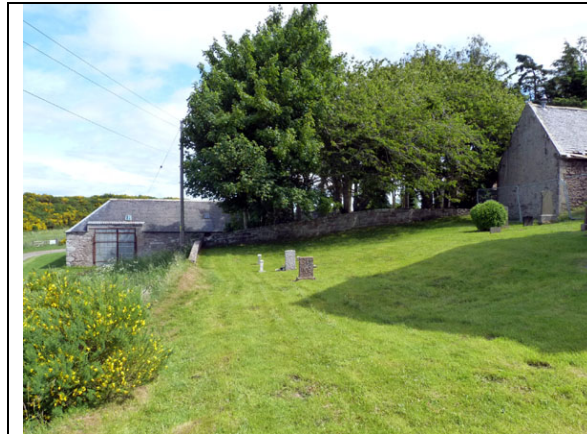
- 6.1 The site is approached by a narrow public road with steep verges, and with a small turning circle at the head at the approach to the graveyard unsuited to heavy goods vehicles. While access might be possible by the farm track to the north of the site this would require to be negotiated with the landowner, but a retaining wall would require to be overcome from this direction in order to gain access to the site. Further constraints are imposed to the west and north of the redundant former church by overhead power lines (Fig 12).

Fig 12 Trees on the east boundary; a change in level and overhead cables will have an impact on access from the north of the site, although there are fewer gravestones to negotiate in this area of the churchyard

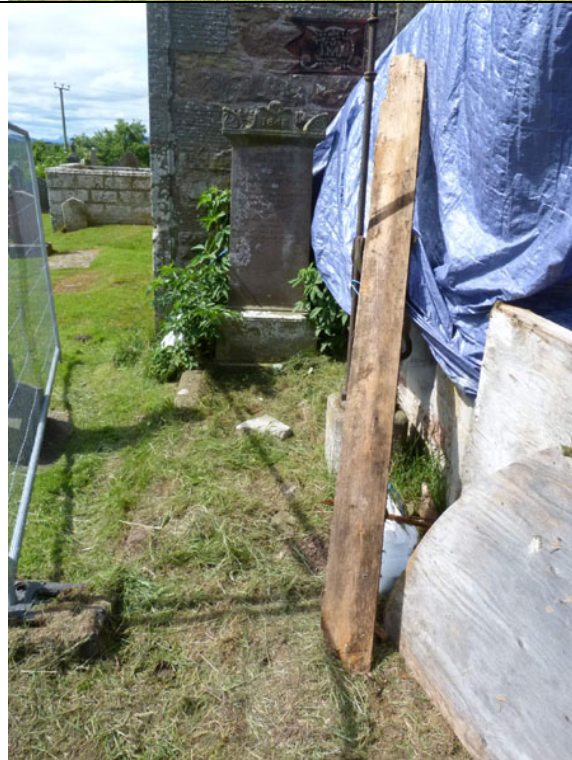
- 6.2 The approach from the public road through the graveyard is also heavily constrained by the sloping ground and by the retaining walls marking the line of the original churchyard. To the west of the older length of wall the gate piers and stone steps leading to the upper burial ground would require to be negotiated. Once within the burial ground there are several gravestones and monuments of which many will be in a fragile state, and some of them are of considerable antiquity. They would require to be negotiated in delivering materials or scaffolding to the site of the mausoleum. Surrounding the mausoleum there are also monuments and graveslabs (Fig 13). The whole of the site is archaeologically sensitive.

Fig 13 A burial lair with a stone kerb and headstone, dated 1848, is in close proximity to the south wall of the mausoleum and will require protection when erecting scaffolding

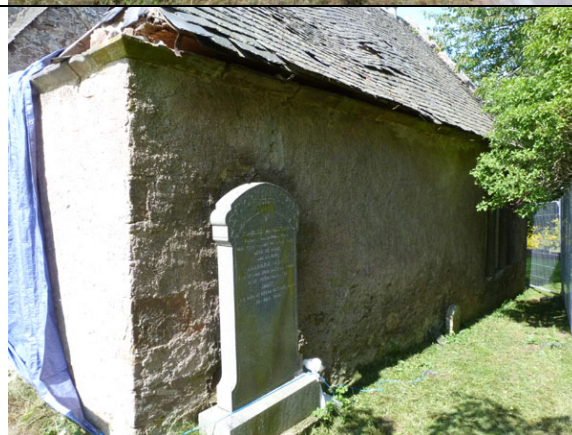
Fig 14 Overhanging trees are placing the mausoleum at risk on the east boundary; the photograph shows also further gravestones in this area which would need to be recorded and protected before works commence

- 6.3 On the east boundary there are a number of trees overhanging the burial ground and the mausoleum. Overhanging branches will require to be trimmed back by an arboriculturist, or an experienced tree surgeon, in consultation with the adjoining proprietor to gain access to the roof of the mausoleum and to prevent the risk of damage in the longer term (Fig 14).

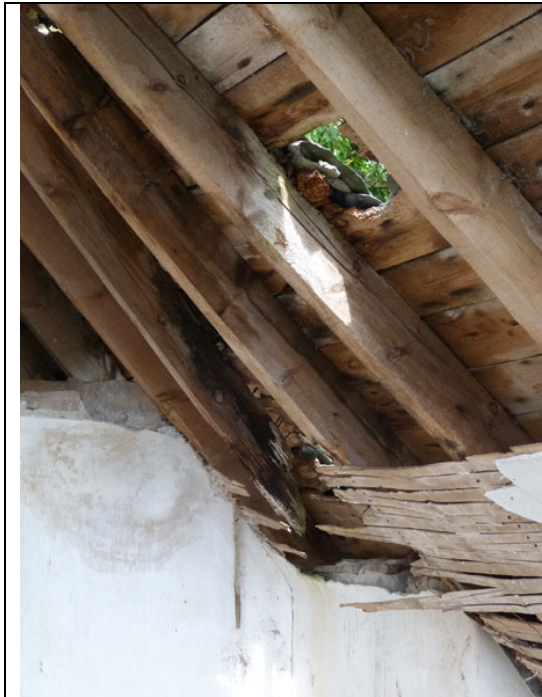
Fig 15 This section of the roof is unsupported after the roof fall, but shows at least two areas in close proximity to one another where the loss of slates resulted in the collapse of the sarking boards and decay of the rafters, allowing water to enter the interior of the mausoleum: one of the rafters has broken through

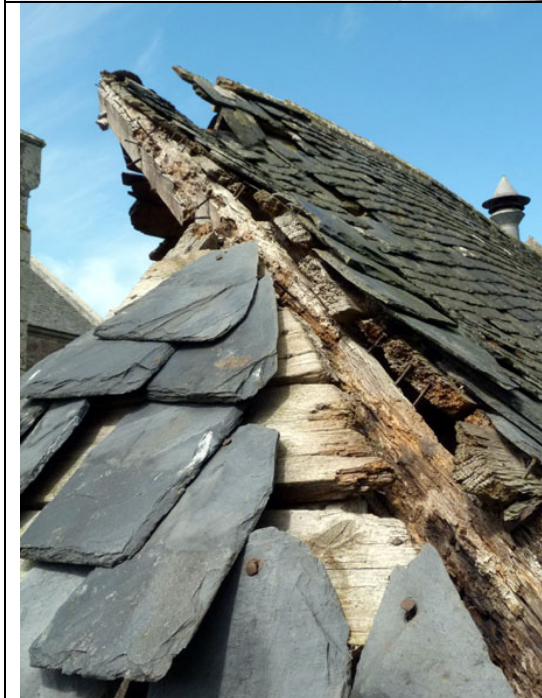
- 6.5 The collapse of the roof can be attributed primarily to the reason of extensive water penetration over the years. While this has been exacerbated by the loss of strength in the rafters at the base of the valley gutter at the northwest re-entrant there have been several isolated areas where the loss of roofing slates has resulted in the decay of sarking boards and individual rafters resulting in breakage or a loss of strength, weakening the roof (Fig 15). Water penetration has occurred also at the head of the roof from the lack of pointing and bedding mortar to the sandstone ridges. The roof structure at the piended section at the southeast corner was intrinsically weak in having no collars to the roof trusses, such that the stability was heavily dependent on the hip rafter and the tie at ceiling level. It can be seen that the hip rafter has suffered from water penetration at the upper surfaces from defects in the roofing materials – it appears that the slates could have been close-mitred and this detail may have failed through lack of maintenance over the years (Fig 16).

Fig 16 The unsupported hip rafter following the roof collapse, showing water damage from defective coverings; it is not known how the piend had been protected, whether by sandstone hip tiles similar to the main ridge, or by close-mitred slates

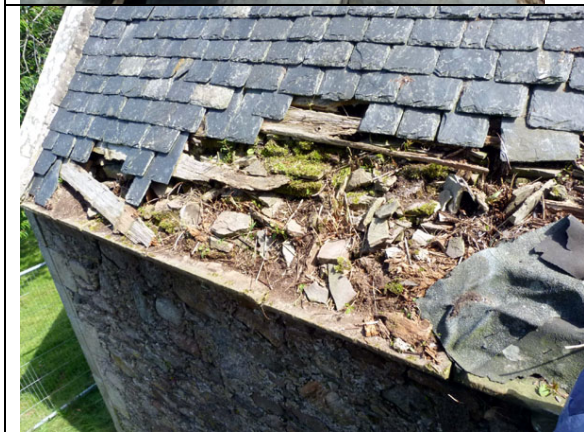
Fig 17 Extensive damage caused by loss of slates and sarking on the west side of the roof above the north vault: the condition of the rafter ends is uncertain, being covered in vegetation growth and debris trapped by the beamfilling and plaster and lath, but is bound to be poor, throwing the stability of the roof into question

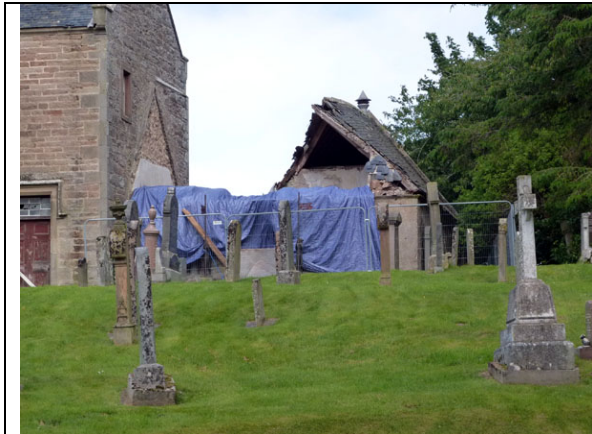
- 6.8 The collapse of the piended section has left a fragment of the roof suspended, extending back to the arched internal wall at the north jamb. From this point southwards the ridge of the roof can be seen to be dipping progressively; the sandstone ridging will be adding to the load (Fig 18). The imbalance over this section caused by the collapse has been such that the wallplate (affected by woodworm infestation) has been lifted clear above the masonry over this section of the wallhead (Fig 19). The exposed areas of the roof are vulnerable not only from self-weight – there is also the risk of collapse from wind damage. This risk extends to the roof of the north vault which would be left open-ended if the unstable section of roof were to collapse which, from being on elevated ground in a coastal location renders the site exposed to potential damage from uplift and suction in extreme conditions. This section of the roof is unstable, and is presently in a dangerous condition.

Fig 18 The unsupported part of the roof exposed after the collapse can be seen from the south, with the stone ridging dipping towards the unrestrained hip rafter

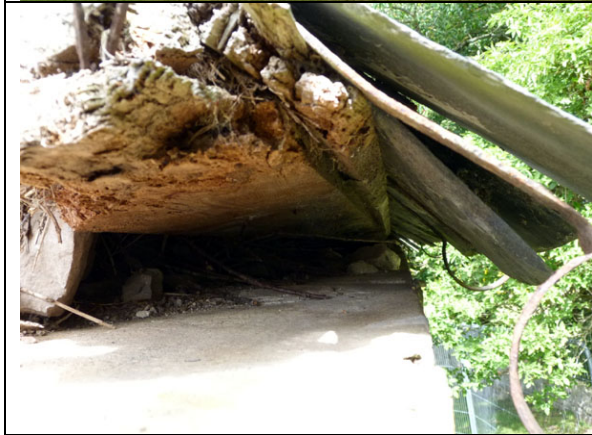
Fig 19 Photograph looking along the wallhead from the southeast corner, showing the wallplate (partially rotten with woodworm infestation) lifted clear from the stone tabling under the weight of the unsupported portion of the roof – this condition extends to as far as the internal wall to the north vault where the roof appears sound

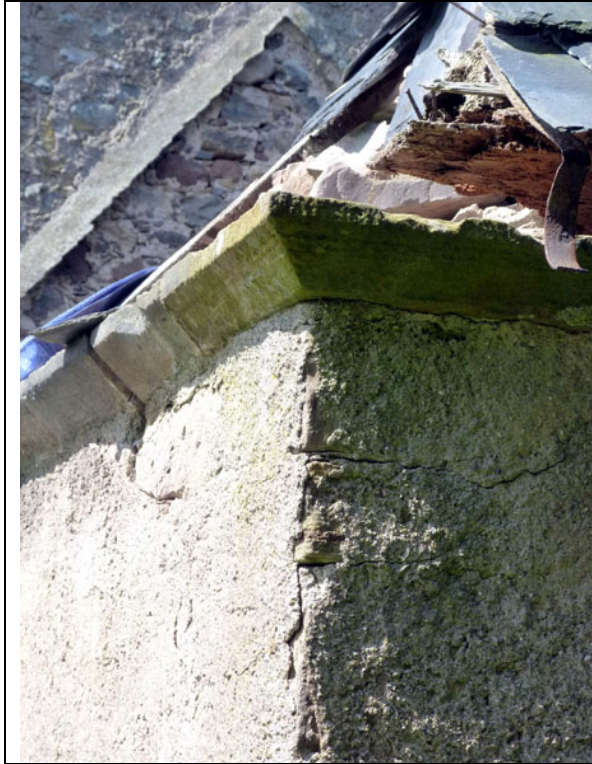
- 6.13 Remarkably, the collapse of the roof does not appear to have affected the structure of the external walls to any great extent. There has been rotation in the masonry of the southeast corner which shows up as a vertical crack in the internal plaster, and on the outside where the tabling stone has moved: close examination reveals that this movement has been longstanding and has not been occasioned by the lifting of the wallplate (Fig 20). There is further evidence of cracking close to the corner on the east wall which has been patched in cement mortar and the cause of this movement may be due to lateral thrust occurring from the hip truss.

Fig 20 Detail of the wallhead at the southeast corner of the building, showing the wallplate lifted from the wall tabling course and rotation in the corner stone which has disturbed the harling, although this is thought to be unrelated to the roof collapse

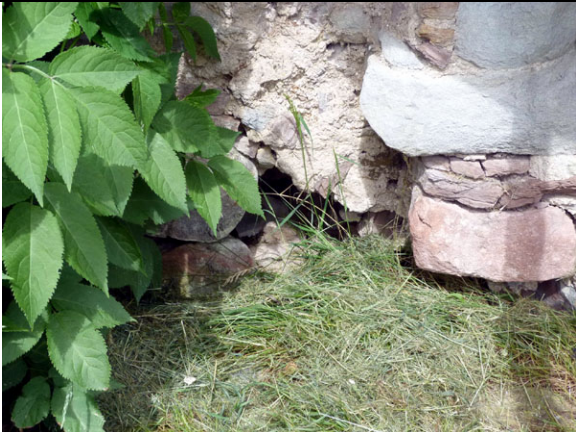
- 6.15 At the south elevation at the abutment with the east gable of the former church, where the wall is chamfered and set back from the face of the wall, there has been a failure in the foundations with voids appearing in the core of the wall (Fig 21). The reasons for this appear to be uncertain, but could be attributed to burrowing animals in the past. The masonry will require to be consolidated to provide a firm foundation.

<p>Fig 21 Open voids in the base of the external wall at the junction with the former church gable, on the south elevation: the grey mudstone of the window rybat and cill is visible</p>

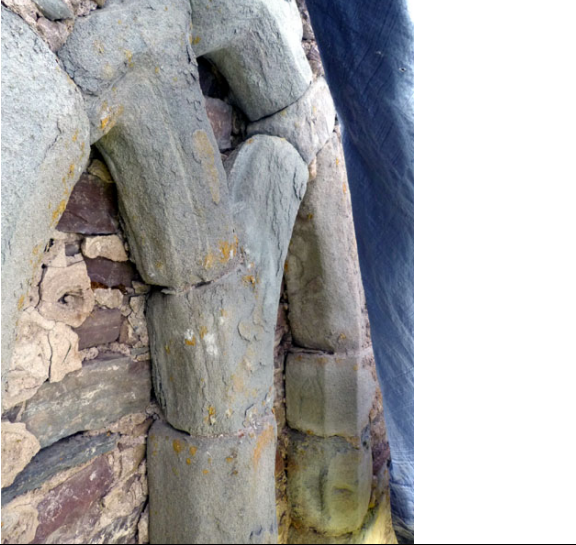
- 6.17 The tracery and rybats of the windows and door of the south elevation appear to have been built roughly, with wider joints than would be normal. Of grey mudstone, they have not weathered well and are prone to exfoliating. While light brushing with a stiff bristle brush may find a sound surface, the exfoliation is likely to continue, given the nature of the material (Fig 22). A conservator's report would be justified to establish if the stone can be consolidated in order to arrest further decay.

<p>Fig 22 The gothic tracery to the windows of the south elevation is poorly formed and unorthodox in detail; the grey mudstone is of poor quality and is exfoliating, with some loss of detail</p>

- 7) An accredited conservator should be commissioned to report on the mudstone dressings and tracery to the openings of the south elevation, the carved lintol of the Venetian window, and on the current condition of the monuments within the mausoleum

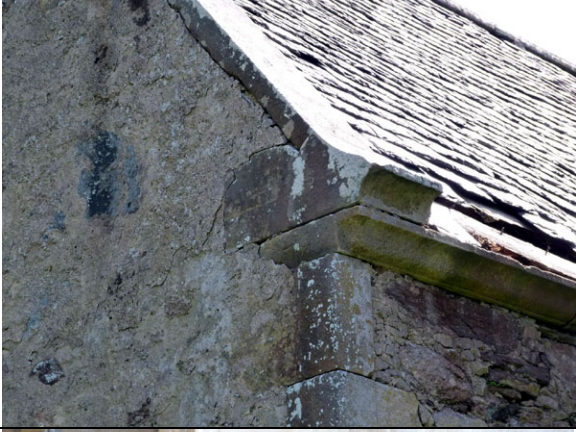
- 6.21 At the north gable the sandstone skews appear to be in reasonable condition although the apex stone has weathered. The skews have wandered slightly out of alignment, and should be lifted, rebbed and repointed in hydraulic lime mortar. Care should be taken not to disturb the harled surface. Depending on the state of the internal gable and levels of dampness, consideration may need to be given to bedding the skews on an 'Alumite' or similar dpc, and to introducing stainless steel dowels to discourage further movement. Although the gable is steeply pitched, downward movement of the skew stones may be discouraged by the inclusion of kneeler blocks at the mid-points of the gable. The skewputt at the northwest corner appears to have moved slightly and may merit lifting, rebbed, and anchoring the stone to the core of the wall (Fig 23).

<p>Fig 23 The skewputt at the northwest corner of the north gable has moved slightly under the load of the skews which are slightly out of alignment; the problem is exacerbated by the steep pitch of the roof</p>

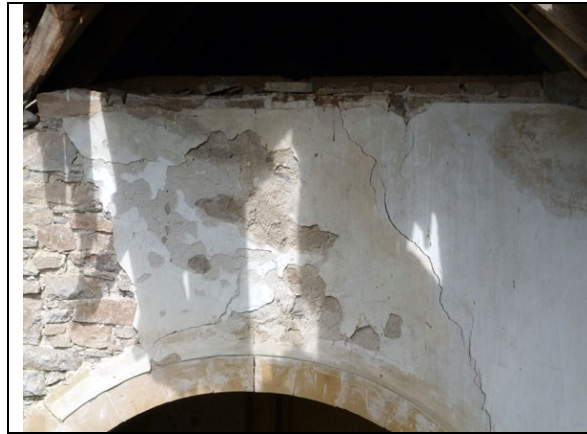
- 6.26 The rounded arch at the opening to the vault within the north jamb is formed of regular yellow sandstone voussoirs. Movement within the wall has caused the keystone to drop slightly and voussoirs to the right of the opening to be displaced, resulting in a fracture to one of them. There is cracking in the plaster above the fracture which extends to the line of the former ceiling (Fig 25). The full extent of the cracking and its likely cause can only be established once safe access is possible.

Fig 25 Cracking in the plaster finish above the arch leading into the north vault, resulting in the keystone dropping and movement in the voussoirs to the right of the opening; the collar tie beyond the head of the wall has snapped due to weakness caused by woodworm infestation
