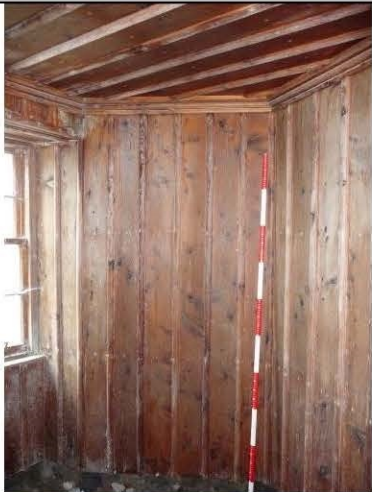
Building Element	Item		Reason		Image
L2	Tower basement	EXCEPTIONAL	Pine clad room with pine batten door and wooden coving. Unpainted 12 pane sash window

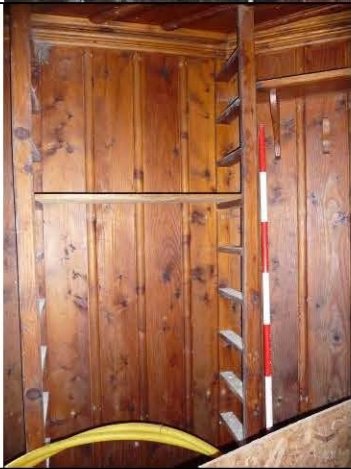
L3	Tower basement	EXCEPTIONAL	Pine clad tower basement with pine batten door. Used for storage of guns, fitted with shelving and wooden coving. 12 pane sash window

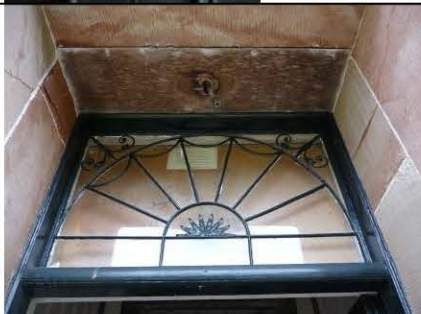
Fanlight	EXCEPTIONAL	Metal framed fanlight of early 18 <sup>th</sup> / late 19 <sup>th</sup> century design with later electric conduit over for central door light. Fanlights were originally intended to create light in the entrance hall, but from Georgian times became increasingly ornate.

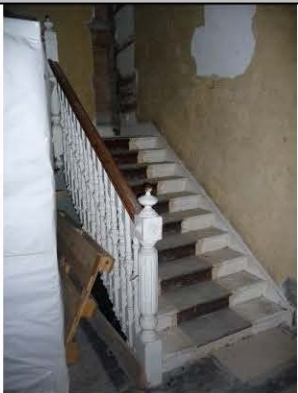
Building Element	Item	Significance	Reason		Image
Room G 02	Painted wooded panelling and newel posts on staircase	CONSIDERABLE	Staircase hall with open well wooden cantilevered stair and decorative balusters and newel posts in high Victorian gothic style. Treading painted on edges only for carpeting in centre; some stair rod hooks intact.

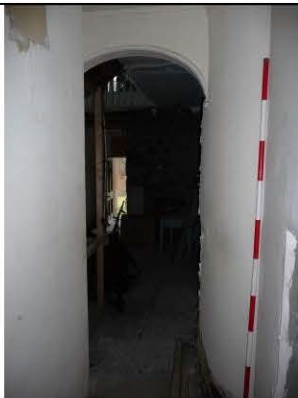
Plaster arch and cornice at approach to G09 hallway	CONSIDERABLE	Archways and gently curved walls have a significant contribution to make towards retaining 19 <sup>th</sup> century character

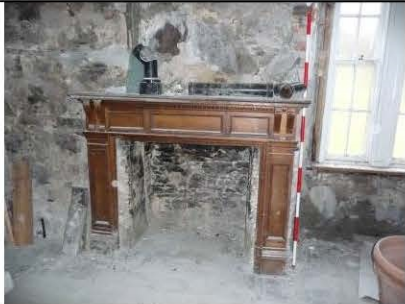
Archway into G10	CONSIDERABLE	Archways are a continuing theme throughout the house and so should be retained. It also introduces a less rigid formal line before entering curved projecting towers.		
Room G 04	Fireplace	EXCEPTIONAL	Original oak fireplace with stone hearth and plain stone surround

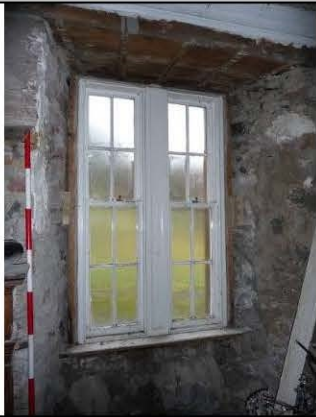
Building Element	Item	Significance	Reason		Image
	Windows	EXCEPTIONAL	The retention of the sash windows is vital in retaining historic character both to internal and external elevations and as a unifying feature imposed by Carruthers throughout the house. This includes the glazing bars, and window fittings such as catches. Original lintel survives above both sets of window. Two sets of double 4x4 pane lights.

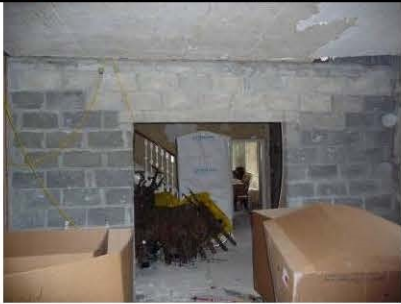
Replacement partition walling on north and west walls and plastic piping	MARGINAL	New partition walling is made from modern materials and of no historic interest. The new angles between rooms that it creates tends to form sharp right angles rather than the curved ones favoured in the Carruther's design.

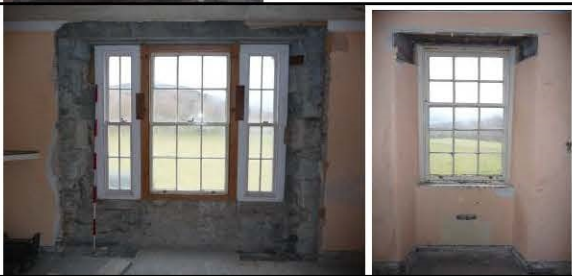
windows	EXCEPTIONAL	Tri-partite sash in west wall and 15 pane multi sash in north wall. Side windows appear to have originally been 'blind' and only opened up as part of works of 2003.

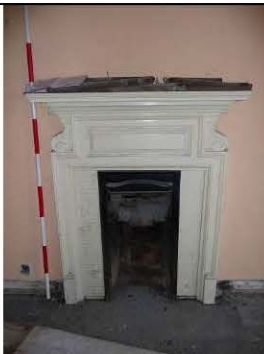
lathe and plaster	CONSIDERABLE	In good condition throughout apart from where removed above window		
	fireplace	CONSIDERABLE	fireplace in bedroom style indicative of original use of room. Cast iron with painted tile surround.

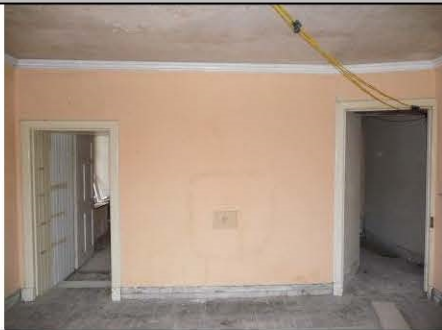
Building Element	Item	Significance	Reason		Image
	ceramic enamelled vent	CONSIDERABLE	Vent to air stack

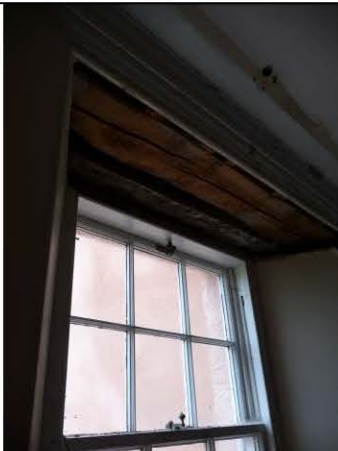
floorboards	CONSIDERABLE	Historic character and helps to ensure breathability. Painted edges where carpet not fitted wall-to-wall		
Room G 08	windows	EXCEPTIONAL	Fifteen pane sash window. Pulley above the latter window, possibly as part of mechanism to make opening the top sash easier – popular in the late 19 <sup>th</sup> century. Evidence of a former fitting to the centre of the top sash suggesting a sash eye or similar for pulling the top sash with a sash stick hook.

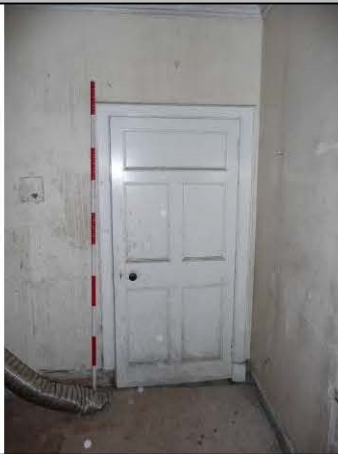
Building Element	Item	Significance	Reason		Image
	Internal door to G7	CONSIDERABLE	Five panel door

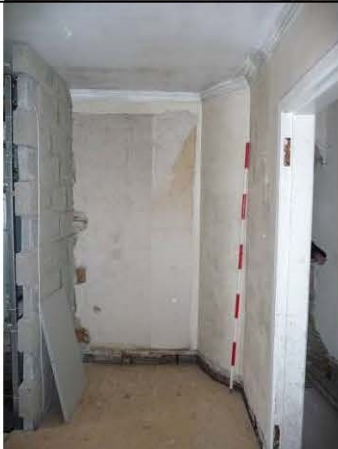
Walls	CONSIDERABLE	The outside north wall appears to have had tongue and groove panelling typical of a service rooms such as a kitchen and used by arts and crafts designers such as Carruthers. These have now been removed. The internal partition wall between hall G9 and G8 curves at the corner adding character and interest. This is highlighted by the ceiling coving. The modern lift destroys the gently curving lines of the coving.

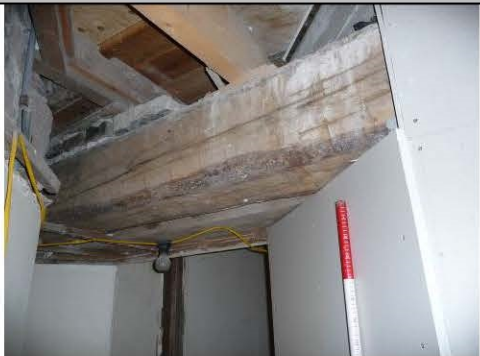
Building Element	Item	Significance	Reason		Image
Room G 09	Walls	CONSIDERABLE	The narrow walls with curves at each end display the Victorian ideal of a medieval castle. The junction with G6 (to the basement) and G& (bedroom) has former render exposed behind lath and plaster work which has been ripped out. This wall appears therefore to have been external in an earlier house layout. A substantial oak beam over this section with some bark remaining has also been exposed.

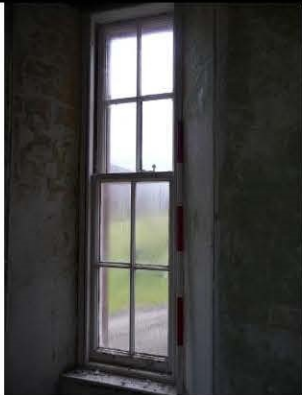
Room G 10	Window	EXCEPTIONAL	8 pane sash windows with brass sash catches. Designed to match the majority of other windows in the house.

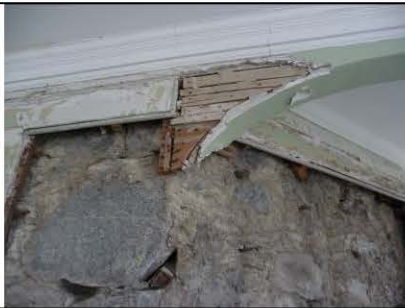
Building Element	Item	Significance	Reason		Image
			into the turret		
	Arched entrance	CONSIDERABLE	Twinned with opposite archway to G11. Continues the arched theme present throughout the house and the gently curving nature of Carruthers's design

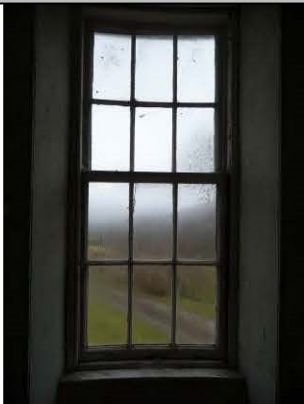
Building Element	Item	Significance	Reason		Image
Room G 11	Window	EXCEPTIONAL	12 pane sash windows with brass sash catches, slightly curved to fit in projecting tower. Designed to match the majority of other windows in the house.

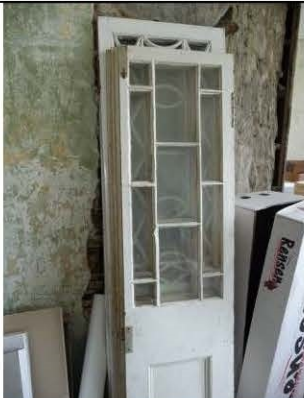
First Floor					
Room FF 01	Internal glazed door	CONSIDERABLE	Part of decorative scheme of 1894 and ties in with ornate glass doors on ground floor and the design matches the overlight above FF1	Retain, currently stored in Room G03

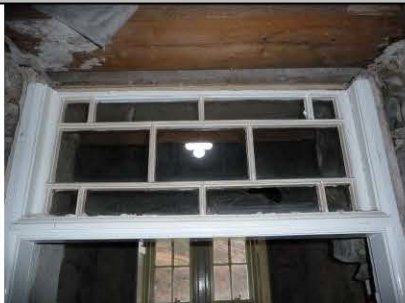
Building Element	Item	Significance	Reason		Image
	Overlight	CONSIDERABLE	Matches the internal doors and allows light into the hall. The simple design reflects a growing rejection of Victorian ornate styles seen in the arts and crafts movement which Carruthers admired.

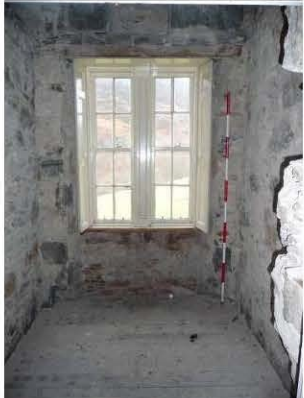
Window	EXCEPTIONAL	Double 8 pane sashes with shutters, sash catches and lifters remaining

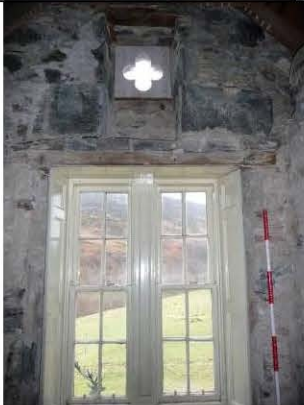
Quatrefoil window	EXCEPTIONAL	Part of the pre- Carruthers design of c.1820-40

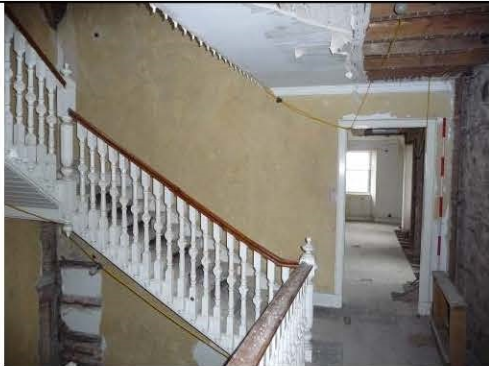
Building Element	Item	Significance	Reason		Image
	Floorboards	CONSIDERABLE	Same 6 ½ inch wide floorboards used throughout the house		
Room FF 02	Stairwell	CONSIDERABLE	Staircase hall with open well wooden cantilevered stair and decorative balusters and newel posts in high Victorian gothic style. Treading painted on edges only for carpeting in centre; some stair rod hooks intact.

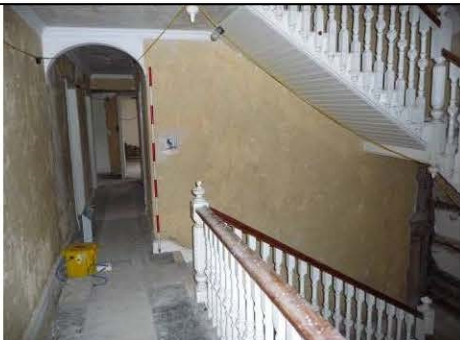
Floorboards	CONSIDERABLE	Same 6 ½ inch wide floorboards used throughout the house		
	Arch to FF10	CONSIDERABLE	Continues the arched theme present throughout the house and the gently curving nature of Carruthers's design. Twinned with arch below between G2 and G9

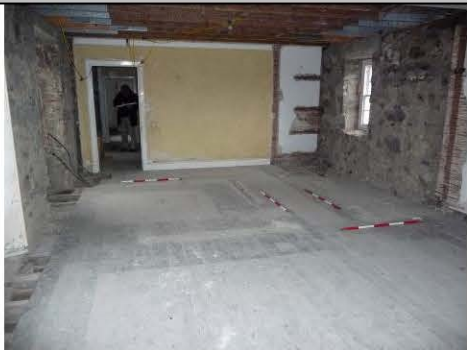
Building Element	Item	Significance	Reason		Image
Room FF 03	Evidence of former layout	SOME	Previous partition wall and carpeting scheme seen in varnished/unvarnished areas of floor boarding. The room was formerly subdivided into three smaller rooms (excluding turrets). This may have been a later modification and did no justice to the spacing and light of the larger room which was originally intended.

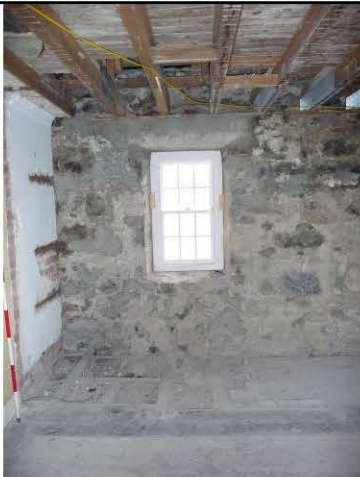
Windows – west wall	EXCEPTIONAL	West wall – 12 pane sash with catch, no lifters.

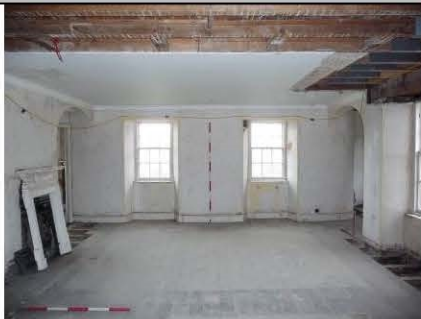
Building Element	Item	Significance	Reason		Image
	Windows north wall	EXCEPTIONAL	North wall – two 12 pane sashes with lifters and catches intact.

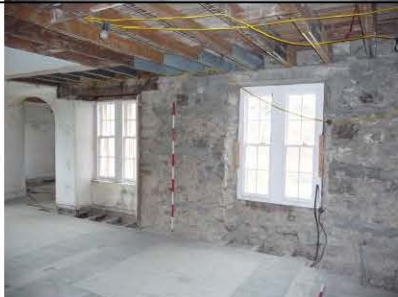
Windows east wall	EXCEPTIONAL	East wall – two double 8 pane sash windows. All catches intact, some lifts intact

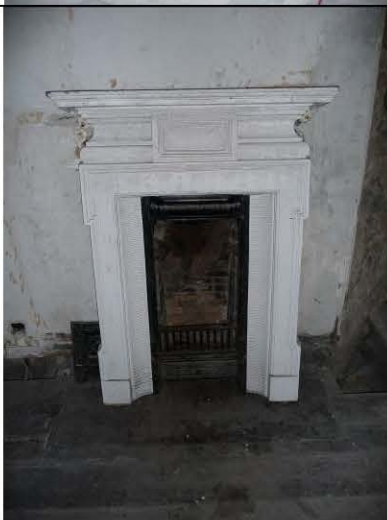
Fireplace	CONSIDERABLE	Cast iron Victorian fireplace – possibly moved from another room when FF3 was subdivided?

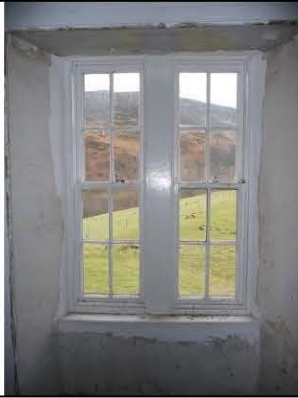
Building Element	Item	Significance	Reason		Image
	Floorboards	CONSIDERABLE	Same 6 ½ inch wide floorboards used throughout the house		
	Finishings – coving, skirting, door frames	CONSIDERABLE	Finishings have been partially removed, but are required to reintroduce smooth lines and to create a quality finish.		
Room FF 04	Windows	EXCEPTIONAL	One set of windows in east wall, double 8 pane sashes matching other windows. Catches intact, no lifters

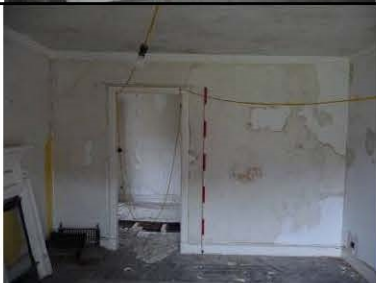
Door through to FF5	SOME	Plain door surround, door in storage

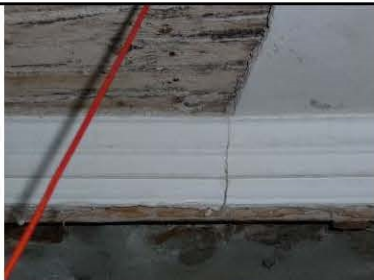
Building Element	Item	Significance	Reason		Image
Room FF 05	Window	CONSIDERABLE	One small replaced 12 pane sash window in mid 19 <sup>th</sup> century style		 
	Floorboards	CONSIDERABLE	Same 6 ½ inch wide floorboards used throughout the house		
	Finishings	CONSIDERABLE	Coving and skirting intact

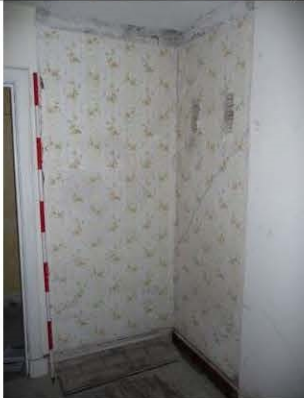
Evidence of corner cupboard	SOME	Surviving wallpaper where former wall cupboard stood. Also baton door on floor

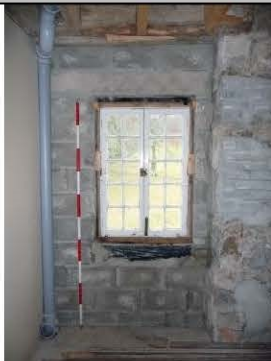
Building Element	Item	Significance	Reason		Image
Room FF 07	Window south wall	CONSIDERABLE	South wall has 2x10 pane side hung casement windows to match the one below in G6. Central brass lever catch survives.

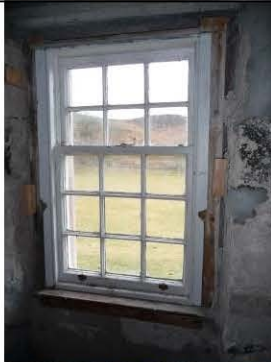
Window west wall	CONSIDERABLE	15 pane sash to match rest of house, both lifts missing, catch intact, ropes intact

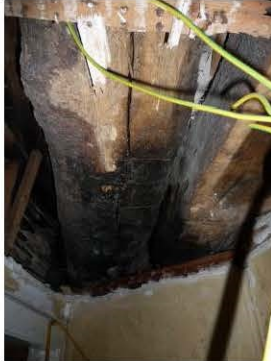
Entranceway to FF10	CONSIDERABLE	Massive oak beam shows signs of fire damage prior to lath and plaster work, therefore pre-Carruthers

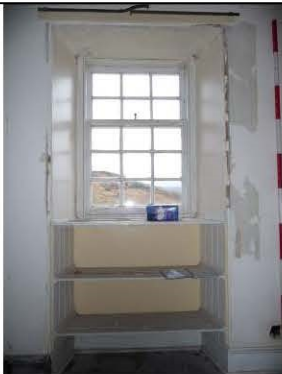
Building Element	Item	Significance	Reason		Image
	Flooring	MARGINAL	Modern replacement		
Room FF 08	Window west wall	EXCEPTIONAL	15 pane sash window with fitted shelves below. Glass lightly rippled with age.

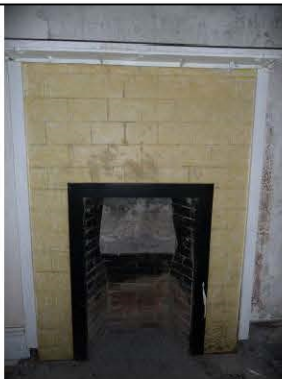
Window north wall	EXCEPTIONAL	Replacement or restored 12 pane sash window, sash lifts missing. Large oak beam over with bark to arrises		
	Fireplace	CONSIDERABLE	Plain bedroom Victorian fireplace with tiled surround, contributes towards Victorian character of the room

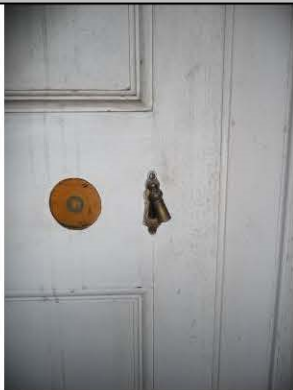
Building Element	Item	Significance	Reason		Image
	Fitted cupboard	CONSIDERABLE	Original Victorian feature. Cupboard with 5 panel door, circular brass handle missing, but lock cover remains. One shelf to top and three brass hooks below

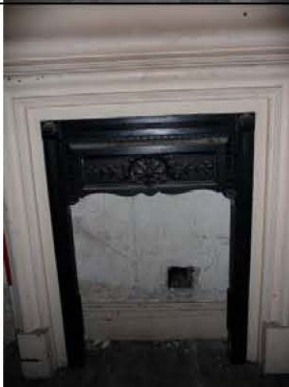
Fireplace	CONSIDERABLE	Part of original Victorian design

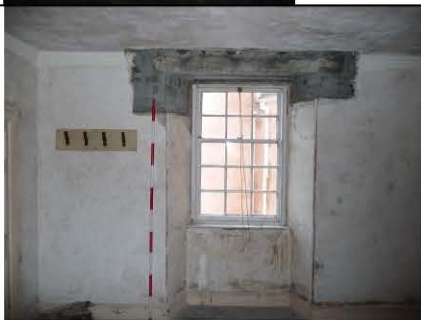
Window	EXCEPTIONAL	15 pane sash window looking towards turret and Loch Ness. A pulley ring above matches one down stairs in G8 and is designed to assist in the opening of the top sash. Rope still intact, lever catch intact, lifts missing.

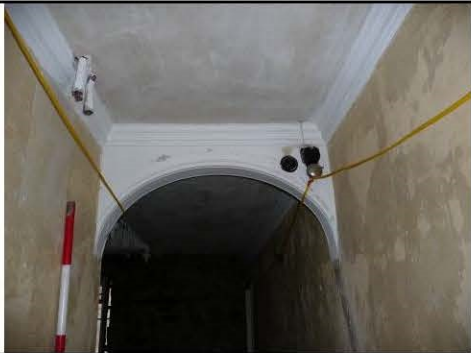
Building Element	Item	Significance	Reason		Image
	Finishings	CONSIDERABLE	Finishings are required to reintroduce smooth lines and to create a quality finish.		
	Floorboards	CONSIDERABLE	Same 6 ½ inch wide floorboards used throughout the house		
Room FF 10	archways	CONSIDERABLE	Continues the arch theme throughout the house. One has servant's (?) bells fixed to it of a recent date.

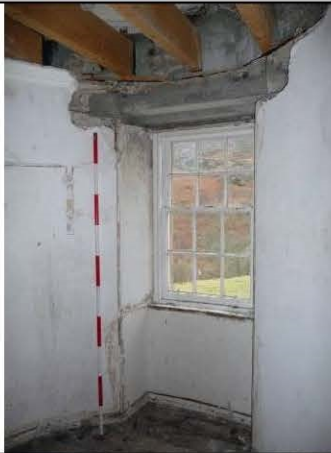
Building Element	Item	Significance	Reason		Image
Room FF 11	window	EXCEPTIONAL	12 pane sash window slightly curved to fit wall; part of the Carruthers extension. Lever catch and lifts intact.

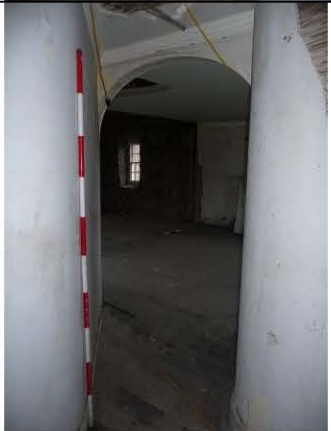
archway to turret and FF3	CONSIDERABLE	Continues arch throughout the house

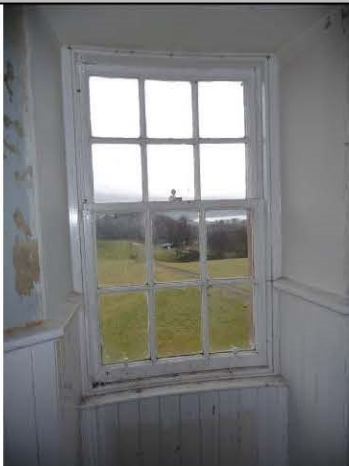
Building Element	Item	Significance	Reason		Image
Room FF 12	window	EXCEPTIONAL	12 pane sash window slightly curved to fit wall; part of the Carruthers extension. Lever catch and lifts intact.

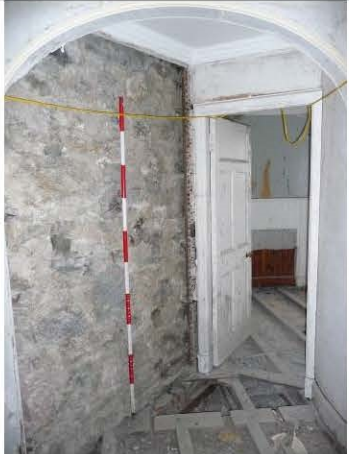
archway to turret and FF3	CONSIDERABLE	Continues arch throughout the house

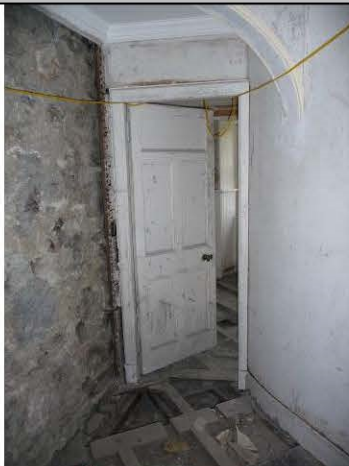
Building Element	Item	Significance	Reason		Image
	Door	SOME	5 panel door with brass handle and key fob	Retain or reuse elsewhere in house. If removed, continue coving through the entrance

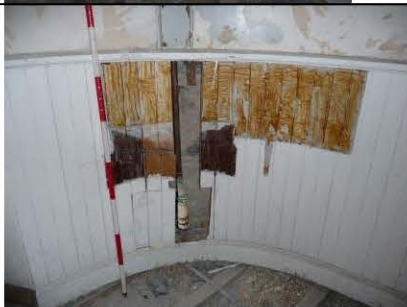
Bathroom fittings	SOME	tongue and groove boarding a popular Victorian and arts and crafts method of finishing walls in kitchens and bathrooms. Former sink fittings etc of no interest. Boarding originally unpainted. Victorian styles could be varnished or scrubbed white.	Retain or remove. If removed, replace skirting.

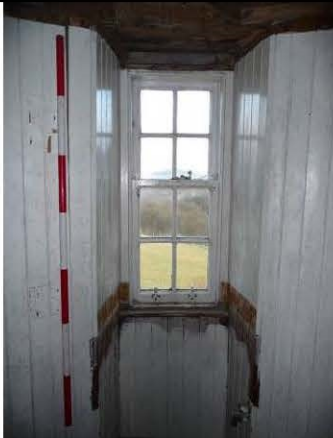
Building Element	Item	Significance	Reason		Image
	Window	EXCEPTIONAL	12 pane sash window matches that used in FF11. Lever catch and lifts intact.		 
Second Floor					
Room SF 01	Window	EXCEPTIONAL	8 pane sash, lever catch and lifts intact – set within tongue and groove

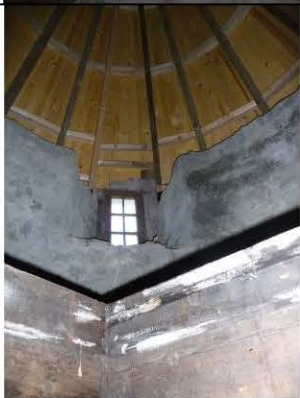
Room SF1A	Window	EXCEPTIONAL	6 pane window inserted into plastered wall above bathroom SF1. Possibly part of servant's quarters or used for storage?

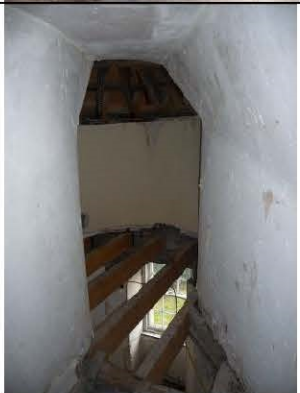
Room SF 02	Room	EXCEPTIONAL	Room currently stripped of flooring and ceiling. No window. Narrow entrance is reminiscent of Victorian idea of medieval castle architecture.

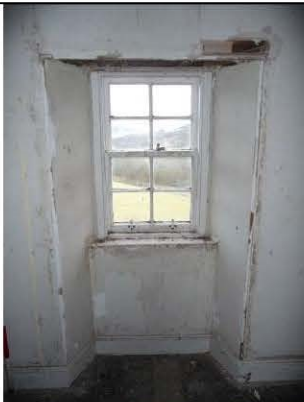
Building Element	Item	Significance	Reason		Image
Room SF 03	Window North wall	EXCEPTIONAL	8 pane sash window in same mid 19 <sup>th</sup> century style and rest of house. Lever catch intact, and both lifters

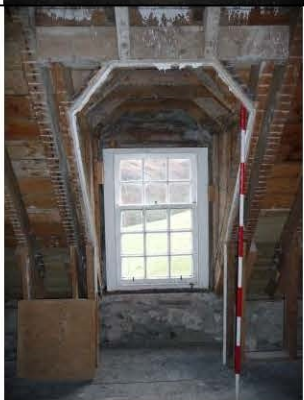
Windows east wall	EXCEPTIONAL	Two sets of 15 pane sashes set within dormers, both modern replacements, but dormers are part of pre-Carruthers house

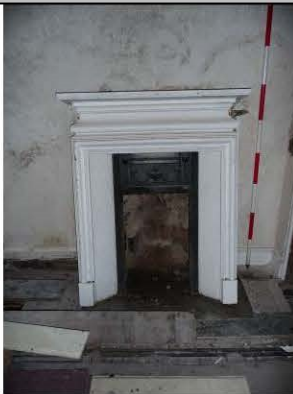
Building Element	Item	Significance	Reason		Image
	Fireplace	CONSIDERABLE	Large bedroom fireplace with rough cast plastered wall to rear

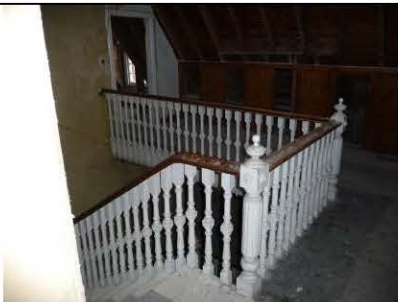
Floorboards	CONSIDERABLE	standard 6 ½ inch style used throughout. Markings on floor suggest small pieces of carpet used, but no signs of partitioning.		
	Finishings	CONSIDERABLE	Some skirting now missing. Coving may not have been used as lower status rooms	Replace skirting	
Room SF 04	Stairwell	CONSIDERABLE	Staircase hall with open well wooden cantilevered stair and decorative balusters and newel posts in high Victorian gothic style. Treading painted on edges only for carpeting in centre; some stair rod hooks intact.

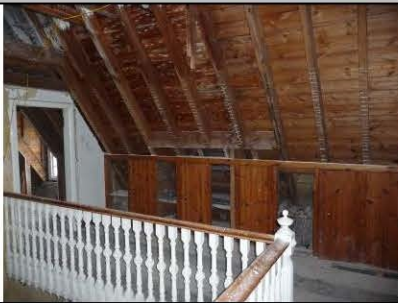
Building Element	Item	Significance	Reason	Management	Image
	eaves cupboards	SOME	Maximising storage space in eaves, pine built. Location of stair rods and sash window weights for re-use

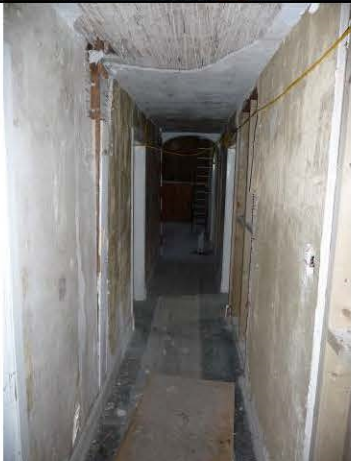
archway	CONSIDERABLE	Continues the arch theme throughout the house.

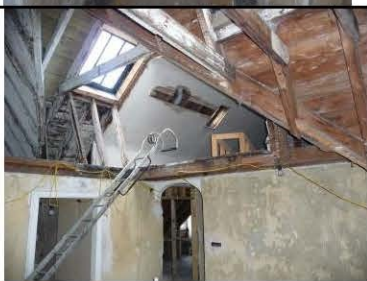
roof lights	CONSIDERABLE	Roof largely replaced by Carruthers but roof lights are likely to have been used previously as seen in 1881-5 photographs.

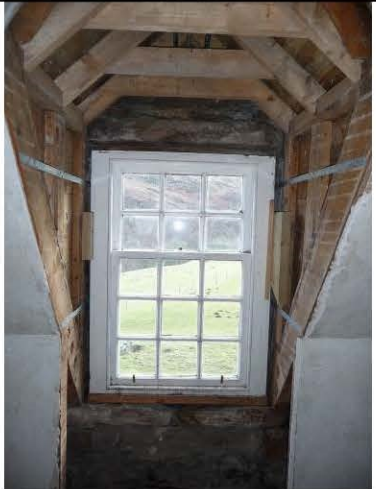
window	EXCEPTIONAL	15 pane sash window overlooking the house front. Catches and lifts intact

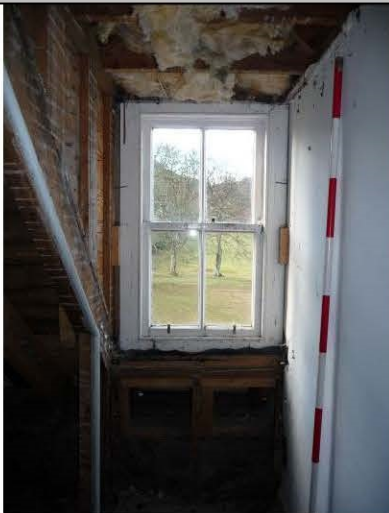
Building Element	Item	Significance	Reason		Image
Room SF 07	Dormer windows	EXCEPTIONAL	Part of the Carruthers redesign – two dormer windows with four pane sashes, lever catches intact on right hand window and lifters intact on both

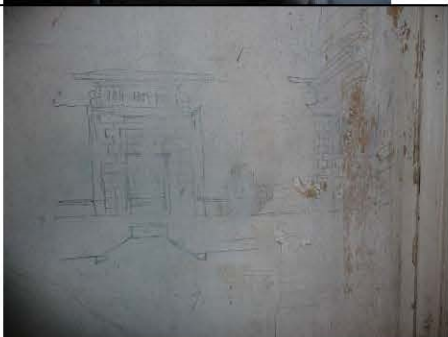
Room SF 08	Surviving pencil sketches on several walls associated with scheme of 1893.	SOME	Added historic interest

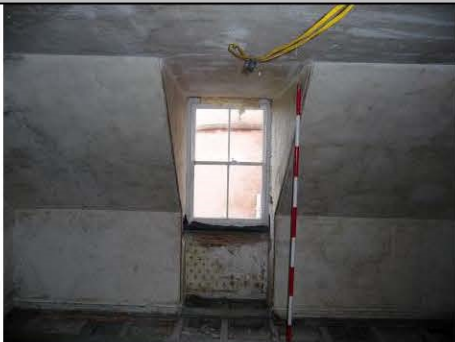
Building Element	Item	Significance	Reason		Image
	window	EXCEPTIONAL	Dormer window with 4 pane sliding sash matching those windows in SF07. Part of the Carruthers redesign. Remnant wallpaper beneath

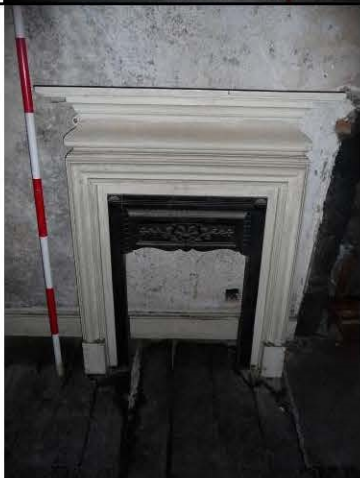
fireplace	EXCEPTIONAL	cast iron bedroom sized Victorian fireplace, part of Carruthers design as seen in wall sketches in same room

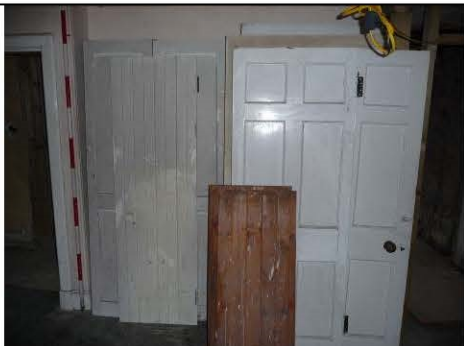
Floorboards	CONSIDERABLE	standard 6 ½ inch style used throughout. Markings on floor suggest central runner along hall originally used with varnished margins		see above
	Finishings	CONSIDERABLE	Skirting survives, but limited coving		
Room SF 10	stored doors	CONSIDERABLE	about 15 doors are being stored here for re-use throughout the house. Also some tongue and groove from turret bathrooms and baton doors for lower status areas

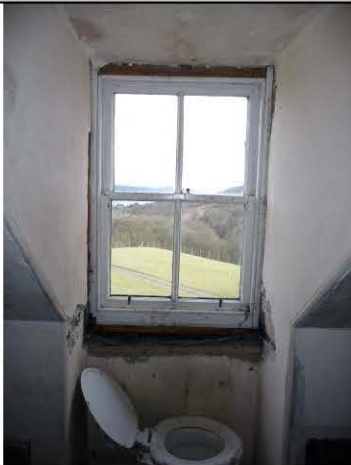
Building Element	Item	Significance	Reason		Image
	window	EXCEPTIONAL	one 4 pane dormer in west wall overlooking Loch Ness.

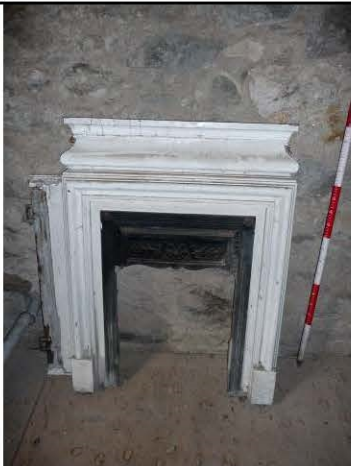
Finishings	CONSIDERABLE	No coving for low status room. Some skirting intact		
	Fireplace	CONSIDERABLE	Currently in storage in SF 11

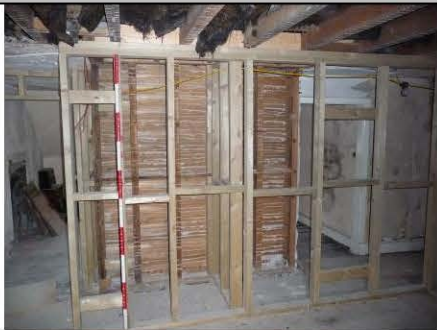
Building Element	Item	Significance	Reason		Image
Room SF 11	Doorway and cupboard	MARGINAL	New doorway inserted to SF10

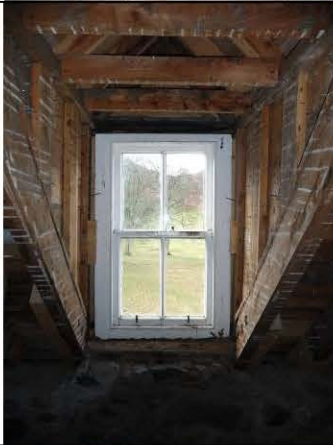
window	EXCEPTIONAL	four pane sash window in dormer - part of Carruthers' design
