Bunroy Mill, Roy Bridge, Lochaber

Desk-based assessment, photographic survey and field recording

National Grid Reference: NN 27392 80597

Author: Maya Hoole

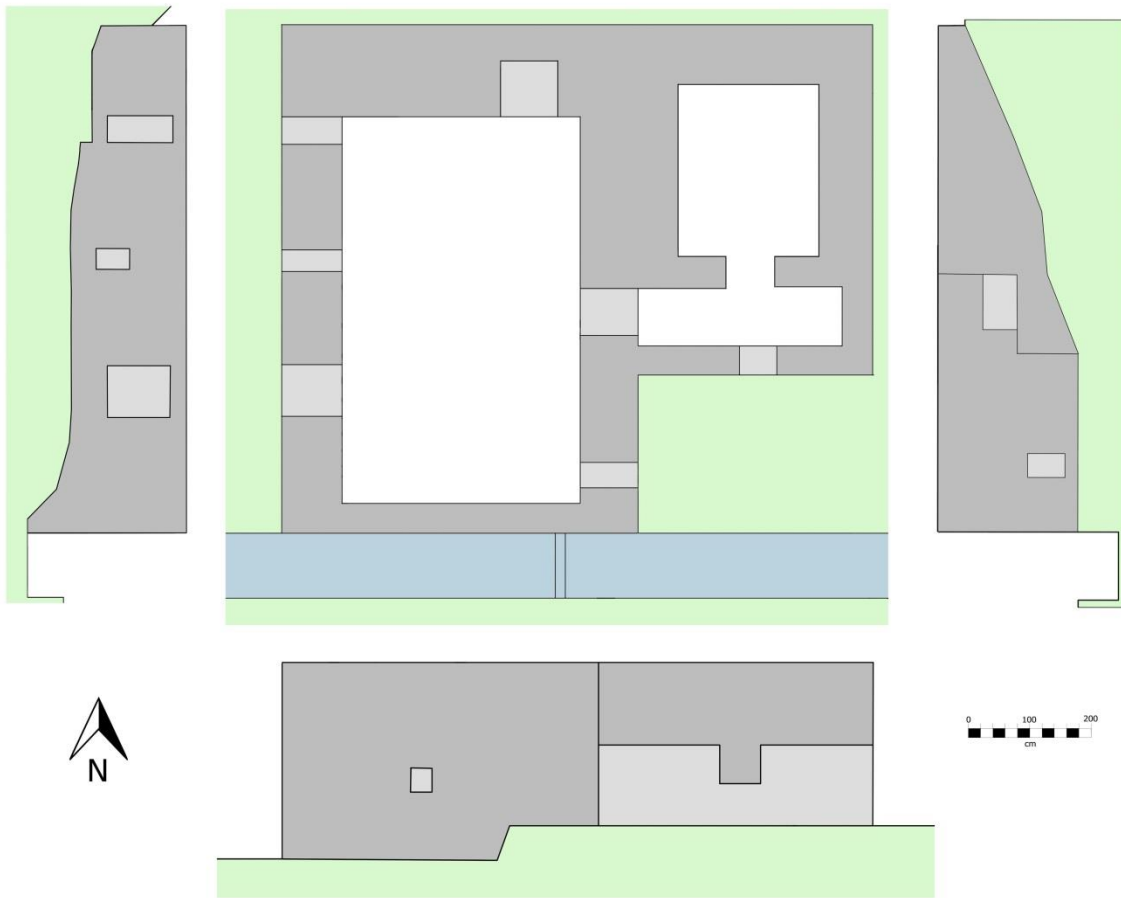
8 – Scale and measured plan of Bunroy Mill, Roy Bridge

- 6.1. The site was surveyed and measured, planned and drawn. A plan and scale drawings of three sides of the building were created as a result of the field survey. The fourth, northern side of the building was embedded into the hillside and so was not planned.
- 6.2. The site was measured using a 7.5m tape measurer and all measurement were noted and recorded in a logbook. These distances were recorded on to a sketch and then were made into a final plan using Adobe Photoshop and a graphics tablet.
- 6.3. The western side of the building consists of a large rectangular room (which may possibly have had an interior separating wall) which has five, possibly six entrances. Four of these were still in use until the abandonment of the site, whilst one had been bricked over. The

last possible entrance may have been the location of the kiln in the north eastern corner of this room.

- 6.8. A plan and section drawings of the mill have been provided below (figure 8). These have been partially reconstructed to suggest the shape of the mill prior to falling into ruin based on measurements and observations made during field recording. The dark grey colour in the plan represents the walls, the lighter grey represents gaps in the walls or features, the green identifies the external areas and the blue indicates where the water channel would have been located.

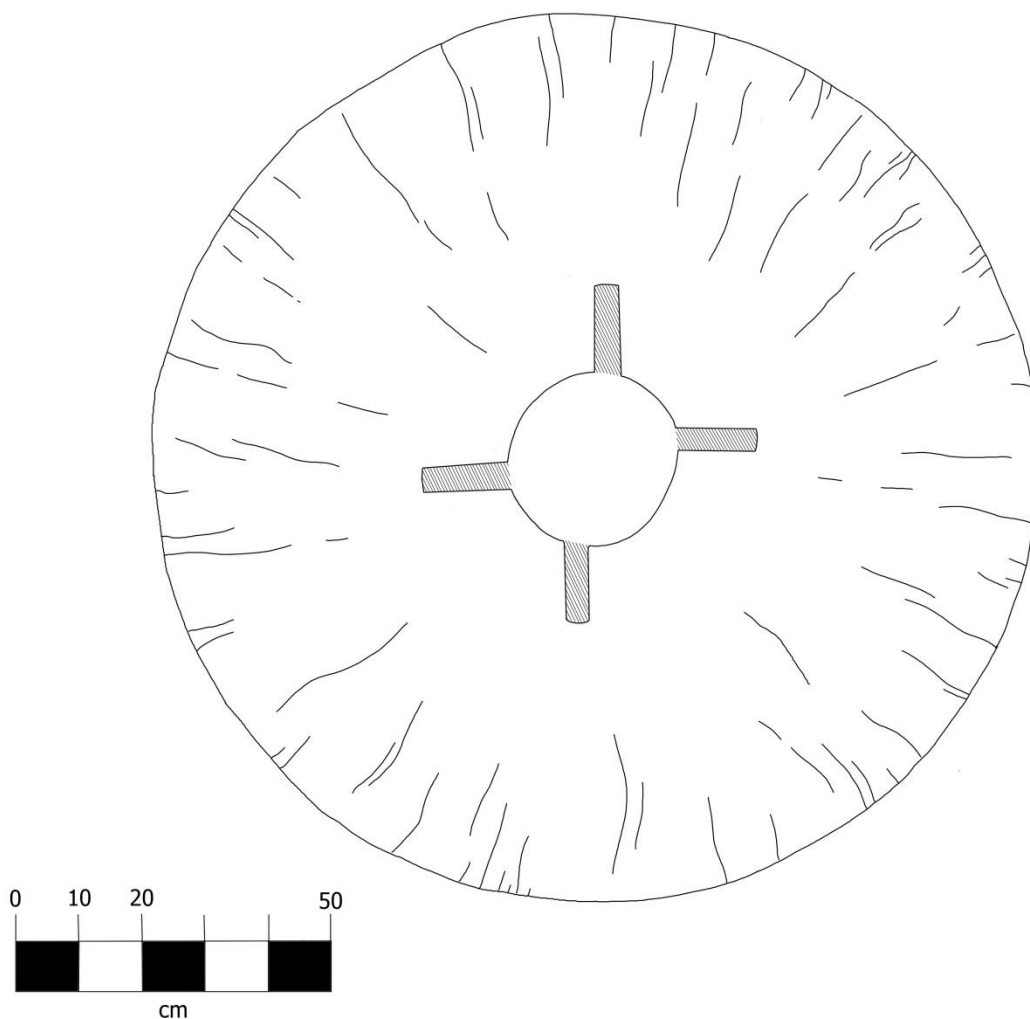
9 - Archaeological illustration of one of the mill stones

- 7.1. One of the mill stones located in the south-western corner of the largest internal space were subject to an archaeological illustration. The stone was approximately 7.5cm in depth, 140cm in diameter and the central hole was approximately 15 cm in width.

- 7.2. The central hole was cut through the whole stone; however it was accompanied by four rectangular sections, 5 cm deep at right angles to each other, although they were off set rather than perpendicular. Presumably, a metal instrument was placed between the two millstones to keep them together during the grinding process and it rested in these rectangular sections. The central hole could have been designed to allow the grain to be poured between the two mill stones, although this is just speculation.

- 7.3. The surface of the mill stone was naturally rough, with undulating lines extending from the centre to the edges.
- 7.4. The illustration of the mill stone was created using Adobe Photoshop and hand drawn using a graphics tablet. It was drawn with a scale to indicate size.

- 8.1. The ruin of the old mill was well known within the local community and has a historical identity amongst them. I would suggest that if possible, the mill stones should be protected as they are at risk of being removed from the site, this is based on the evidence that a lot of the stones have already been taken. It might be best if the mill stones were relocated to a more secure location within the community to ensure their protection and preservation for future generations.

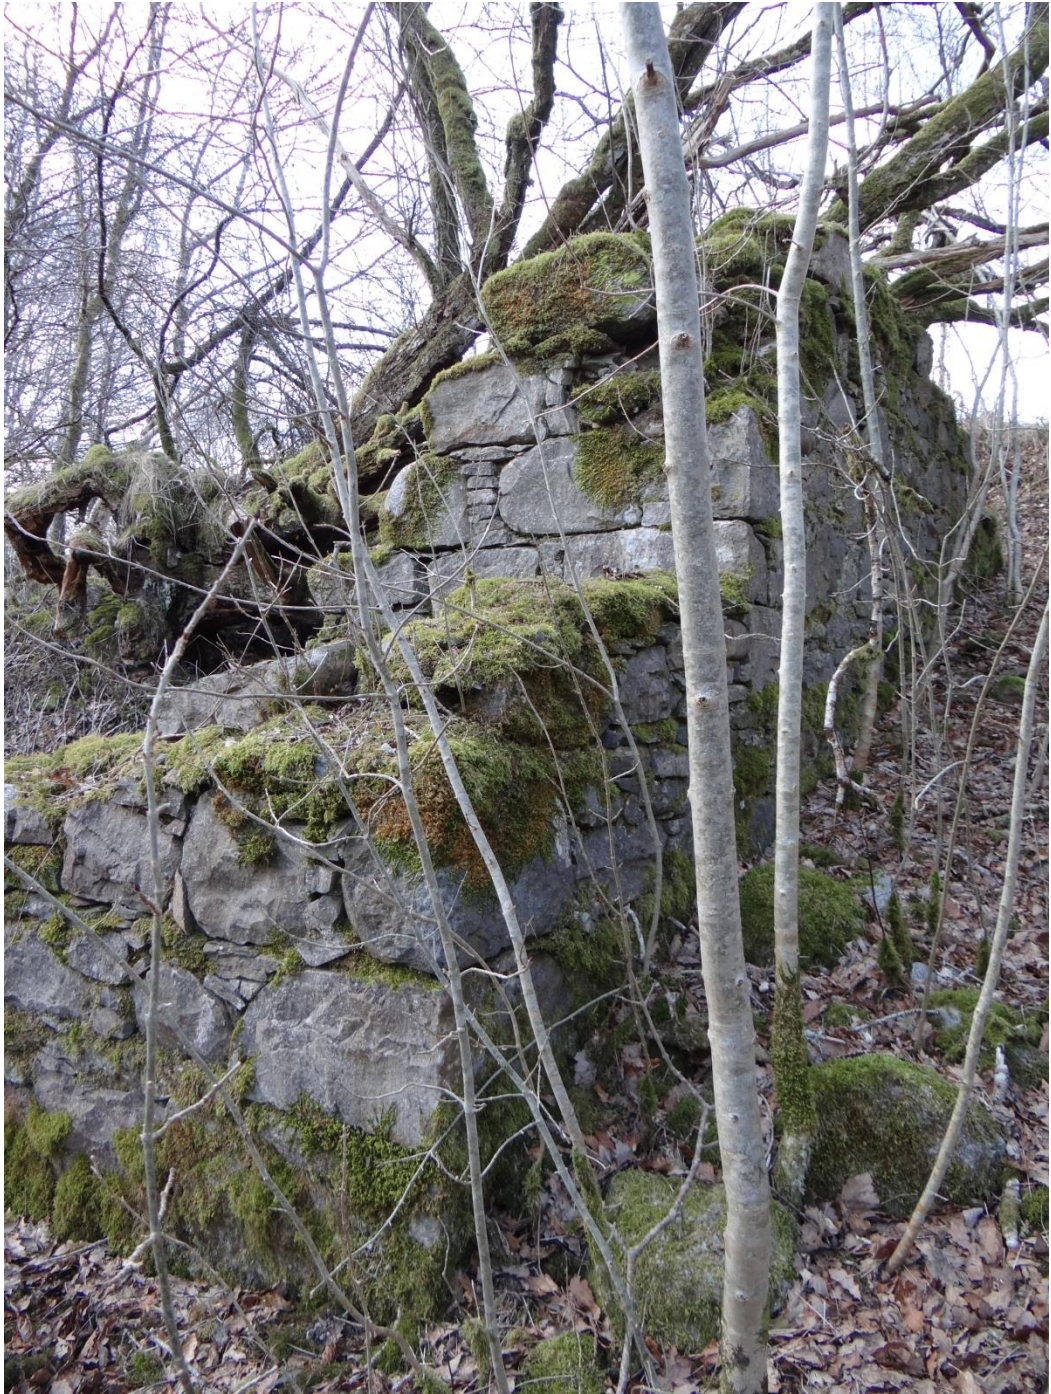
10 - South eastern corner of the eastern section, view from the south east

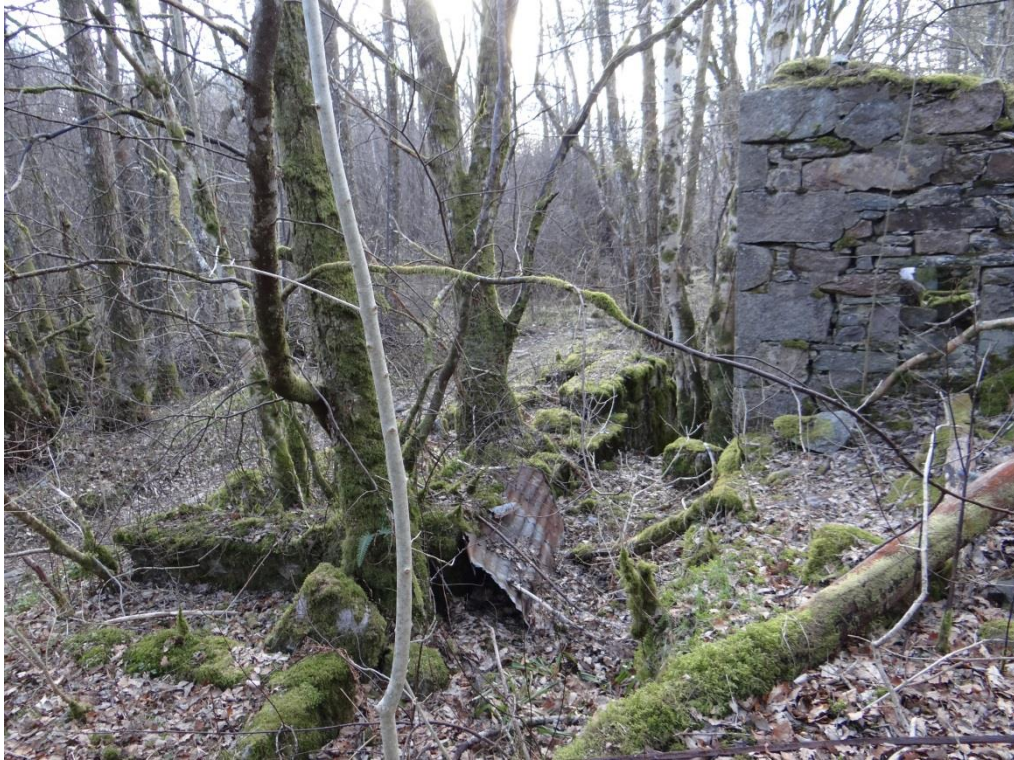
- 2.2. A channel to run water from the river to power the millstones was constructed on the southern side of the site. This channel was traceable to the east where it led back to the original source of the river Spean. The condition of this channel was variable, but was mostly distinct and always visible. However, to the west the channel was no longer visible

11 - The channel running towards the main southern wall, view from the east, facing west

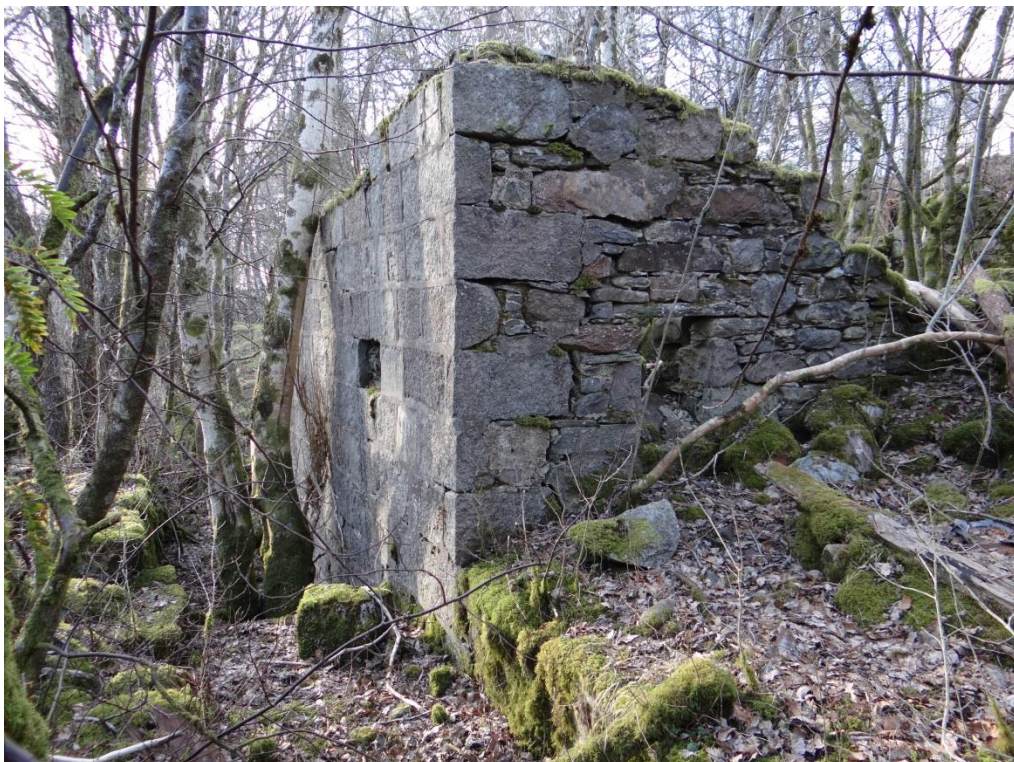
- 6.7. The channel had a smooth drop to the east of where the watermill would have been situated. This drop would have been design to make the water, flowing from the east, turn the wheel in an anti-clockwise rotation.

12 - The main wall and channel of the water wheel, viewed from the east

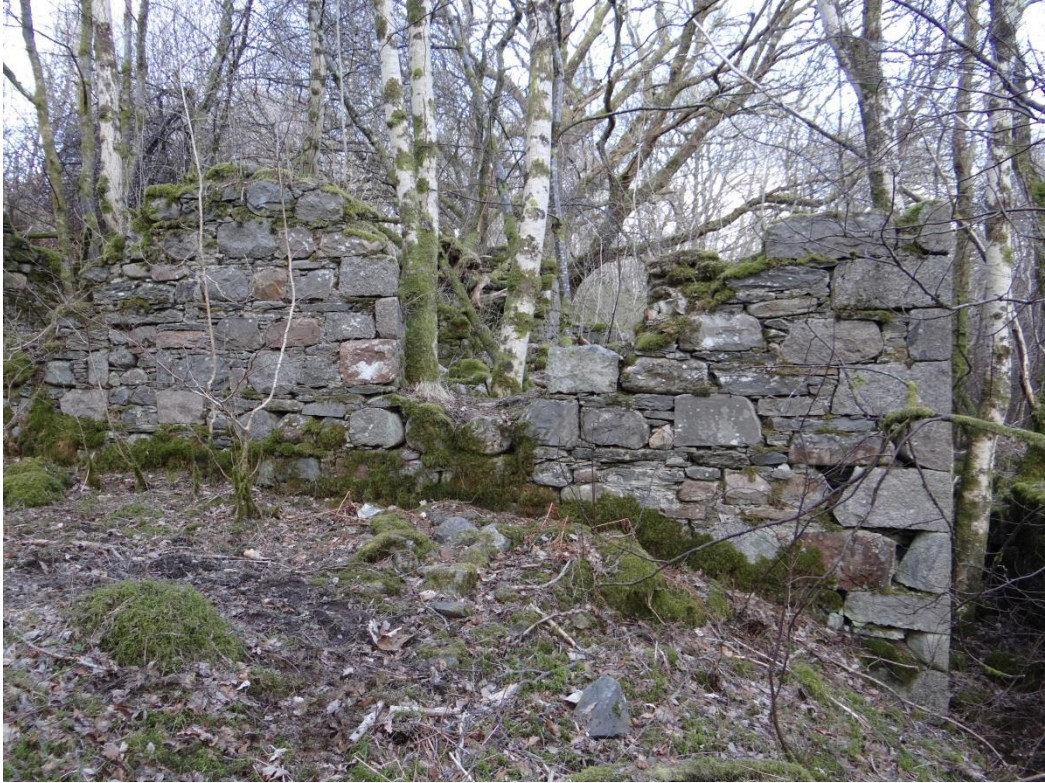
13 - Southern section of the western wall, viewed from the west facing east

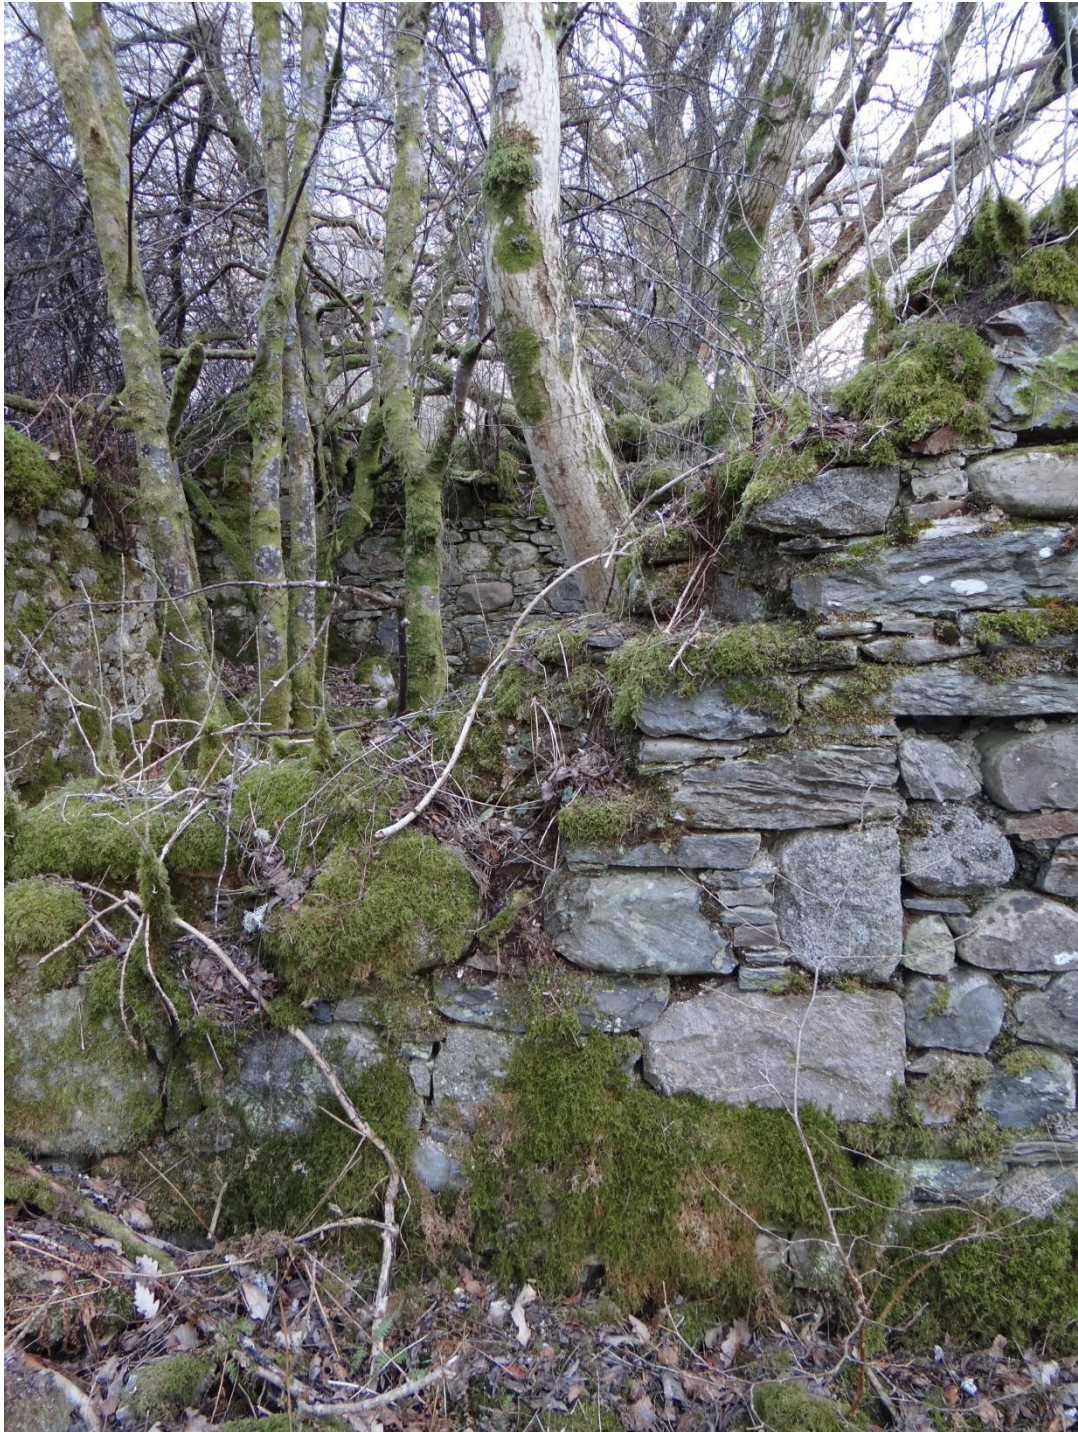
14 - Central section of the western wall, viewed from the west facing east

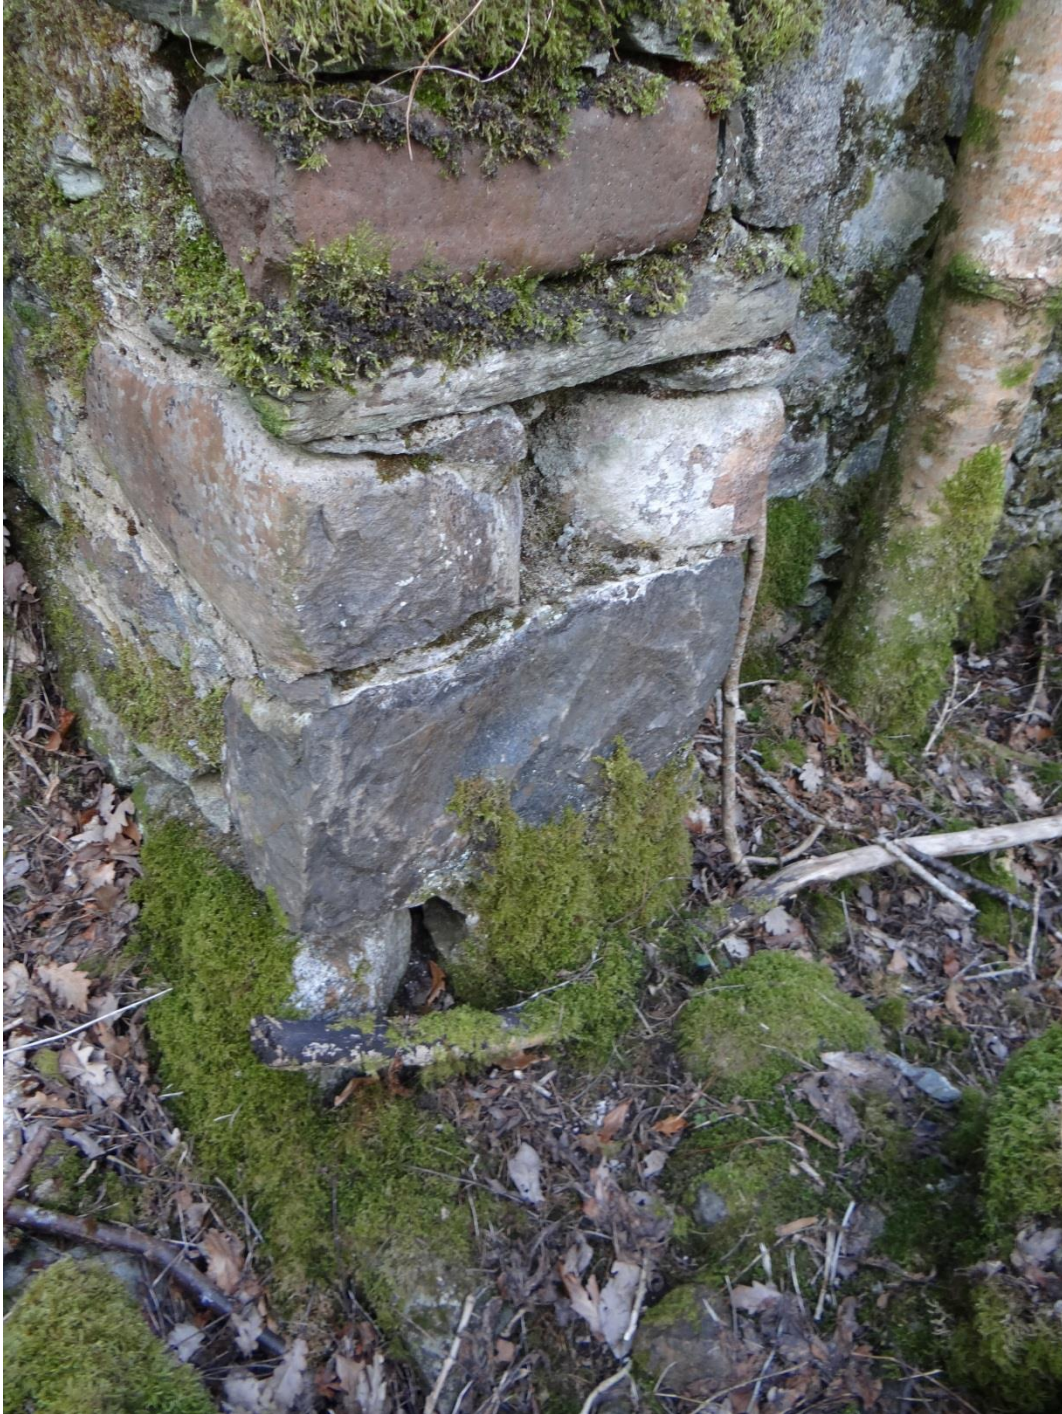
15 - Detail of the northern side of the most northerly gap in the western wall, view from the south west facing north east

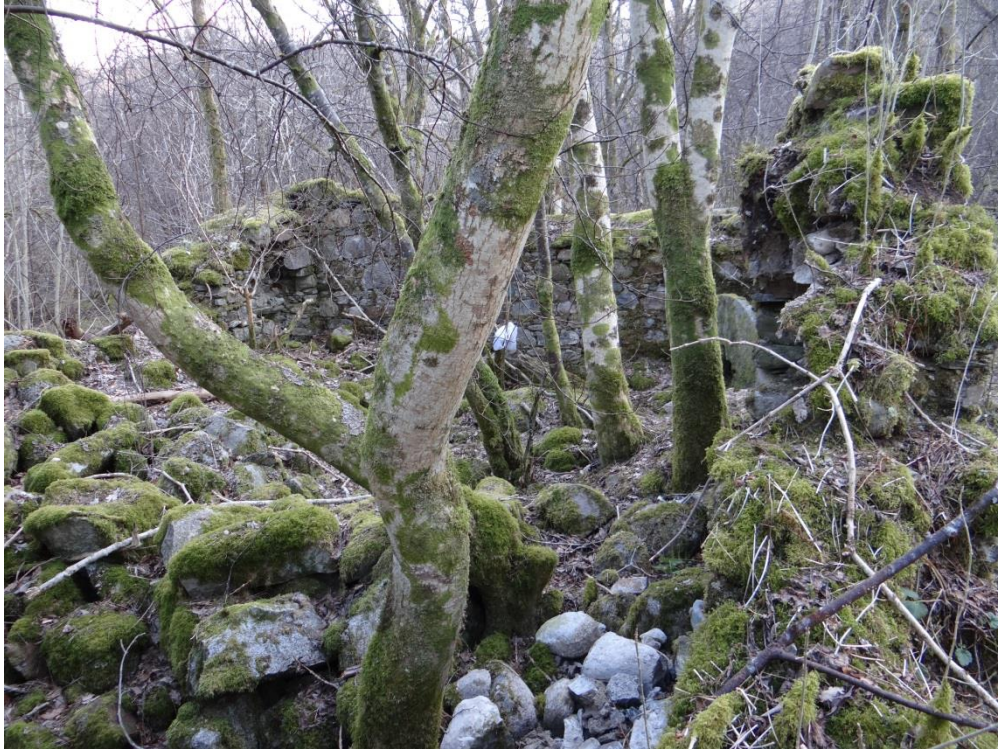
16 - The interior of the main room of the mill, viewed from the north facing south

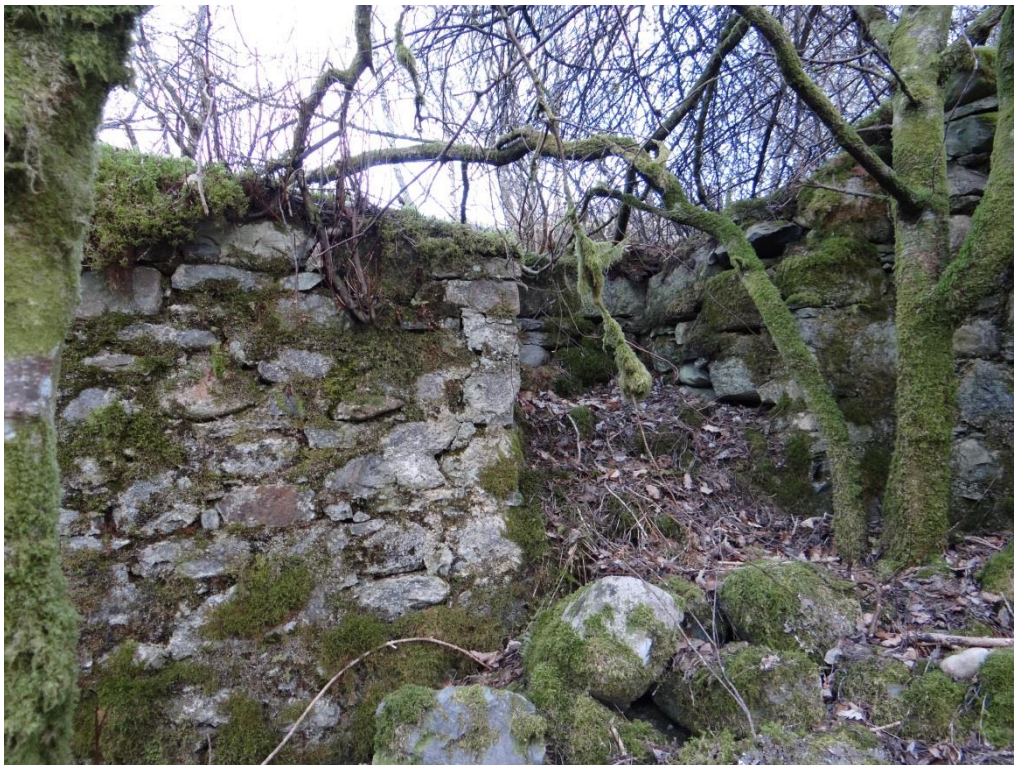
17 - Possible kiln, viewed from the south facing north-east

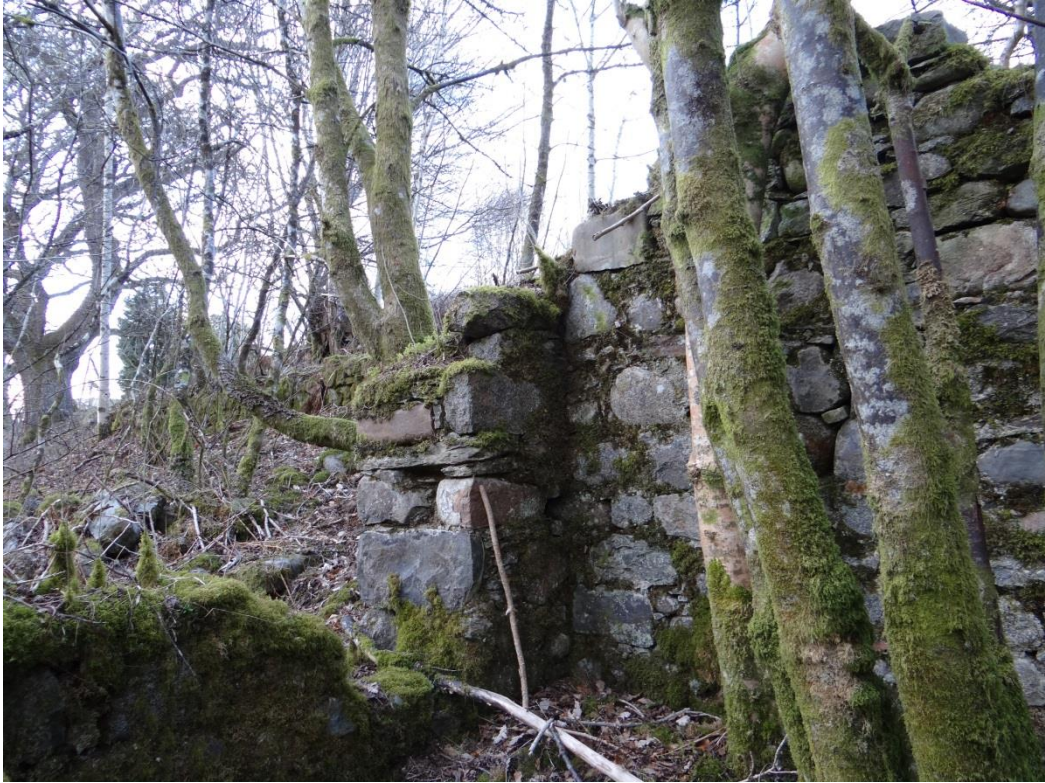
18 - The most northerly entrance on the western wall, view from the interior to exterior, facing north west

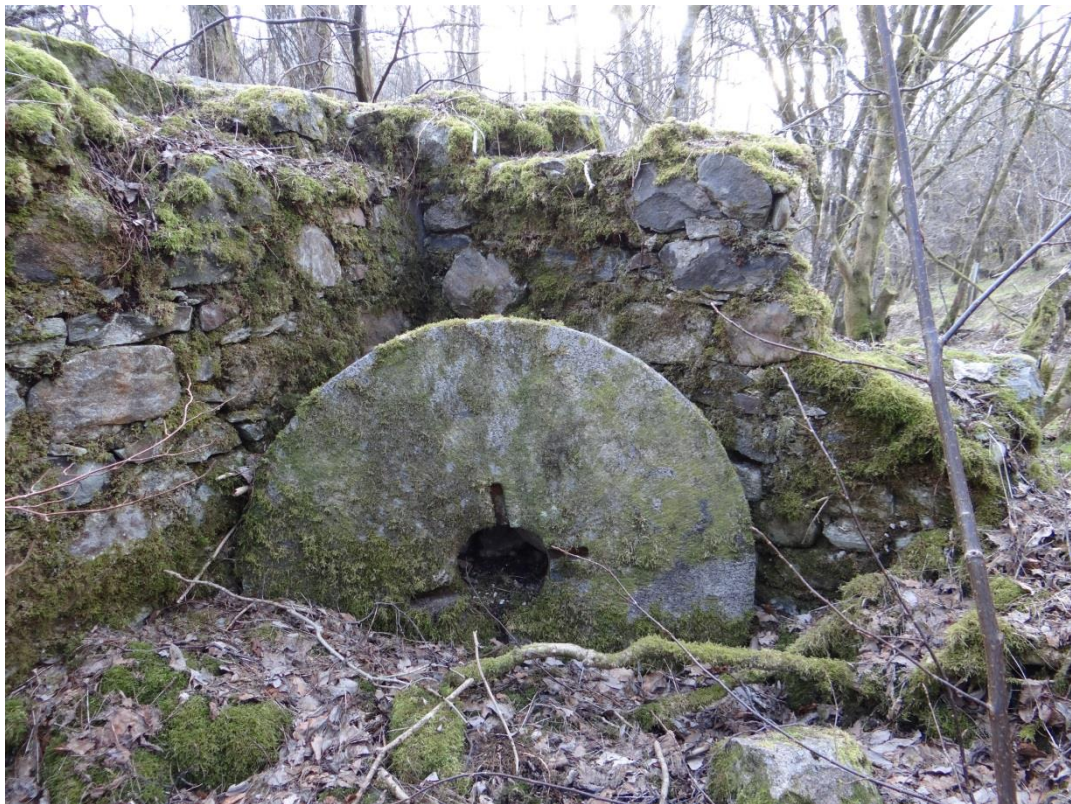
19 - The abandoned mill stones in the main interior space, in the south west corner

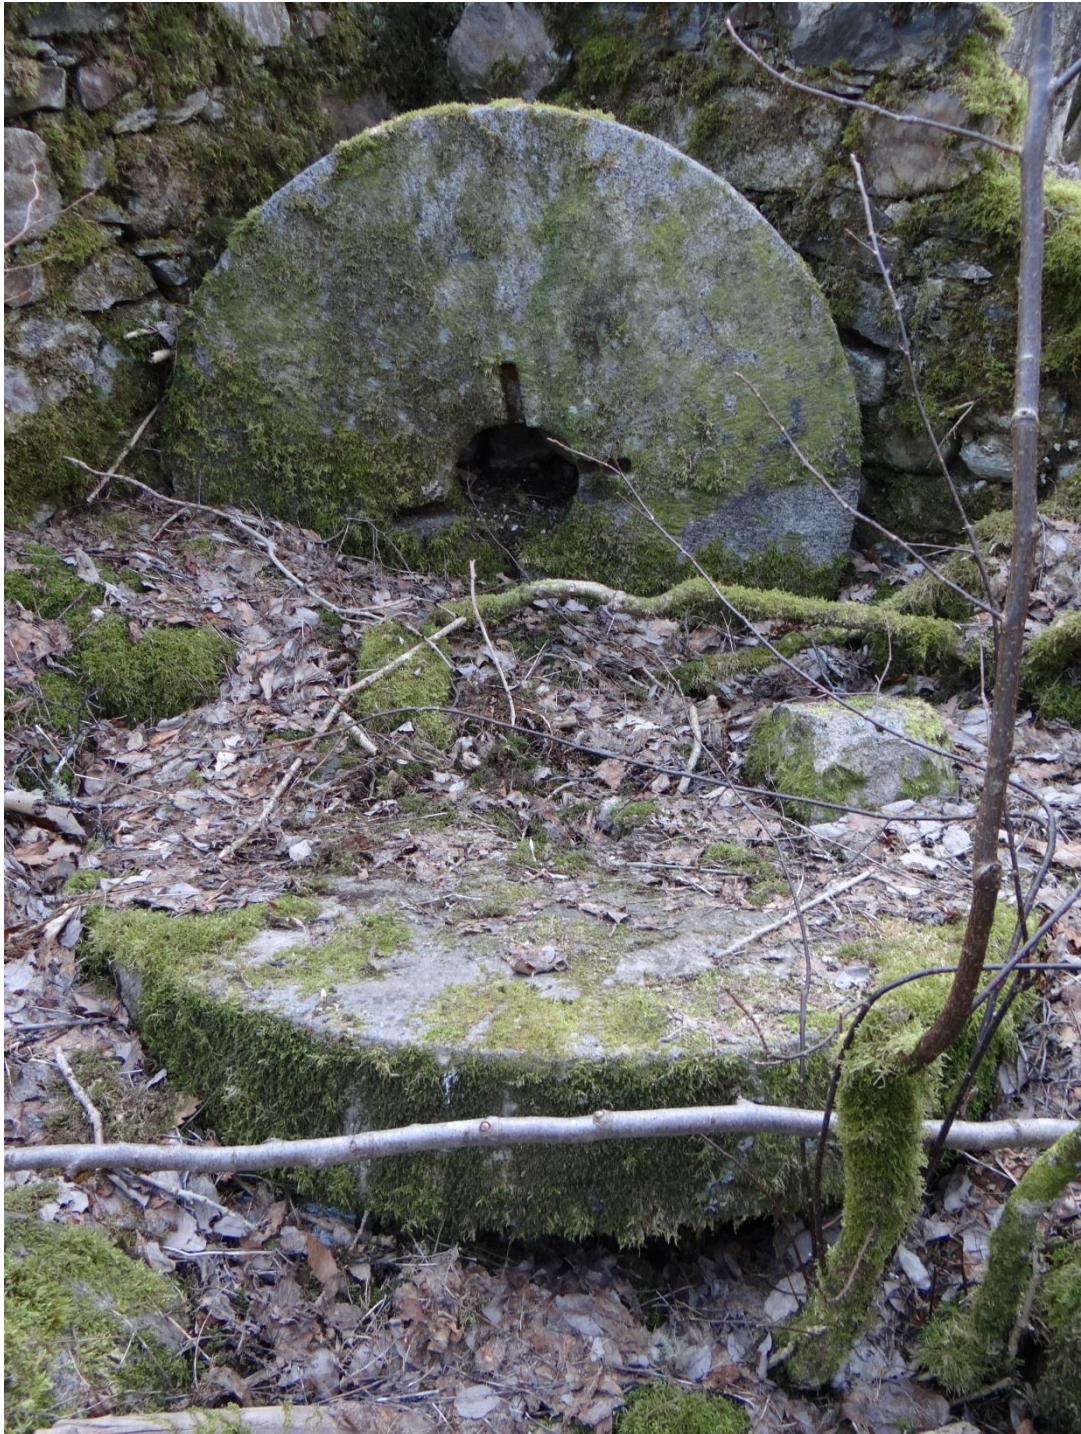
20 - Close view of the abandoned mill stones in the main interior space, in the south west corner

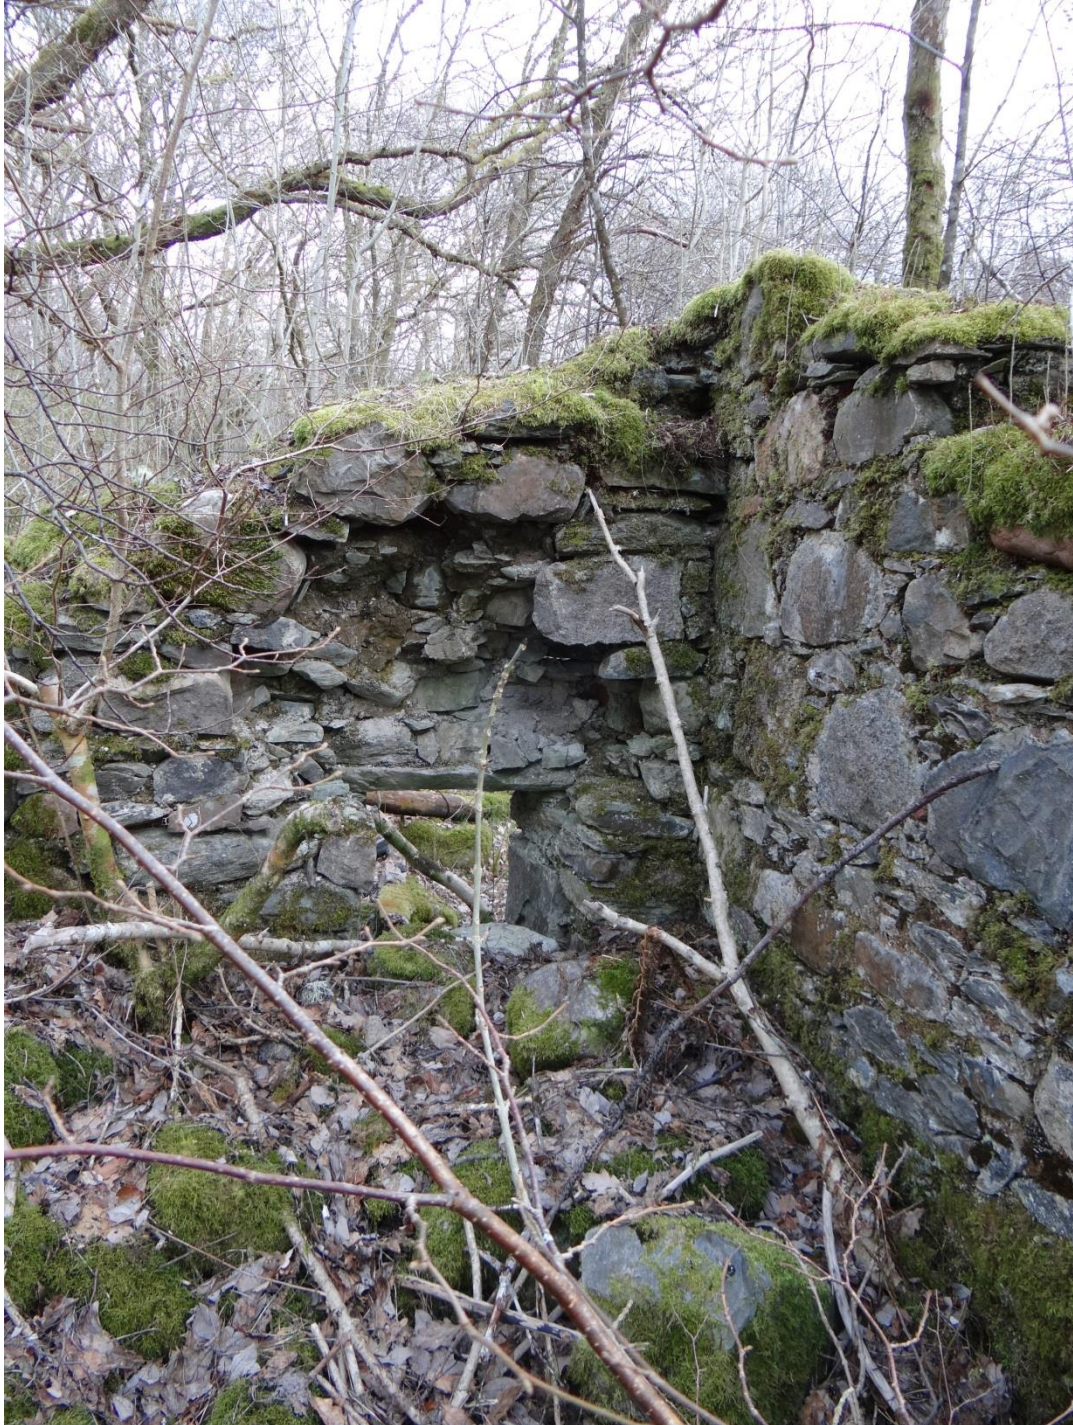
21 - Interior, southern wall on the right, showing the eastern wall and window, facing east

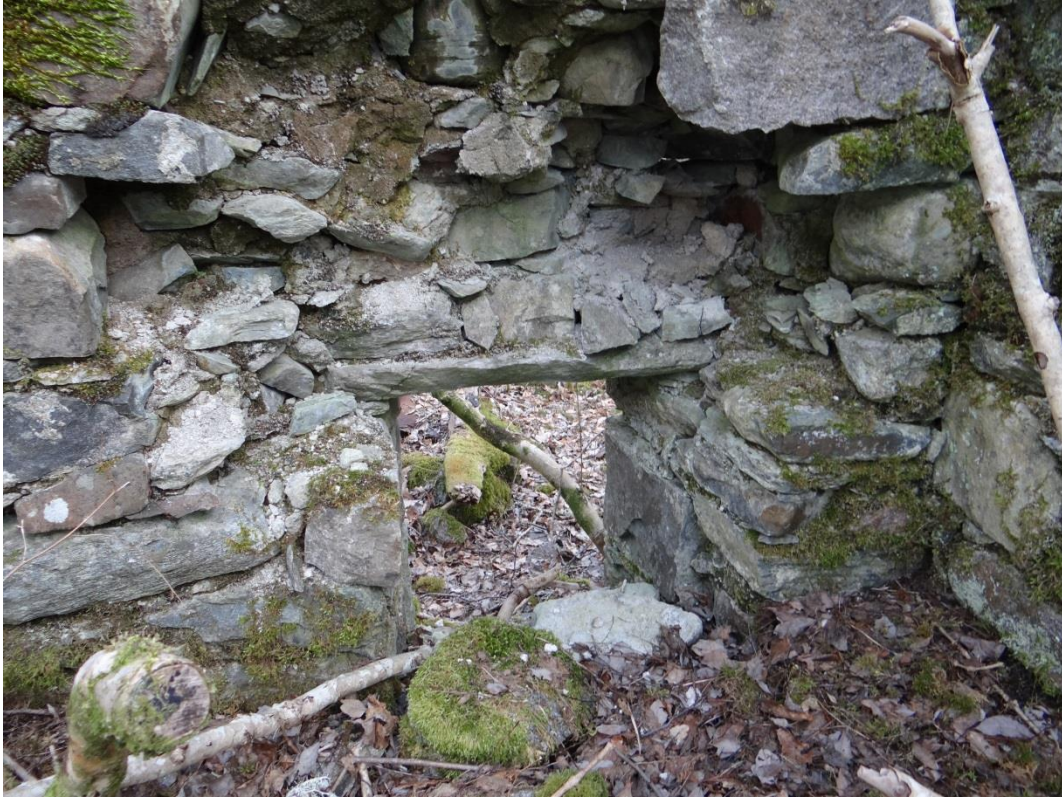
22 - Close up of the window in the eastern wall, view from the interior, facing east

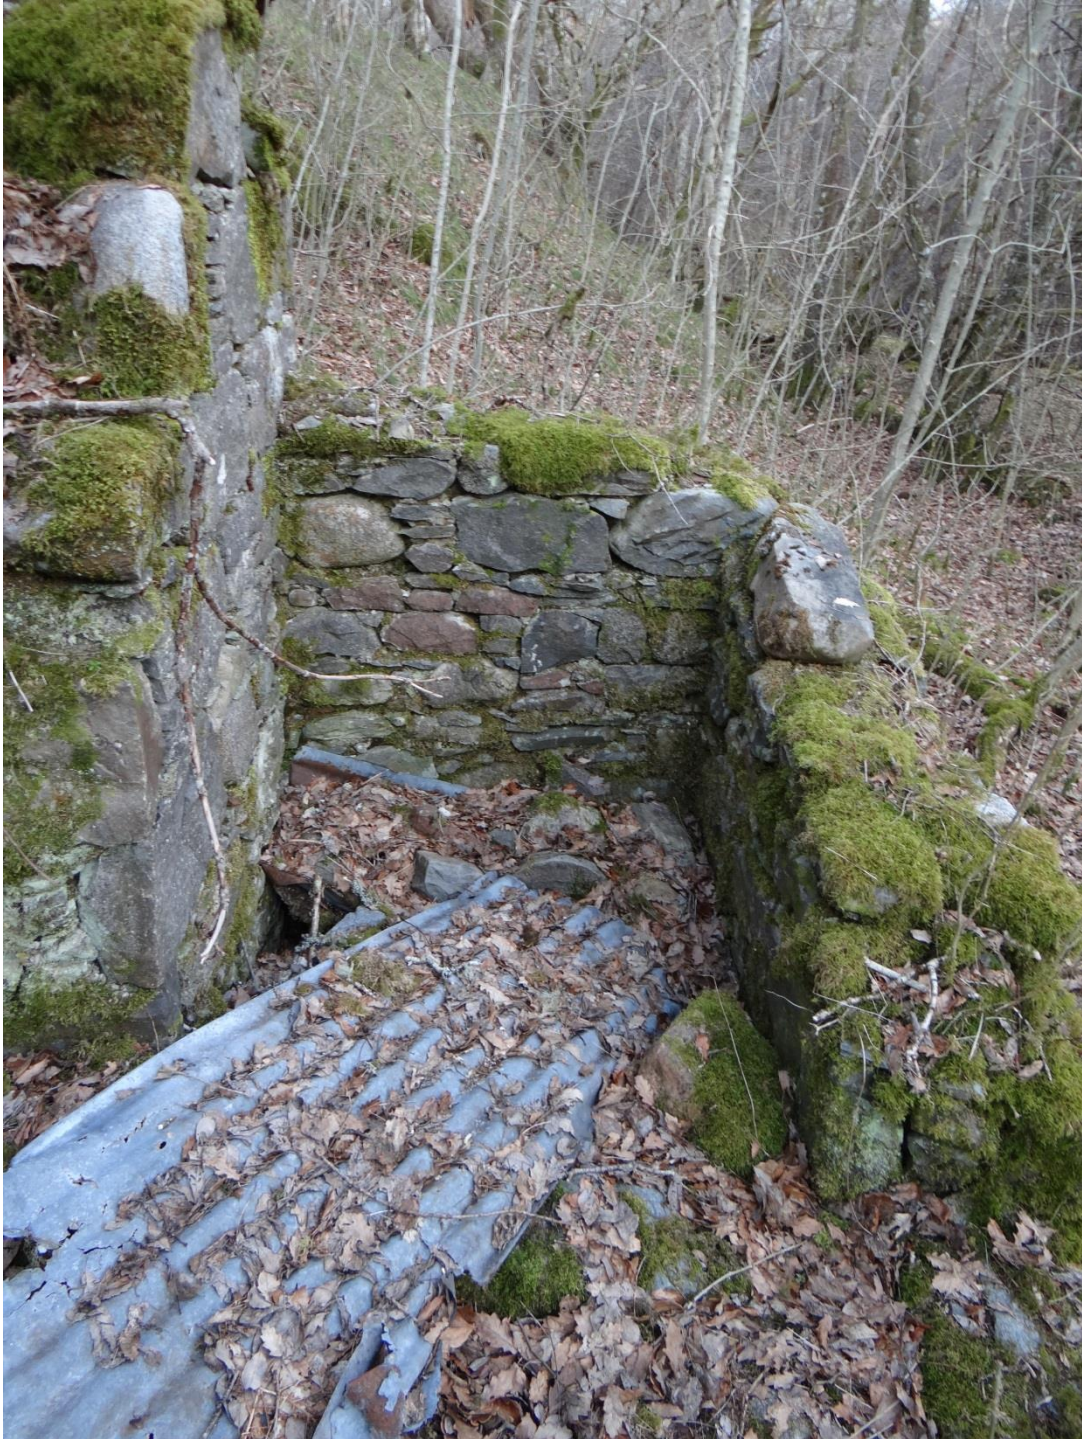
23 - View of the exterior area on the eastern side of the mill, facing east

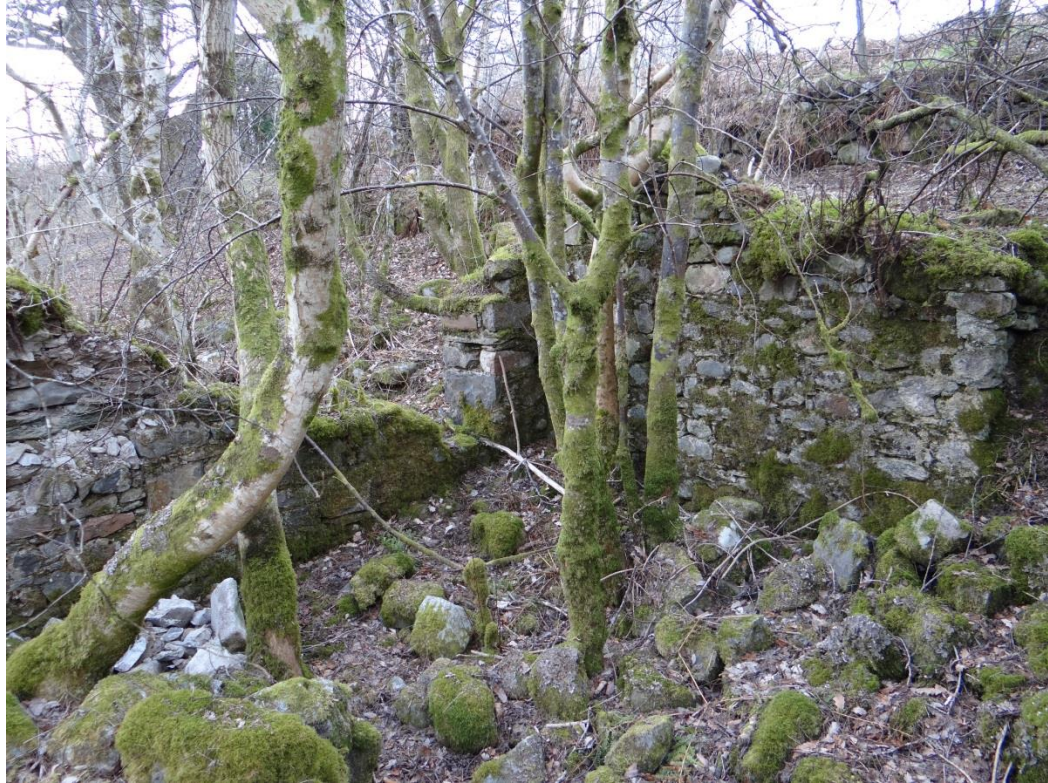
24 - Interior of the main room, facing north west taken from the south east corner

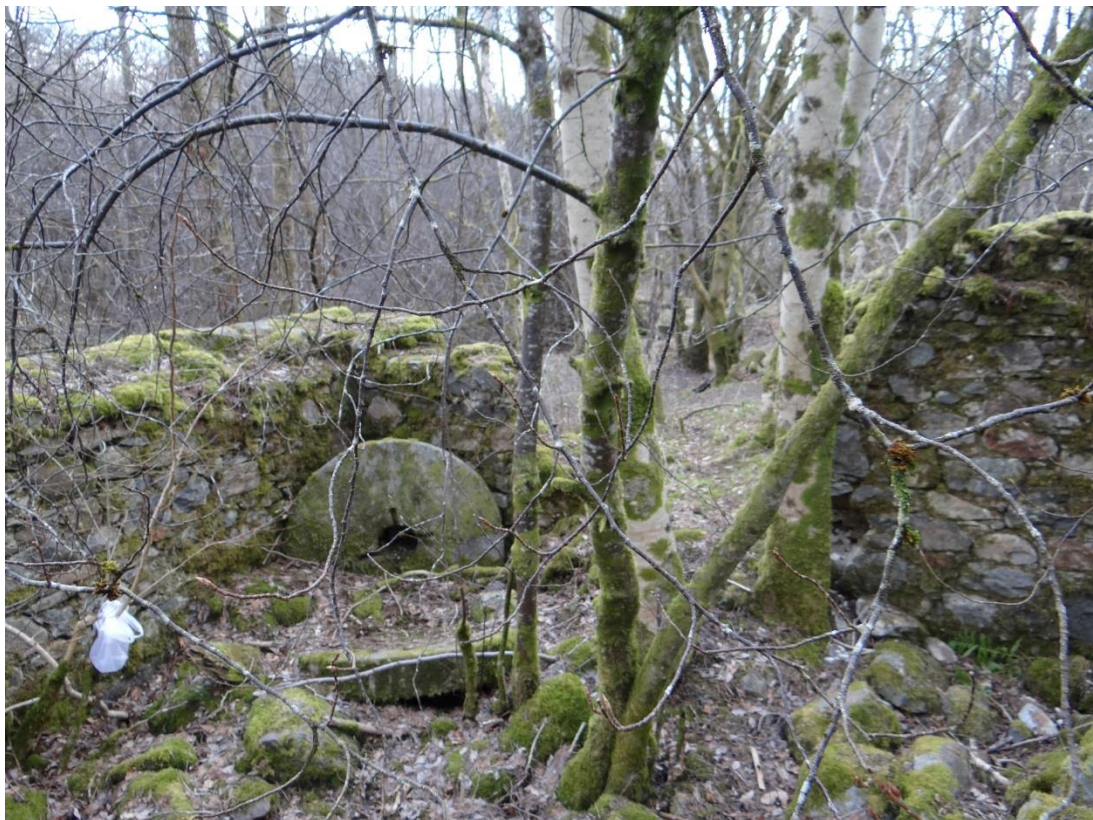
25 - Interior of the main room showing the mill stones, and facing west

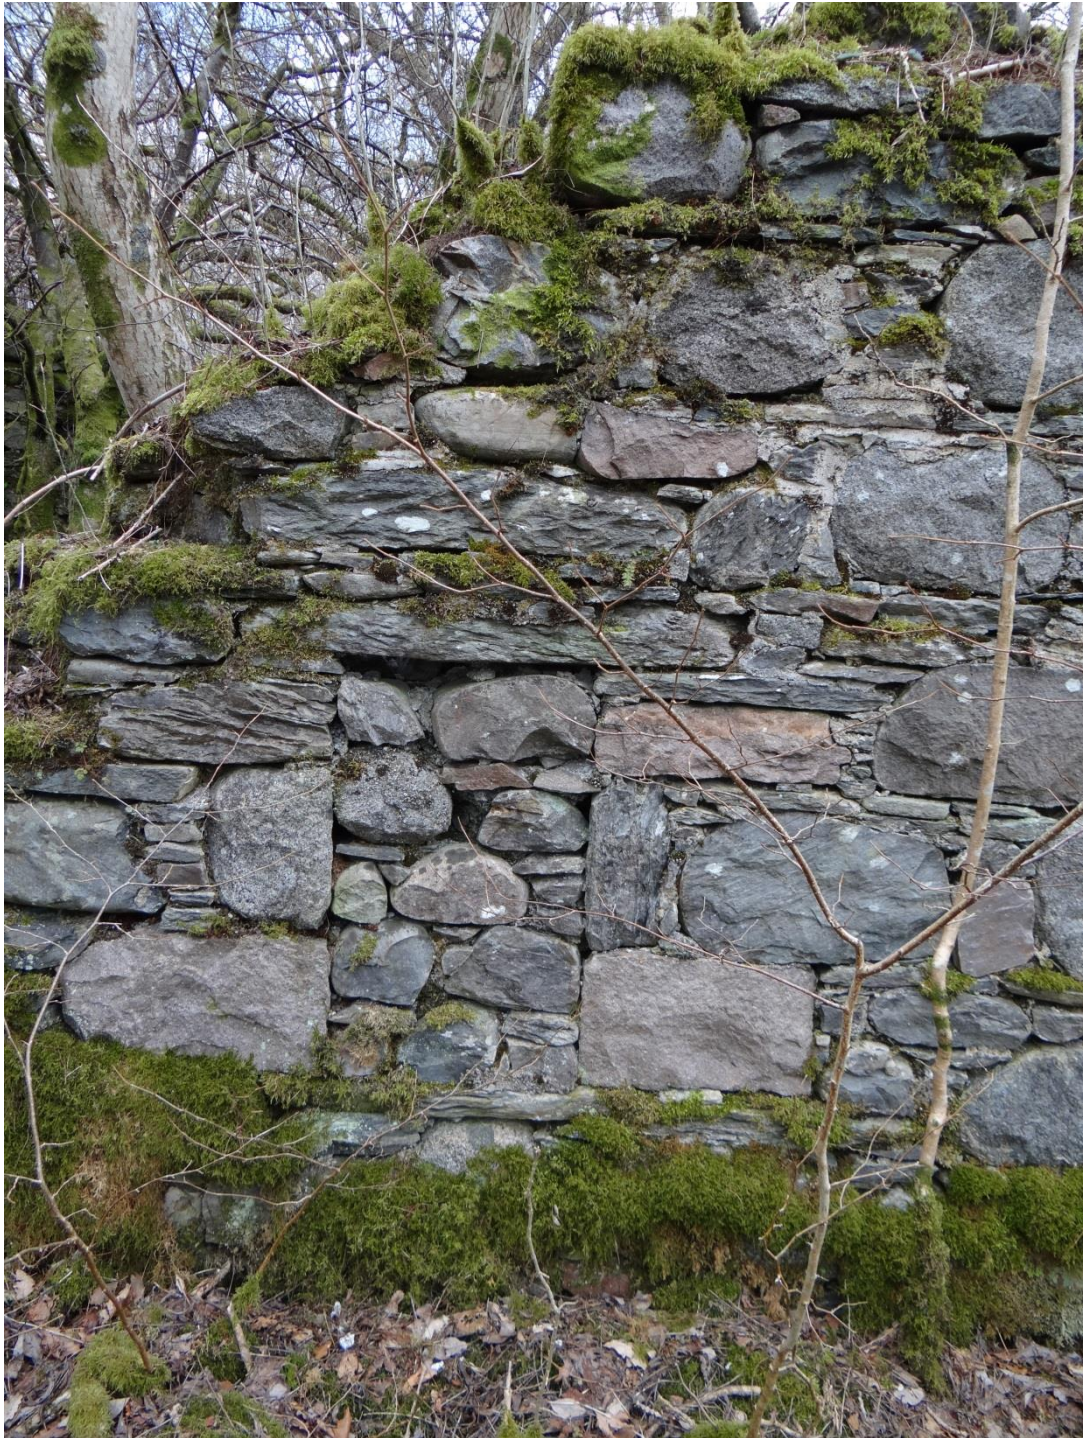
26 - Filled in window in the western wall of main building, facing east

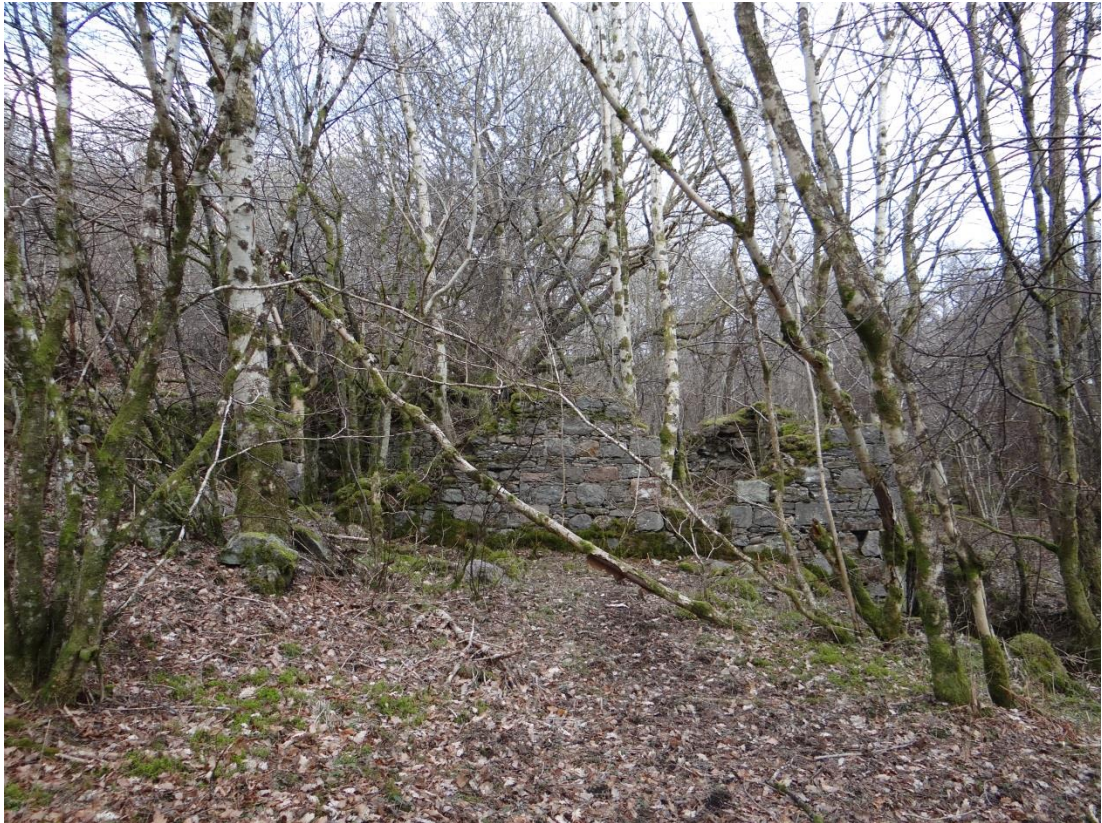
27 - View of the western wall, facing east
