Bunroy Mill, Roy Bridge, Lochaber

Desk-based assessment, photographic survey and field recording

National Grid Reference: NN 27392 80597

Author: Maya Hoole

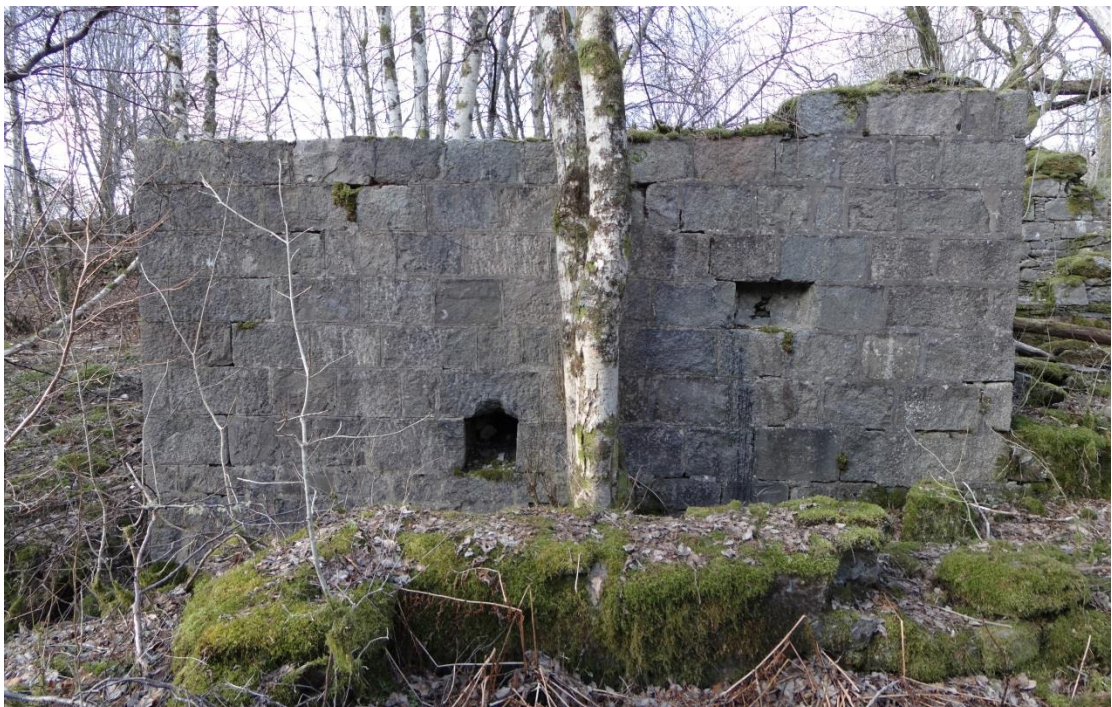
- 6.6. The southern wall was the tallest remaining wall which reached to the base of the channel, and appeared to survive to the full height of the building. This wall may have been younger in date than the eastern part of the building. One of the main bricks had been removed from this southern wall; otherwise the only feature was a medium sized hole, where the watermill would have been attached.

28 - View of the exterior, main, southern wall where the water wheel would have been located, facing north

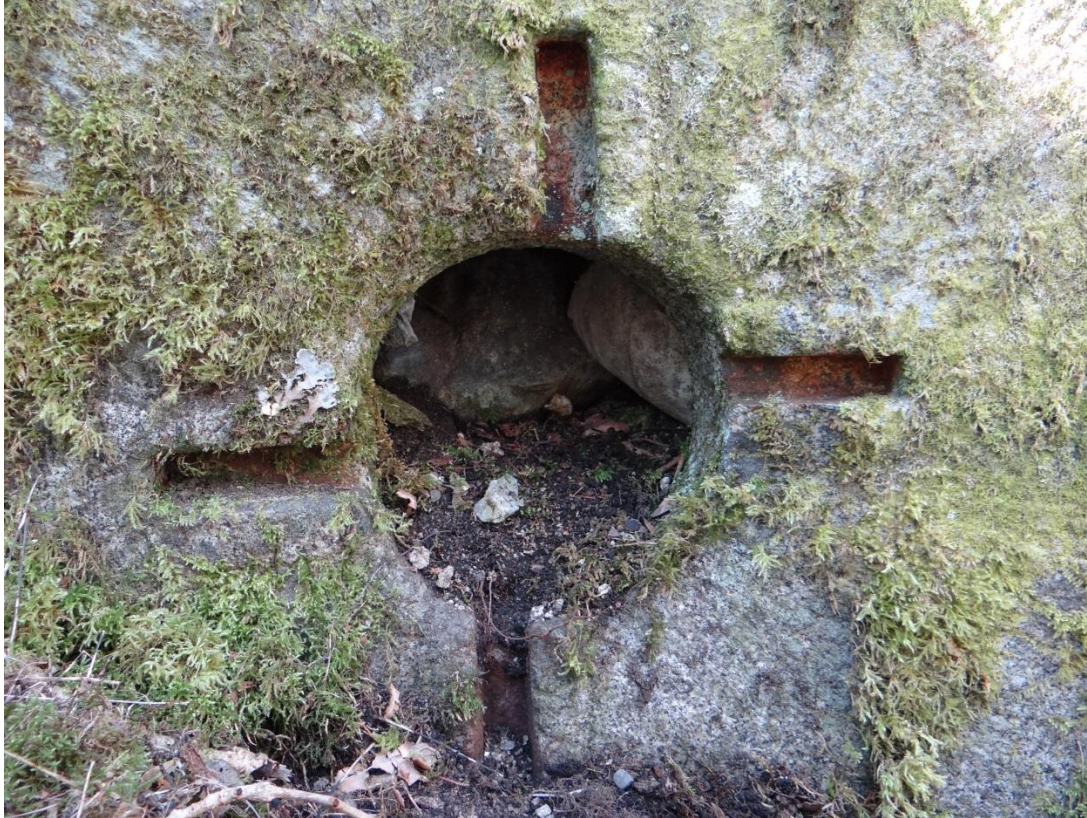
29 - Close up the centre of the mill stone showing offset rectangular sections

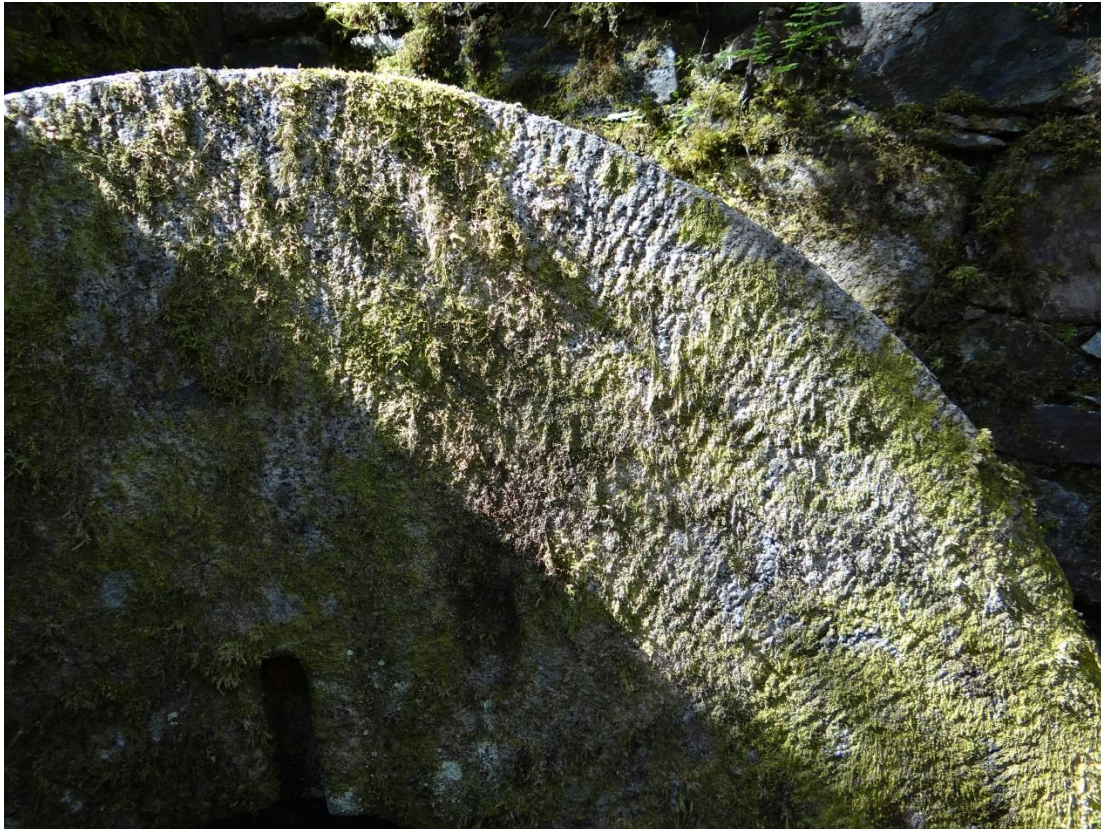
30 - Close up of the mill stone showing rough rivets for grinding

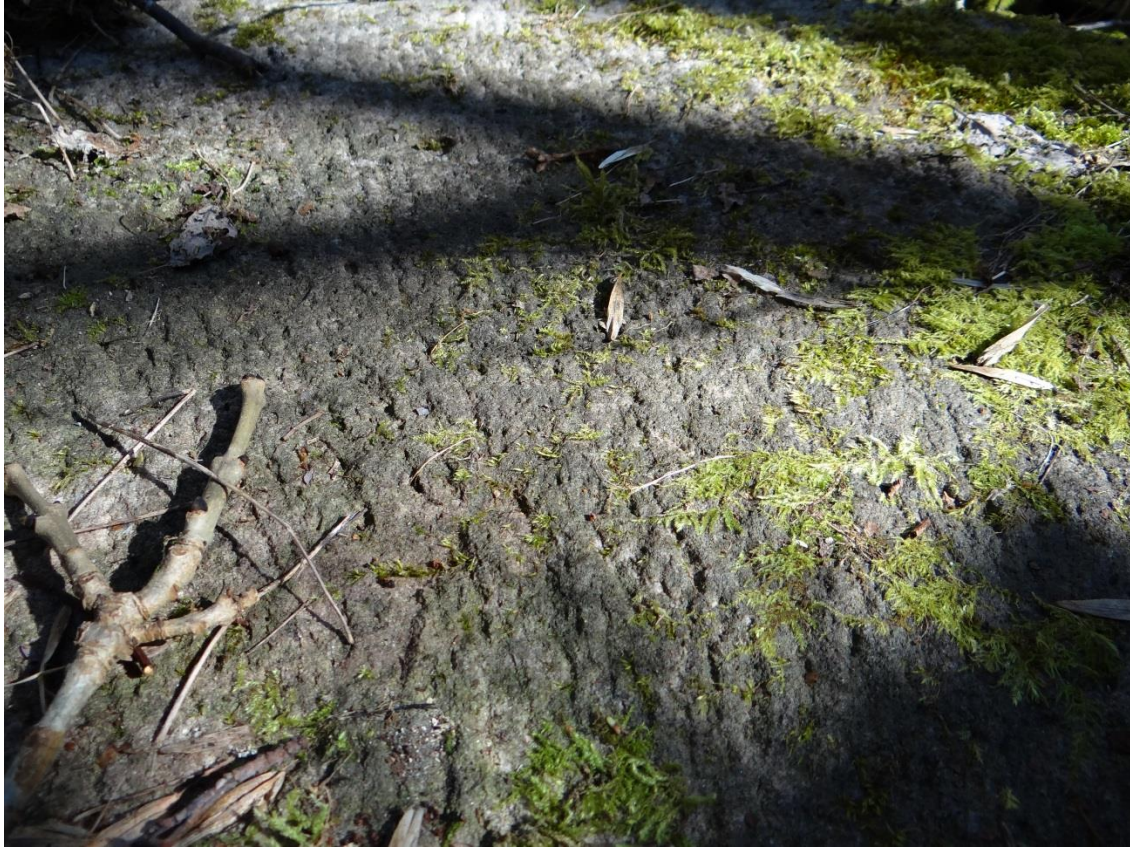
31 - Detail of the texture of the mill stone, showing rough surface

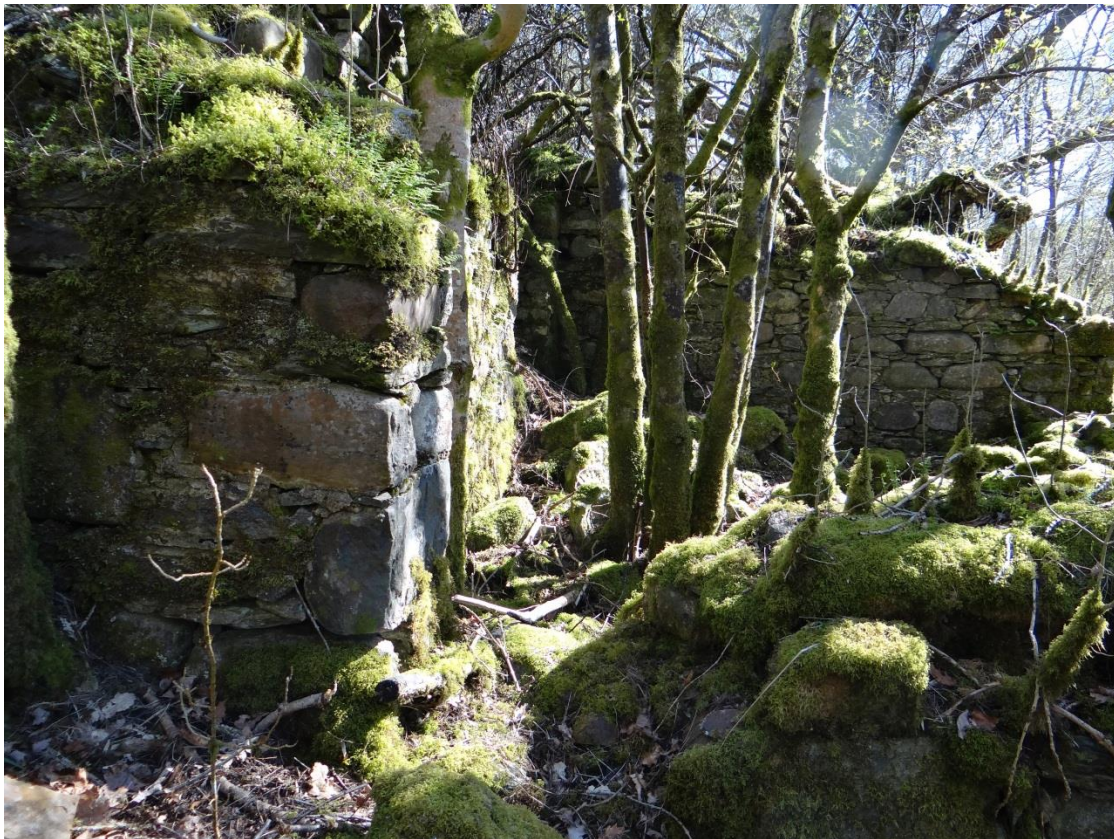
32 - Centre of the western wall, showing southern gap, facing east
