Oswald Lane, Cromarty

Archaeological Watching Brief

Report No.	HAS150104
Site Code	HAS_COL14
Client	C and C Keith
Planning Ref	11/01283/FUL
OS Grid Ref	NH 78930 67489
Date/ revision	22/01/2015
Author	John Wood

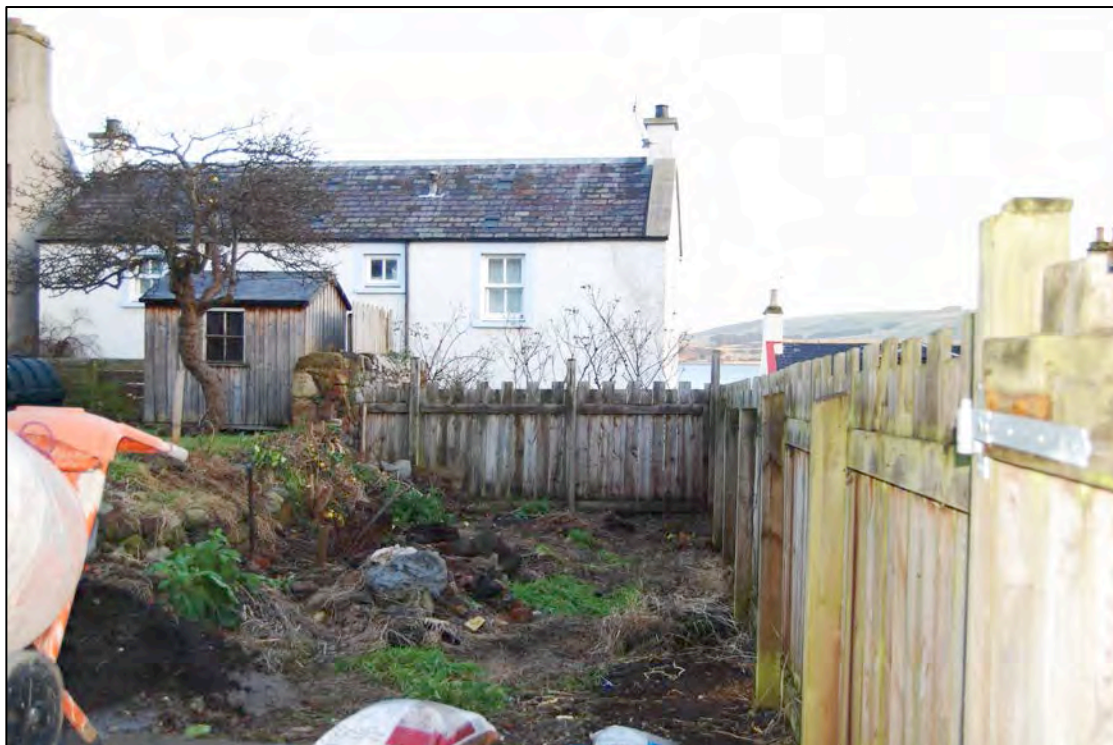
Plate 3 The site pre-start

Initial pre-start photographs were taken by Zoulla Spirou, the site owner. These show garden ground [1] with a wall running parallel to Oswald Lane and about 4.4m back from it. This wall retained approximately 1.1m depth of soil to the west. The considerable depth of topsoil suggests that soil has been imported to level up the garden, but there is also a natural slope here which continues down Gordon's Lane to the east (Plate 3).

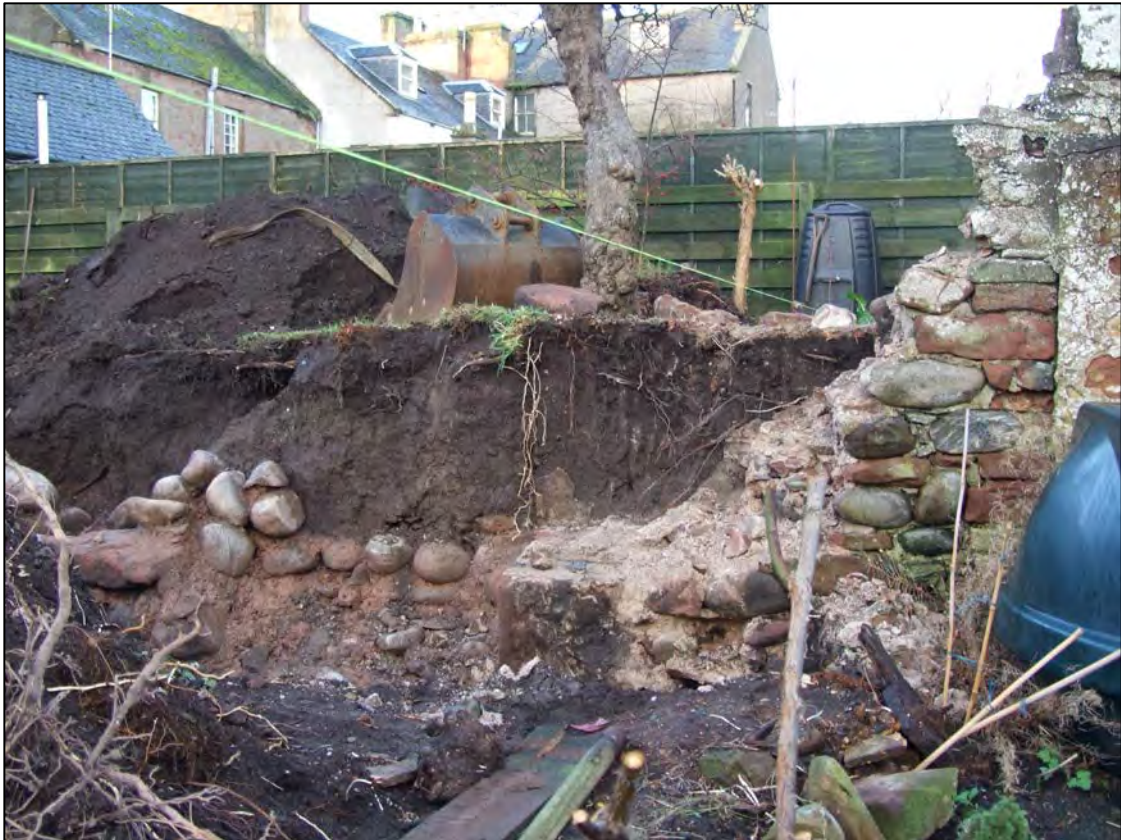
Removal of the modern wooden fence along the roadside was followed shortly afterwards by (unobserved) excavation of a test pit to establish levels at the north end of the site. This removed part of a stone wall end projecting into the site from the north-east, which was subsequently identified as a corner of a former house (House B; context [3]). It was found to be well built of quarried, partly dressed sandstone. Below it there appeared to be evidence of trampled surfaces [13] (Plate 4).

Plate 4 Soil level in garden to NW retained by wall following test pit excavation (photo: ZS)

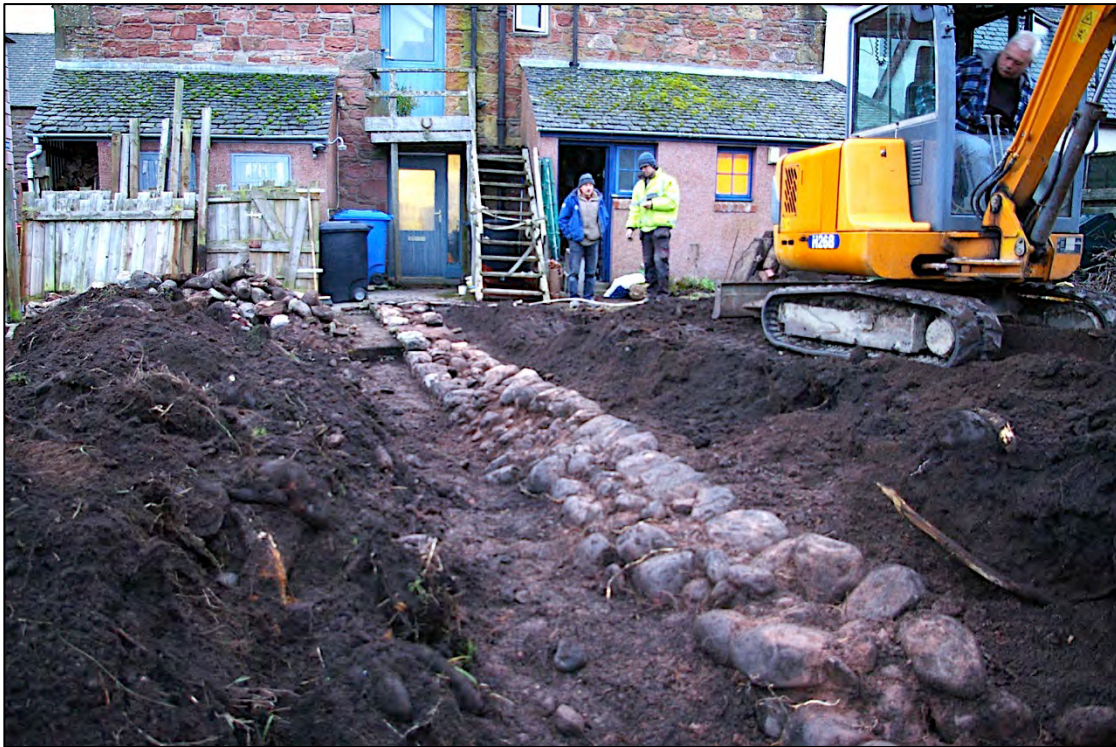
The wall running through the site could be divided into several sections. For the most part it had formed the back wall of a house standing on the site itself (House A)[5]. It was poorly built of rounded beach or field stones bonded with clay rather than quarried sandstone, and appeared to have been constructed as a revetment with no outer (north-west) face. The inner (south-eastern) face showed traces of lime plaster or harl at the southern end. No evidence was found to indicate when this wall was constructed. The wall appeared to have been rebuilt at the southern end, with some lime mortar included in the bonding [3]. (Plate 6).

Plate 5 Wall (House A) as initially exposed

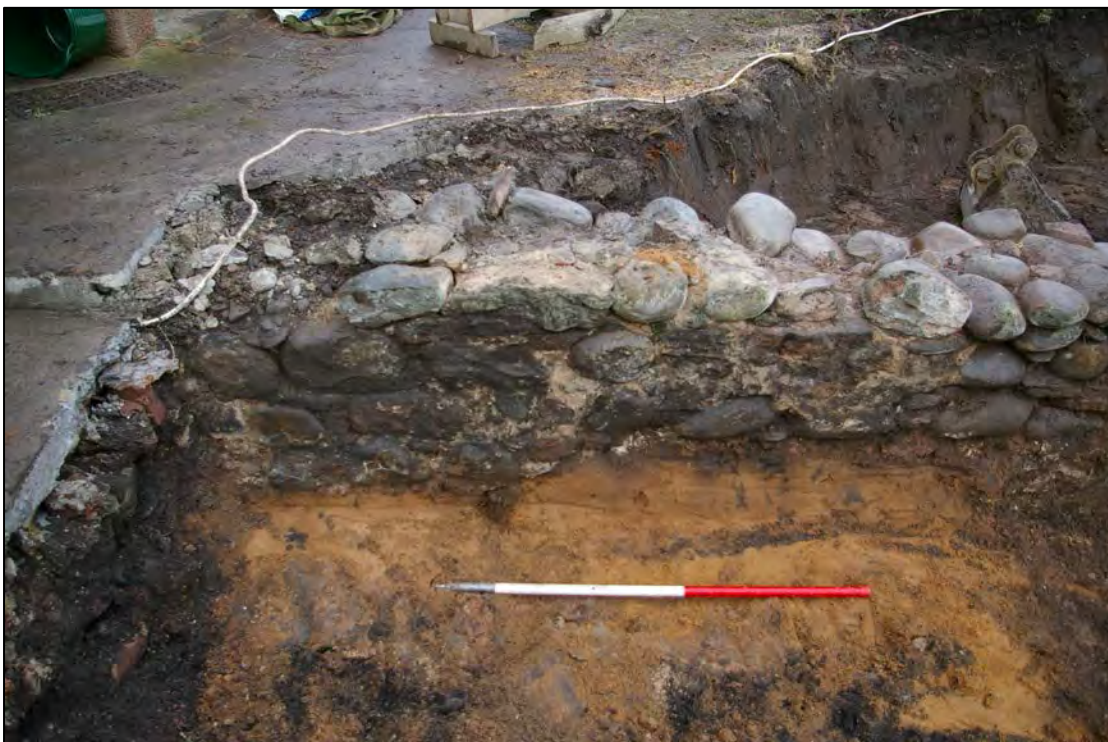
As excavation progressed it became clear that one reason the floods caused such destruction was that these houses, like most Cromarty houses, had no foundations and in this case were laid directly on sand which had been washed out by the floods. At the time no doubt Oswald Lane was apparently not metalled, so erosion would have been severe.

Plate 6 S end of wall from SE: no foundations, built on sand. This section was clearly a repair and contained lime mortar.

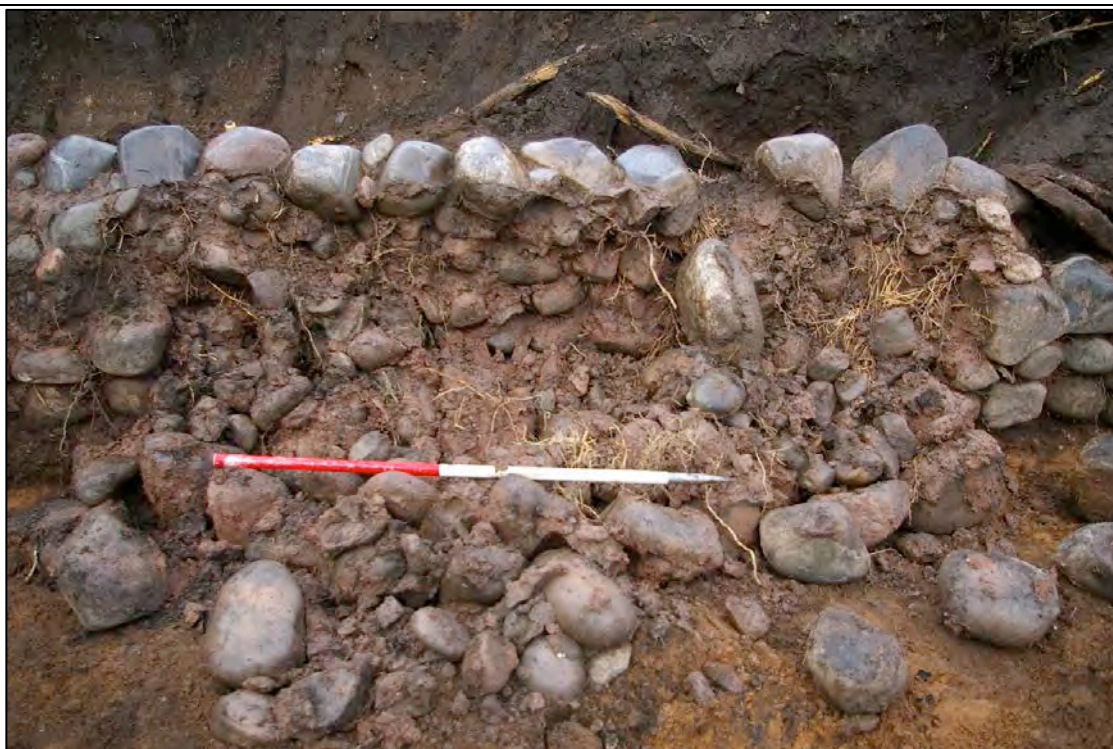
Very soon after it was exposed and cleaned, rain penetrated the clay bonding and a section of it collapsed (Plate 7).

Plate 7 Wall collapse following rain (N end of house A)

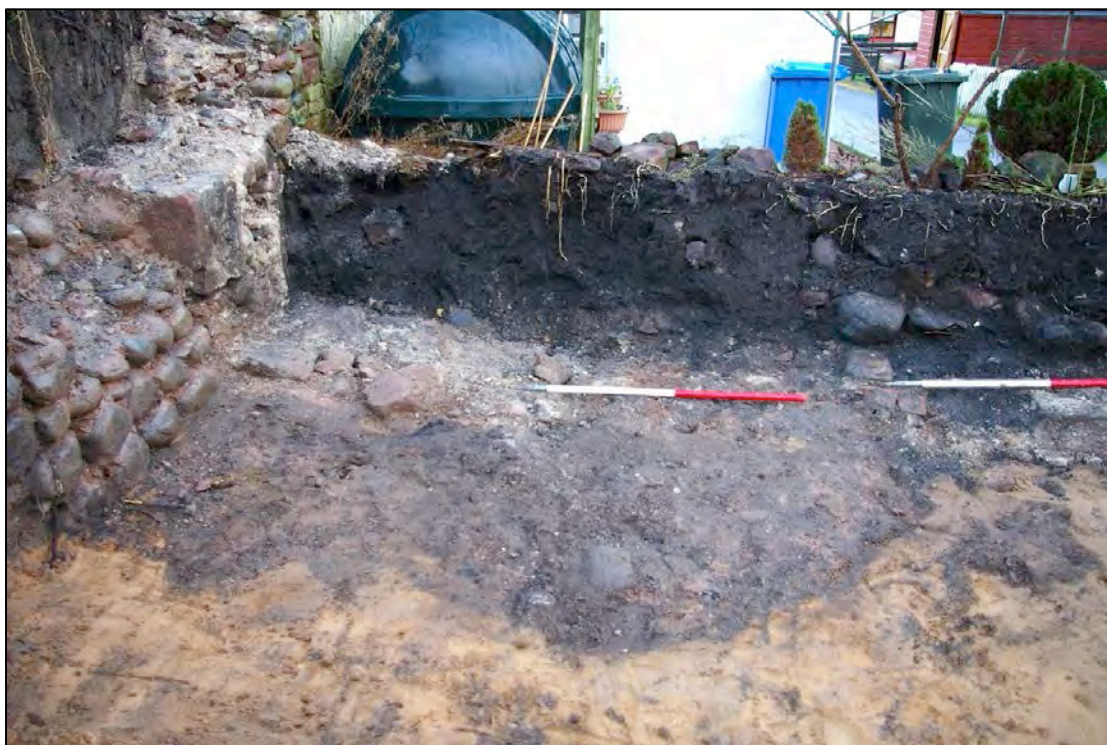
At the north-east end of the site a much more substantial, lime mortar bonded, sandstone wall on the same alignment formed the back of another house (House B)[3]. There were traces of a possible return but on investigation this appeared ephemeral and likely to represent demolition surface [13] and built-up debris [7]. The line lay lay along the north-eastern boundary of the site (Plate 8).

Plate 8 North corner of site following initial clean, showing destruction layer over natural sand

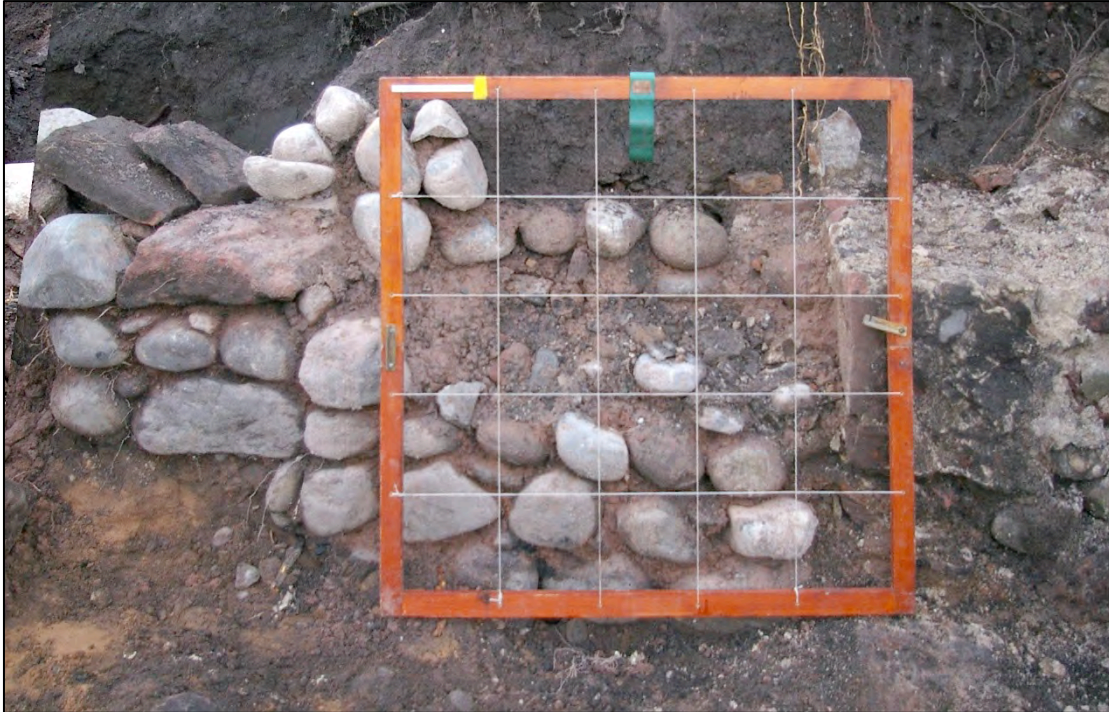
Between House A and House B there had apparently been a gap at one time, forming a narrow alleyway. This had been blocked at some point with an infill along the back wall alignment of rounded, clay-bonded beach or field stone [2] (Plate 3). No gap is shown on the first edition OS 1:2500 map, but the boundary between the two properties appears on the map along the southern wall line. The northern house is of better and perhaps later construction. The blocking must have occurred before, or at the time that, the ground levels were built up in the garden to the rear (Plates 9, 10).

Plate 9 Blocking in wall between buildings A (left) and B (right).

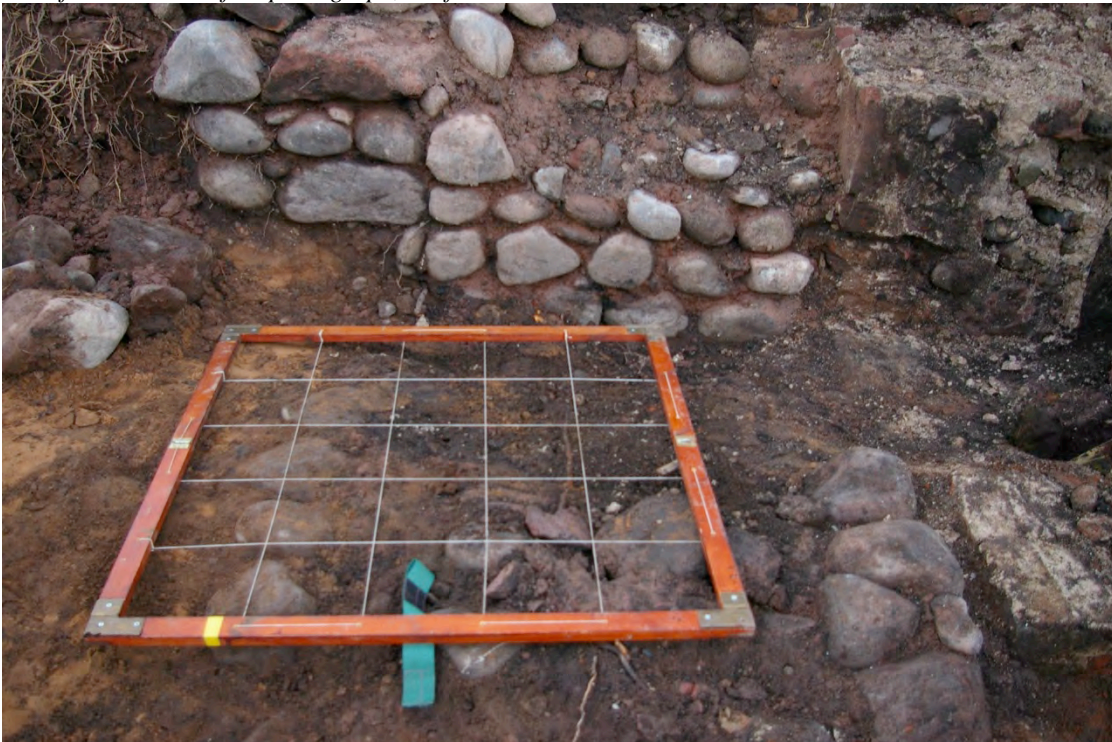
Plate 10 Blocked alley between Houses A and B.

Note line of rounded stones on line of House A gable return [6], under left side of planning frame.

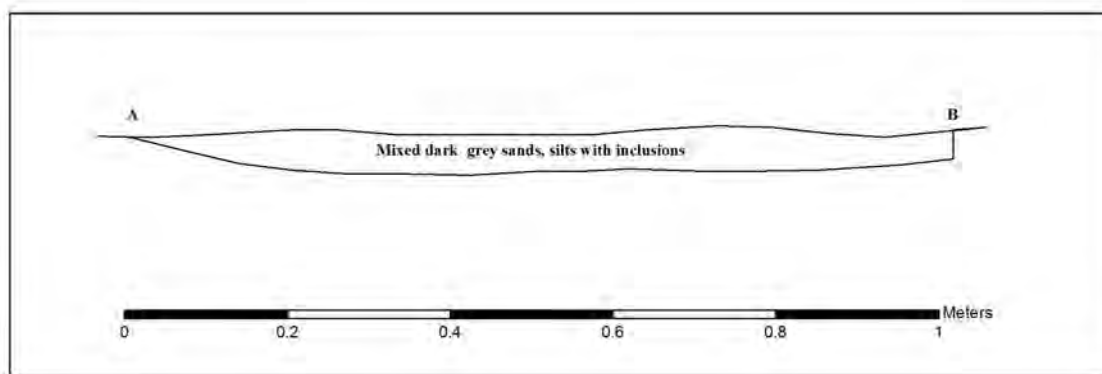
Figure 9 SE facing section through deposit (Section 1)

An area of mainly dark, mixed deposits with inclusions of mortar and rubble was visible in the north corner of the site, extending SE from the wall about 2.9m towards the lane and about 2.15m SW from the northern trench edge [7]. It extended to a maximum depth of c.5 cm. One area of this (Plate 10, to right of planning frame) appeared initially to be a structure but after investigation was interpreted as collapse. A section 1m x 1m was taken through the eastern corner of these deposits (Figures 9, 10; Plate 11) The section was placed so as to pick up any surviving wall line of house B, but none was found and it seems this had been demolished entirely (Plates 8, 9). This material was all found to represent destruction and / or demolition debris. The rest of this layer was then removed archaeologically but no artefacts or further structures were found.

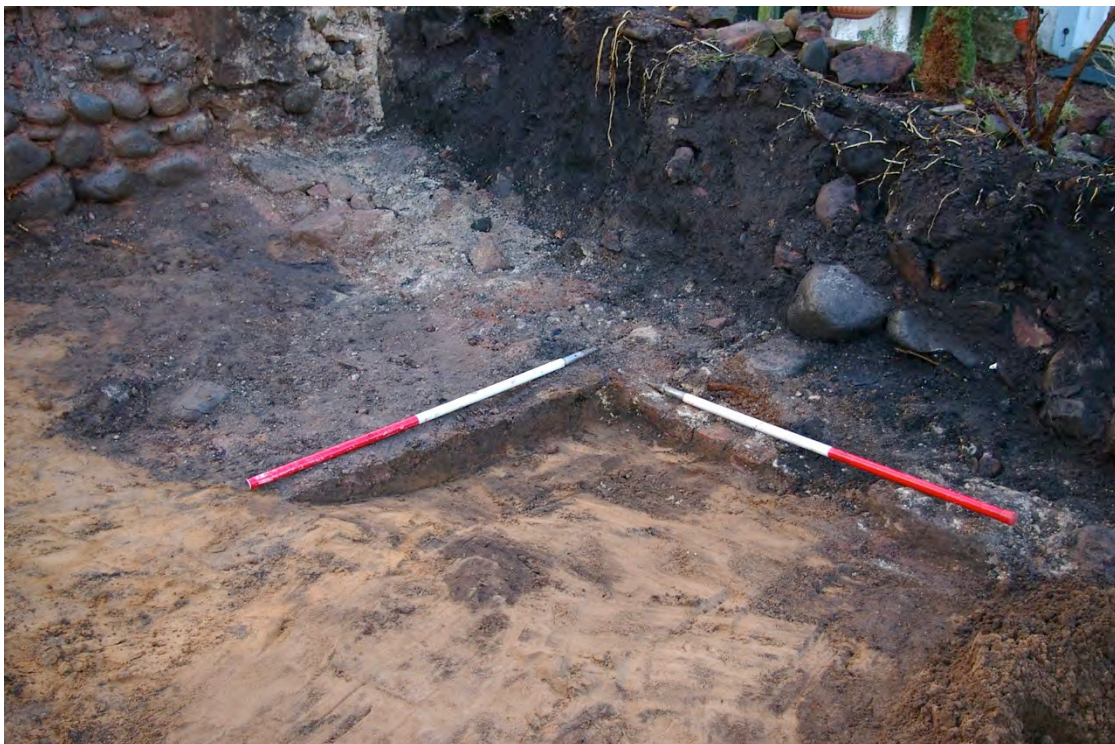
Plate 11 Section 1: Profile of destruction debris in north corner of site

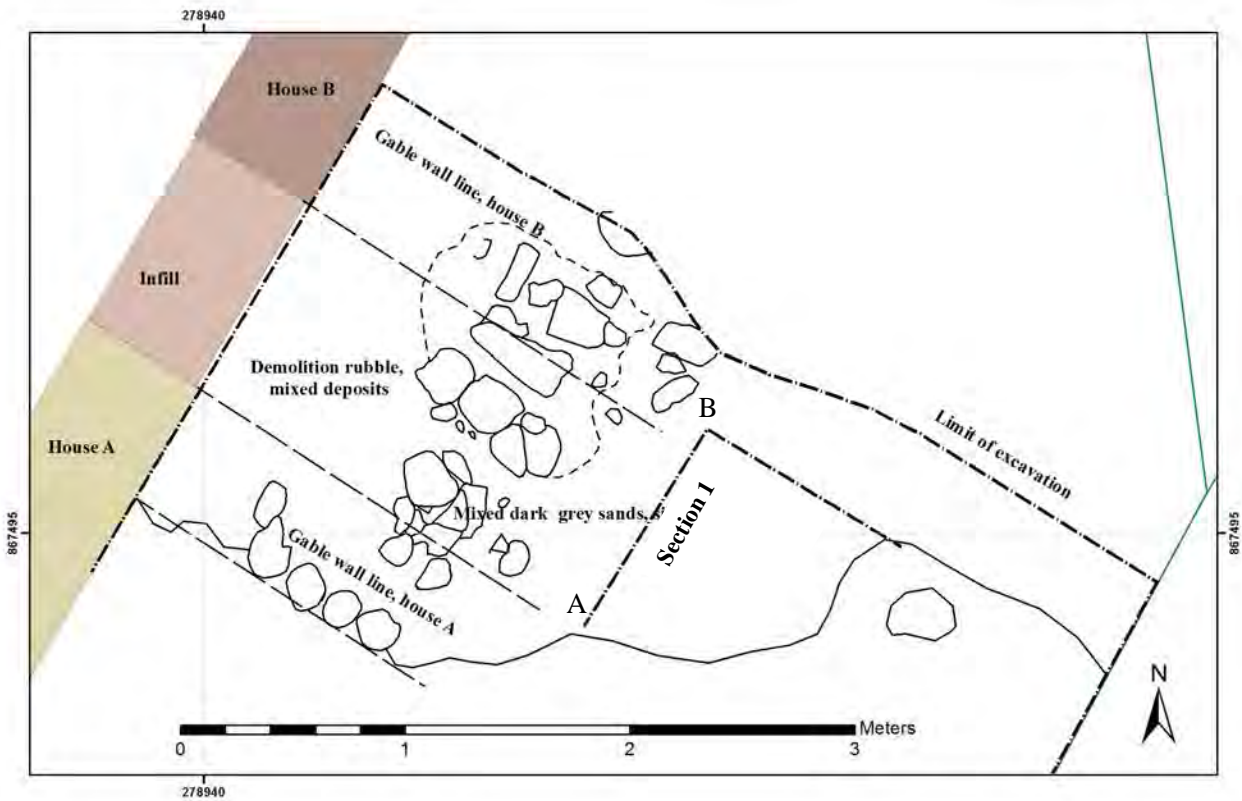
Figure 10 North end of trench showing boundary between house A and house B

House A therefore seems to have been relatively poorly constructed of field or beach stone, and bonded with clay. House B was much more substantially built using quarried and partly dressed sandstone and bonded with lime, although this also contained rounded field or beach pebbles, but was apparently destroyed in the 1940 flood.

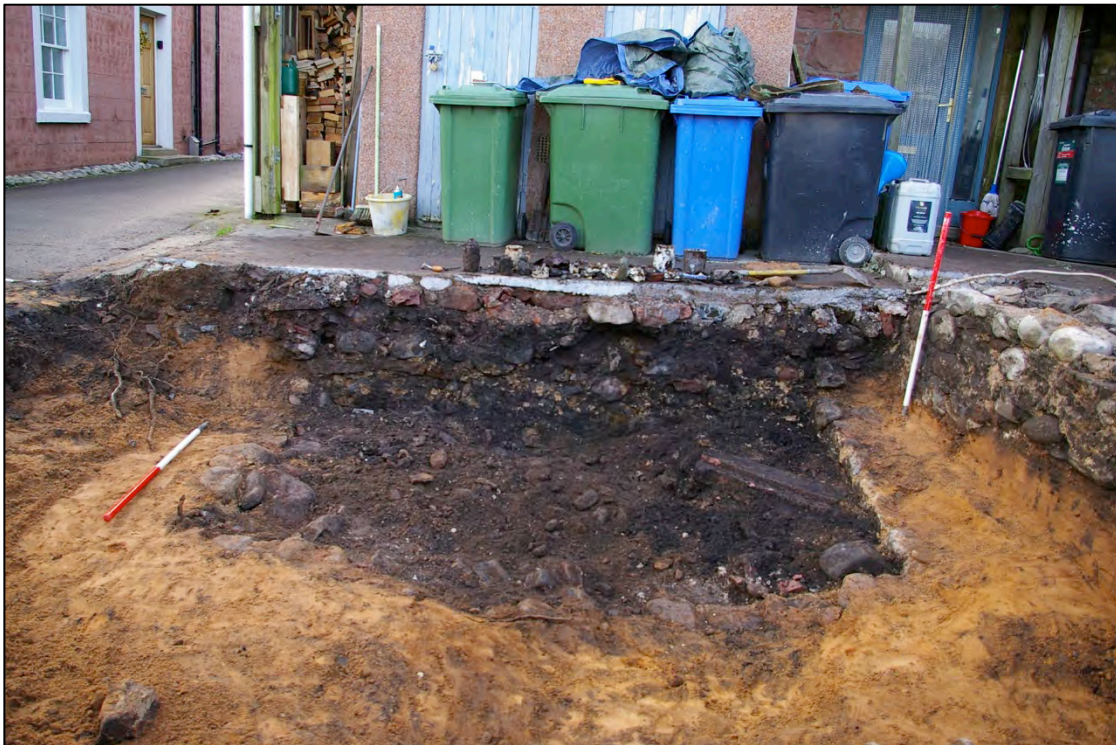
Plate 12 Surface of coal cellar after cleaning

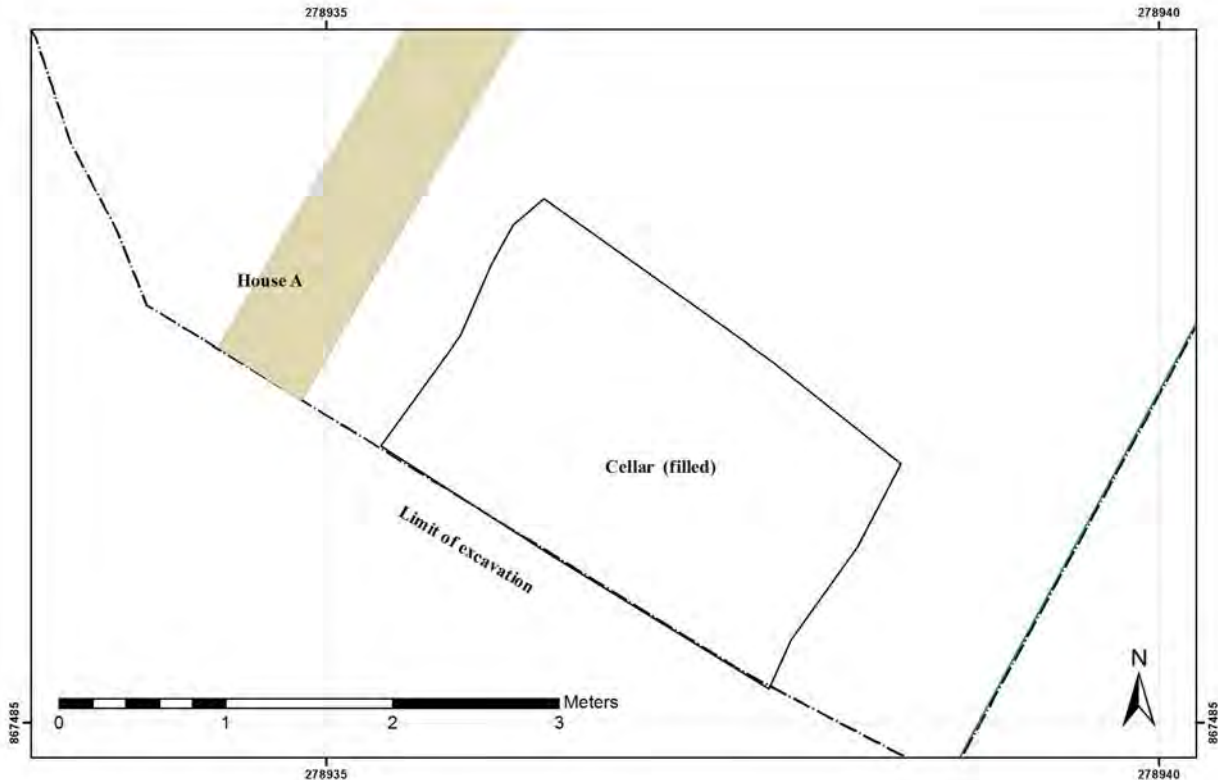
Figure 11 Cellar, House A

In the southern end of House A, clearance revealed the outline of a filled-in coal cellar [8,9,10]. This appeared to be simply a rectangular pit. This was roughly rectangular, and lined with field or beach stone with some clay bonding [9]. It measured approximately 2.7m by 1.55m. internally. The western side measured slightly longer at 1.8m, apparently owing to surface damage by the digger during excavation (Figure 11).

It became apparent that this cellar area lies outside the footprint of the proposed new house and will be left undisturbed by the present development. It was therefore left in situ and covered over. Various household items were found in the surface of the infill [10] including cutlery, broken china, some iron objects and the workings of a small clock. These all appeared to be of early-mid 20th c. date and probably represent debris from the flood used to fill the cellar in 1940. They were unstratified, and not retained.

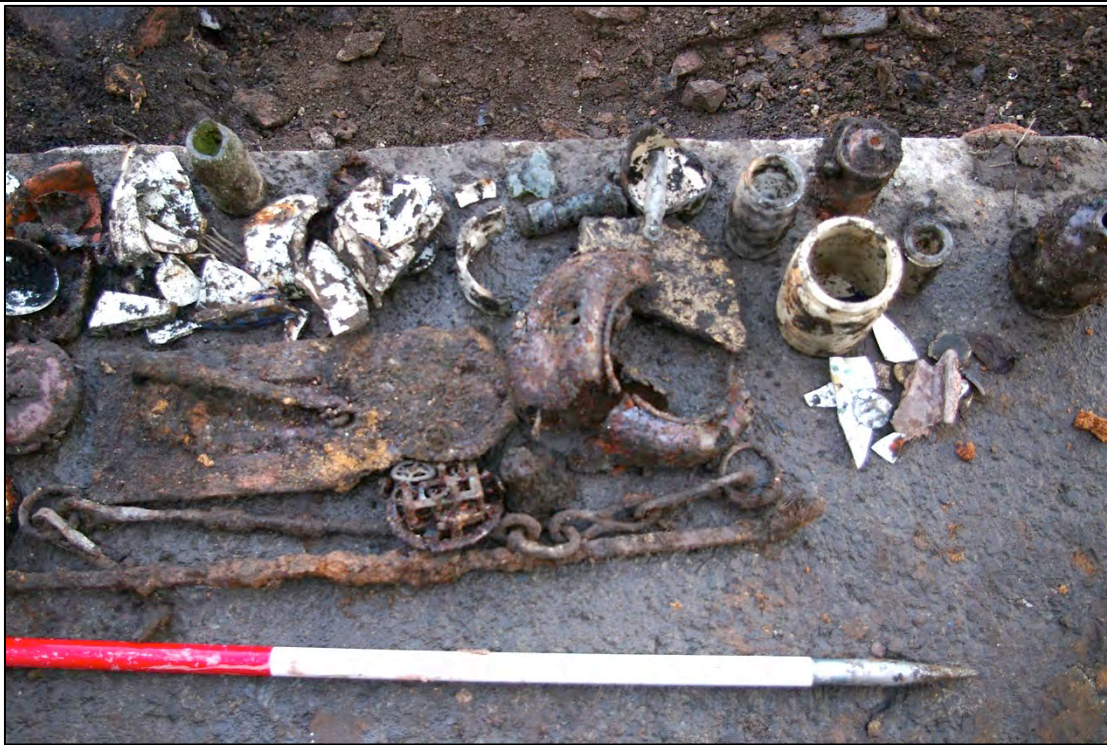
Plate 13 Unstratified artefacts from the surface of the cellar fill
