Plockton Harbour CIC Equipment Store

Plockton, Balmacara Estate

Photographic Building Survey

Historic Building Survey Report

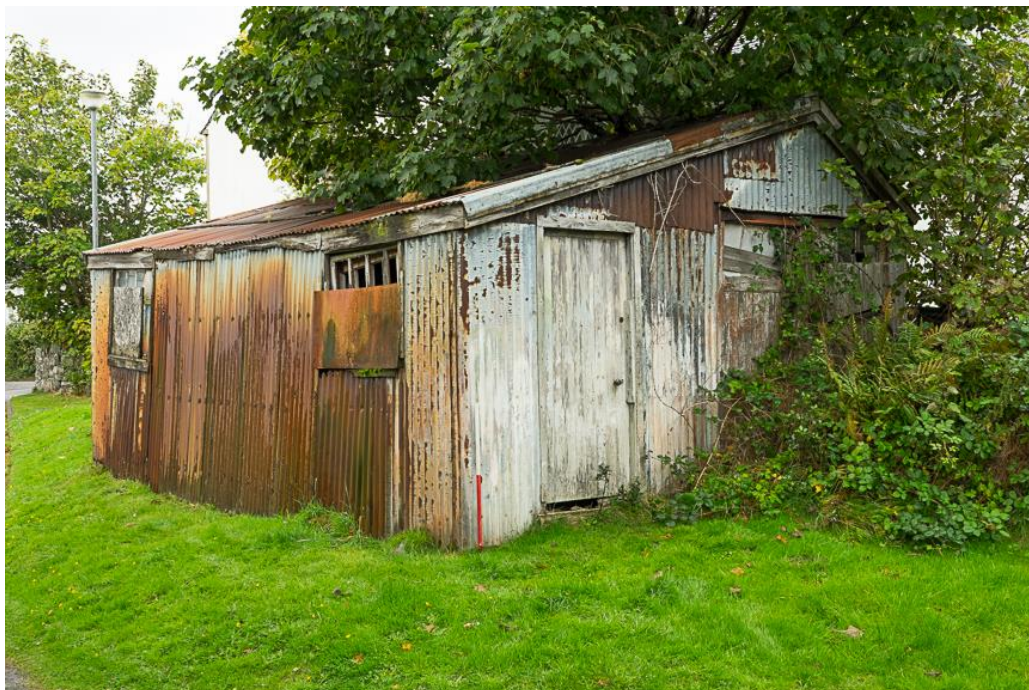
Plate 1: The tin clad garage building

space, have timber linings. Otherwise walls and roof are unlined. The exterior, both walls and roof, are clad in corrugated, galvanized steel (**Plates 1; 2**).

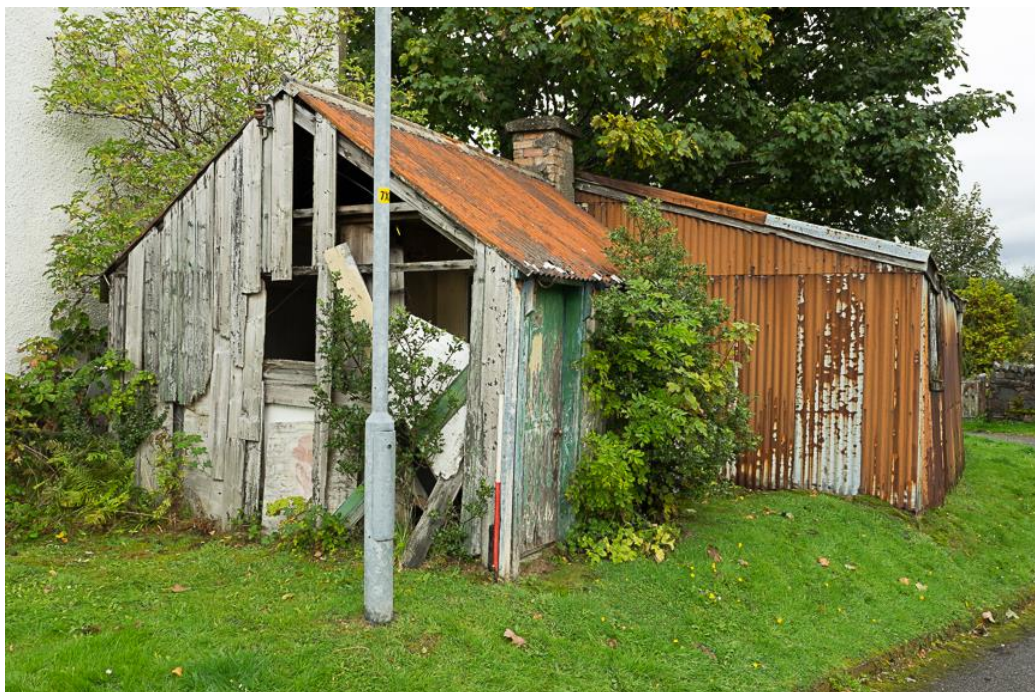
Plate 3: The cabin building, with the tin-clad garage situated behind

This seems to have been built as a very modest dwelling with a single room (**Plate 3**), and includes a plumbed wash basin, fireplace, water heater, a few cupboards, porch, and at least one sash window in the east wall, though another may have existed in the degraded south wall. It is timber lined throughout on the inside. The quality of construction is much superior to that of the garage. On the outside, the long walls and roof are clad in corrugated steel, while the gable ends are clad in painted timber. The fireplace (**Plate 4**) is vented through a brick chimney. It is currently being used to store road salt and a salt spreader.
