**Archaeological Evaluation of Buildings at Balavoulin, Glenelg,
Inverness-shire, and the potential impact of a Proposed Water
Main**

Archaeological Evaluation of Buildings at Balavoulin, Glenelg, Inverness-shire, and the potential impact of a Proposed Water Main

Sketch Plan of Buildings and other features

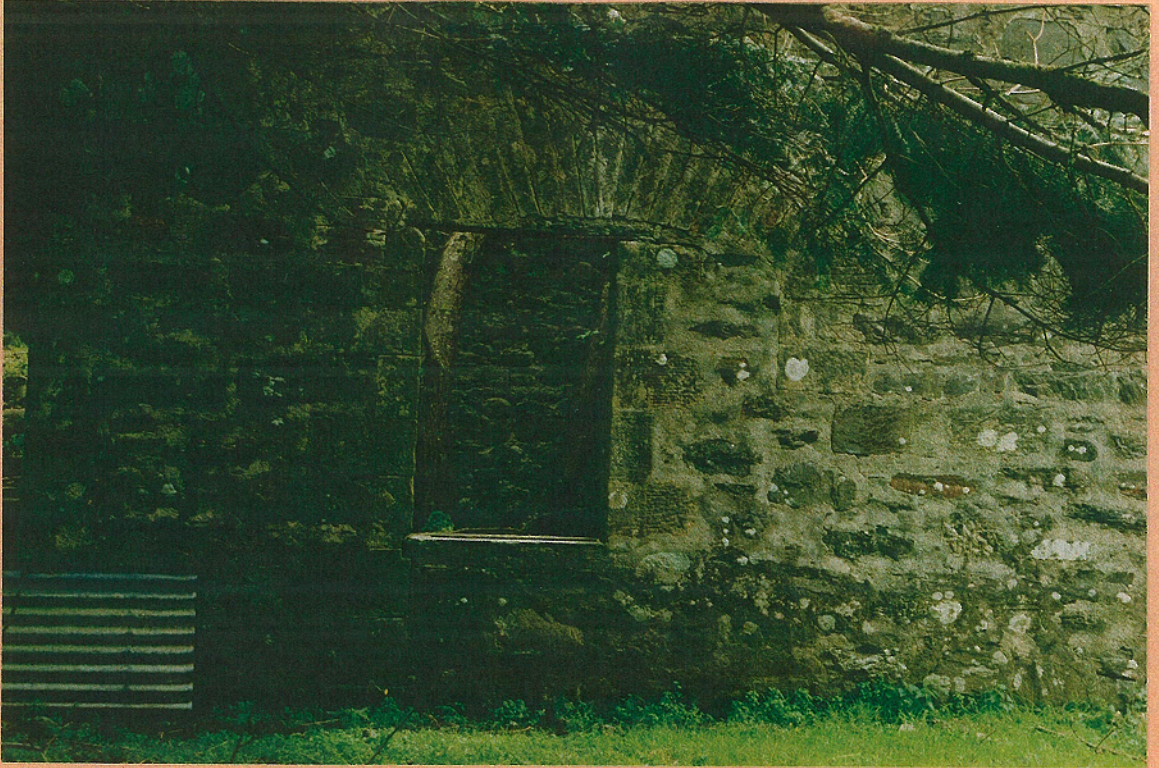
①

1. **Building A:** Window set into a wide arched doorway. Note the decoratively dressed corner stones, some re-used for the window, and the iron window lintel, probably a part of the water wheel.

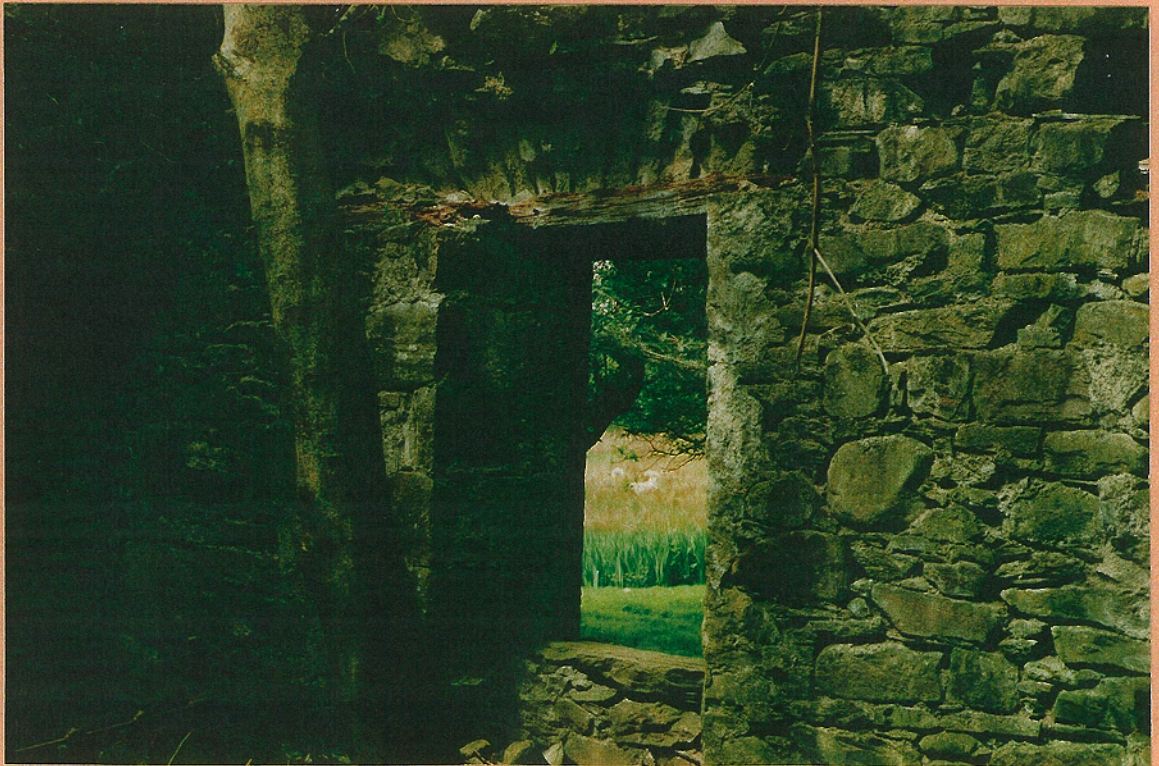
②

2. **Building A:** Back of window and arched doorway, showing the wooden lintel running the width of the doorway. To the left is the internal partition wall, not keyed into the main wall, and the blocked-off doorway into the outhouse section.

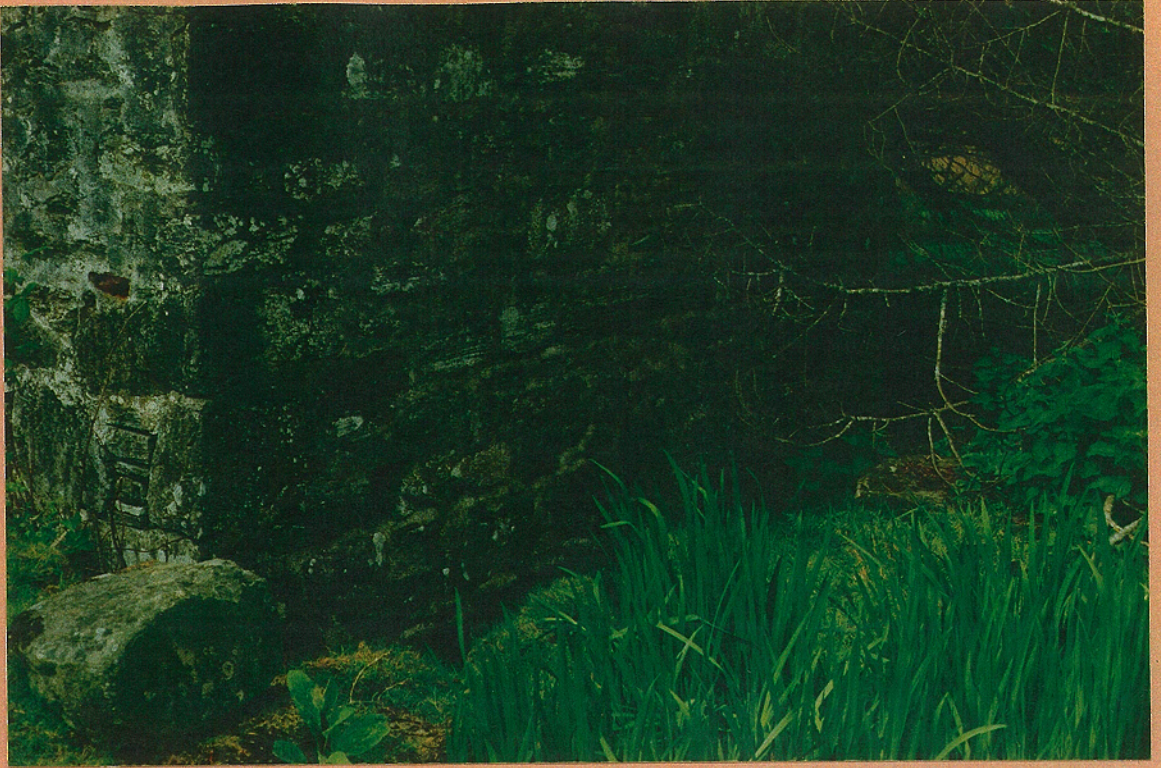
3

only about 20cm deep, which presumably supported beams over the channel (**Photo no. 3**). Where the axle of the wheel would have passed through the wall is one of the blocked-up windows. The only trace of the wheel within this building are the iron lintel over the window in the arched doorway and iron bars placed as floor joists to a second storey in the outhouse, which may originally have been spokes.

3. **Building A:** NE gable where the water wheel would have been located. The lintel stone visible in the centre of the picture is above a blocked up aperture where the axle would have passed through the wall. Near the corner of the walls are small square niches which presumably supported beams.

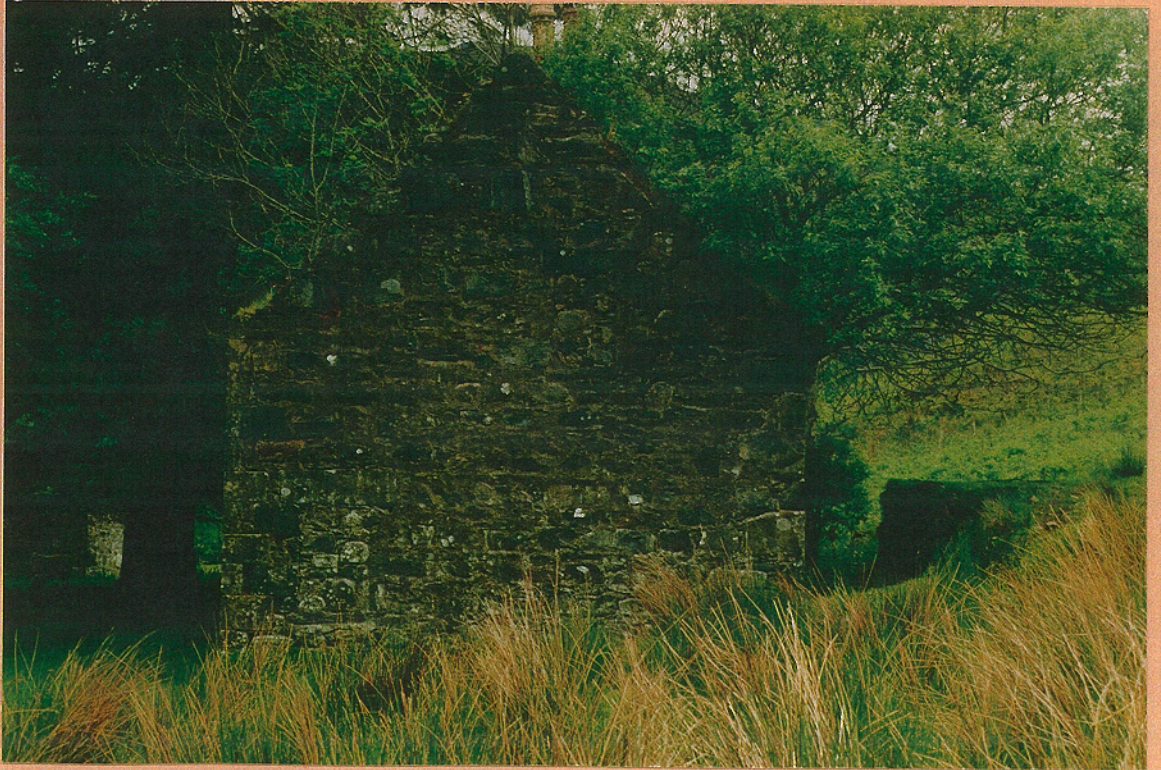
4

4. **Building A:** SW gable. This picture shows the raised line of the roof and two blocked-up windows. To the right is the remaining section of the retaining wall running along the back of the building.

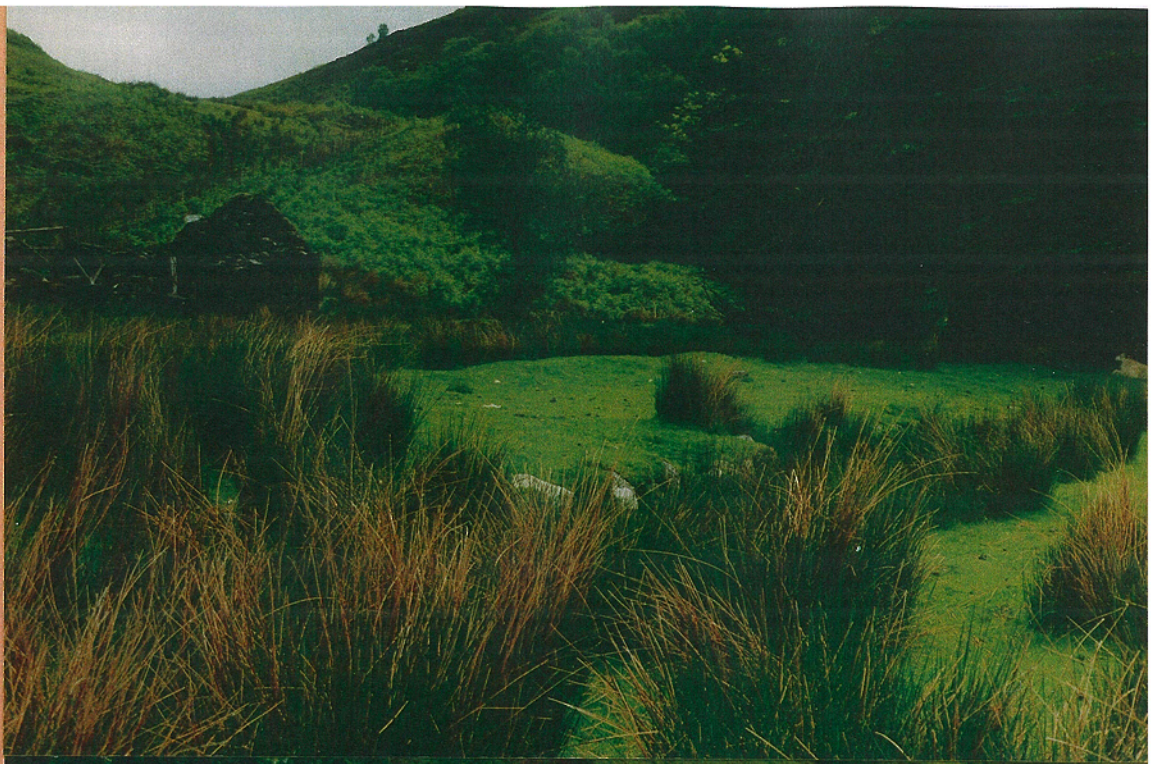
5

1. **Stone lined ditch; Trackway** This ditch probably indicates the line of the trackway running from the mill building to the ford, and later footbridge, across the Glenmore River (**Photo no. 5**) The line of the raised track has now been cut across by the changed course of the Allt a' Mhoulinn

5. **Feature 1, Ditch / Trackway.** The line of stones in the centre foreground mark the edge of the rush-filled ditch presumably at the edge of the trackway from the mill building to the Glenmore River.

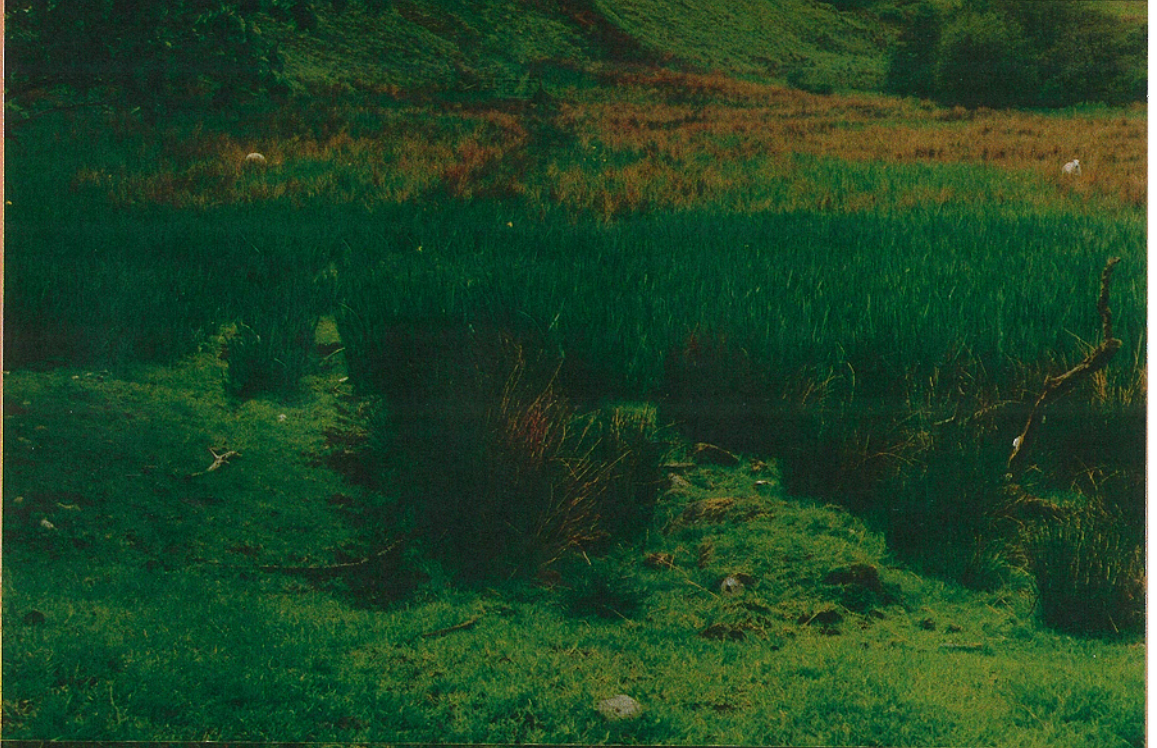
6

8. **Trackway.** This track descends from the raised platform surrounding the mill building into wet ground to the west, heading for a gateway to the SW (**Photo no. 6**)

9. **Footings of drystone dyke.** These grass-covered footings appear to run parallel to the trackway (above, no. 8) at a distance of less than 2m (**Photo no. 6**) This is probably the line indicated on the 1st and 2nd edition OS maps.

6. **Features 8 and 9, Trackway and Drystone Dyke.** The footings of the drystone dyke are to the right of the track which runs to the gate in the background.

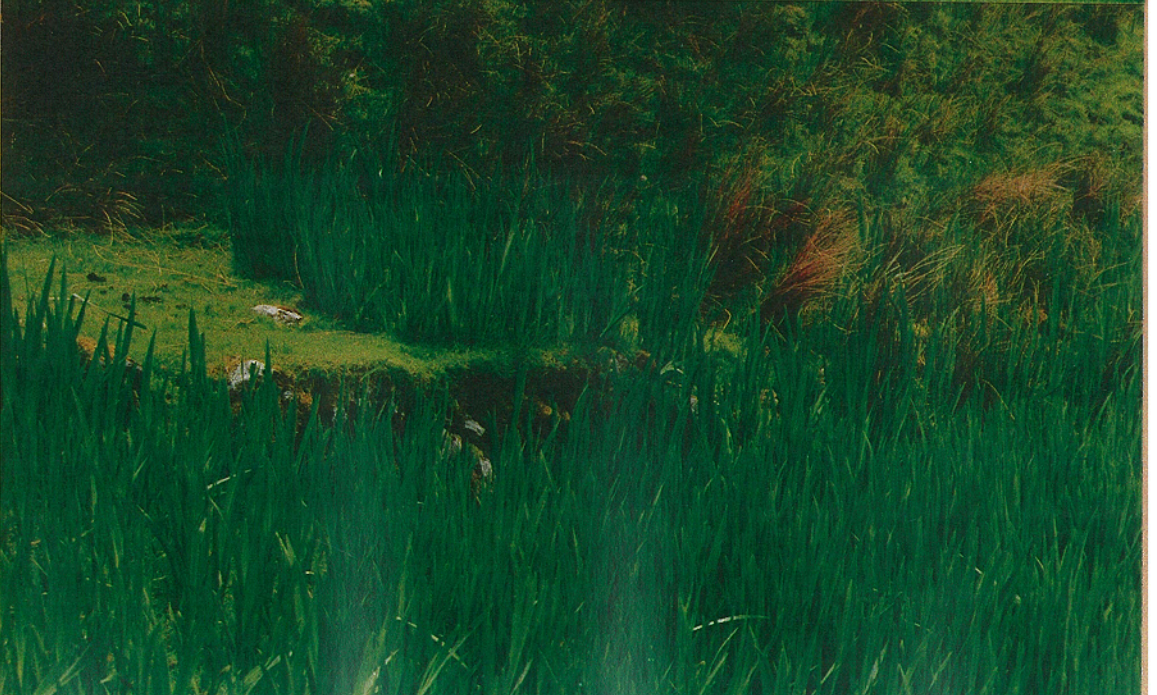
7

7. **Retaining wall.** This short section of wall appears to be supporting a level platform running for a short distance away from the mill building below the hill slope. It does not continue as a track. (**Photo no. 7**)

7. **Feature 7, Retaining Wall.** This supports a small platform extending out from the leveled ground on which the mill building is located.
8. **Feature 6, section of walling.** This is located west of the line of mill lade.

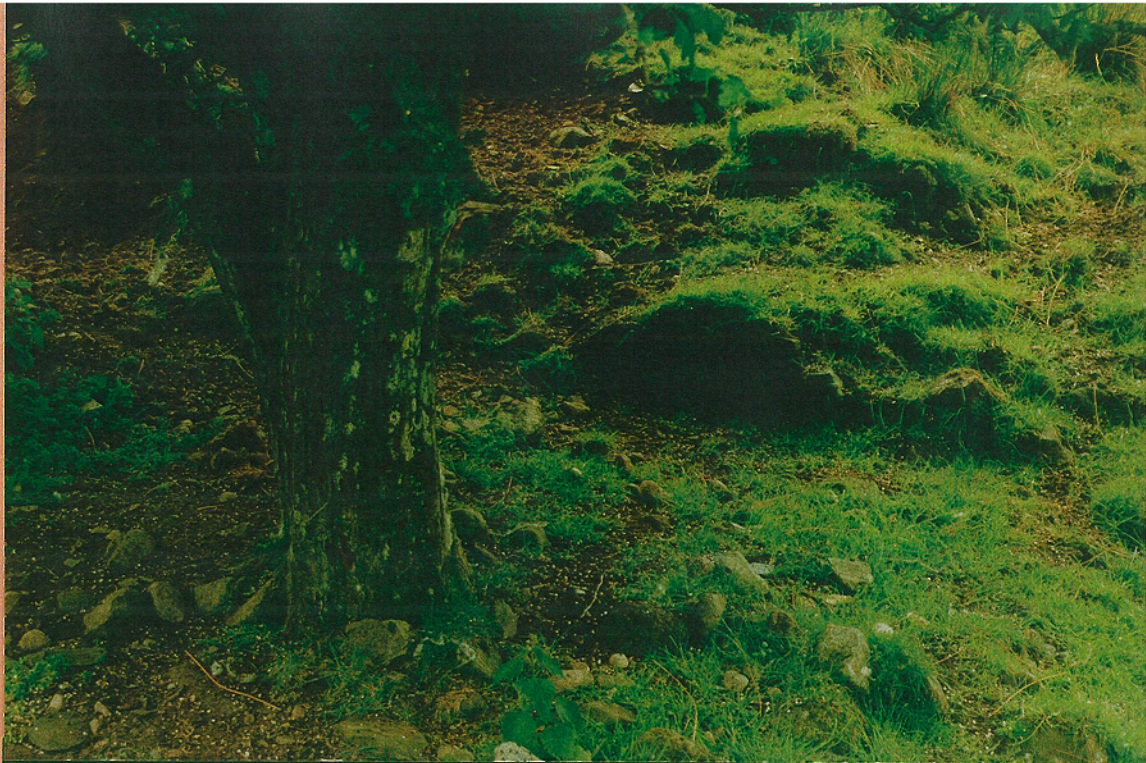
8.

6. **Small Section of Walling.** This was originally thought to be a remnant of the lade, but it is too far west and, if a wall, is running towards a point one third of the way along the back wall of the mill building. (**Photo no. 8**) The remaining section is only 6 stones in length and two high.

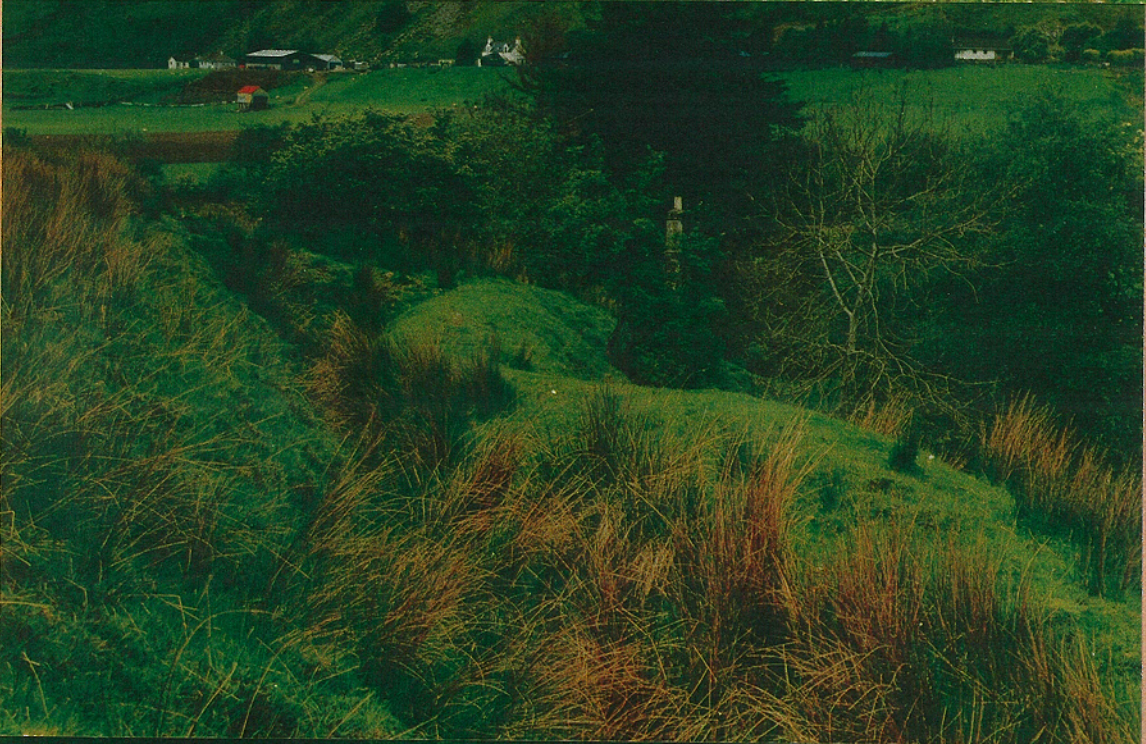
5. **Mill Lade.** Approximately 20m of the lade has been removed completely by the construction of the 1960s water main and access track, but above this, it is well-preserved running for approximately 40m round the contour from an intake point on the Allt a' Mhoulinn. Nothing is visible at the intake point. (**Photos 9 and 10**) Piles of rubble lying beside the modern access track where it runs up the slope behind the house probably represent the stone lining of the lade removed while excavating for the water main.

9. **Feature 5, Mill Lade.** View NW from Building E. The access track / pipeline crossing the lade are visible in front of the trees.
10. **Feature 5, Mill lade and Building E.** View SE from the access track. The Allt a' Mhuilinn is visible on the far left. The point of intake for the lade is in the trees.

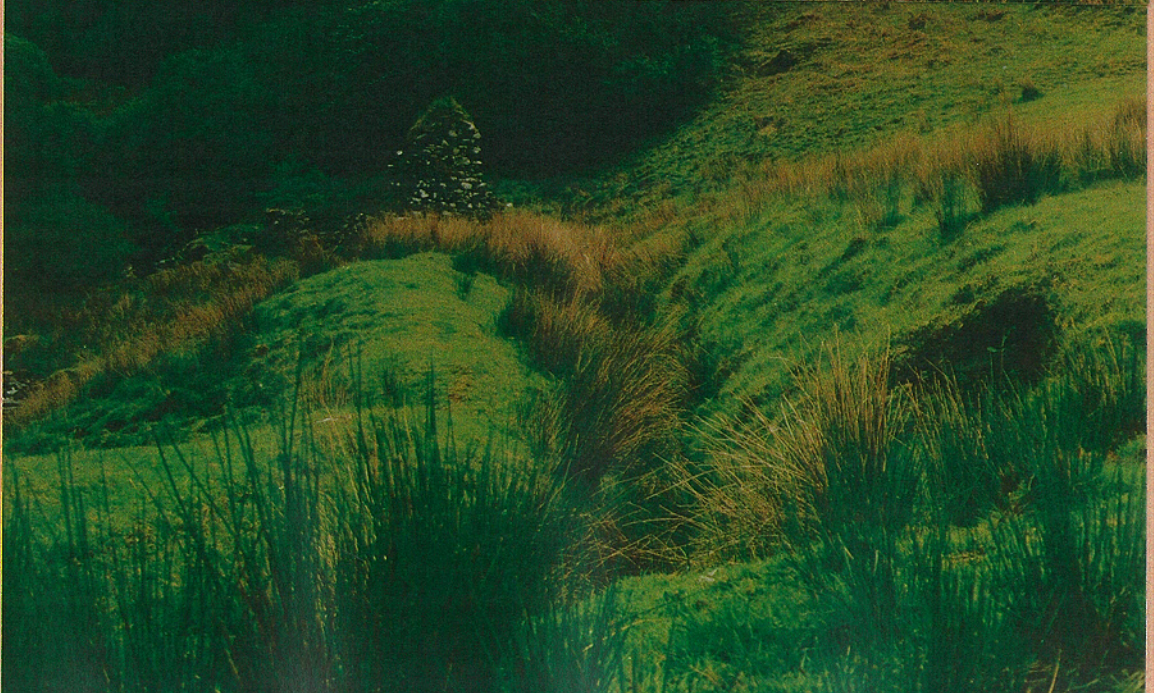
10.

This is the building upstream from the mill, which is located between the lade and the Allt a' Mhuilinn. It is of rubble construction, the walls mostly standing no more than 1m high, except for the west gable, which is almost to its full height (**Photo no. 10**). It is possible that a water channel ran down from the lade to the stream immediately east of the building; this is suggested by a line drawn on both the 1st and the 2nd edition OS maps. The omission of the building from the 1st and its inclusion on the 2nd edition OS map suggest that it must have been constructed between the dates of these two editions, in the 1880s-90s, but its function is unclear

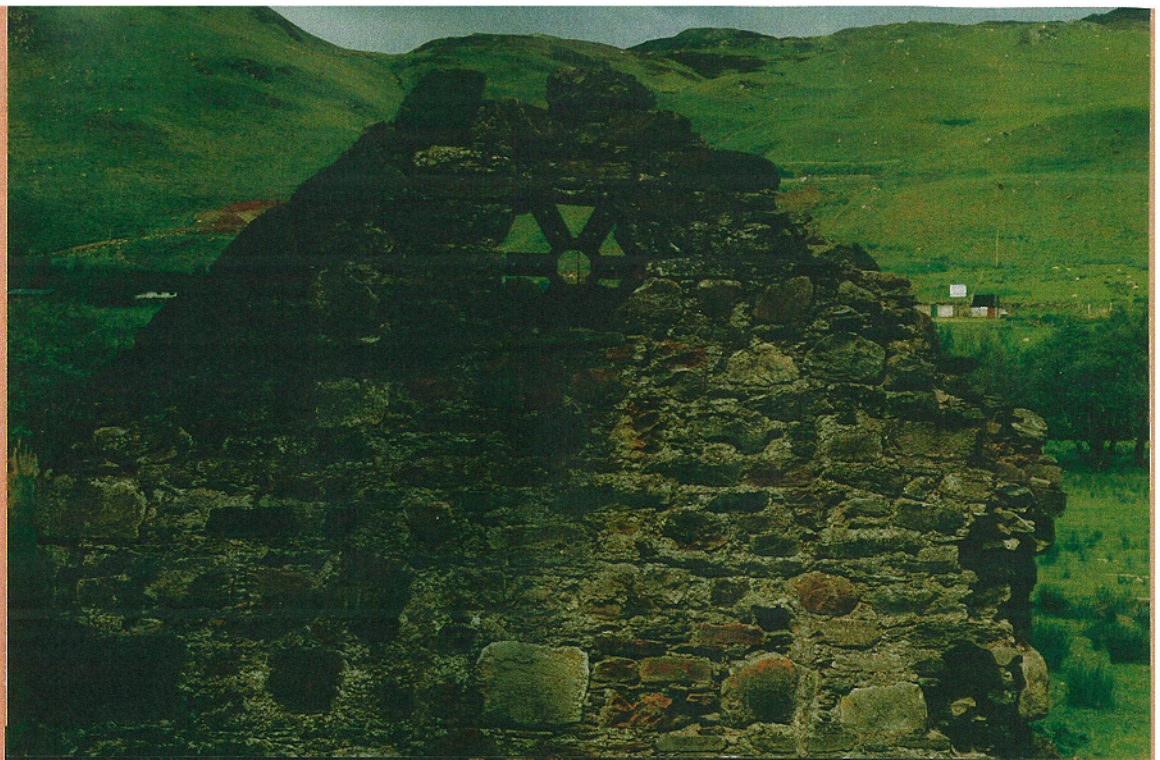
The main point of interest in this barn is the hub of the water wheel set into the gable end (**Photo no. 11**) A second hub is lying against the wall near the other gable, which has collapsed, and may have performed the same function (**Photo no. 12**) Although this building is in the same position as indicated while the mill was still in existence, it was obviously rebuilt considerably when the hubs were inserted, possibly incorporating stone from the demolished Building D. Two opposing, fairly wide doors suggest a threshing barn, with the hub windows for extra ventilation. The remains of a tin roof lie within the ruin, and there is the concrete platform of a small extension on the north gable.

11. **Building B, Barn.** SE gable with the inset water wheel hub.
12. **Building B.** second water wheel hub lying on the ground near the NW gable, now collapsed.

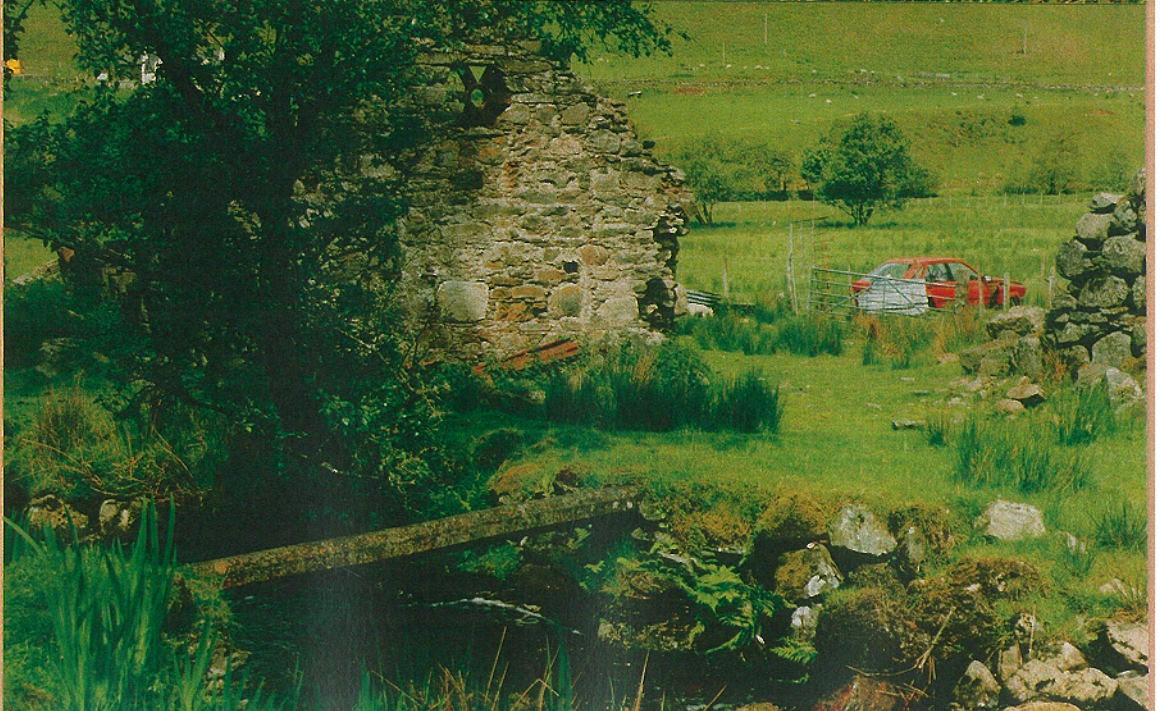
4. **Bridge and Water Wheel Axle.** The stone piers of a narrow bridge, now removed, over the Allt a' Mhoulinn. For some reason, the cast iron axle of the water wheel has been placed on the piers. This may have supported some form of footbridge structure. (**Photo no. 13**)

13. **Building B and Feature 4, Bridge Piers and Water Wheel Axle.** Building C is on the right, and the trackway passes between these two buildings.
14. **Building C.** View from the NE with building B in the background

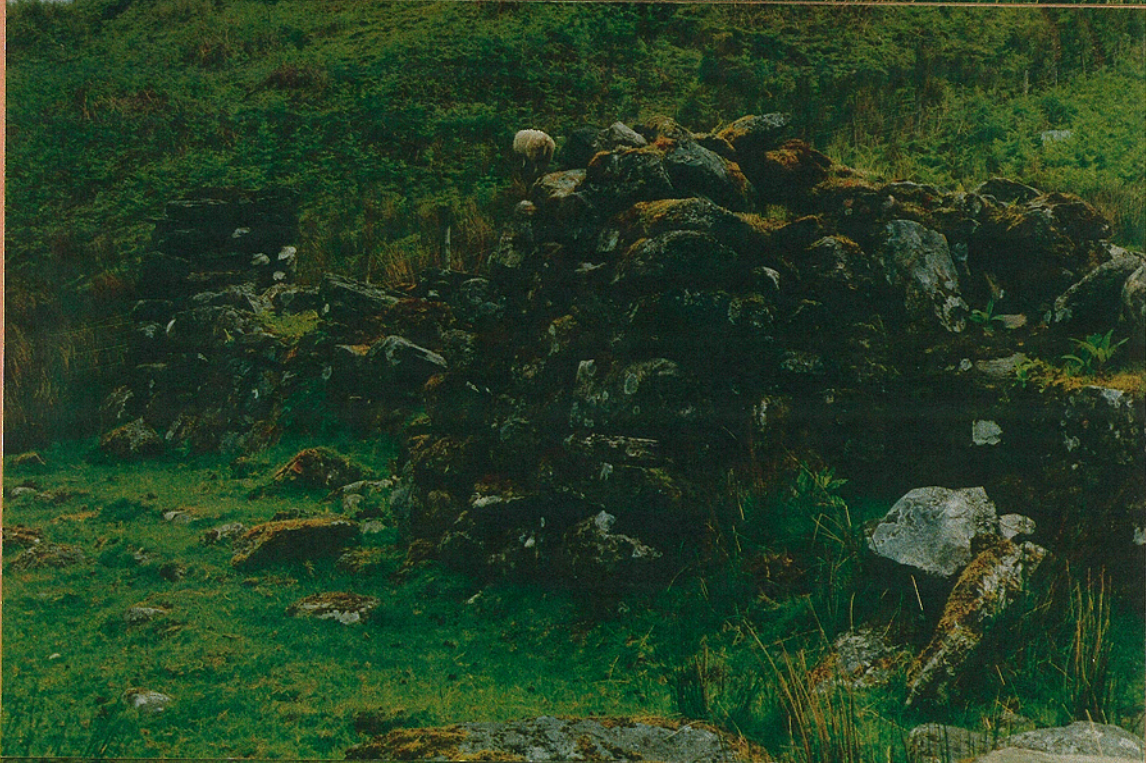
This building is probably a ruin from the early 19th century, which was abandoned by the time of the conversion of the mill. The walls are well built of rubble with no dressed stone, and a pronounced batter (**Photo no. 16**) The front, north facing wall is shored up with a rubble buttress just west of the doorway (**Photo no. 15**) and a corner of the interior has probably been used as a sheep pen

15. **Building C.** Rubble buttress supporting the NW wall.
16. **Building C.** SW gable end, demonstrating the batter of the walling.
