**Macleod Vault  
Inchnadamph Parish Church**

**An Archaeological Watching Brief**

**March 2002**

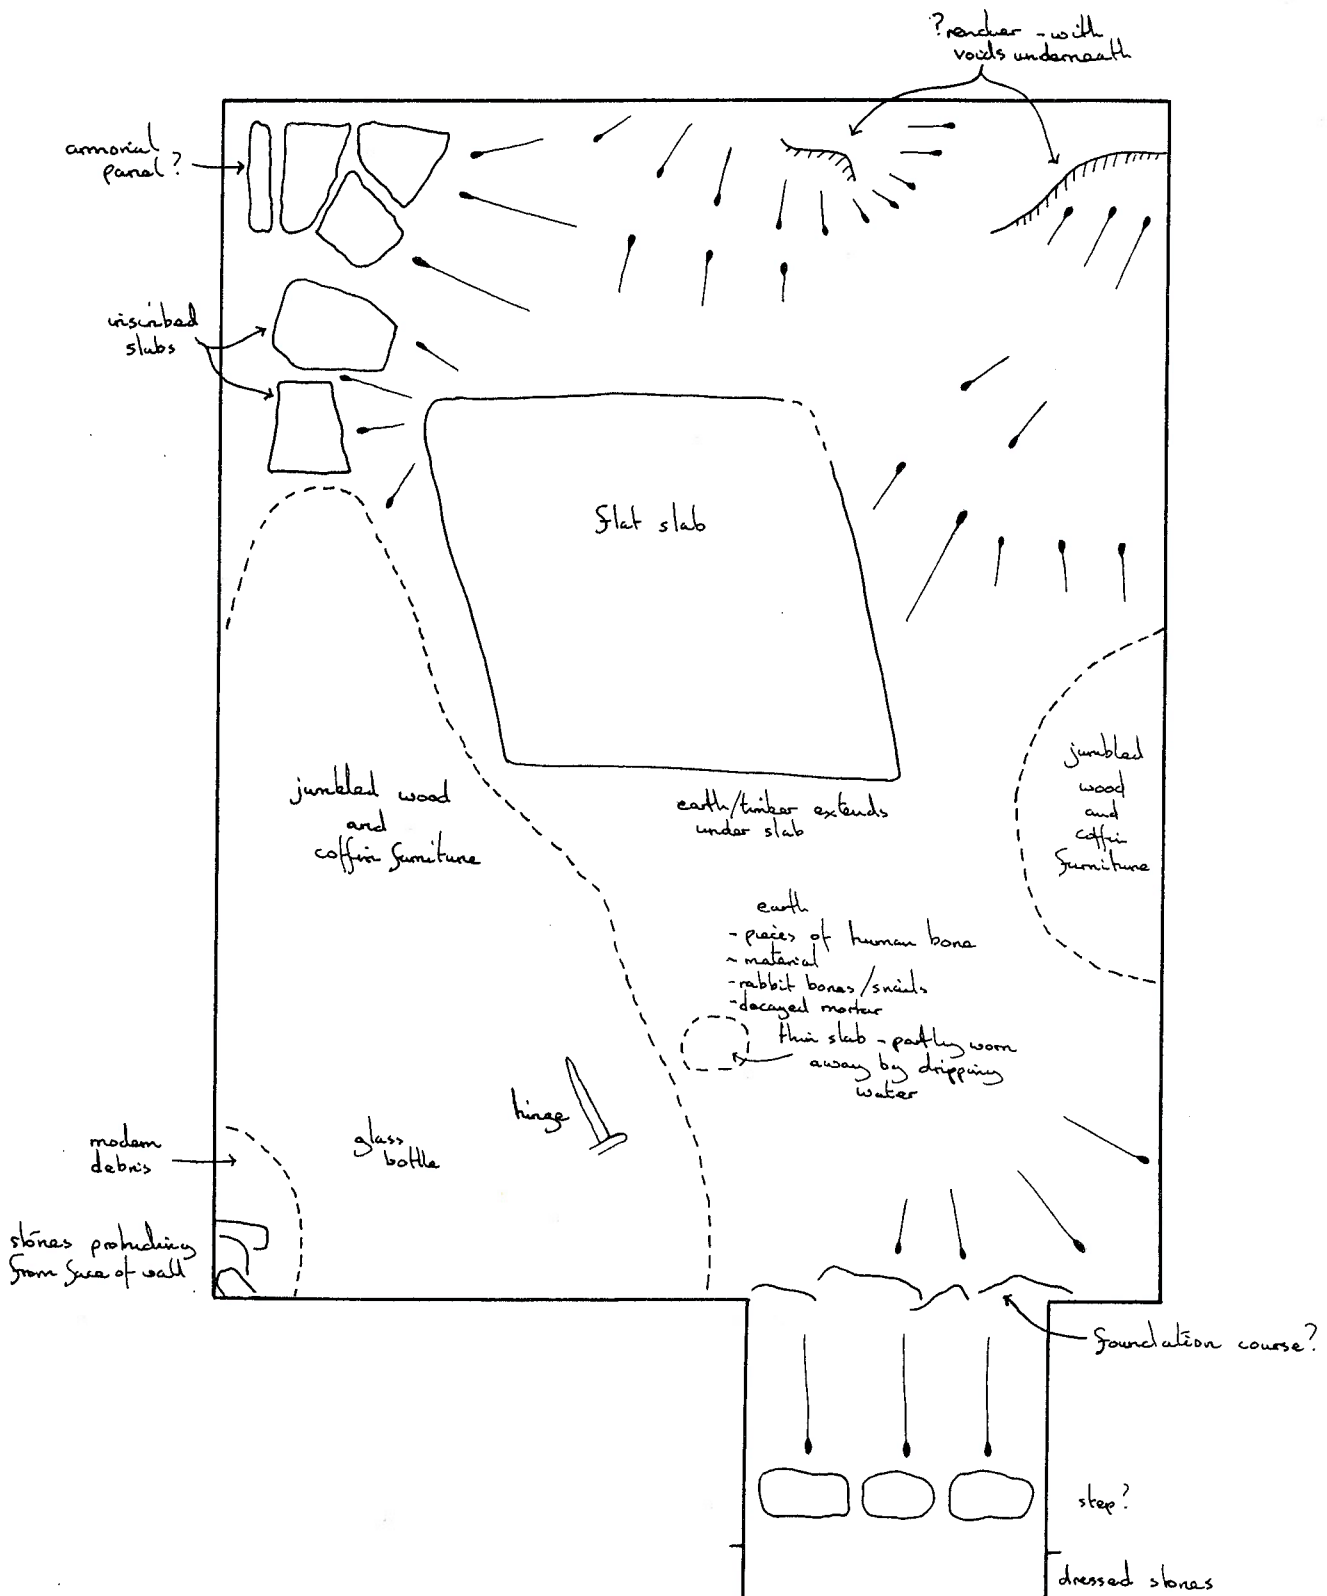
Macleod Vault  
Sketch plan of interior  
14/3/2002

Within the vault, the floor level slopes away unevenly towards the north west, following the external fall of the ground. It is impossible to determine the actual floor level, because of the amount of debris within the vault. This comprises a jumble of coffin wood, other coffin furniture (handles and plaques), rabbit bones and snail shells, mixed in with earth and decayed mortar. Amongst this are pieces of human bone and material, possibly from shrouds, alongside clearly modern artefacts such as broken glass bottles and a large hinge, presumably from a door. Lying in the centre of the northern part of the floor is a large roughly square slab, approximately 2m square, which is dark grey in colour. The slab stands proud of the ground surface and is approximately 400mm thick. Although largely obscured by the overlying deposits, another similar slab lies within the northern part of the chamber. This is visible in two places and in both cases voids can be seen underneath the slab, where water dripping from the roof has dissolved away the stone. In the south west corner of the vault, voids are also apparent underneath an uneven layer of what may be render washed down from the walls. The armorial panel of the Macleods of Assynt, broken into at least four pieces, appears to lie in the south east corner. To the north of these, against the north east wall, are two small irregularly shaped gravestones with clearly recognisable inscriptions. These would seem to be of eighteenth or nineteenth century date. In the north east corner of the vault, three unshaped stones protrude from the face of the long east wall, just above present floor level; it is possible that these represent an earlier building phase.
