'BADAN DUBH'
NEAR KINCRAIG
BADENOCH & STRATHSPEY

ARCHAEOLOGICAL WATCHING BRIEF

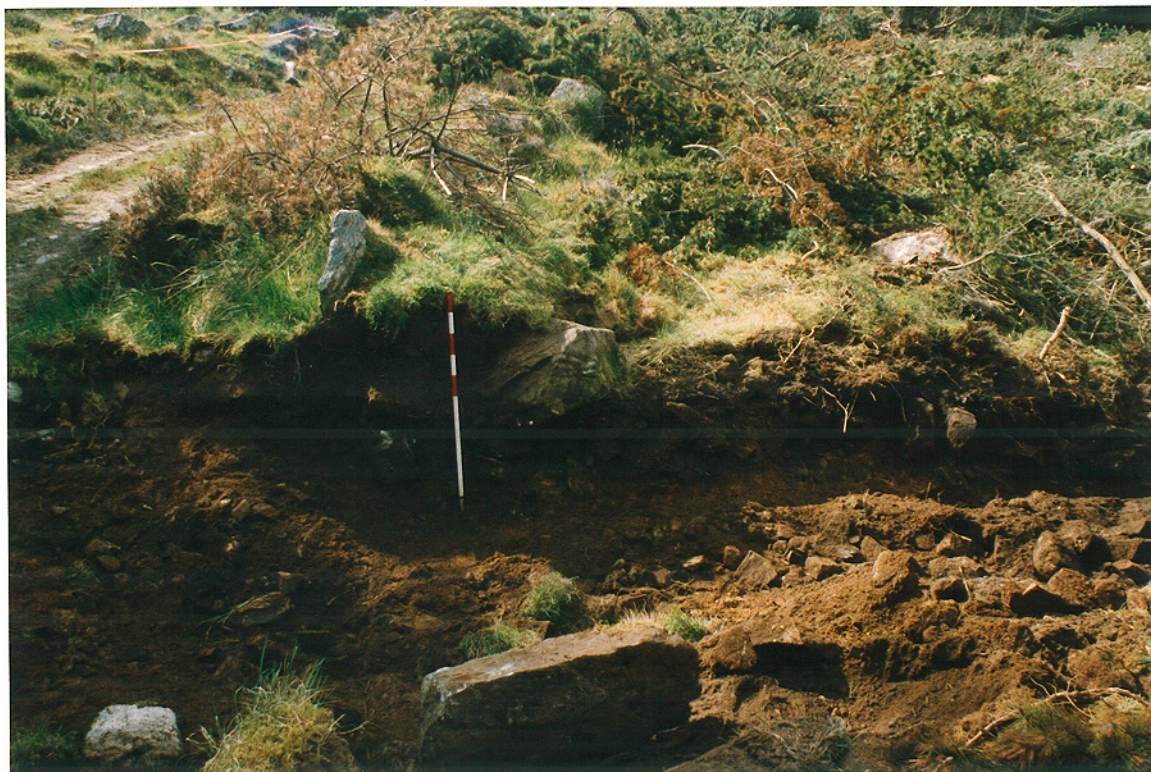
The ruined dyke stood to approximately one metre in height and survived to approximately one hundred metres in length. The first section, cut near to the northern end of the dyke, revealed little structural information. (See Photograph 1) The majority of stones used in the dyke's construction were between twenty and thirty centimetres in diameter, some washed but some angular. The dyke was built directly onto fluvio-glacial material of sand, gravel and larger boulders. Some boulders, up to one metre in diameter, sat on the existing surface of the dyke, but were most likely dragged into place there by deep ploughing in the past. Further evidence for ploughing

is the large proportion of peaty soil that overlies the rubble of the dyke. This would account for the ruinous nature of the dyke.

Photograph 1: North-facing section through dyke

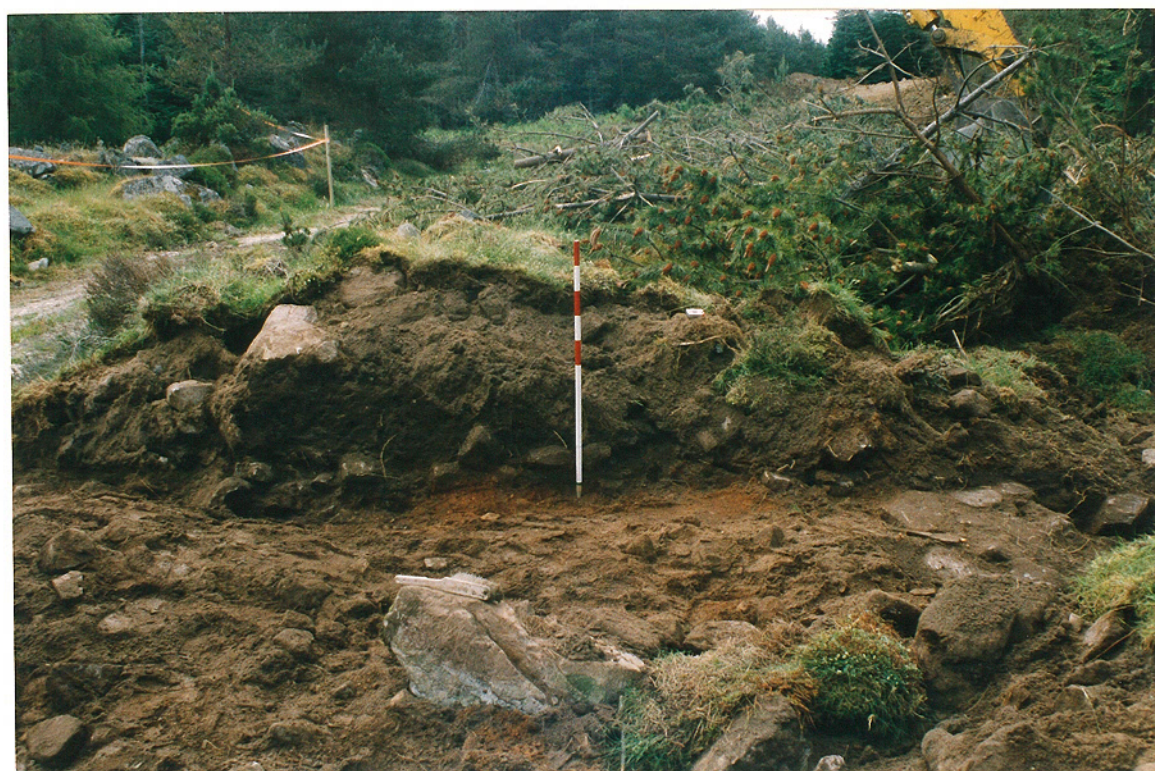
The second section in the southern portion of the dyke opposite to the truncated building, revealed more structural details. (See Photograph 2) Similar collapse has taken place, again with boulders sitting on the modern surface but with collapsed material to the West and East. Immediately to the left of the ranging pole are the remains of the footing of the dyke. Again, a large proportion of the material that formed the existing shape of the dyke is peaty earth. This section also revealed paving stones to the West of the dyke. (See Photographs 3 & 4) These stones were laid into the natural sub-soil forming a pathway up to one metre in width. The natural sub-soil dropped sharply to the West of the paving stones, suggesting either a drainage ditch, or more likely the natural slope to the boggy ground. Beneath the eastern area of collapsed material were found two small pieces of ceramic, both glazed. One piece is decorated with hand-painted, blue curvilinear design on a white background. The other piece is cream in colour and decorated with an embossed flower bud. The dating of such pieces can only be approximated, but neither are likely to be earlier than the mid-seventeenth century. When they were deposited in their most recent context is even more open to question.

Photograph 2: North-facing section through dyke, revealing wall-footings
and paved area to the West

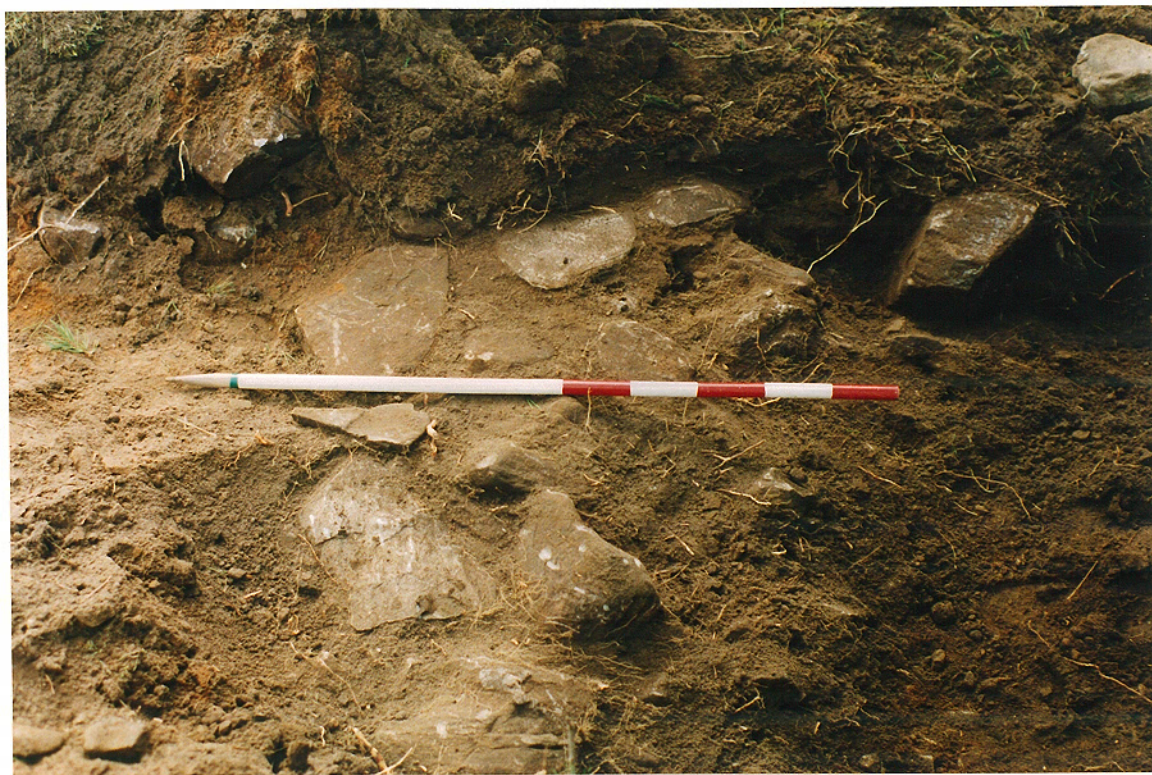
Photograph 3: Paved area in plan: photograph taken from the North

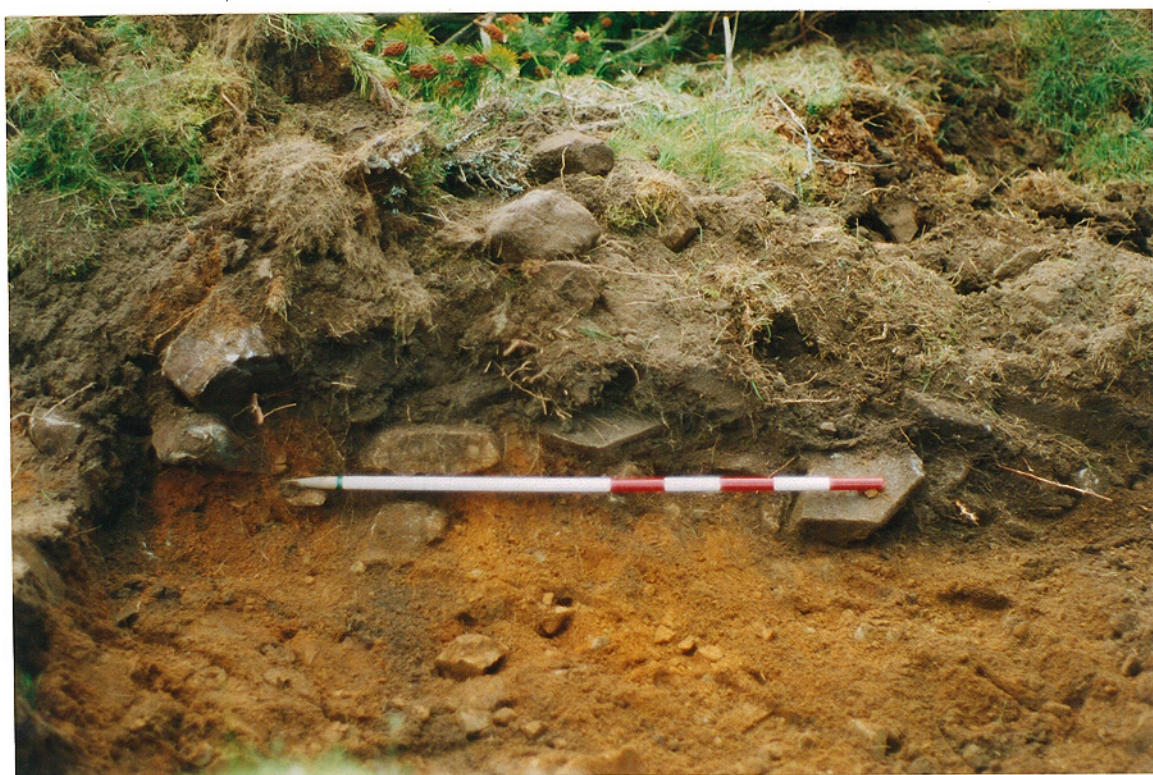
Photograph 4: North-facing section through paved area

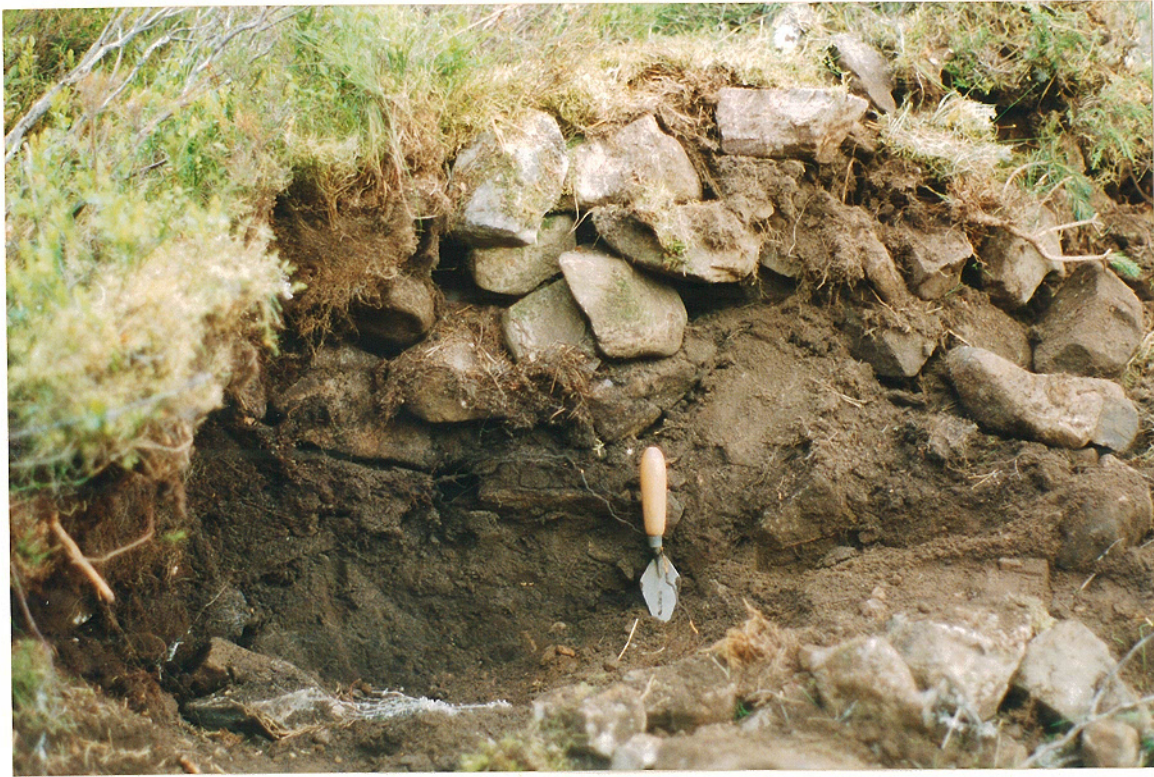
At the extreme southern end of the dyke a section revealed a large quantity of stones of approximately twenty centimetres in diameter. These topped a layer of loamy soil thick with roots and vegetable matter. (See Photograph 5) It is possible to conclude that sections of the dyke were constructed using peat, or that an existing bank was incorporated into the dyke. This section of the dyke has not suffered the destruction of the sections to the North.

Photograph 5: West-facing section through southern end of dyke
