Drumfearn, Isle of Skye **Archaeological Walkover Survey**

November 2010

Archaeological Walkover

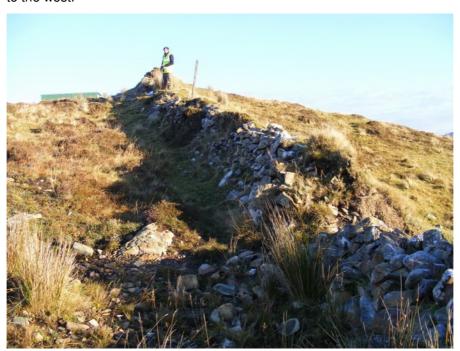
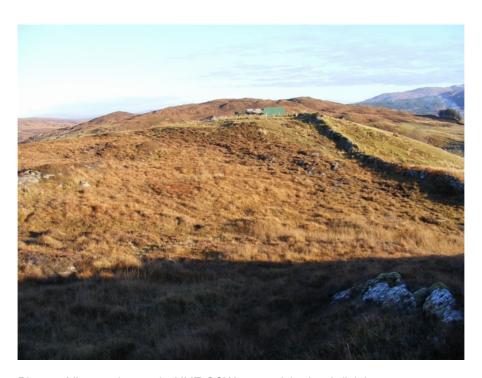
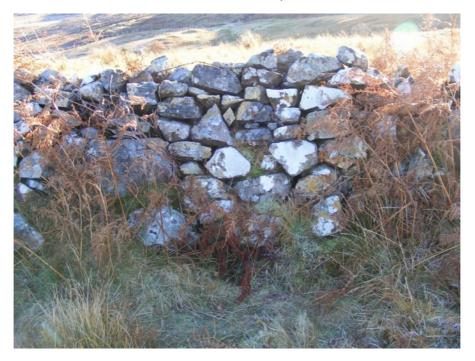
Site ID: 1 HER Ref: N/A

Description: Extant stone dyke land division, aligned NNE/ SSW and then turning to roughly SE/ NW. Marks the western boundary between Drumfearn Common and the marshy moorland to the west.

Plate 1: View to the north. NNE SSW stone dyke land division

Plate 2: View to the north. NNE SSW stone dyke land division

Plate 3: View to the East. Stone dyke land division.

ID	E	N	Description	Mitigation
1	167232	815412	NNE SSW Dyke	If avoidance of dyke is impossible, then the pipe trench should cross perpendicular to the dyke, not at an oblique angle, to reduce the level of impact
2	167291	815228	SE NW Dyke	If avoidance of dyke is impossible, then the pipe trench should cross perpendicular to the dyke, not at an oblique angle, to reduce the level of impact
3	167168	815927	Short, bulky standing stone and earthen bank	Outside of LoD. No impact.
4	167116	814878	Earthen mound, possible natural feature	A 10m buffer zone from this asset should be maintained
5	167064	814167	Viewpoint location	No Impact
6	167583	814294	Possible cairn site – likely natural feature	A 10m buffer zone from this asset should be maintained
7	167584	814222	Natural feature	A 10m buffer zone from this asset should be maintained
8	167561	814075	Stone shieling	A 10m buffer zone from this asset should be maintained

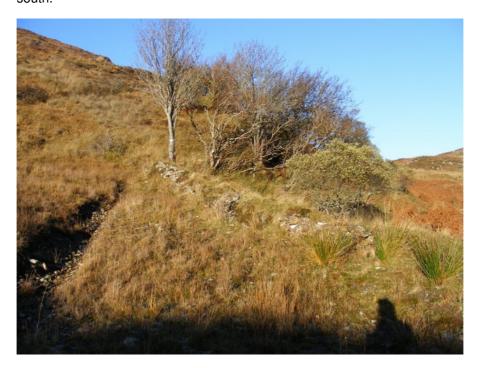
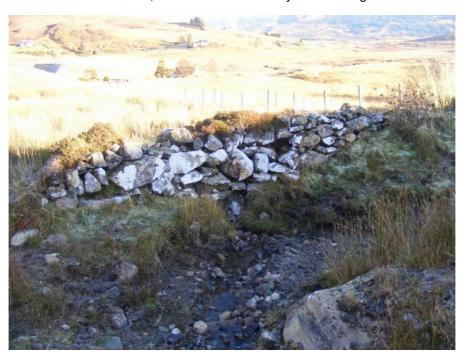
Site ID: 2 HER Ref: N/A

Description: Extant part earthen/ stone dyke land division, aligned SE/ NW. Marks the boundary between the southern edge of Drumfearn Common and the marshy moorland to the south.

Plate 4: View to the NW; earthen bank/ stone dyke bordering the south of Drumfearn Common.

Plate 5: View to the North; stone dyke bordering the southern edge of Drumfearn Common.

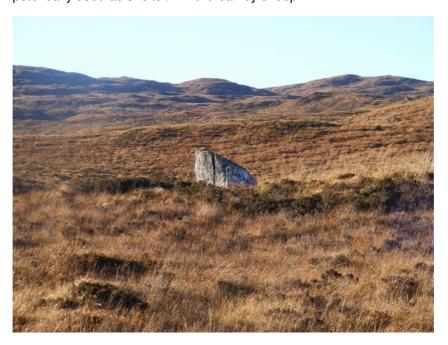
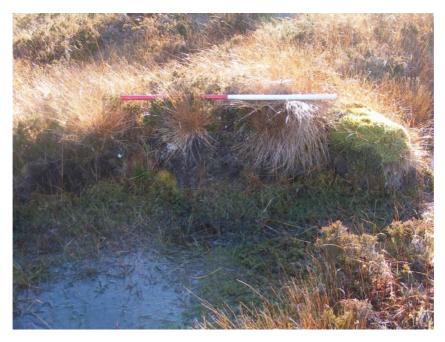
Site ID: 3 HER Ref: N/A

Description: Short, standing stone and earthen bank. The stone is an isolated feature in an area of very wet boggy ground. Around the northern edge was a short stretch of upstanding earthen bank, approx. 400mm high. The bank or peat ledge appeared to be a natural feature, potentially used as shelter/ wind-break by sheep.

Plate 8: View to the South, setting of standing stone in area of boggy ground.

Plate 9: Close up of natural earthen bank or peat ledge, approximately 500mm in height. 1m scale.

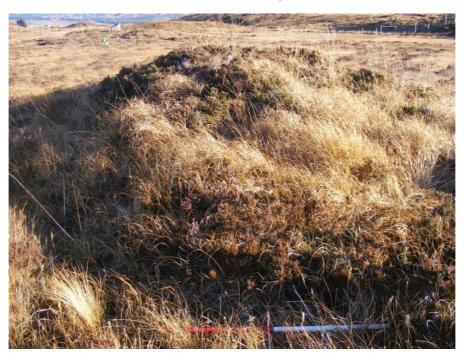
Site ID: 4 HER Ref: N/A

Description: earthen mound; natural feature. When viewed from a distance, feature was thought to be a potential cairn. However closer inspection confirmed the feature was natural. It is included in the walkover record as an example of natural features within this landscape.

Plate 10: View to the North; natural feature, mound. 1m scale. Standing stone and Drumfearn Common in the background.

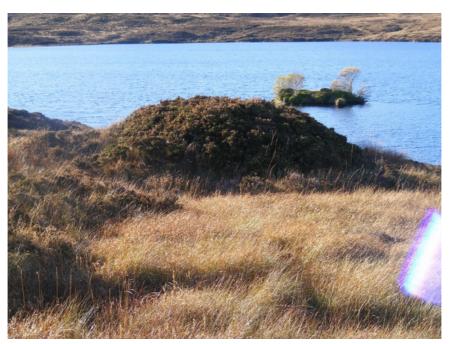
Site ID: 6 HER Ref: N/A

Description: Natural feature on southern edge of loch.

Plate 18: Natural feature on southern edge of loch; not a cairn.

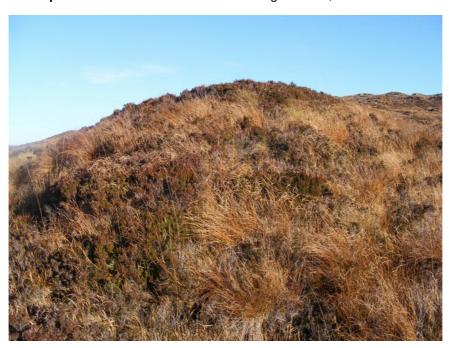
Site ID: 7 HER Ref: N/A

Description: Natural feature on southern edge of loch; not a cairn

Plate 19: View to the SE; natural feature

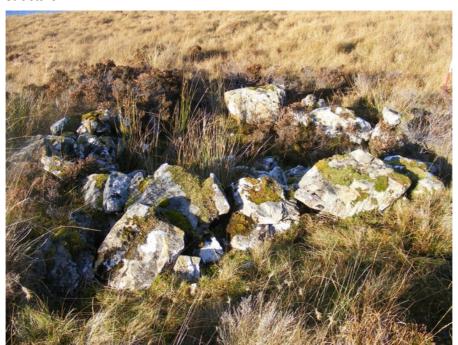
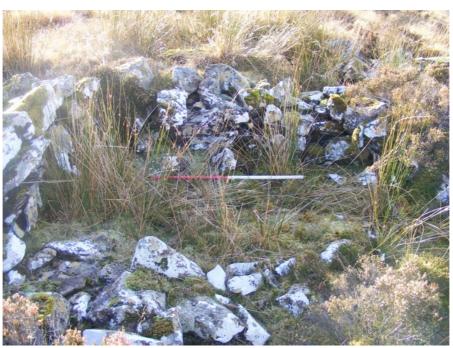
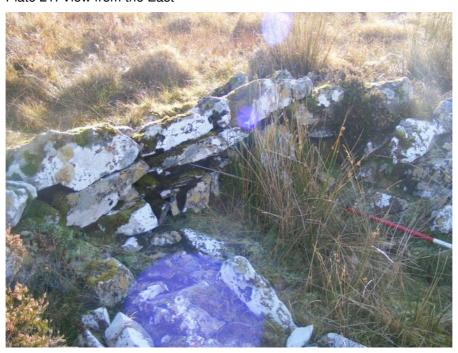
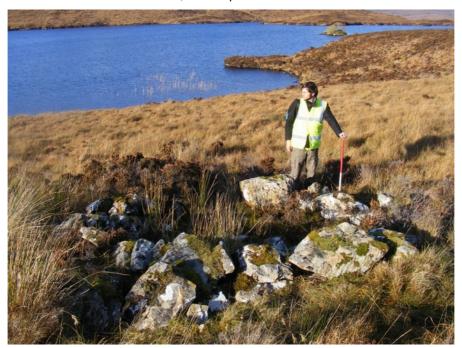
Site ID: 8 HER Ref: N/A

Description: Stone shieling situated on hillside overlooking loch an lasgaich. Shieling is subcircular with a N/S diameter of 3.6m and an E/W diameter of 3.75m. The subcircular chamber is constructed of unbonded roughly hewn stone and survives to 3 courses. Two upright stones flank a NNW/SSE facing entrance. An area of tumble is located on the western side of the structure.

Plate 20: View from the East

Plate 21: View from the East

Plate 22: View from the north; close up of internal face.

Plate 23: View from the south; general dimension view; shieling entrance faces NNW/SSE overlooking the loch.

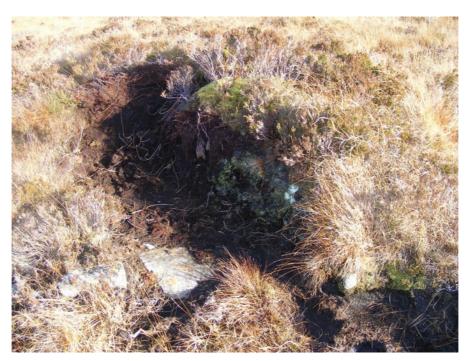
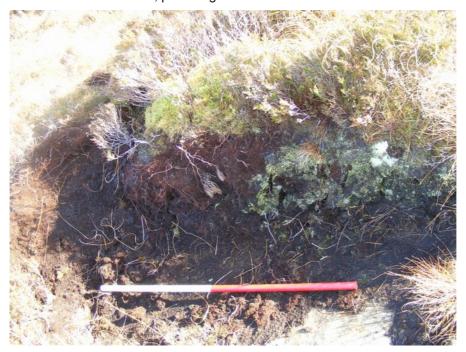
Site ID: 9 HER Ref: N/A

Description: Natural feature: Peat ledge offering shelter for sheep/ deer.

Plate 24: Natural feature, peat ledge

Plate 25: Natural feature, peat ledge.

_				
ID	E	N	Description	Mitigation
9	167501	813917	Peat ledge; semi-enclosed space providing low level shelter for sheep/ deer. Natural feature.	A 10m buffer zone from this asset should be maintained
10	167529	813411	Shallow peat scoop - earthen shelter	A 10m buffer zone from this asset should be maintained
11	167547	813280	Shallow peat scoop - earthen shelter	A 10m buffer zone from this asset should be maintained
12	167554	813275	Shallow peat scoop - earthen shelter	A 10m buffer zone from this asset should be maintained
13	168451	812608	Point taken at position of NE SW earthen enclosure	Current proposed route should be maintained as this utilises an existing break/ trackway through the enclosure. If this solution is impractical, then a watching brief shall be maintained during the excavation of the pipe trench through the enclosure and associated features (ditch)
14	168439	812601	Point taken at position of NE SW earthen enclosure	As above

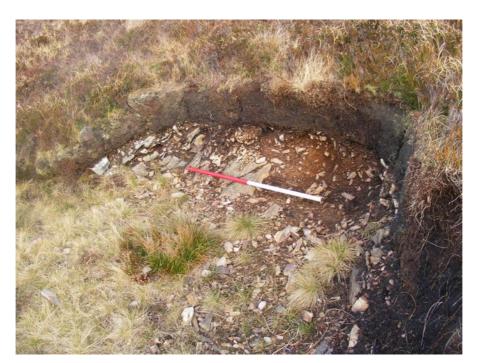
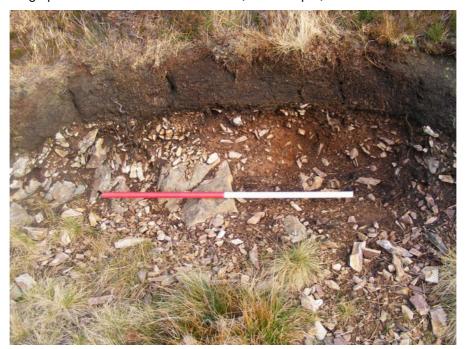
Site ID: 10 HER Ref: N/A

Description: Shallow peat scoop; earthen shelter

Plate 28: Semi-circular earthen shelter cut into SW face of hillside, overlooking flat expanse of rough pasture and moorland. 1m scale, 600m depth, 2m diameter.

Plate 29: Semi-circular earthen shelter cut into SW face of hillside, overlooking flat expanse of rough pasture and moorland. 1m scale, 600m depth, 2m diameter.

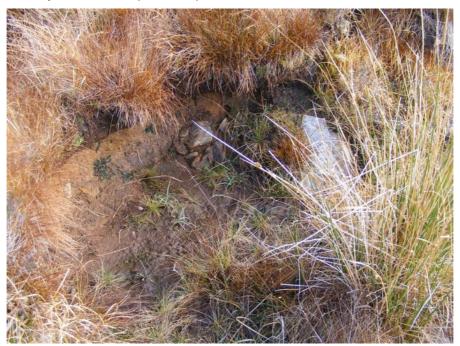
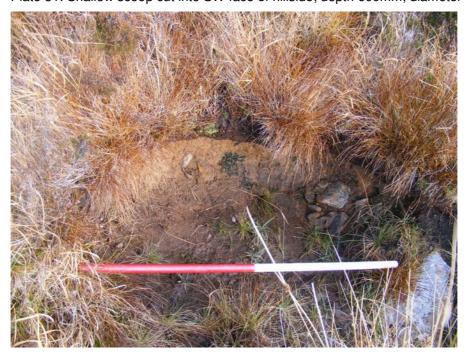
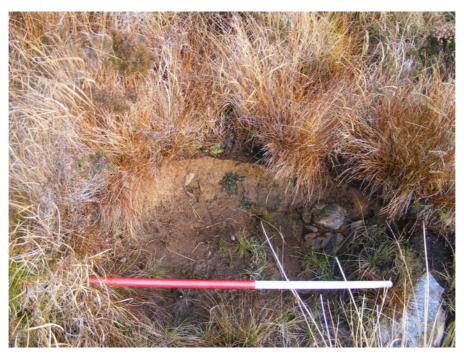
Site ID: 11 HER Ref: N/A

Description: Shallow peat scoop; earthen shelter

Plate 31: Shallow scoop cut into SW face of hillside; depth 600mm, diameter 1m.

Plate 32: Shallow scoop cut into SW face of hillside; 1m scale, depth 600mm, diameter 1m.

Plate 33: Shallow scoop cut into SW face of hillside; 1m scale, depth 600mm, diameter 1m.

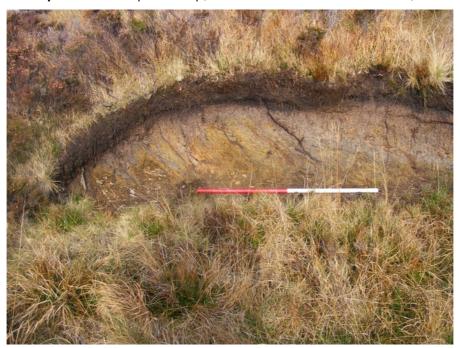
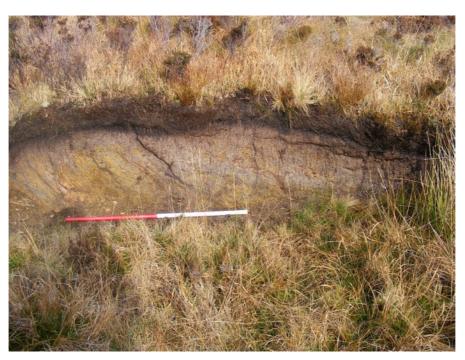
Site ID: 12 HER Ref: N/A

Description: Shallow peat scoop; earthen shelter. 2.3m in diameter; 650mm deep

Plate 34: Semicircular shallow scoop shelter; 1m scale

Plate 35: Semicircular shallow scoop shelter; 1m scale

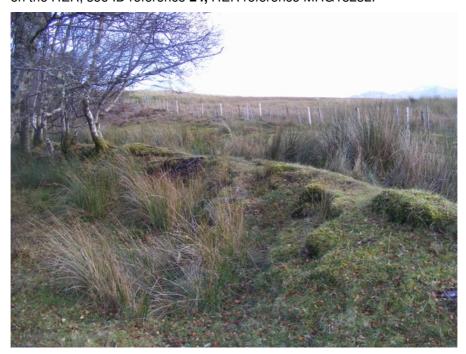
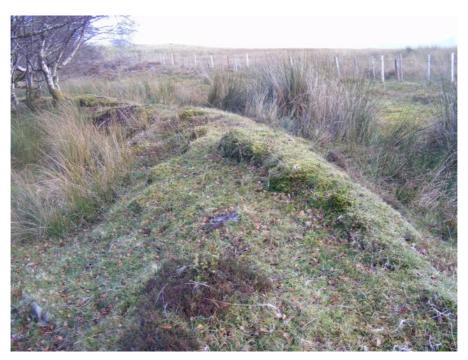
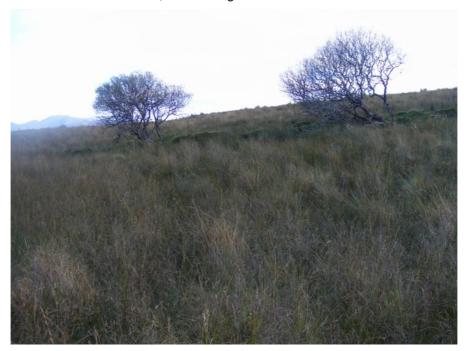
Site ID: 13, 14 & 24 **HER Ref**: N/A

Description: Earthen banked enclosure aligned approximately NE/SW/W. Enclosure is listed on the HER, see ID reference **24**, HER reference MHG18232.

Plate 36: View to the NW, NE/SW aligned stretch of earthen bank. Width ranges from 1.2m to 3m, although the latter dimension has been created by bank erosion. Heavily disturbed by grazing sheep and animal burrows.

Plate 37: View to the NW, NE/SW aligned stretch of earthen bank.

Plate 38: View to the South. Stretch of segmented earthen enclosure, aligned NE/SW. Bank is 1m wide on average and 2m wide maximum. Bank is associated with 2m wide infilled ditch on external edge. Remnant rig and furrow aligned NE/SW is visible within the enclosure.

- Extant land divisions dykes (Site ID points 1 and 2); and
- Undated earthen enclosure (Site ID points 13-16 & 24).

15	168507	812559	Point taken at position of ENE WSW earthen enclosure	Current proposed route should be maintained as this utilises an existing break/ trackway through the enclosure. If this solution is impractical, then a watching brief shall be maintained during the excavation of the pipe trench through the enclosure and associated features (ditch)
16	168503	812553	Point taken at position of ENE WSW earthen enclosure	As above
17	6740	1560	A crofting township comprising forty- nine roofed, two partially roofed and four unroofed buildings, one of which is annotated as a school	Outside of LoD. No Impact
	0740	1300	is annotated as a scrioor	A 10m buffer zone from this asset
18	6730	1480	Shieling listing - no detail	should be maintained
19	6730	1470	Cairn (modern) listed only - no details given	A 10m buffer zone from this asset should be maintained
20	6740	1450	Site of purported fort	Outside of LoD. No Impact
