Avingormack Steading / Docharn Lodge

Boat of Garten, Inverness-shire

Photographic record 2005

Report No. HAS050601

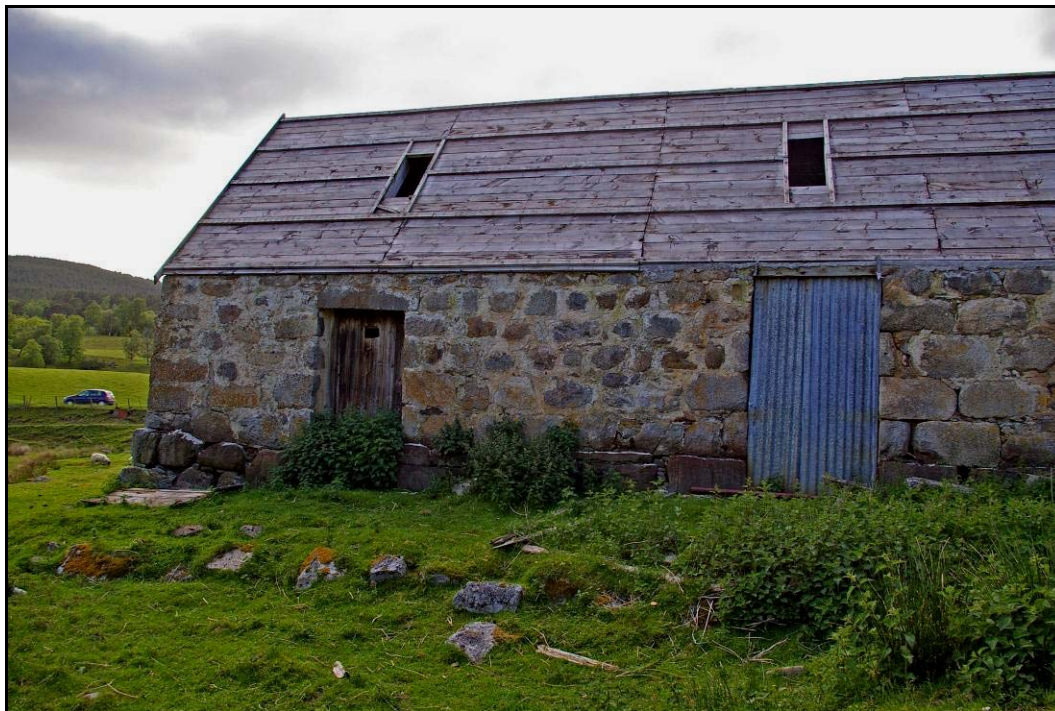
The barn seems to be built onto older, more substantial stone foundations, and around the central doorway in the east wall are ashlar blocks. Perhaps in its present form it was rebuilt from a ruin. Inside, there are the marks on the west wall of former animal stalls and at the southern end a line of feeding troughs. (Figs 4, 5, 6).

Figure 4 Barn, showing foundations and ashlar stonework

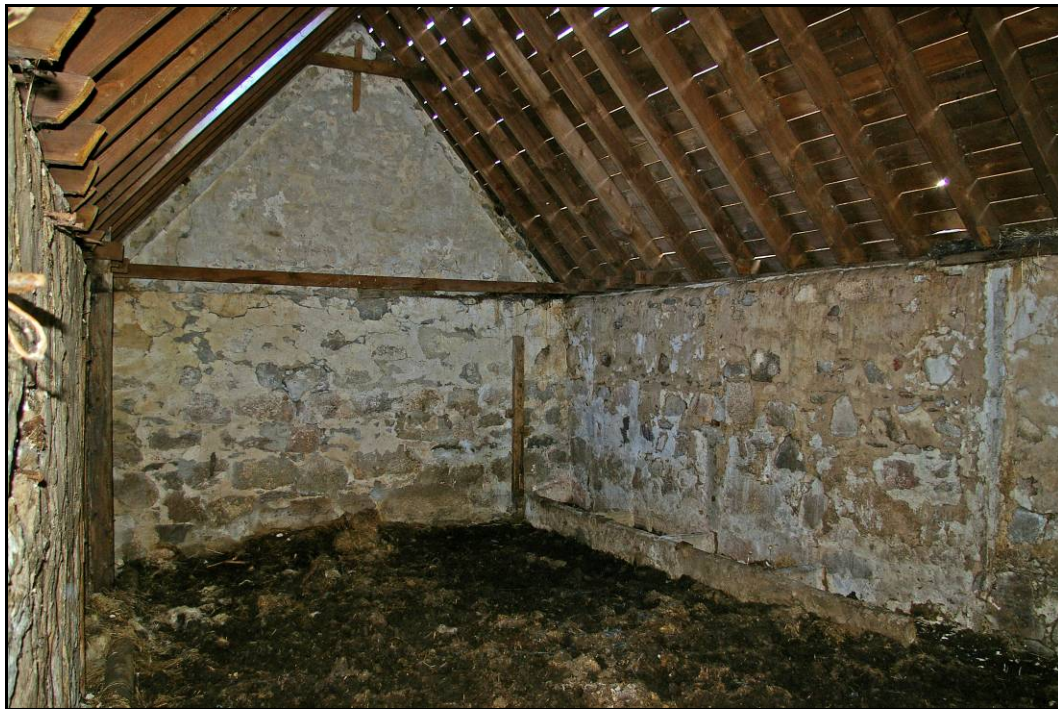
Figure 5 Barn, showing feeding troughs and one former stall division (View from N)

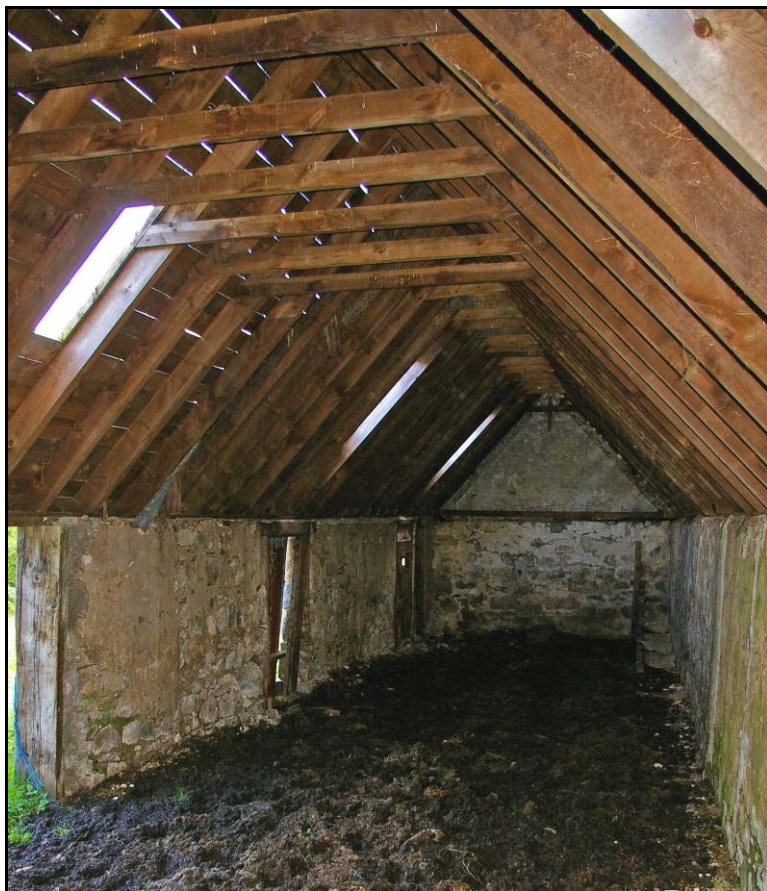
Avingormack consists of a modern house and garden, and two buildings that make up the steading – a barn built mainly of local freestone, and a smaller wooden shed on a concrete base. The barn is shown on the 1st edition Ordnance Survey 6" map (1875), but seems to have been rebuilt on older foundations. Its roofing slates have been removed exposing the sarking. The shed is clearly mid-late 20th c. in date.

Figure 6 Barn - roof construction (view from N)

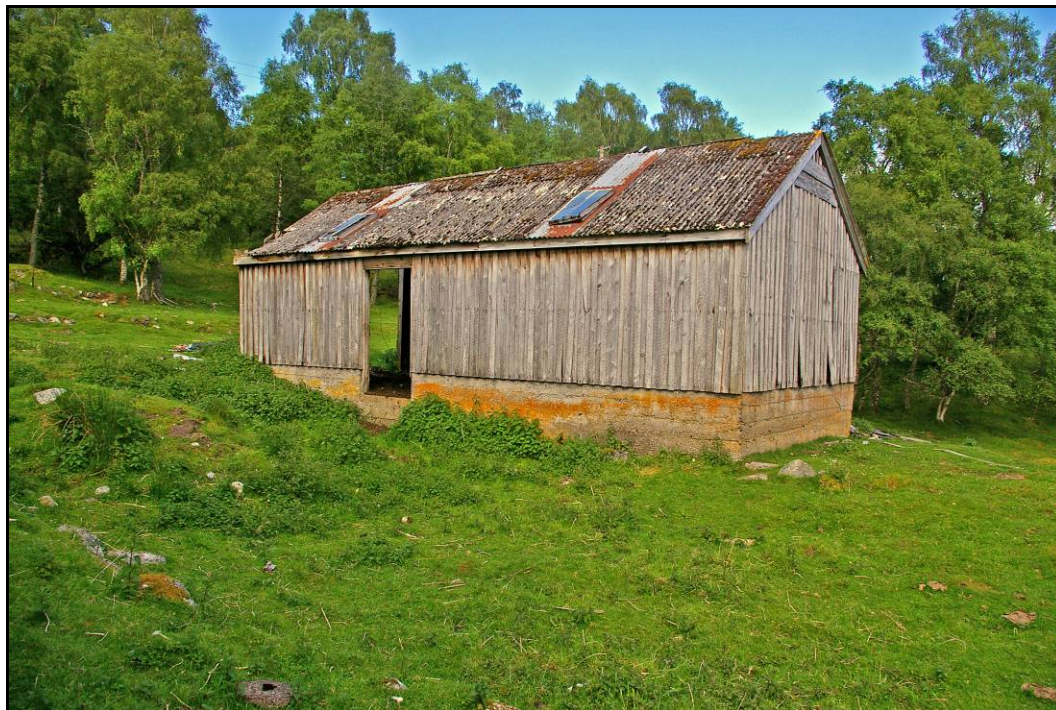
Figure 7 Shed (View from SW)

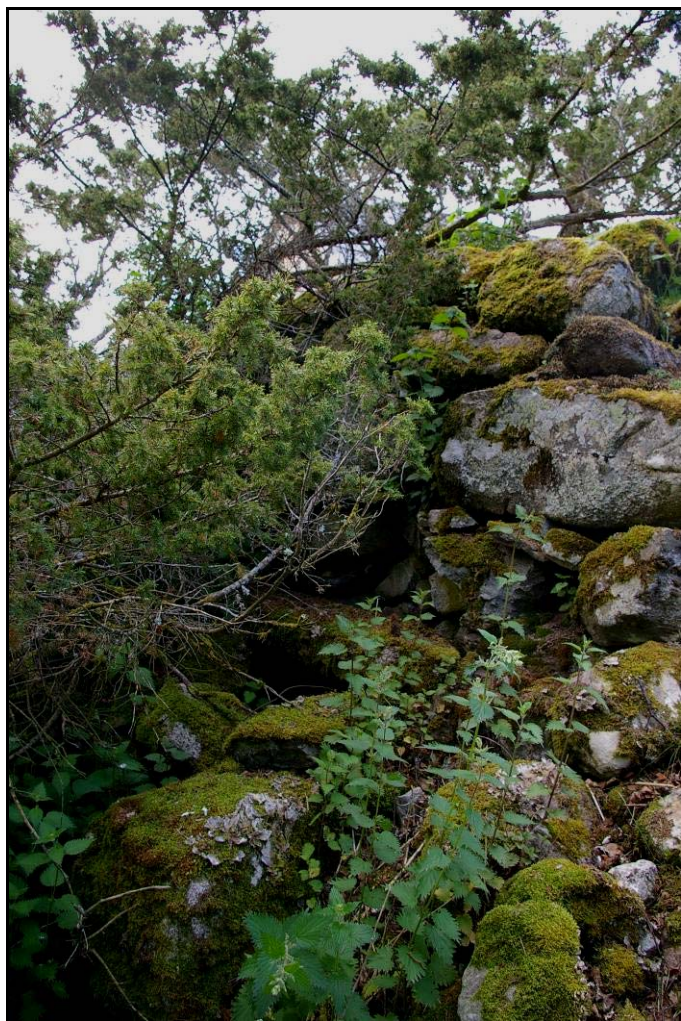
A retaining wall south of the steading was noted on site which may be the north wall of the building shown in 1875. It seems to have formed part of a kiln (Figs 9, 10). Indeed the whole steading seems to be based on a platform, built of or reinforced with field clearance stone, which provides a level surface on the sloping hillside. There is little sign of the limekiln shown on the 1st edition OS map, but indications of a roughly square building to the north of the barn may be the site. (Fig. 11)

Figure 9 Kiln - draw hole

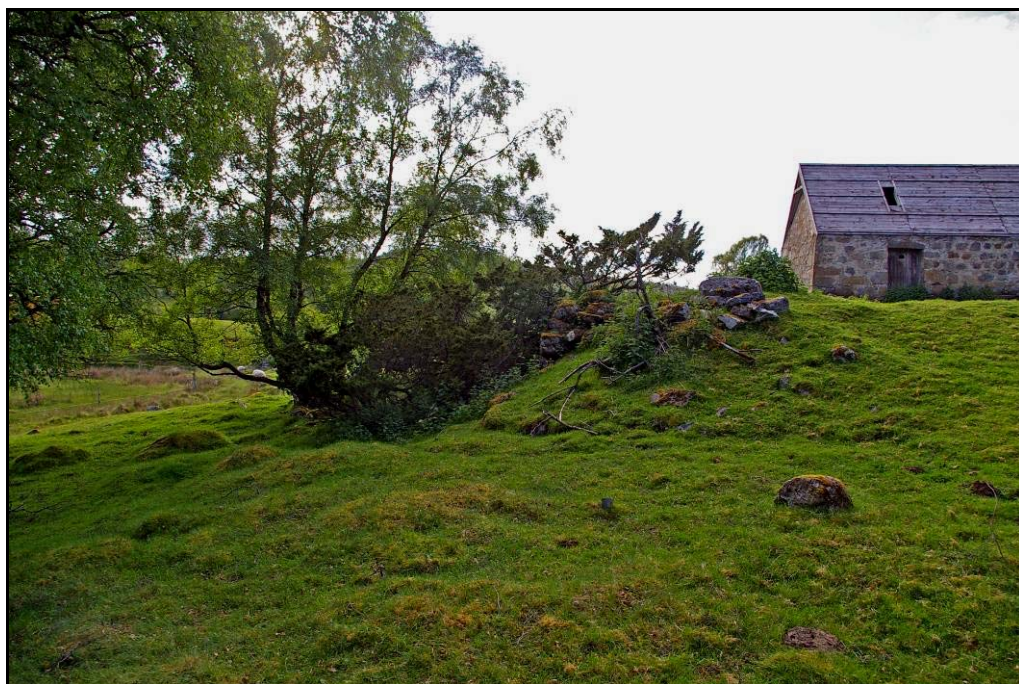
Figure 10 Kiln (View from E)

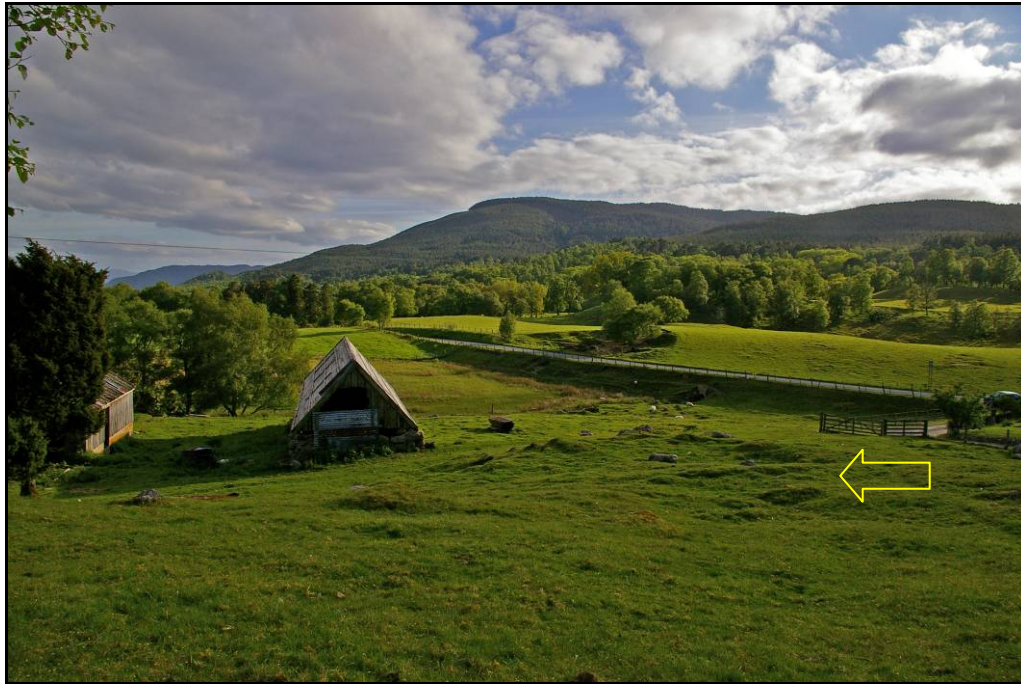
Figure 11 View from N, showing probable site of limekiln on 1st edition OS map

The steading currently consists of two buildings, of which the larger one stands on the footings of an earlier building. Indications of other former buildings on the site, including two limekilns, were noted on site or from the 1st edition OS map. Any further evidence of these and other former buildings or occupation on the site should be noted and recorded during the site excavation works.

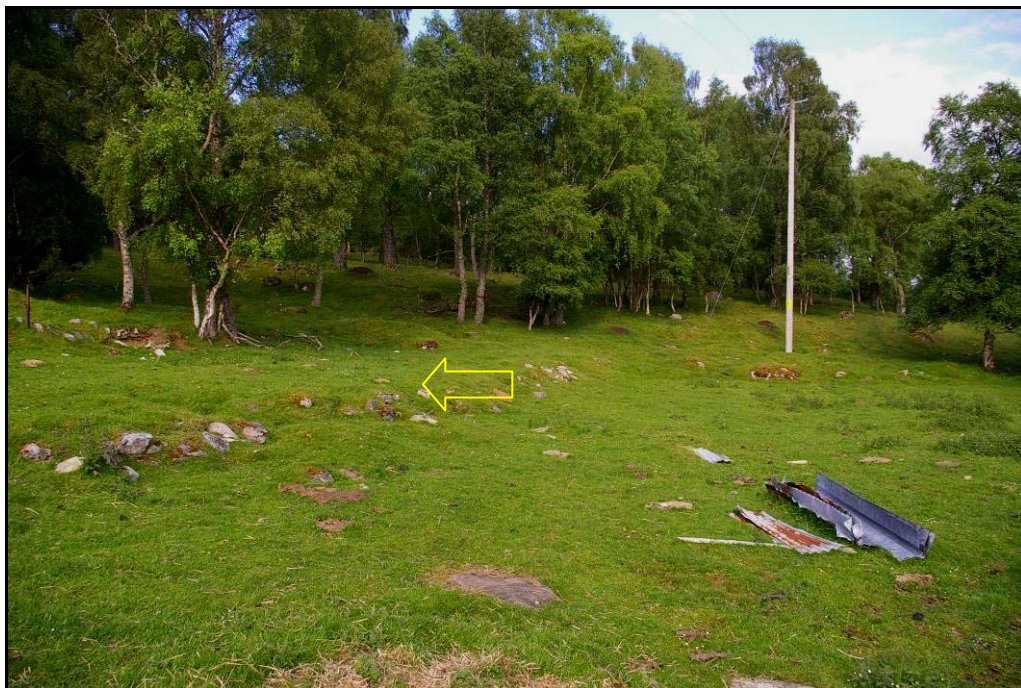
Immediately north of the steading running east-west is a rectangular platform cut into the hill-slope, which could represent the footings of a former long-house or barn. (Fig. 12)

Figure 12 Possible site of former house
