STRATHMASHIE FOREST COMMUNITY HERITAGE PROJECT: STAGE 1

ARCHAEOLOGICAL SURVEY

PROJECT 1873

carried out
on behalf of
Laggan Heritage

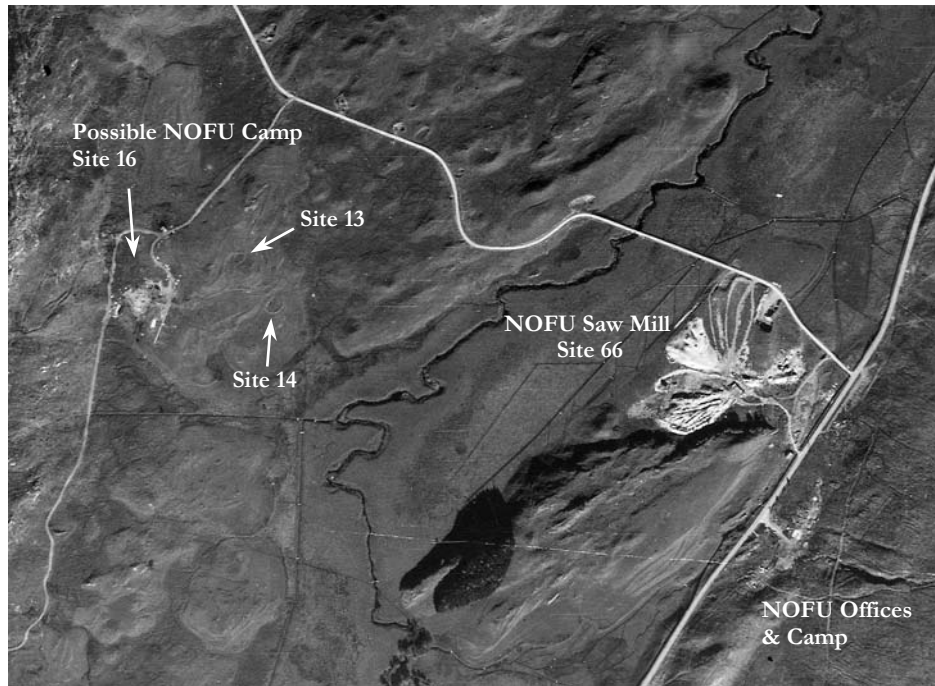
Figure 3:

To the west of the mill is a possible NOFU camp (site 16), which was further investigated during the field survey (see Section 6.2 below).

To the east of this camp, two enclosures (sites 13 & 14), to the west of the River Mashie, can also be seen.

Extract from RAF vertical aerial photograph CPE/UK/Scot/177 frame 4122 (1946).

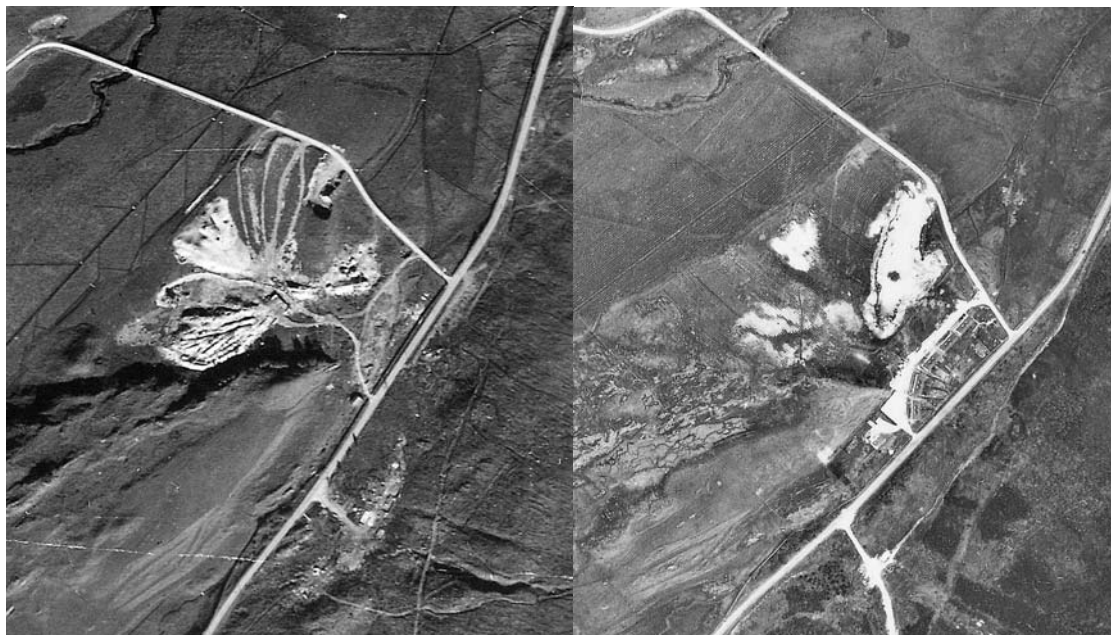
Figure 4:

Figure 4 below shows how the Achduchil saw mill has changed over time. The left-hand image shows the site in 1946, in apparently relatively good condition with no clear sign of the earlier farmstead (site 89). The image on the right shows the site in 1965. The foresters' cottages, constructed in the 1950's (Laggan Heritage 2000), now occupy the area to the east of the sawmill and a large sand quarry has developed behind the cottages. Much of this area is currently forested, adding another layer of activity on top of the sawmill. No sign of the offices on the eastern side of the road is apparent. This shows how, over a relatively short period of time, the nature and condition of a site can alter.

Extract from RAF vertical aerial photograph CPE/UK/Scot/177 frame 4122 - left (1946) and OS-65-178 frame 075 -right (1965). Reproduced by permission of Ordnance Survey on behalf of The Controller of Her Majesty's Stationery Office. Crown copyright. All rights reserved. Licence number 100040218.

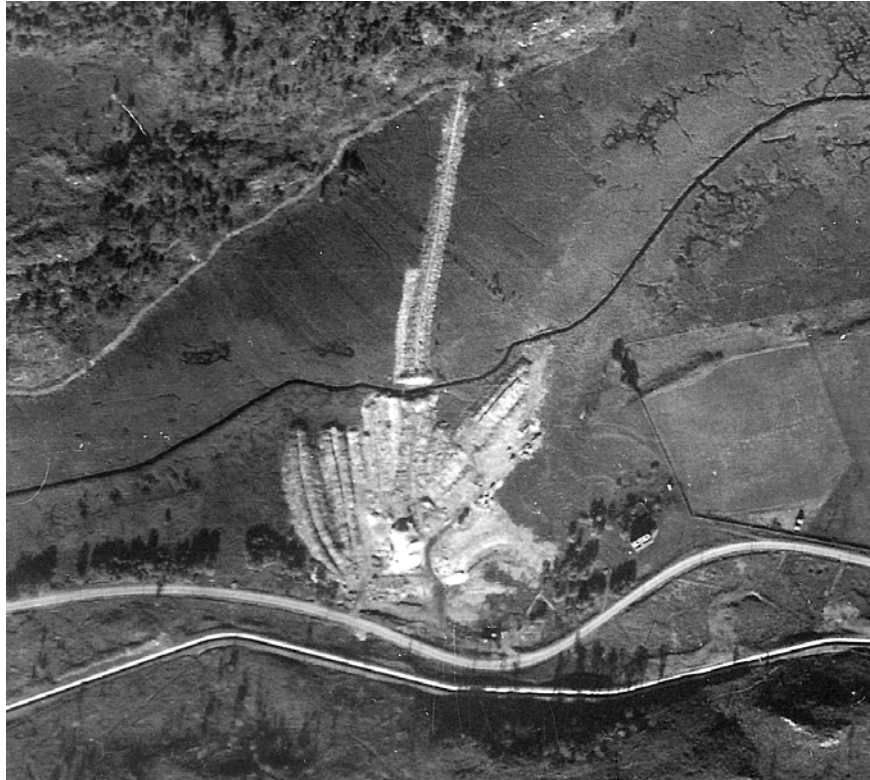
Figure 5:

What appears to be another road/track is visible as a dark line running up the eastern side of the mill, starting near the main road and winding its way north. It appears to then curve slightly to the north-east, leading to where a number of possible buildings and a yard are located. It is possible that the buildings are part of a camp or office buildings/stores relating to the saw mill.

It is clear from the aerial photograph that the NOFU mill at Wester Strathmashie was a substantial site.

Extract from RAF vertical aerial photograph CPE/UK/Scot/177 frame 5211 (1946).

The large piles of saw-dust visible in the aerial photograph (Figure 5) have gradually settled to their current condition. Although the sawdust is still visible it is difficult to trace any definitive shape such as the various linear arrangements visible in the aerial photograph. Where the lines may be visible on the ground are where linear arrangements of upright poles are found. This occurs to the north-west of the sawpit area where two to three lines of upright poles, in pairs, are visible. This may indicate the darker lines visible on the aerial photograph, indicating where the sawdust was removed from the work area and dumped over the side to form the large piles. Some of the poles are up to 2 m in height and do not exist to their original height. If, for example, the sawdust was being removed by a light gauge railway mounted

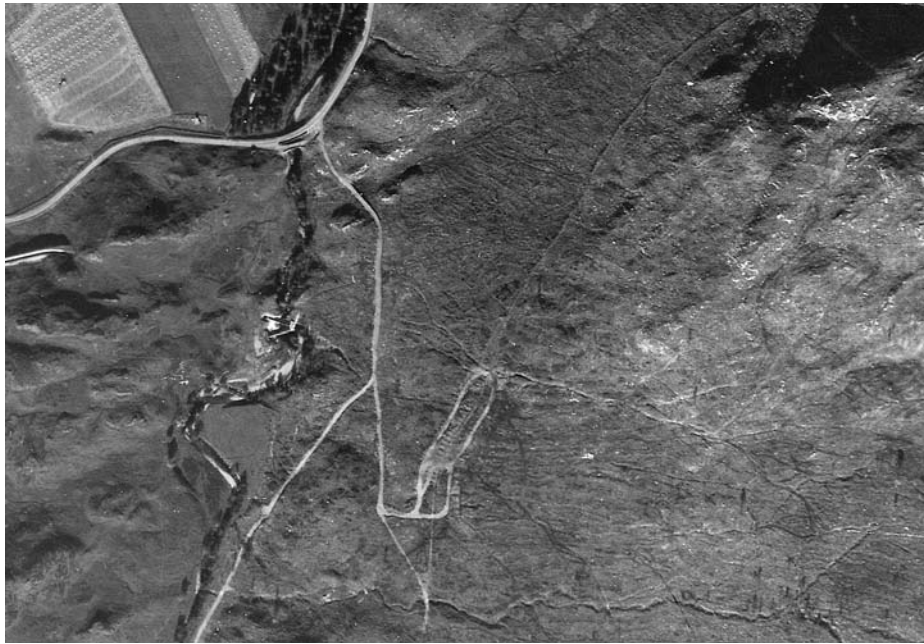
Figure 6:

The extract from RAF vertical aerial photograph CPE/UK/Scot/177 frame 5211 (1946) shown below in Figure 6 shows an oblong area of ground with a track running up to it and subsequently looping around it.

Extract from RAF vertical aerial photograph CPE/UK/Scot/177 frame 5211 (1946).

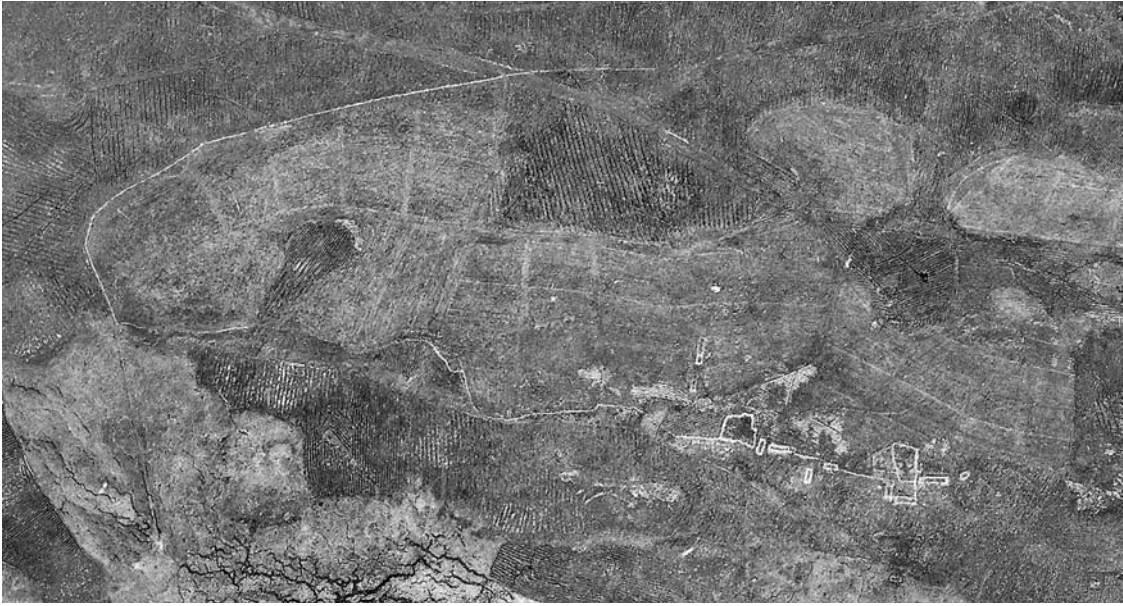
Figure 7:

The aerial photograph clearly shows the settlement as consisting of structures and associated enclosures spread out in an overall linear fashion. The large dyke extends off the left hand side of the township forming a large, open-ended enclosure. The site itself is dealt with in further detail in Section 6.3 below. Forestry plough marks are visible all over the site.

Areas of lighter ground within the enclosure and two patches to the top right of the photo may indicate the former grazing grounds of the Township.

Extract from Ordnance Survey vertical aerial photograph OS-65-178 frame 099 (1965). Reproduced by permission of Ordnance Survey on behalf of The Controller of Her Majesty's Stationery Office. Crown copyright. All rights reserved. Licence number 100040218.

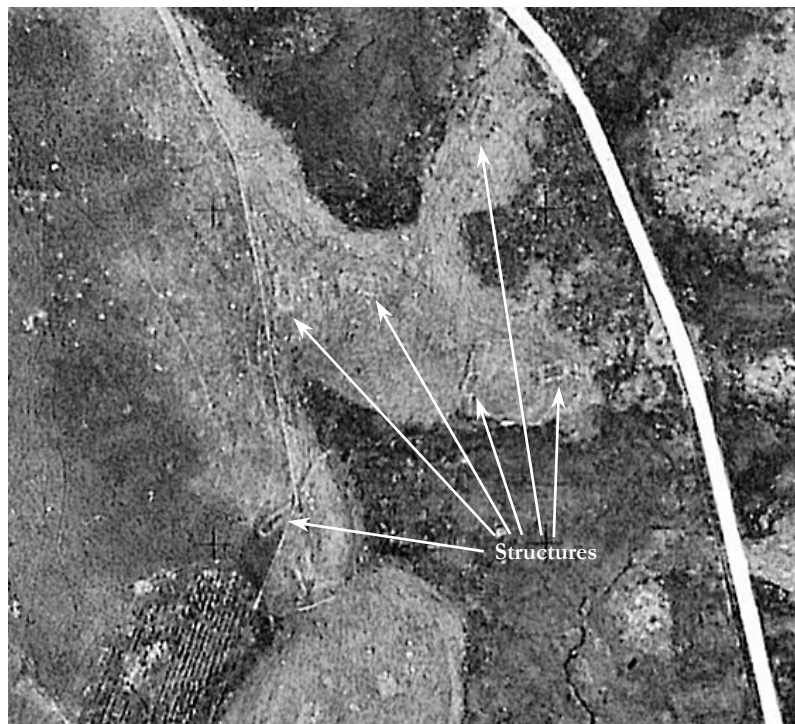
Figure 8:

The extract from Ordnance Survey vertical aerial photograph OS-65-178 frame 075 (1965) shown below in Figure 8 shows a series of rectangular structures located on the eastern lower slopes of Dun da Lamh. These relate to sites 61, 63 and 64, which were recorded during the field survey.

Extract from Ordnance Survey vertical aerial photograph OS-65-178 frame 075 (1965). Reproduced by permission of Ordnance Survey on behalf of The Controller of Her Majesty's Stationery Office. Crown copyright. All rights reserved. Licence number 100040218.

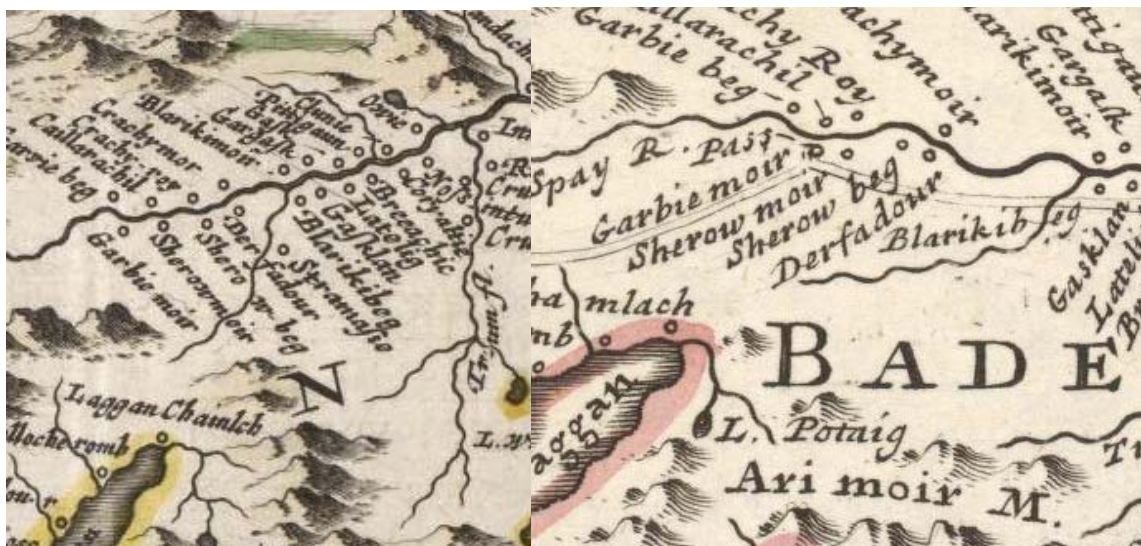
Figure 13:

*Bleau's map of 1654 (left) and Moll's map of 1745(right).
(Courtesy of the National Library Scotland)*

Other historical maps noted give further pieces of information on the survey area. Both Bleau's map of 1654, largely based on information drawn from the Pont Maps, Moll's map of 1745 (Figure 13) and Weller's map of 1863 depict the site of Derfadour (Tirfadoun, sites 9, 10, 63 & 64) and Blarikibeg (Blargie Beg (site 107). This placename of Tirfadoun, and its variations, has appeared on many historical maps suggesting that it was a reasonably substantial settlement that was not overlooked by different map makers. It is a placename that does not, however, appear on any of the OS maps from the first edition to the current edition.

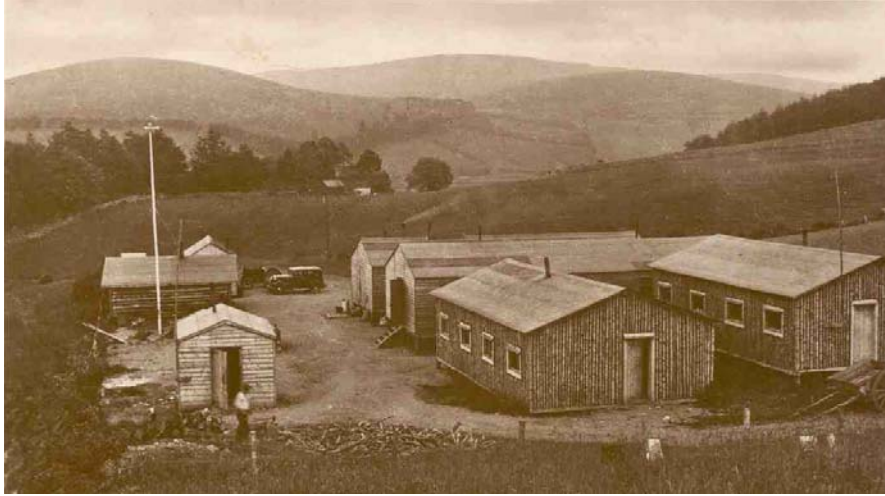
Figure 15:
Example of part of a NOFU camp at Kildrummy.
(Courtesy of Cliff Pike)

As noted previously, it is thought that Laggan had between five and six camps in and around Strathmashie Forest. They would not all have operated at the same time, but would be constructed and dismantled, possibly moved, depending on the areas of forest being felled. A typical camp of the NOFU would consist of bunkhouses, a cook house, a dining hall, a recreation hut/canteen and the 'fore peak' where the camp foreman and his clerk and tallymen would work. Further buildings might include sheds to house horses, tractors and other machinery. All the buildings were constructed of wood by the NOFU themselves. Most of the buildings would have been constructed with either plain wood sections/planks or logs caulked with moss and sometimes protected at the base by an outer wall of earth. It has been noted that it took the Newfoundlanders three to four days to build a log cabin to sleep twenty men and

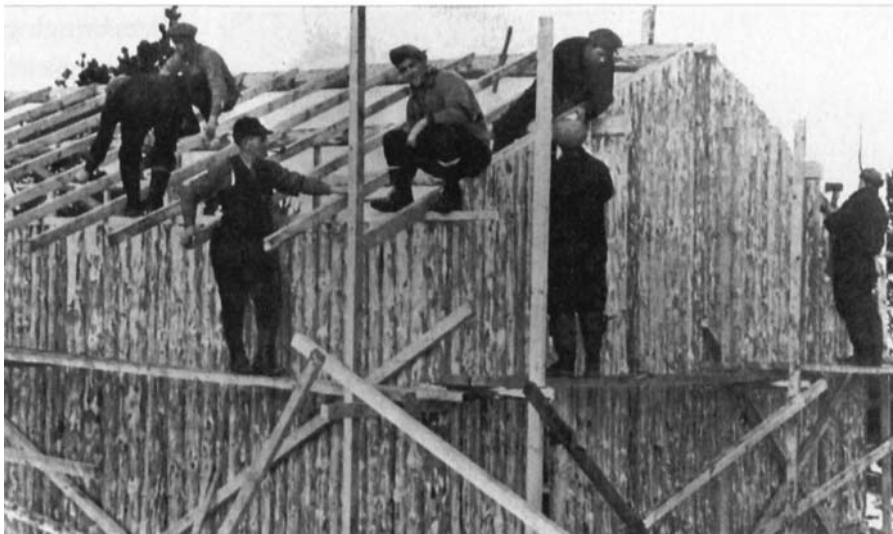
Figure 16:
Example of camp construction, location unknown.
(Courtesy of Cliff Pike)

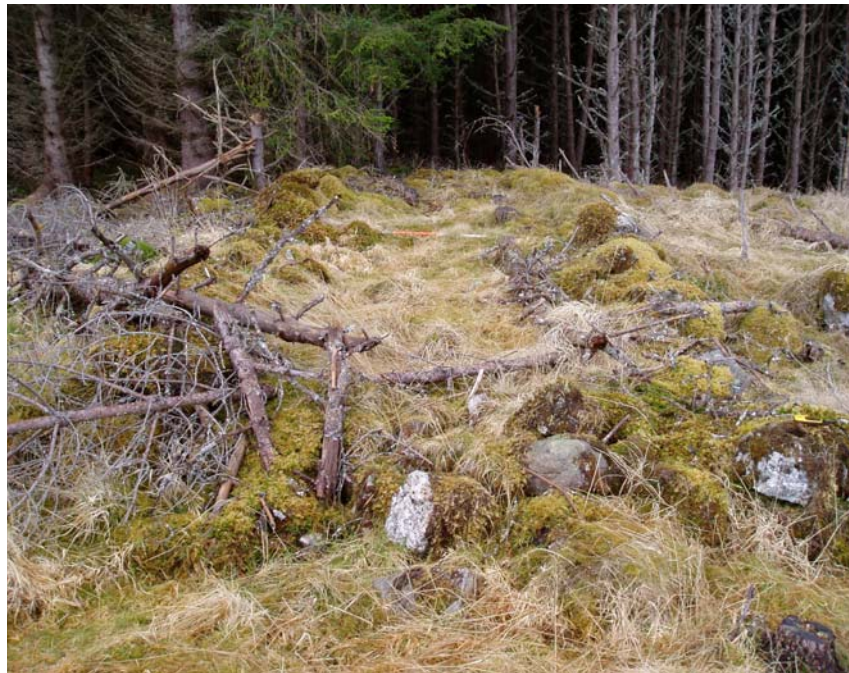
*Figure 17:
MoLRS building to the east of Sron a' Mbadaidh (site 33).*

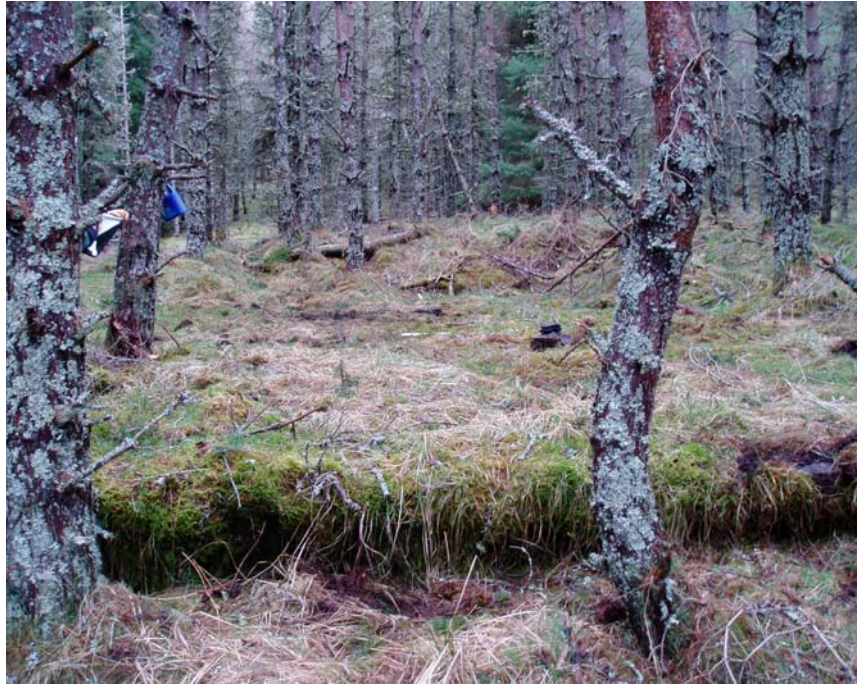
*Figure 18:
Concrete platform of probable NOFU camp (site 16).*

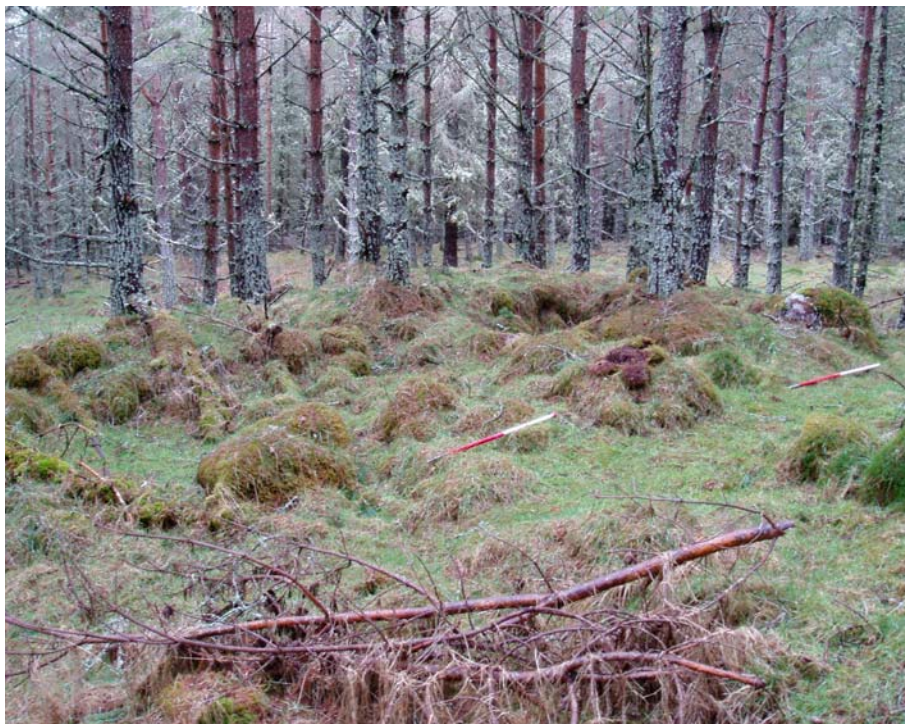
*Figure 19:
Remains of a corn drying kiln in Strathmashie (site 12).*

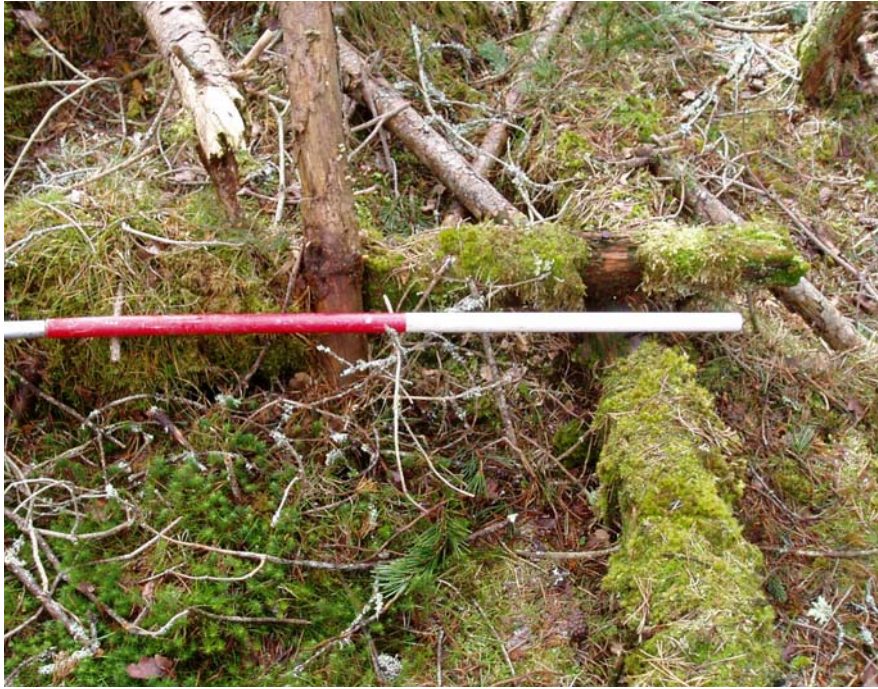
*Figure 20:
Detail of NOFU railway (site 82).*

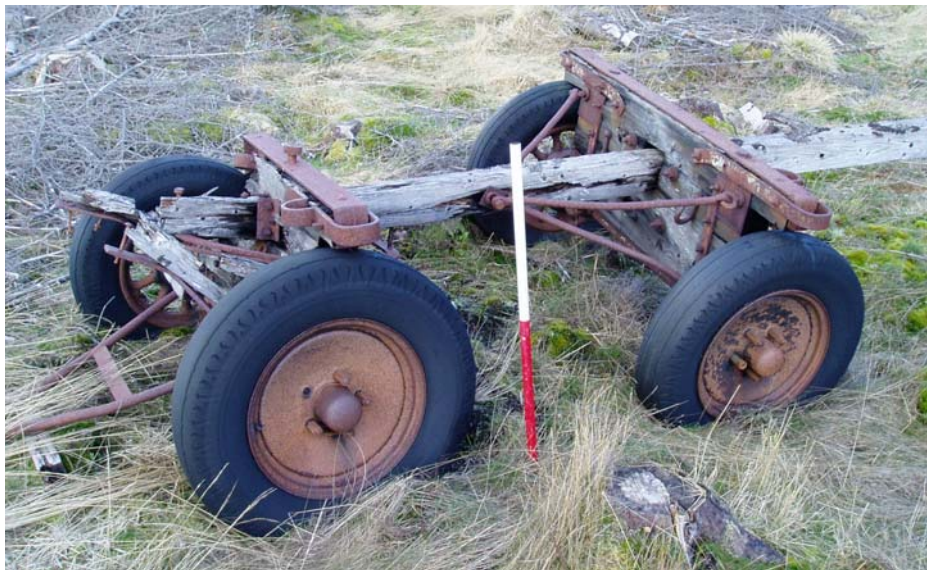
*Figure 21:
NOFU Pole Wagon (site 87).*

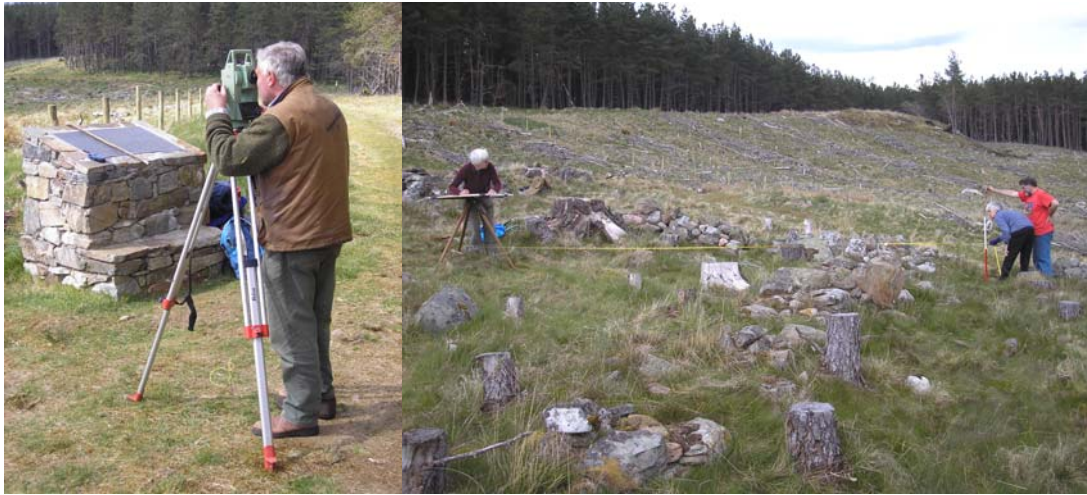
Figure 22:
Volunteers undertaking Topographic (left) and Plane Table (right) survey at Druim an Aird.

The MoLRS site of Druim an Aird, Wester Strathmashie NOFU Mill (Teenies), and Macoul NOFU camp were surveyed with the total station. Figure 22 show Laggan Heritage volunteers undertaking both forms of survey.

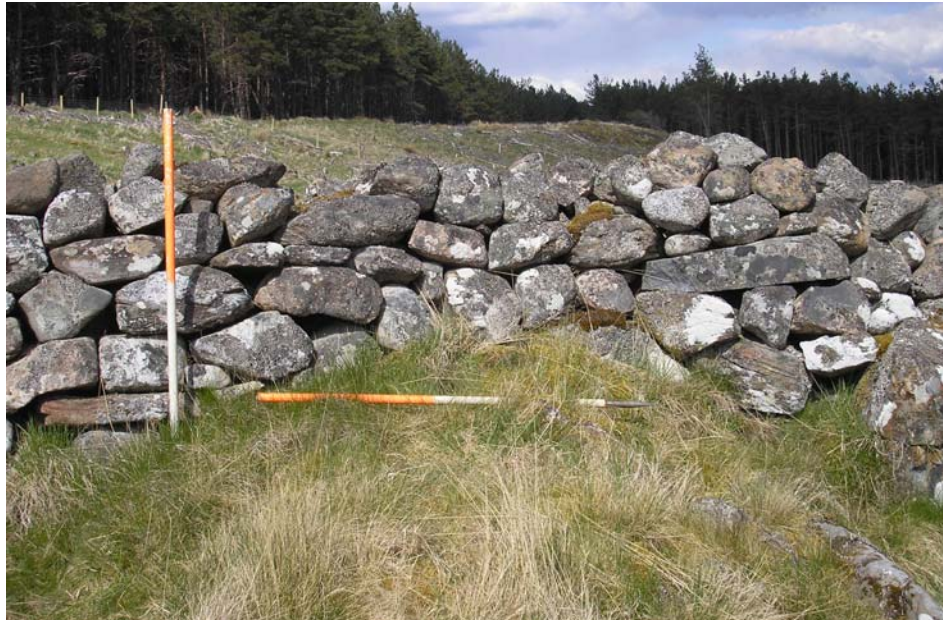
Figure 25:

Dry stone wall of enclosure A running over the top of enclosure B at Druim an Aird.

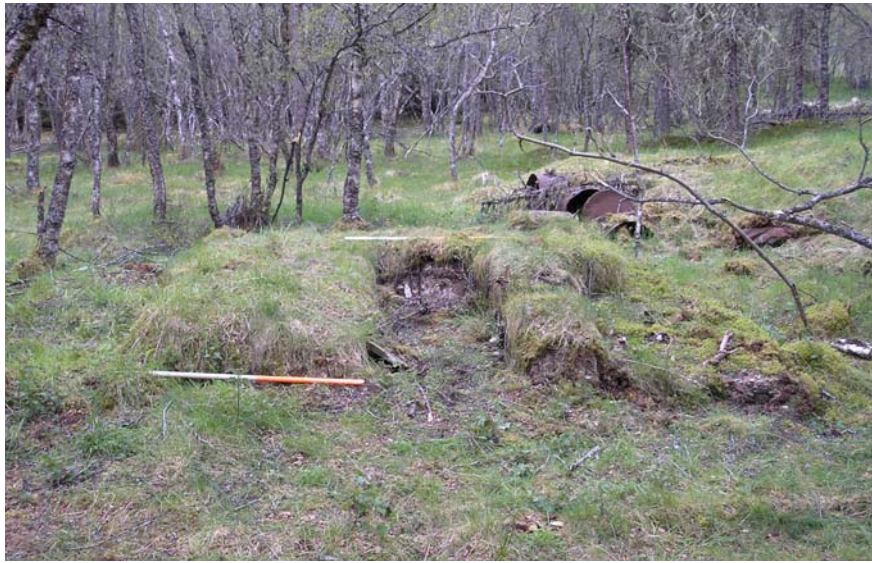
Figure 28:
Saw pit at Wester Strathmashie NOFU Mill.

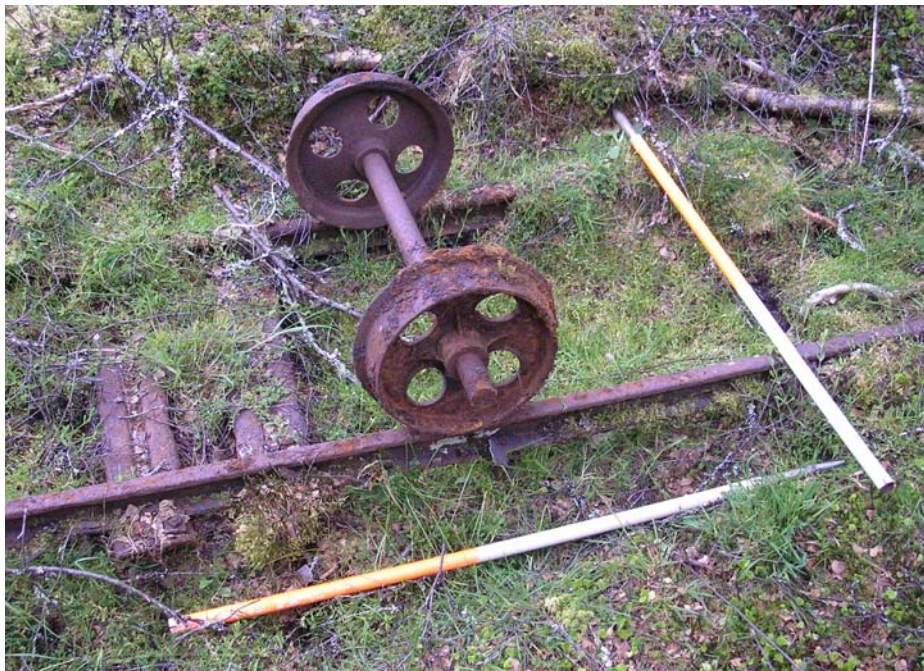
Figure 29:
Remains of light gauge railway at Wester Strathmashie Mill.

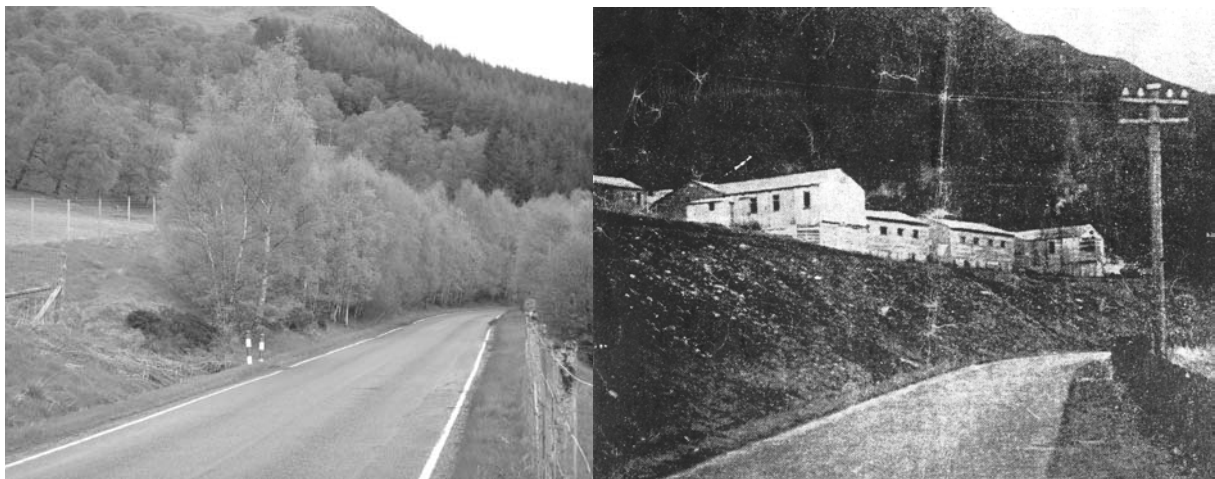
Located outwith the main survey area, on Ardverikie Estate, is the site of the former NOFU Camp at Macoul. The site is located on south-east facing grassy slopes continuing down to the A86. The site is bound on the north and north-western sides by a disused field dyke, beyond which the ground turns steeper and rougher. Figure 30 shows how the camp looked at its time of use and how it looks currently. The NOFU camp site was located on land that was previously used by Carmichael during the construction of the road in late 1930s (Grant pers comm.). It is unclear whether some of the surface remains present today relate to this road camp or if all relate to the NOFU.

*Figure 30:
The NOFU camp at Macoul when in use (right) and currently (left).*

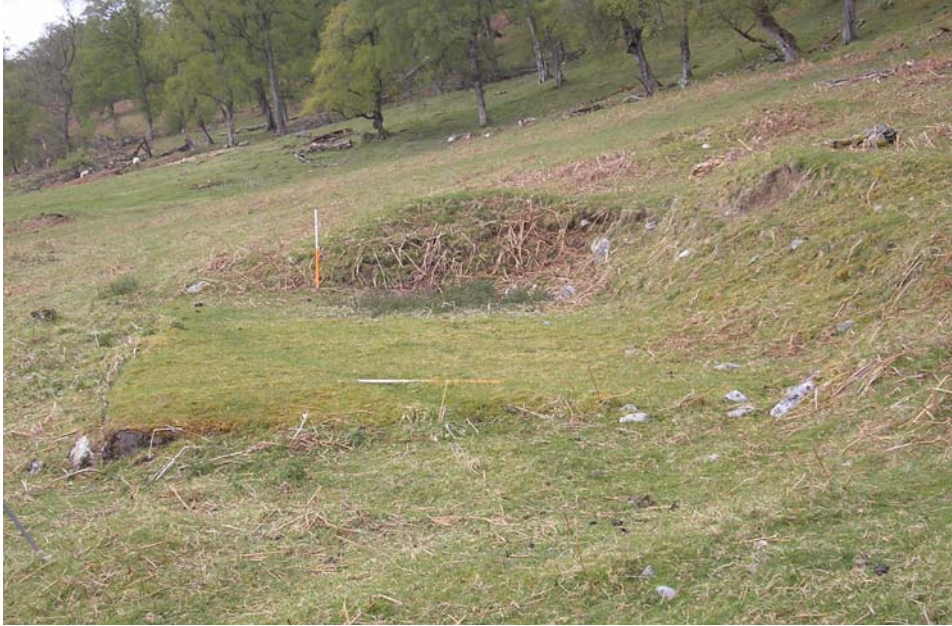
*Figure 32:
Concrete based platform cut into slope at Macoul.*

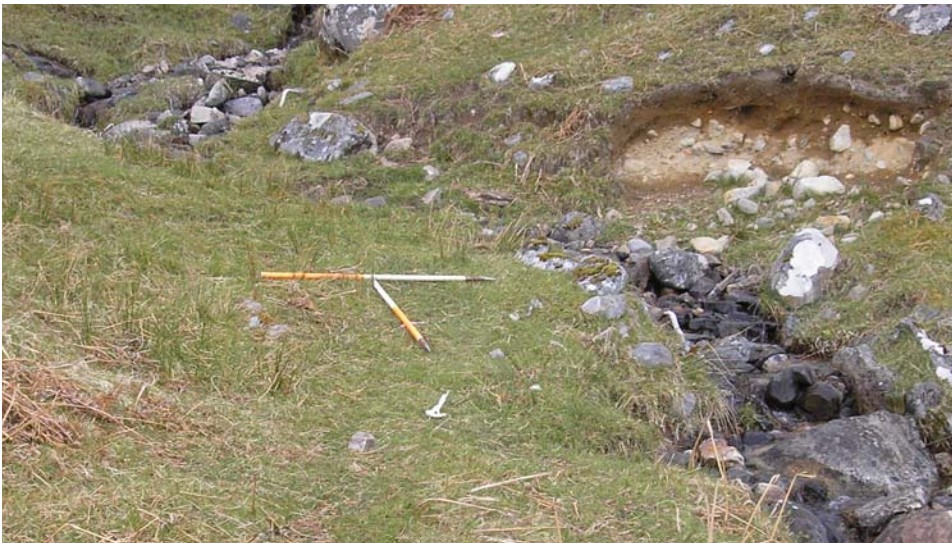
A burn runs down the hill to the north of the entrance. At the northern end of the site, on the uphill side of the track and next to the burn, exists a small platform (Figure 33) that does not appear natural in origin and where some drystone work is visible. This may relate to the water supply for the camp.

*Figure 33:
Possible platform relating to water supply at Macoul.*

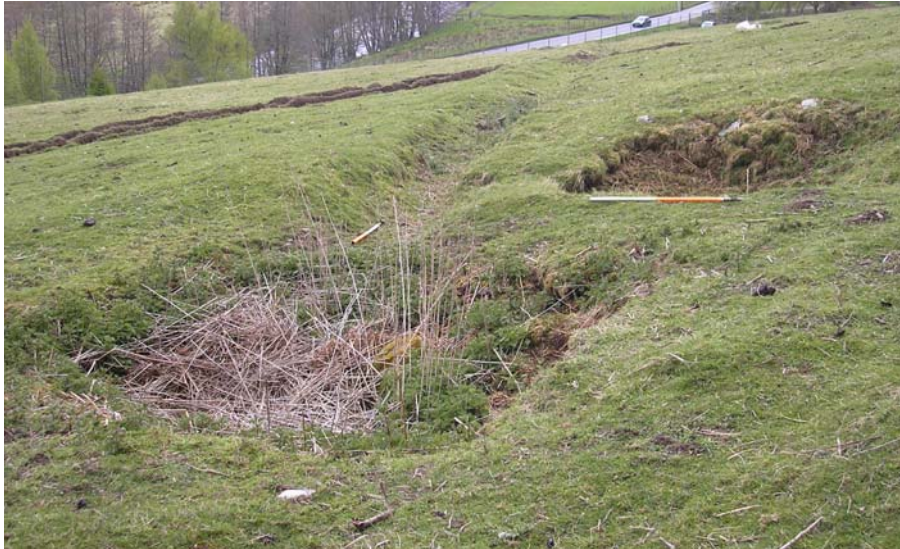
Figure 34:

Another common feature to the camp is the presence of a series of square pits, up to approximately 1.5 m by 1.5 m in size. Eight of these pits were noted in total, the majority being located at the western edge of the site. Two of the pits located higher up the slope have small channels running out of their south-western corners (Figure 34). They continue diagonally down-slope before turning straight downhill. One of the channels can be traced running into a smaller pit at the base of the slope; the other into a burn. It is likely, therefore, that the channels formed part of a drainage system removing material from the pits.

Pit with channel at Macoul.

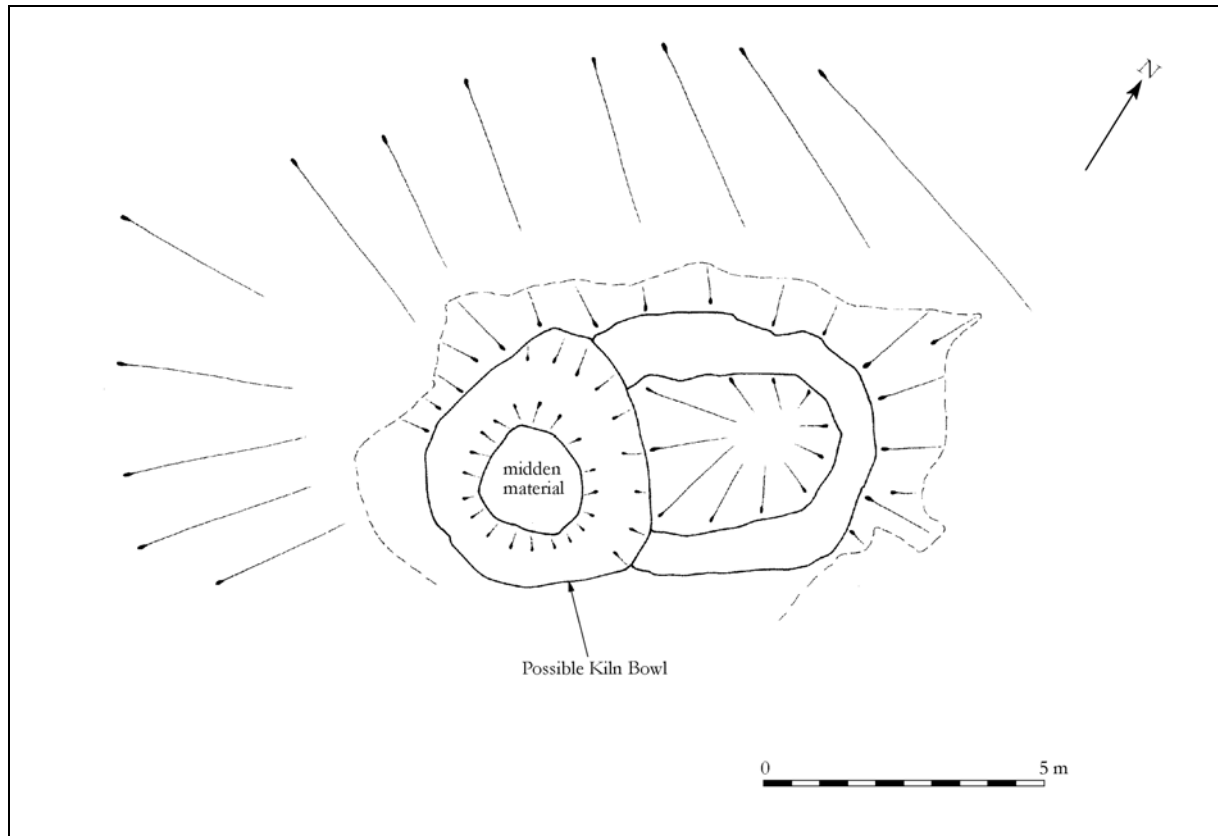
Figure 36:
Plane table survey of possible drying kiln at Blackwood.

The kiln exhibits a similar bowl shape to other kilns noted during the survey. It has subsequently been filled with midden material. A small drystone enclosure extends off one end of the potential kiln bowl.
