New House and Vehicle Access Kingsburgh Isle of Skye

Archaeological Watching Brief

17th January 2006

Report No. 165

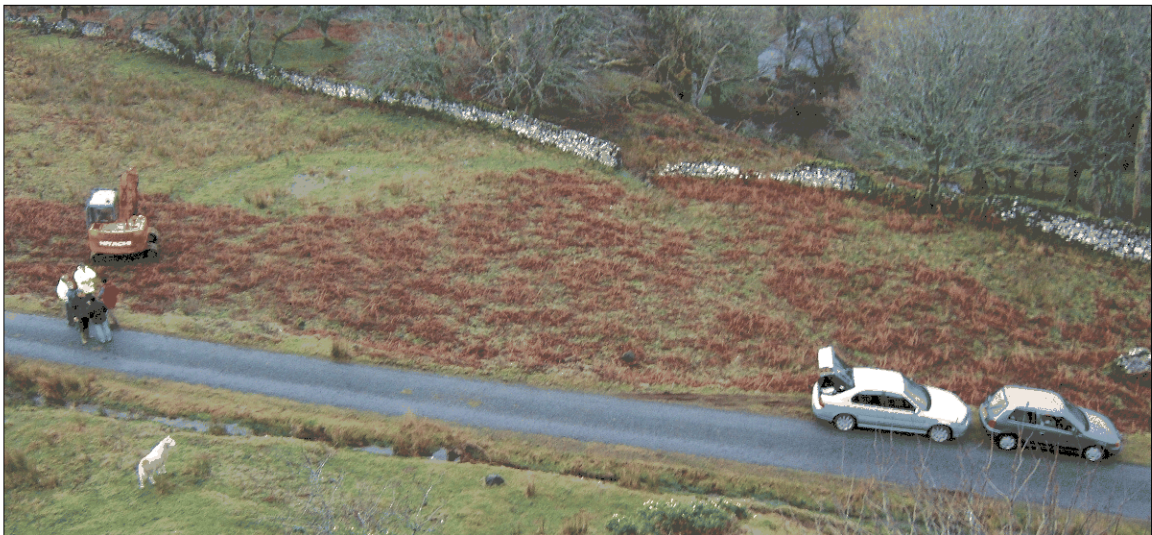
illus. 1 Kingsburgh : The plot before excavation.

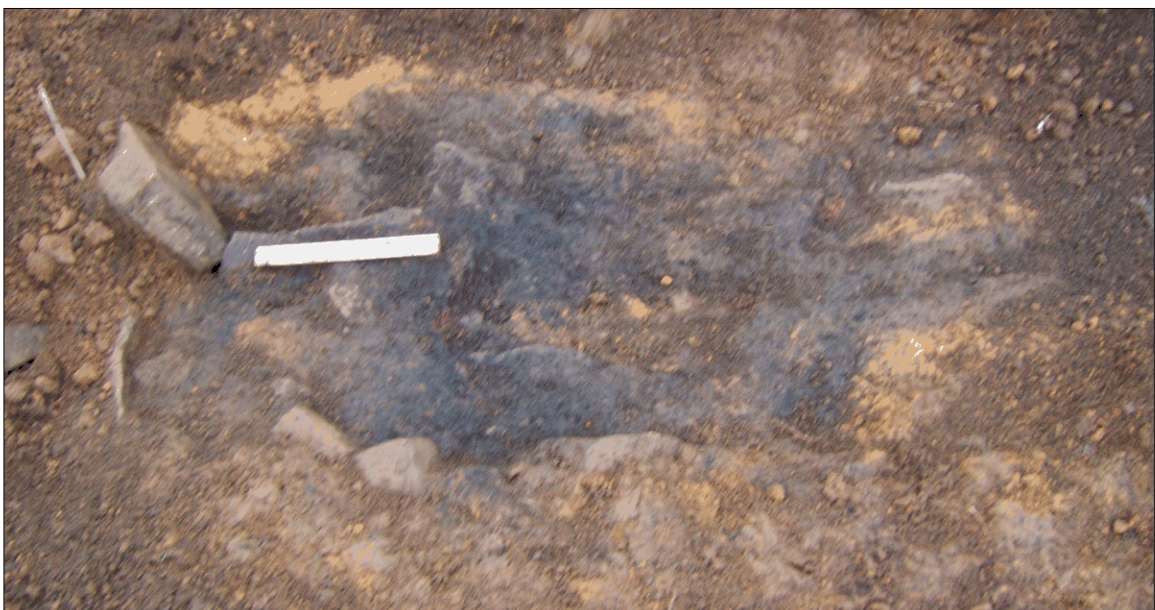
Lying below 300mm of plough soil was an oval area of black soil, charcoal and stones which measured 1.80 meters N – S by 1.20 meters E – W. This feature had been cut into the natural orange clay and had been truncated by the plough. There was no sign of black soil or stonework in the overlying plough-soil. The feature was recorded, and sectioned on a NW – SE line before being completely excavated. A large sample (10 litre bucket) of the fill was retained for later wet sieving. No finds or other dating evidence were recovered during the excavation.

illus. 5 : Feature 1 as first exposed. (North to right. Scale = 30cm)

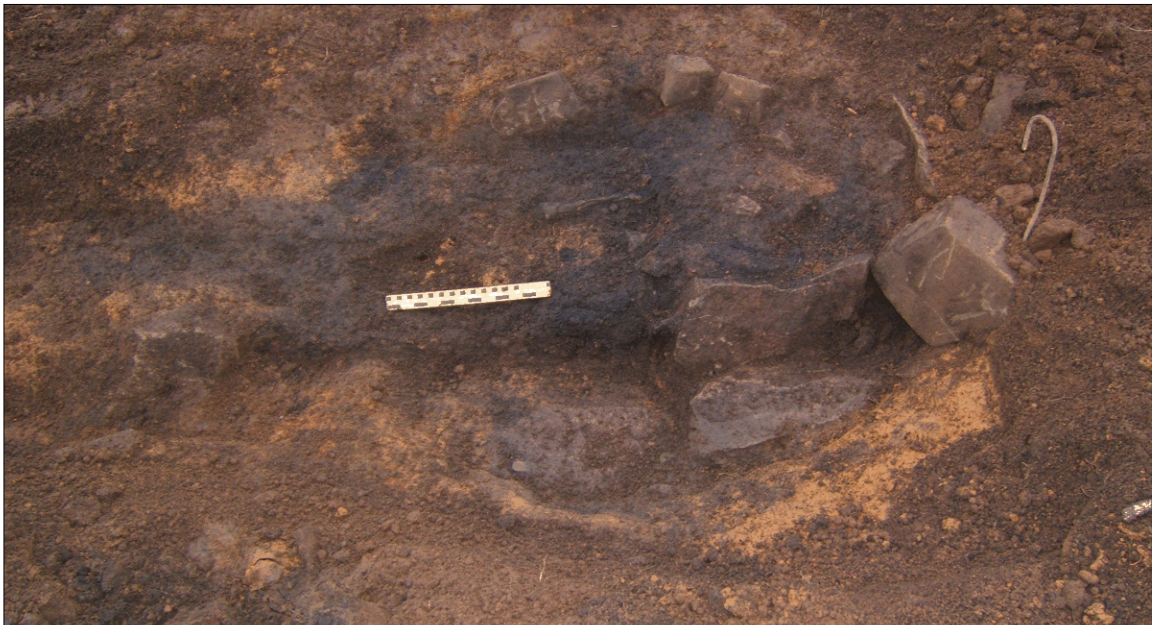
The fill consisted of a black charcoal rich soil containing thin lenses of pure charcoal, orange peat ash and stones.

illus. 6 : Feature 1 sectioned (North-west to left. Scale = 30cm)

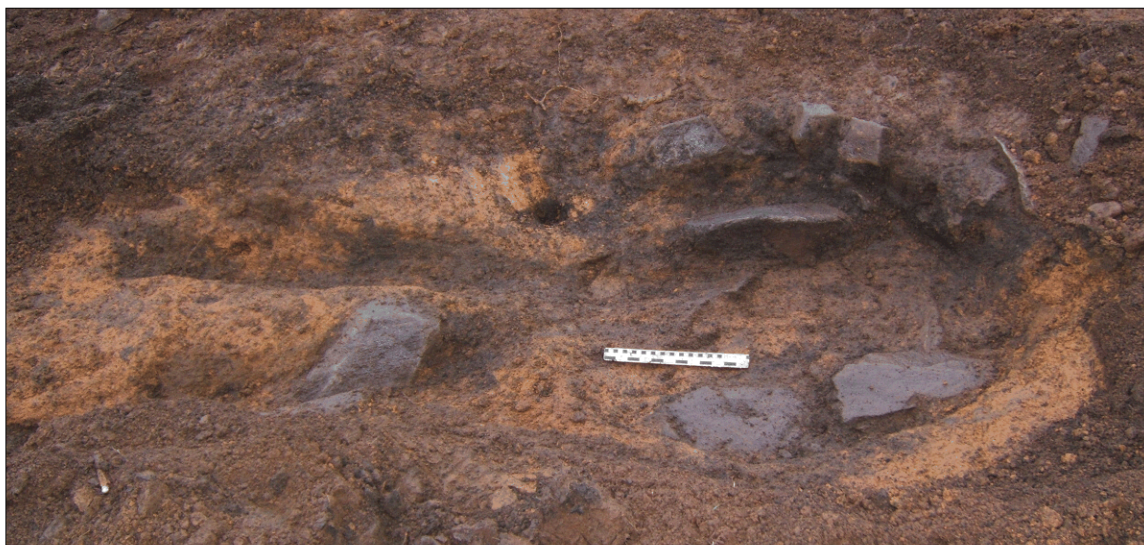
illus. 7 : Feature 1 fully excavated (North-west to left. Scale = 30cm

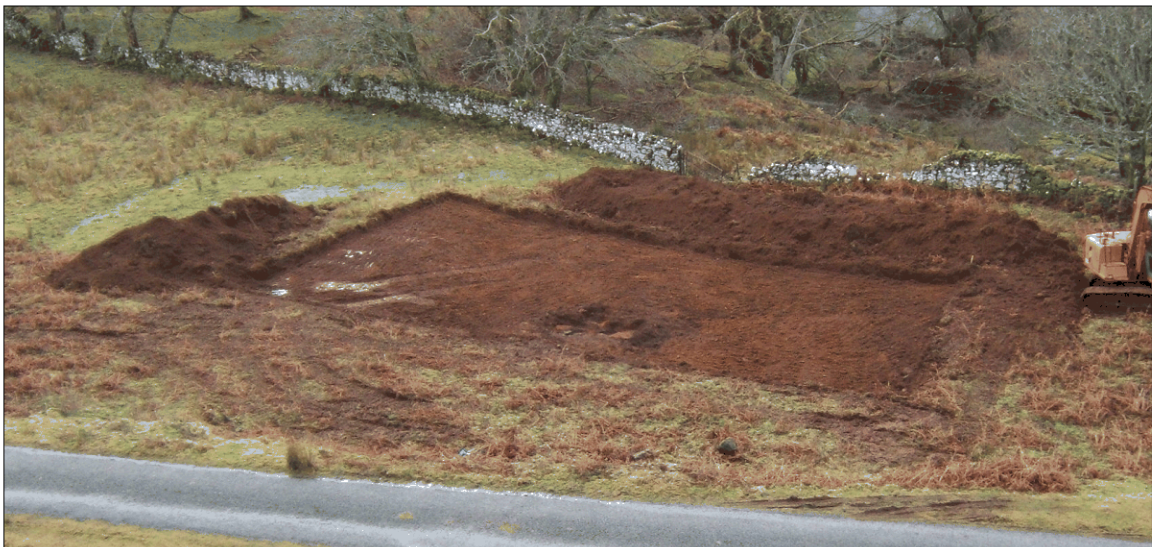
illus. 9 : The house plot after clearance.
