**Site Code: MMW06**  
**Date: August 2006**  
**Client: Millennium Wind Energy Ltd (MWEL)**

## **Millennium Windfarm, Glenmoriston, Highland**

### **Archaeological Watching Brief on the Stage 1 Programme of Works**

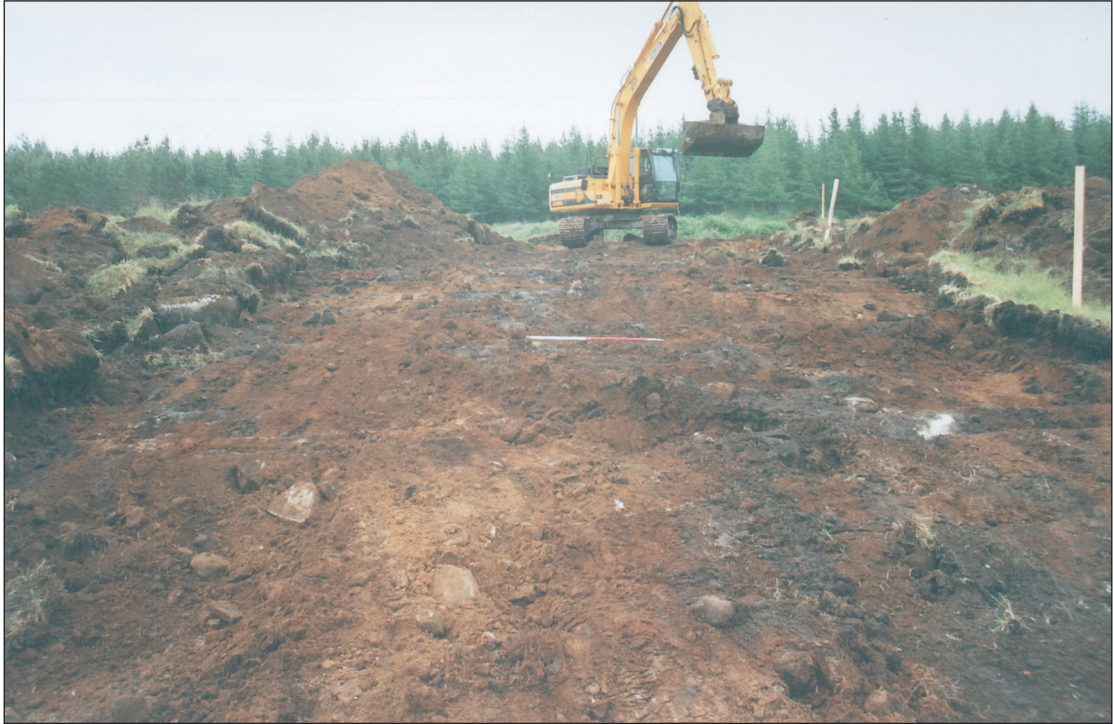
Plate 2: General shot of excavation for track extension

The watching brief identified no archaeological finds or features in the areas of the new-build track, the track extensions or the control building (Plates 2 & 3). Excavations either side of the existing track did reveal features associated with the initial building of this track in the form of a borrow pit. In addition, the remains of a shieling-hut at the base of the hill-track suggest the area has been associated with the use of hill pasture for a considerable amount of time.

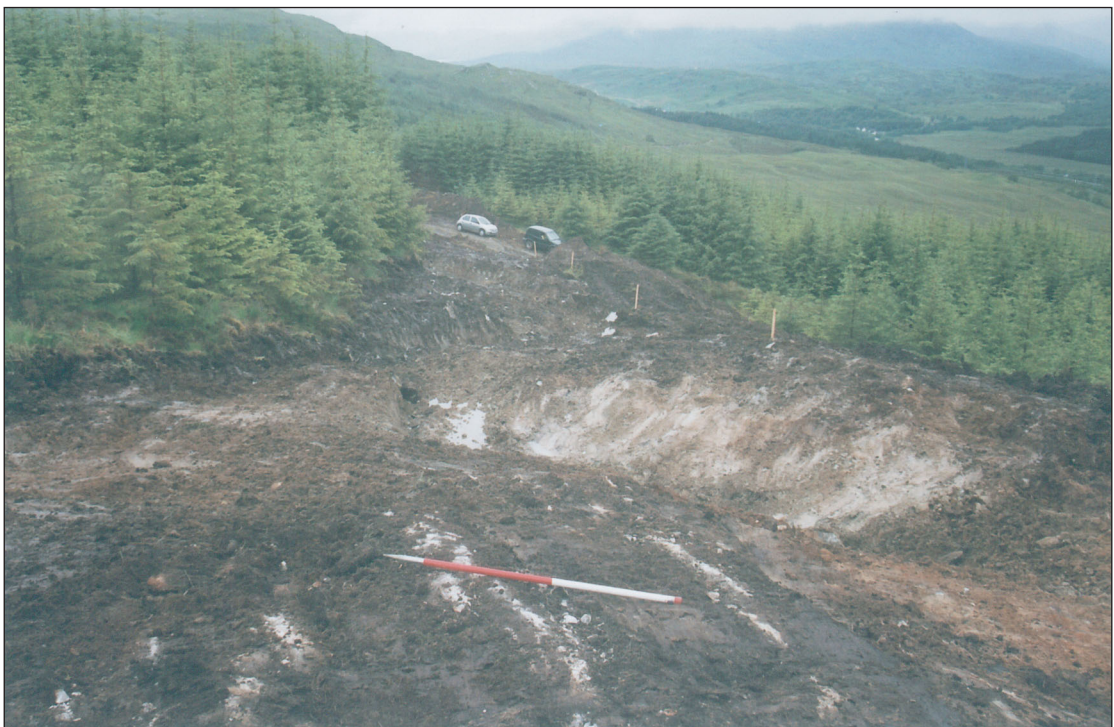
Plate 3: General shot of excavation through wooded area

Situated in the forested area, the woodcutters had cut the trees and were followed in by the machine which initially removed the felled trees and pulled out the remaining roots. The machines then removed the topsoil and where access was difficult they then dug through the natural down to bedrock. The trees appeared to have been planted onto a subsoil of grey sand which had been previously ploughed and deep stone-lined furrows created for every row or two of trees. No archaeological features were discovered.
