Woodlands **Boblainy, Beaully**

Watching Brief

Report No.	HAS061101
Site Code	HAS/ BBW06
Client	Mr & Mrs P. McLellan
Planning Ref	IN-05-1251
Date	16 November 2006
Authors	Gemma Shannahan and John Wood

An archaeological watching brief was carried out to record the nature and extent of any archaeology revealed during a proposed development at Woodlands, Boblainy, by Beaulieu. No features or artefacts of archaeological significance were found.

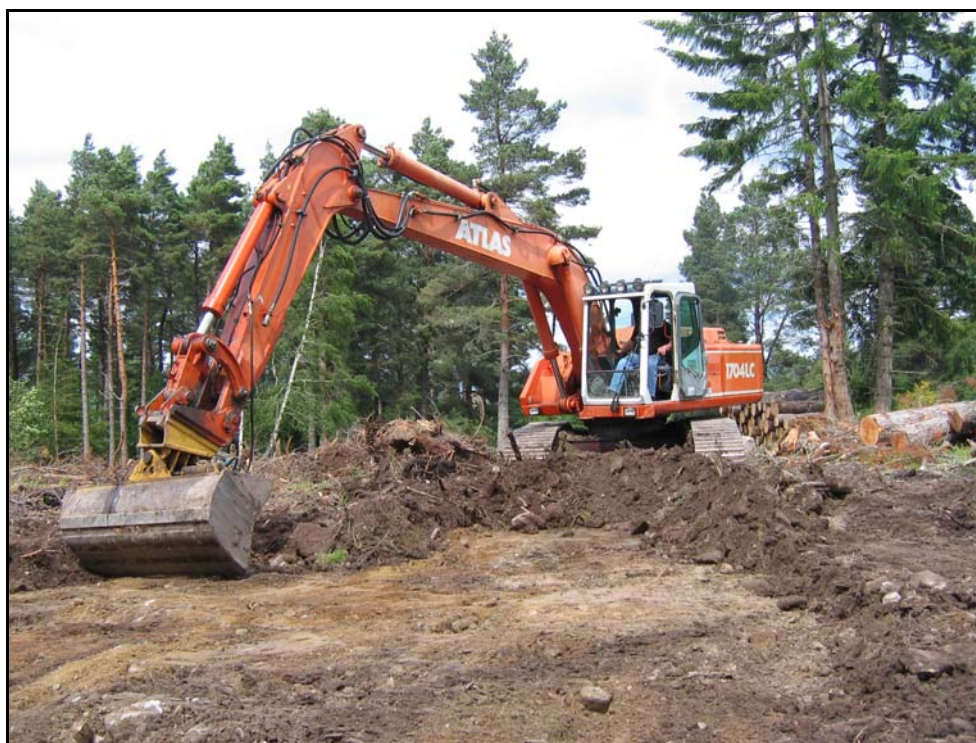
Figure 7 Extending trench to septic tank

The drainage route and position of the septic tank were plotted out by the client, and subsequently excavated. This area revealed the only finds, which were two small fragments of mid-20th century pottery in the topsoil [1]. The clients had also found similar pot sherds in the woods to the north, some time previously, which they believed to be associated with a former croft house said to have been occupied by refugees during the Second World War.
