Report of Archaeological Watching Brief
September – November 2000
Strone, by Newtonmore, Highland

By
Stuart Farrell
B.A A.I.F.A F.S.A.Scot.
December 2000

This report is for a watching brief conducted for George Leslie Ltd on behalf of NOSWA by the author for a water pipe and access road at Strone, by Newtonmore, Highland.

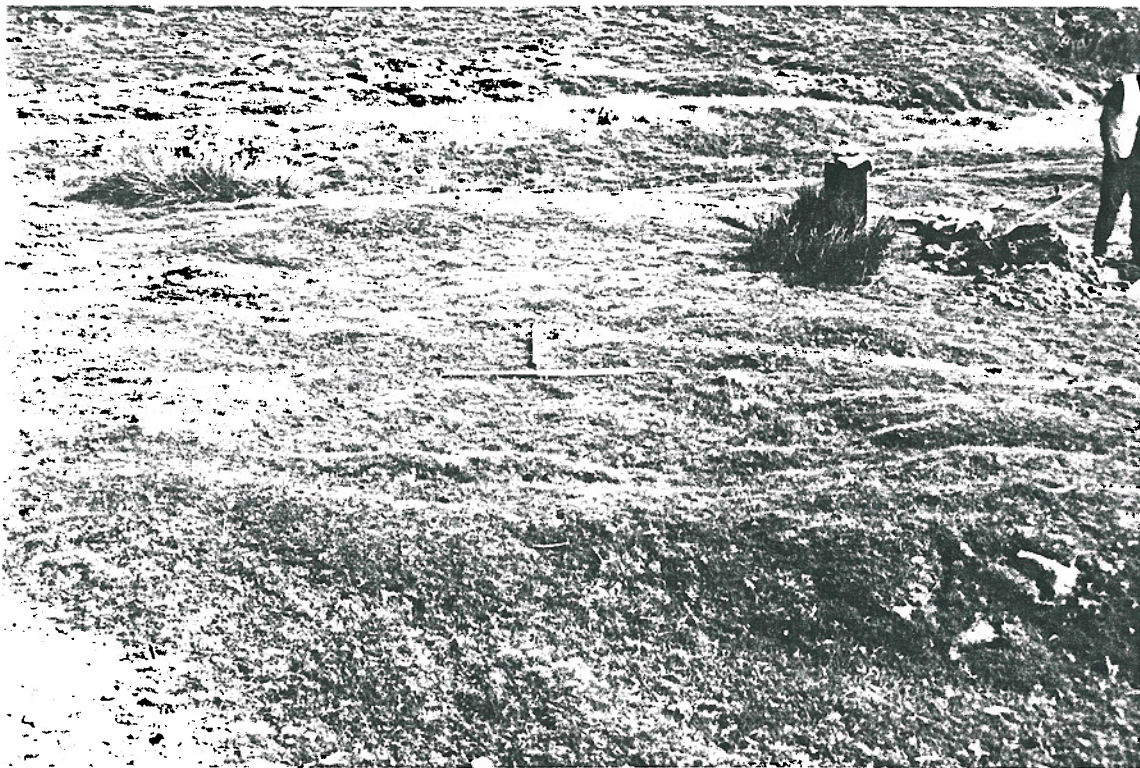
- 4 – structure – 4.2m x 7.2m EW – cut partially by track and fence line [426]
- 5 – structure – 4.5m x 9.7m – doorway to south. Midden to SE. [429]
- 6 – structure – 4.5m x 8.8m – cut by existing pipelines and track [430] (see photo 3)

An initial inspection of the site revealed that structure 6, although looking complete, was heavily truncated by three previous excavations for pipelaying operations and by existing track. Subsequent work showed no archaeological deposits to be remaining.

Photo 3 – Structure no.6 from west.
Photo 4 – Structure no.11 from south.

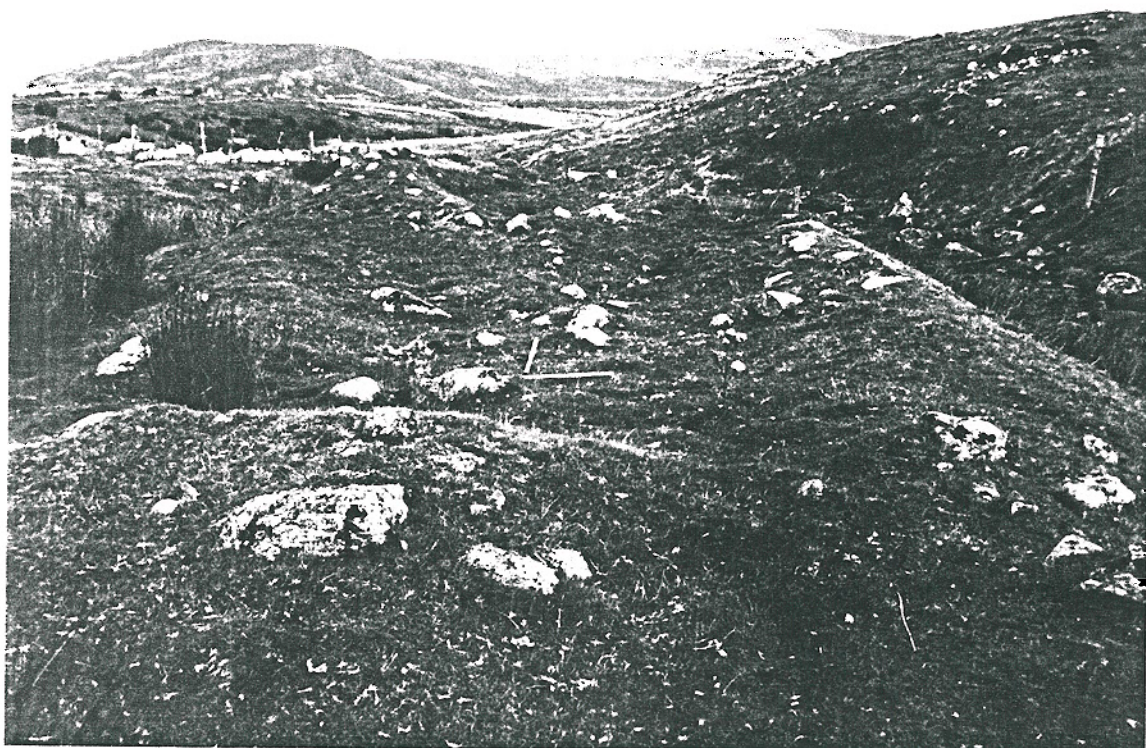
- 10 – structure – 5.4m x 10.8m NS with enclosure adjoining to East 10.8m x 15m. [425]
- 11 – structure & kiln – 8.2m x 5m NS with adjoining circular kiln of 2.4m². Walls are 0.8m thick and 0.4m high, entrance to SW. [428] (see photo 4)

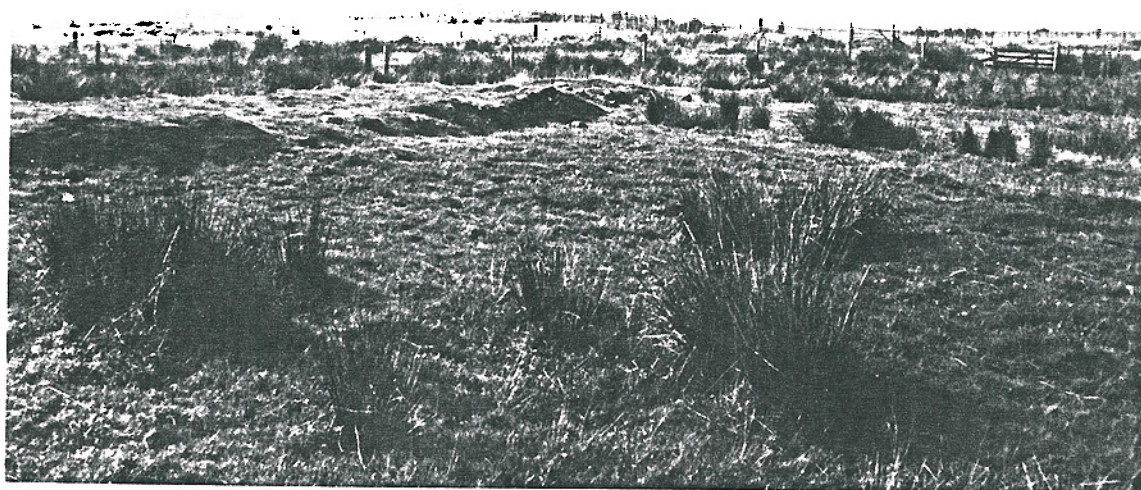
The trench for the pipe revealed topsoil to a depth of c.100mm with underlying natural of bluish-grey clay. No archaeological deposits were revealed during the course of the work. The only find was some rounded stone rubble to the west of structure no.2 (See photographs 5 & 6 for area of pipeline) and is probably the result of the building collapsing.

Photo 5 – Structure no.2 from northeast.

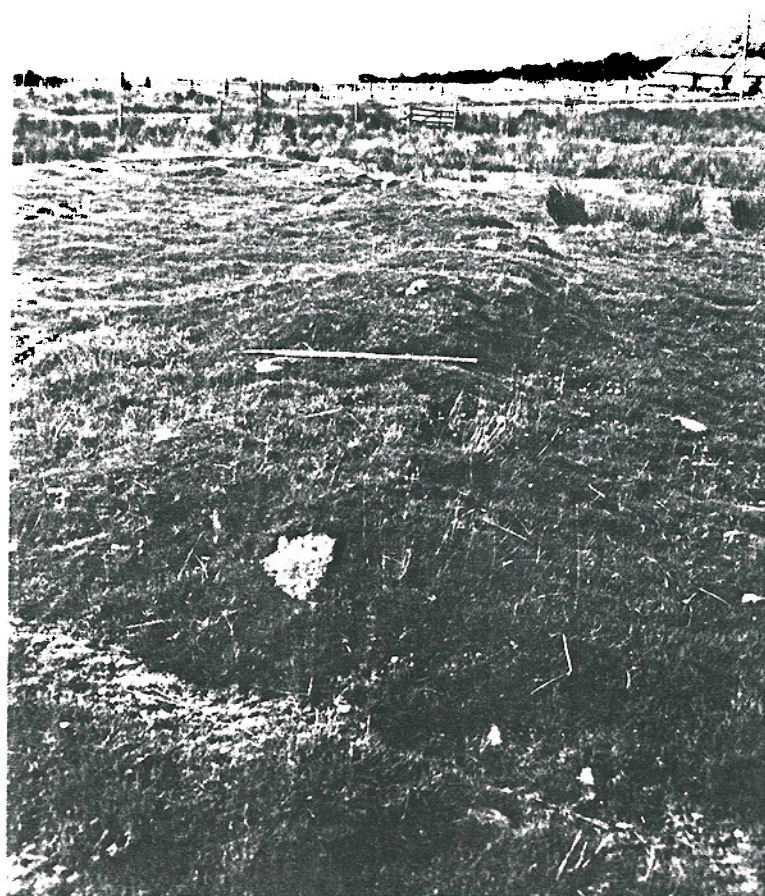
Photo 6 - Structure no.2 –detail of wall from east.
