Site Evaluation

***69-71 and 73 High Street
FORTROSE
Highland***

Site Evaluation
69-71 and 73 High Street
Fortrose, Highland

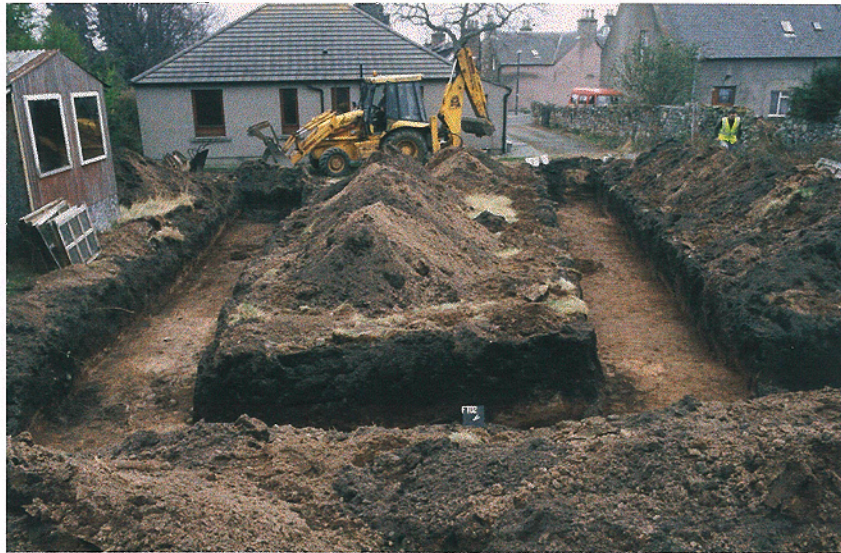
Illus 4

Trench B (Illus 4) was located 6 m to the south of trench A and ran parallel with it. It was 10.30 m in length. The stratigraphy of this trench was basically the same as that of trench A. The topsoil and subsoil had a combined depth of 0.60 m. As in trench A two rough field drains were observed, one between 1 m and 2 m from the trench west end and the other between 7 m and 8 m from the west end. These features were considered to be continuations of those found in trench A.

Trench C (Illus 4) was 13 m in length, aligned north to south and ran south from the east end of trench B. The main stratigraphy was the same as trenches A and B.

Trench **D** (Illus 4) was 14 m in length and ran southwards from the western end of trench **B**. It revealed the same basic stratigraphy as trenches **A-C**. A rough field drain similar to those found in the previous trenches was observed in the west facing section between 2.50 m and 3.50 m from the north end. The field drain fill was 0.12 m in depth.

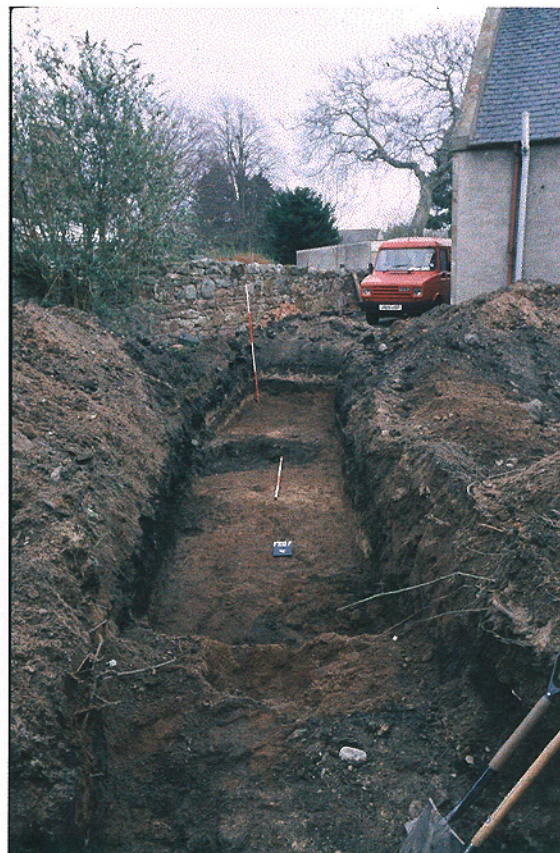
Illus 5

Trench **F** (Illus 5) was located in the rear yard of 69-71 High Street, close to the eastern side of the property. It was 13 m in length and aligned NNW-SSE.

The yard surface comprised small stone chippings in gravel up to 0.24 m thick at the north, thinning to 0.05 m at the south end. Below the modern stone chippings was a black silty loam up to 0.50 m thick. The loam contained abundant small-large stone fragments, which appeared to be remains of a demolished building. Natural silty sand deposits were reached at 0.80 m below the site surface.

At 9.0 m from the north end of the trench, the remains of a stone built feature were found on the east side of the trench. The feature comprised one large rectangular *in-situ* stone in a foundation trench cut into the natural sandy silt. Around the main stone was a packing of small-medium stone fragments in a matrix of silty sand mottled with black silt. The remainder of the feature was seen to extend westward 0.85 m into the trench and did not reach the opposite side of the trench. Immediately to the north of this feature was a deposit of large stone mixed with black soil which appeared to be demolition remains.

To the south of the stone wall feature, below the black loam, were three layers of makeup. The top layer was 0.20 m thick and comprised pale yellow sand containing abundant sandstone fragments and small pebbles. The middle layer was 0.15 m thick and comprised a mid-brown silty sand with frequent small-medium pebbles. The lower layer was 0.08 m thick and comprised light brown sand with small pebbles. These layers appeared to be cut by the stone wall foundation trench and probably represent a pathway around the frontage property as indicated on the OS first edition Ross-shire sheet XC 7, 1871, 1:25". The stone wall feature probably represents an outbuilding shown on the OS second edition of 1905.

Trench F, to the rear of 69-71 High Street revealed a wall and garden path dating from the modern period that could be identified on the first and second editions of the ordnance survey map.
