**Archaeological assessment of the proposed Route of Water
Pipelines between Letterfearn and Ratagan, Ratagan and
Ault a' Chruinn, and Ardelve and Sallachy, Lochalsh,
Inverness-shire.**

**Catherine Dagg
2, Ruigh'riabhach
Scoraig Peninsula
Dundonnell
Wester Ross
IV23 2RE
Tel: 01854 633 337**

Introduction

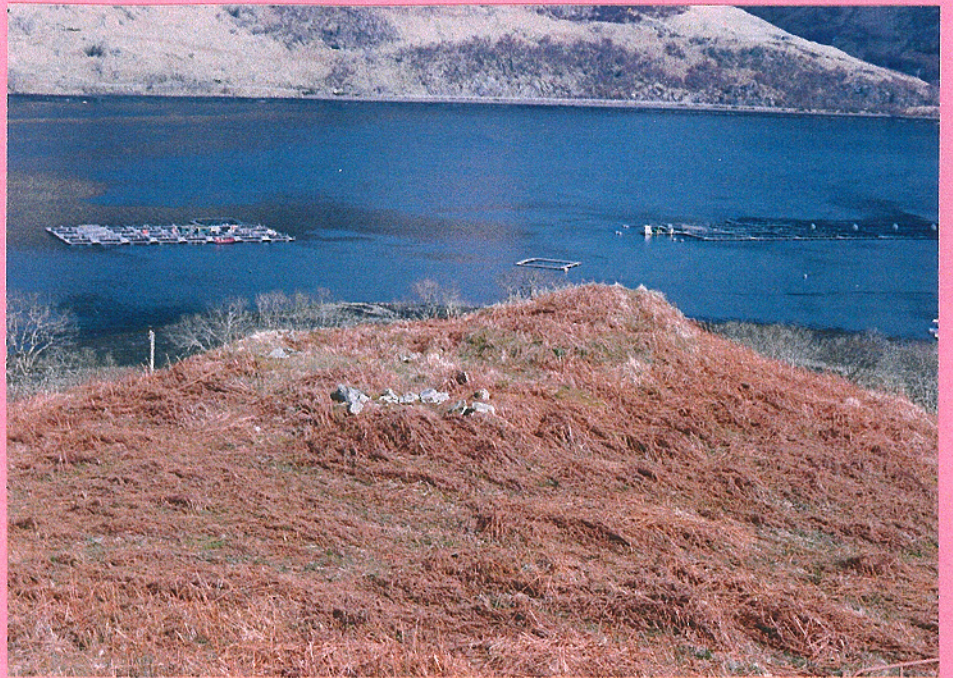
①

1. **NG8877 2303 Structure on knoll** Indistinct footings of a structure, probably associated with the township of Hazel brae, marked on the 1st Edition Ordnance survey map whose head dyke passes close behind the knoll. **(photo no. 1)**

Recommendations: This structure should be unaffected by the project, but further remains of the pre-crofting township may be revealed in the vicinity during excavation for the pipeline.

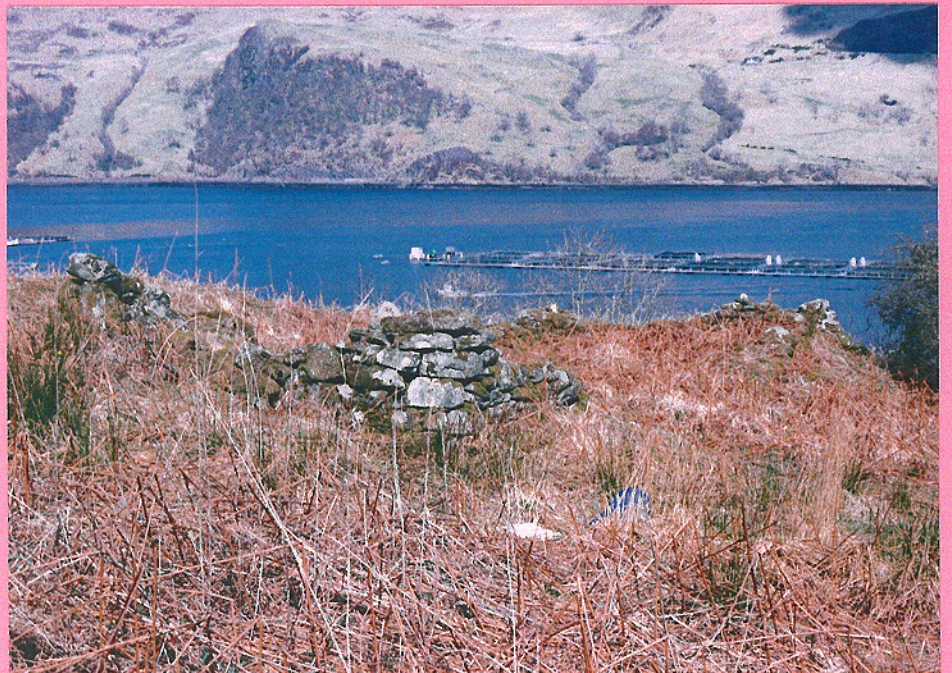
②

3. **NG 8910 2282 Structures** The footings of two rectangular buildings, the larger aligned NE-SW, the smaller to the north of this and aligned NW-SE. Not now visible on the ground but indicated by aerial photographs, is an enclosure to the SW of the larger building. A track is visible connecting these buildings with the road. One building and this track are marked on the 1st edition Ordnance Survey map. **(Photo no. 2)**

Recommendations: The proposed route of the pipeline passes almost exactly through these buildings. It is recommended that the route be changed if possible to avoid them. It is noted that the ground falls steeply to the NE of the buildings, probably a difficult route to excavate for the pipeline. The alternative route to the SW would have to pass as close as possible to the present forestry to avoid cutting through the enclosure. However, damage to the enclosure may have to be considered acceptable.

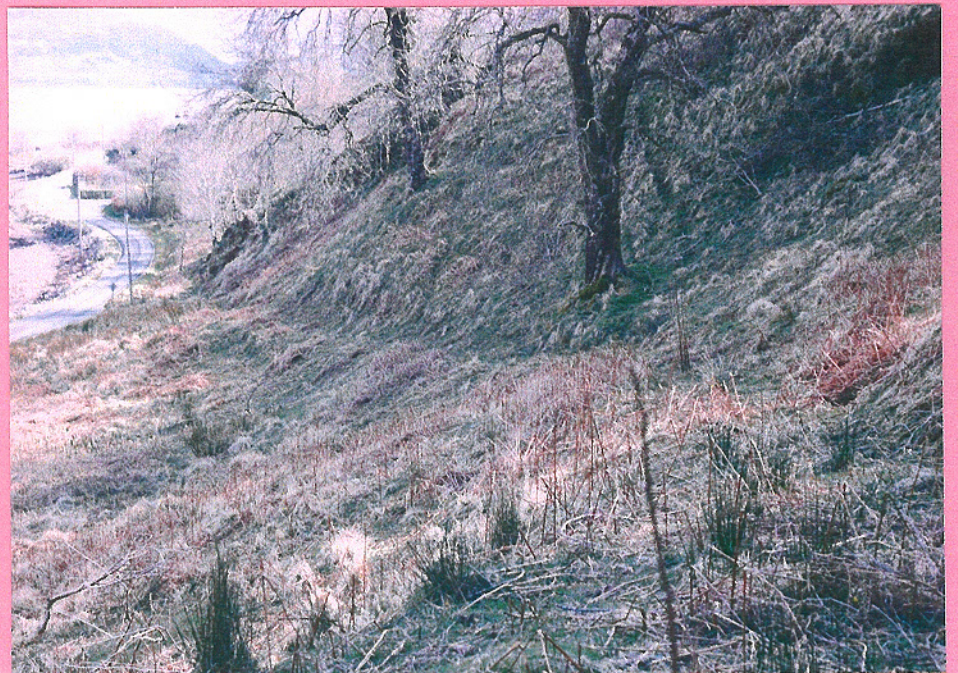
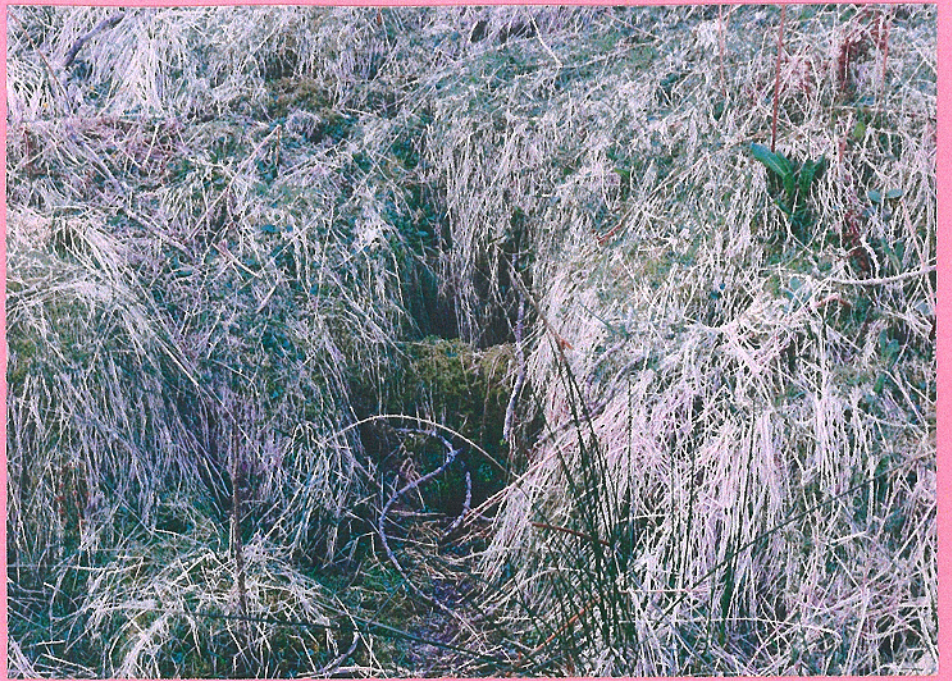
③

4. **Centred on NG 8912 2276 Track and Well** The track passes WNW up the bank from the structure (no. 5) It is not marked on the 1st edition Ordnance Survey map. The well is at the upper edge of the track about halfway between the road and the forestry. **(Photos 3 and 4)**

Recommendations: The pipeline will inevitably cut through the track. It is recommended that this be done through as narrow a passage as possible, and avoiding the well, which should be marked to avoid accidental damage.

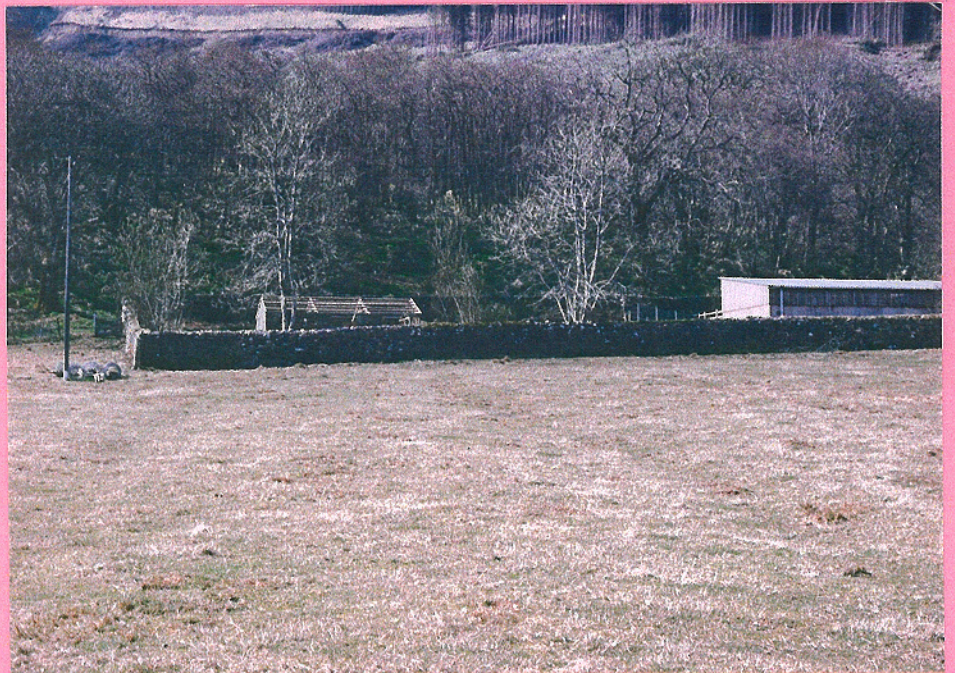
5

7. **Centred on NG 8960 2200 Manse and associated buildings. Old settlement area.** The alluvial fan now occupied solely by the manse and its associated farm buildings is most likely the site of the pre-Clearance settlement named as Muck on the Blaeu map. It does not, however, appear to be marked on the Roy map. Aerial photographs show no features, and it is possible that no structures have survived later ploughing and field clearance. **(Photo no. 5)**

Recommendations: It is noted that the proposed pipeline route passes through the walled enclosure which is an integral part of the farm buildings contemporary with the Manse. Is it possible to re-route the pipeline a bit further east to avoid damage to these walls? The unlikelihood of pre-Clearance features remaining under the cultivated fields would suggest that archaeological monitoring of this area would not be necessary.

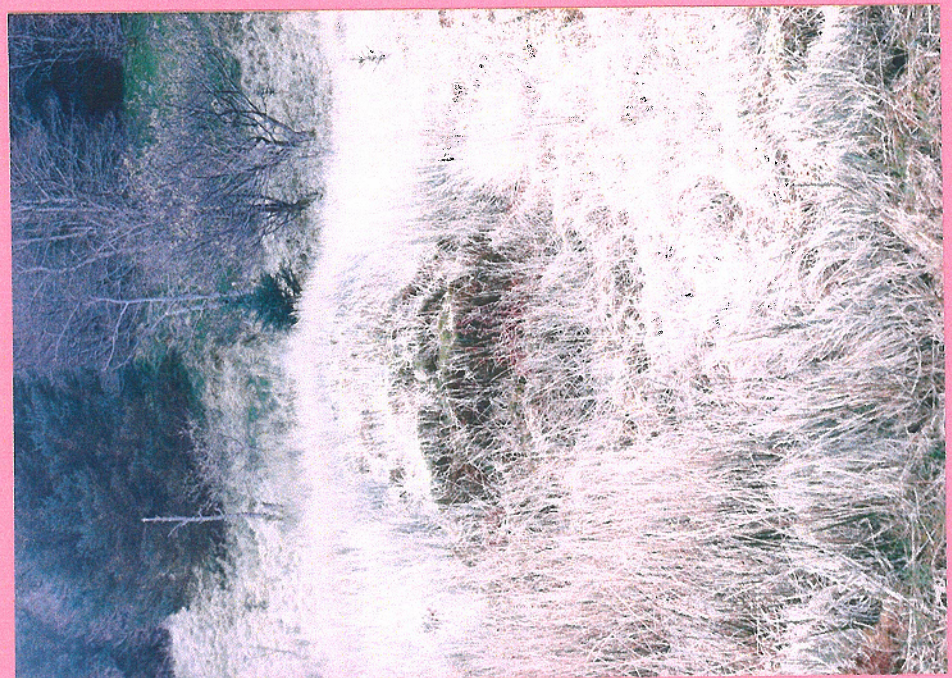
6

11. NG 9073 2085 Enclosure associated with structure Turf and stone dyke forming an irregularly shaped enclosure, associated with a probable farmstead on the other side of the stream behind the modern cemetery, marked as unroofed on the 1st edition Ordnance Survey map. The lower ground within this enclosure is level enough to have been suitable for a burial ground, but no structure or head stones were visible under the deep bracken cover. This type of turf dyke is not what one would expect to enclose a burial ground. The township marked here on Roy's map may refer to this farmstead. **(Photo no. 6)**

Recommendations: Although it is considered unlikely that this is the burial ground, it may be useful for archaeological monitoring to be carried out when excavation work crosses the enclosed area. The farmstead is far enough away from the road to be unaffected.

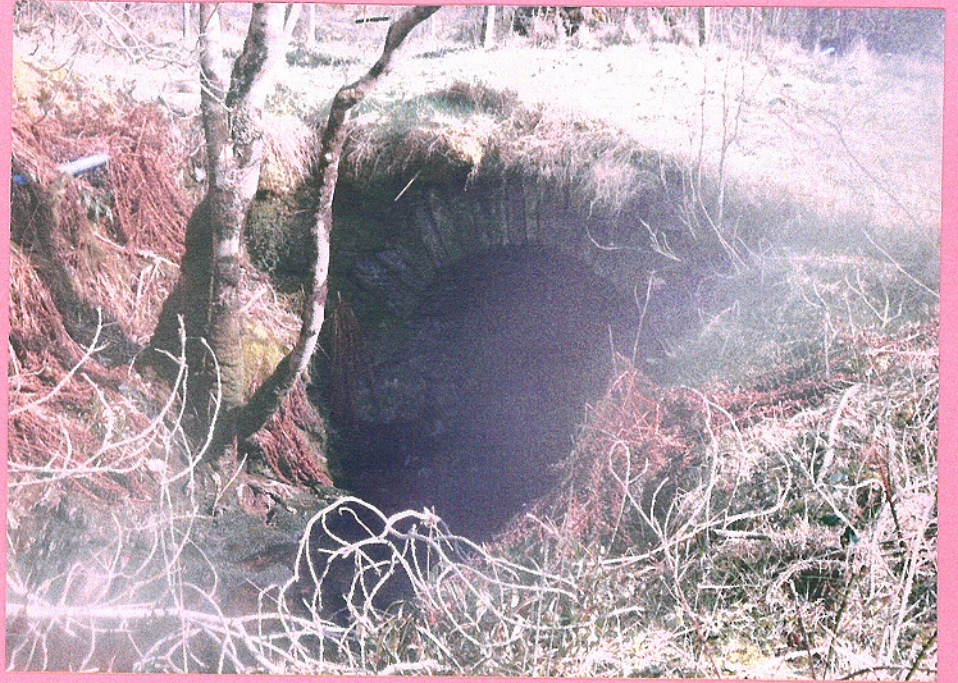
7

15. **NG 9165 1995 Bridge** A single-span arched stone bridge over the Allt na h-Inghinn. **(Photo no. 7)**

Recommendations: Although well above the proposed route of the pipeline, it has been included in this survey to ensure that no vehicles or plant attempt to cross it as a short cut, as it is in a fragile state.

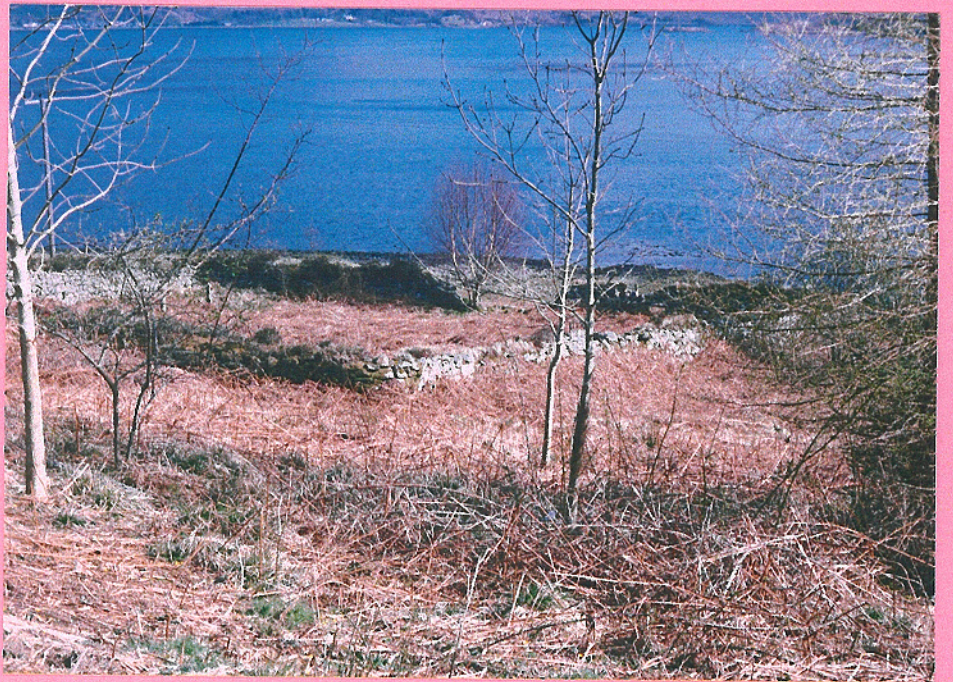
8

18. **NG 9267 1882 Sheepfold** of drystone construction, roughly square, the only feature a lamb creep in the SE corner. Internal divisions have been of fencepost and wire.

(Photo no. 8)

Recommendations: The route of the pipeline should pass safely above this feature, so no mitigating action considered necessary.

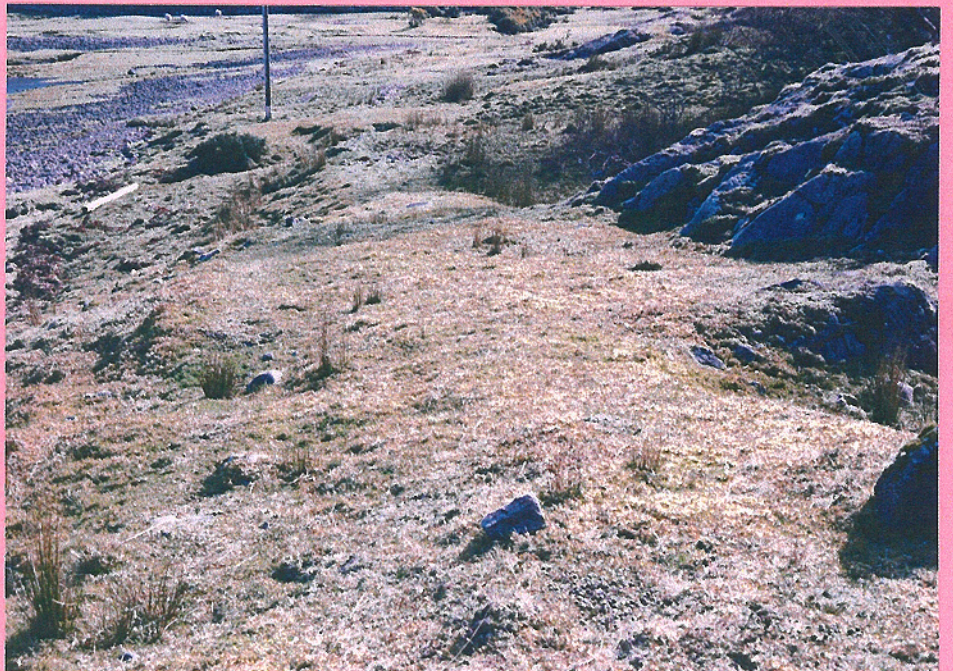
9

19. centred on NG 9173 1995 Track This old track can be followed passing between the shore and the road, then below the sheepfold. In places the ground has been build up with rubble to provide a steady gradient, presumably for carts. Marked on the 1st edition Ordnance Survey map. **(Photo no. 9)**

Recommendations: the track and the pipeline share the same route for a short distance, there is not enough leeway here for the pipeline route to be altered to avoid damage to the track, nor is it probably necessary. It may be considered useful for more detailed recording of the track and its construction to be carried out before work commences.

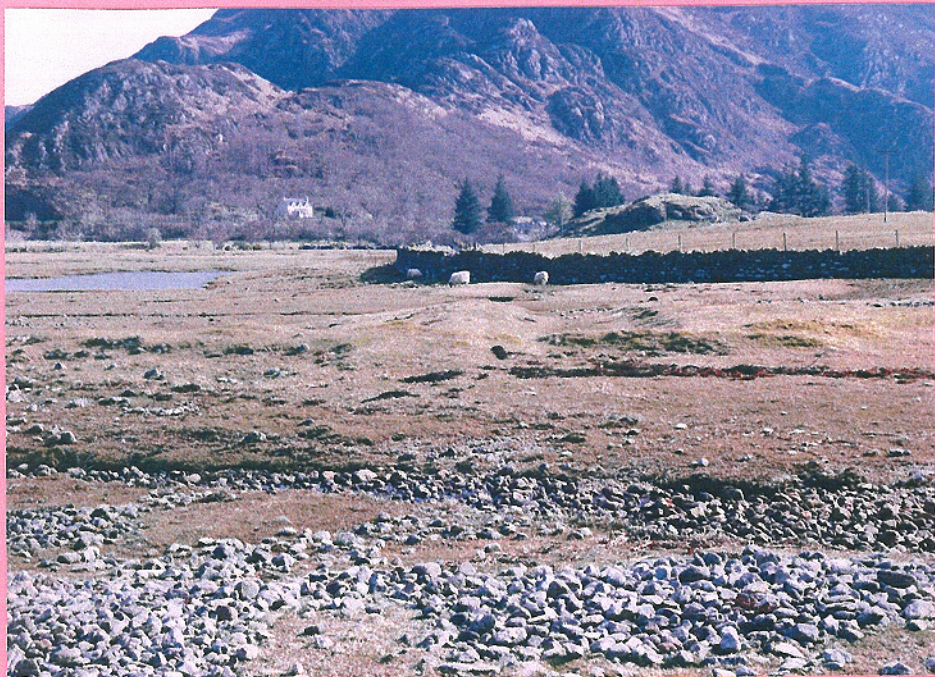
10

20. centred on NG 9292 1869 Area of dykes and cultivation. Old settlement area this area of pre-clearance cultivation is probably associated with the un-named settlement marked above the military road on the Roy map. Cultivation rigs and an enclosing turf dyke. Turf dykes also appear to extent out onto the shore, and there are confused features on the shoreline, including some apparently modern cuttings. **(Photo no.10)**

Recommendations: The route of the pipeline crosses this area and more detailed archaeological recording of the features is recommended before work commences.

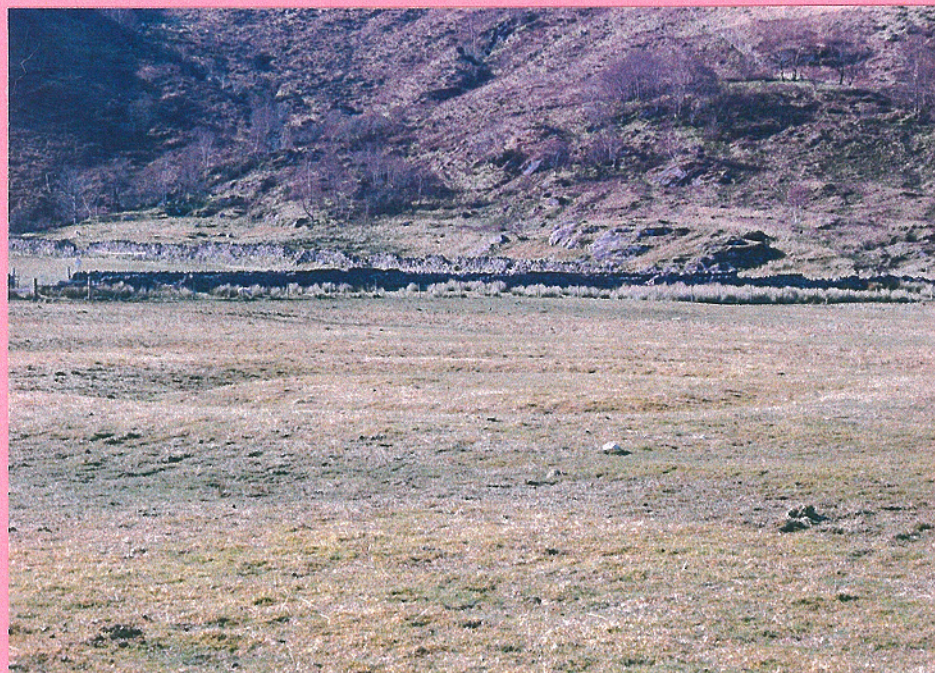
11

21. NG 9308 1868 Henge (Late Neolithic ritual monument) Visible as a low grass-covered circular platform surrounded by a ditch and bank, total diameter about 19m. This is the only known henge on the west coast of Scotland, and is similar in type to the group of 5 henges in east Ross and Cromarty, indicating a probable route of communication in Neolithic times between east and west along Glen Carron. This henge is not published, at the request of the landowner, but is recorded on the Highland Council's SMR and the NMRS. **(Photo no. 11)**

Recommendations: This monument is vulnerable to accidental damage by any vehicle or plant crossing the field to gain access to the pipeline route. It is recommended that an exclusion zone of 20m. beyond the edge of the feature be taped. The pipeline should pass about 40m. north of the henge, but archaeological monitoring along this section may be advisable in case any associated features are in the vicinity.

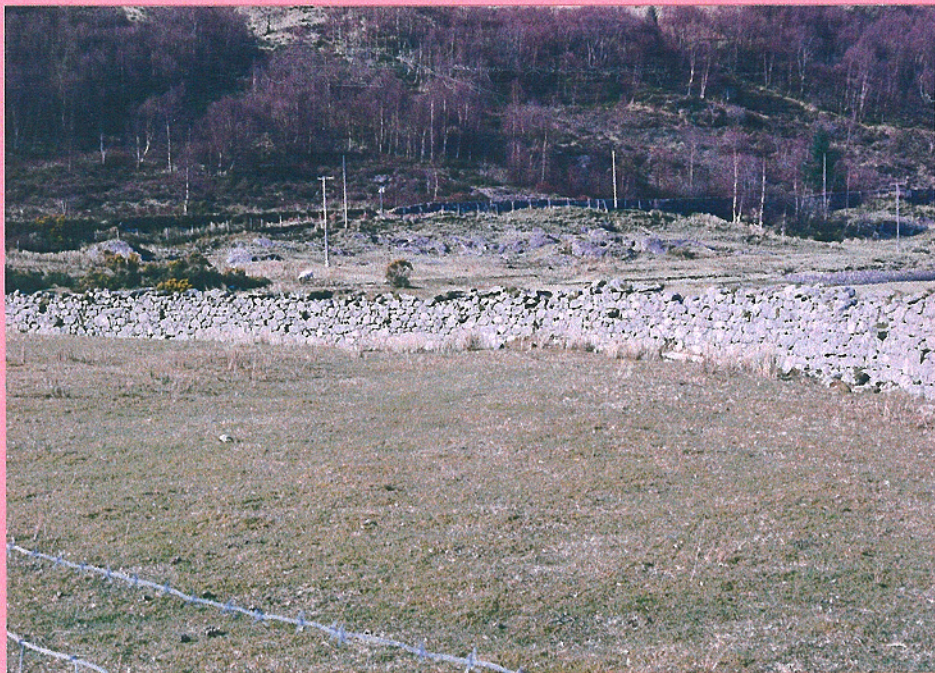
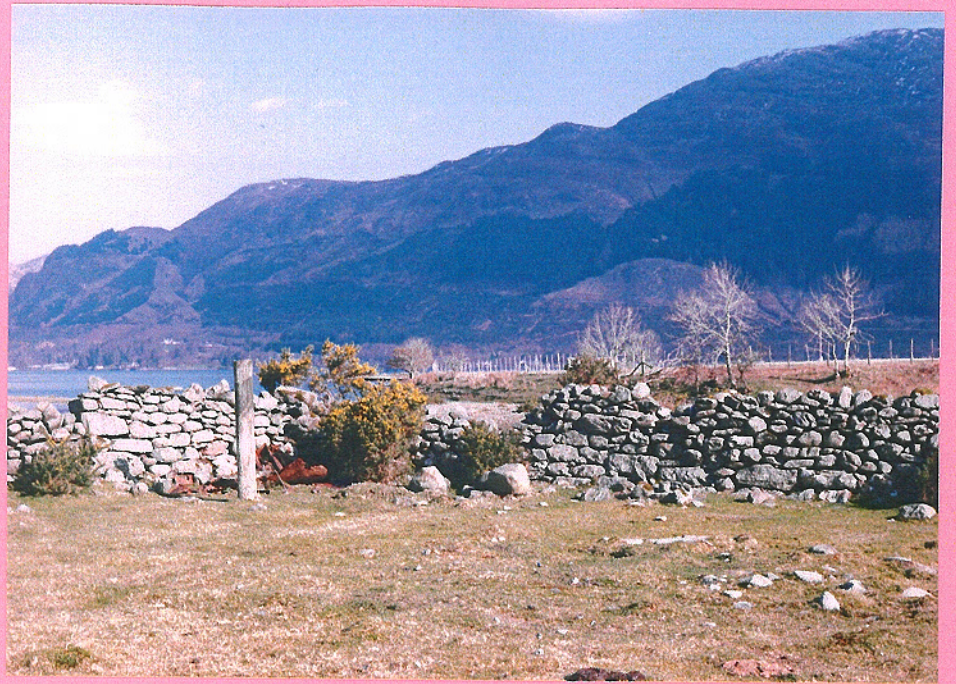
22. NG 9296 1871 and NG 9326 1887 Drystone Dykes The drystone dyke enclosing the post-Clearance field pattern, associated with the establishment of the home farm at Shiel House in the 19th century. **(Photos 12 and 13)**

Recommendations: The dykes will be broken through at two points but it is not considered that any action need be taken beyond recording the location.

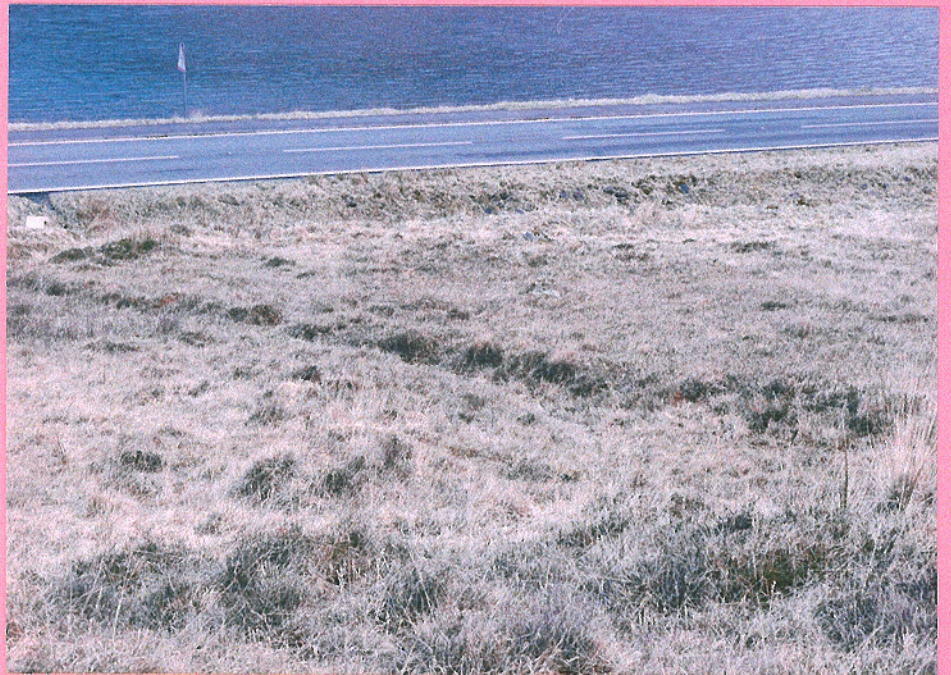
14

26. **centred on NG 9427 2002 Turf Dyke** This low turf dyke runs SE from the road, clearly visible across the low ground but cannot be followed on the higher ground. The aerial photograph suggests that the dyke extends SW along the higher ground and curves back towards the shore to form an enclosure or head dyke. **(Photo no. 14)**

Recommendations: This dyke will be broken through by the pipeline, but it is not considered that any action is necessary beyond recording the location of this feature.

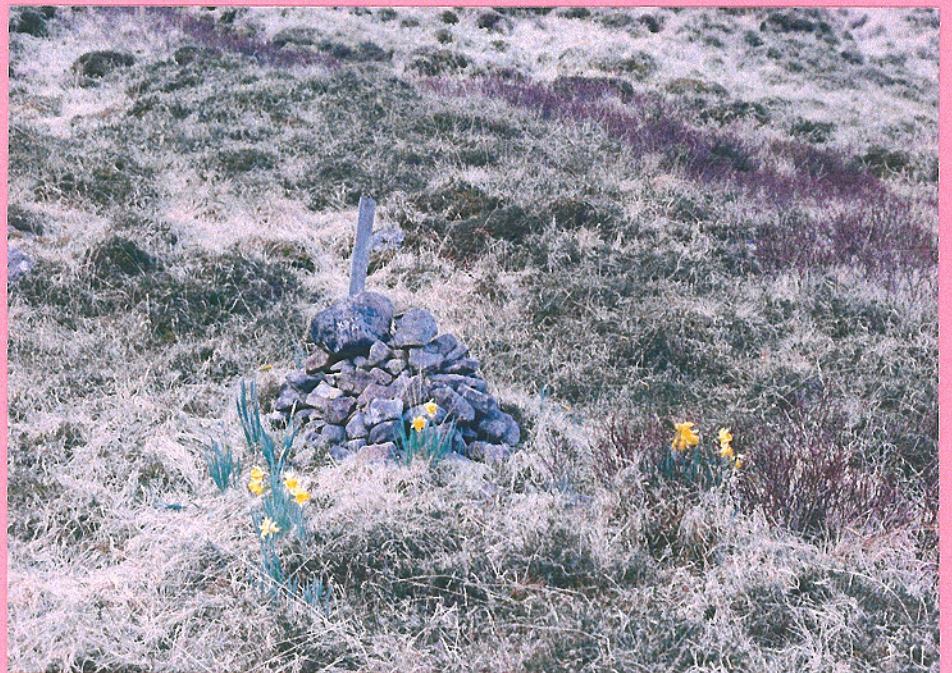
15

27. **NG 9431 2004 Memorial** A low pile of rubble topped by a wooden post. An inscription painted on one stone dates the memorial to 1949. This feature is about 15m. up from the road. **(Photo no. 15)**

Recommendations: This feature should be far enough away from the proposed route of the pipeline to be unaffected.
