**AN ARCHAEOLOGICAL WATCHING BRIEF AT THE SITE OF THE
PROPOSED NEW SEWAGE TREATMENT WORKS, NORTH
BALLACHULISH**

Wordsworth Archaeological Services
4 Balbeg, Balnain, Glenurquhart
Inverness-shire IV3 6XQ
(tel 01456476 288)

As part of the planning consent for the construction of a new sewage pipeline and treatment works for North Ballachulish, an archaeological condition was put on part of this project. This condition required archaeological supervision during the topsoil strip of the site of the proposed treatment works and part of the pipeline route. This report discusses the background to and the results of this work.

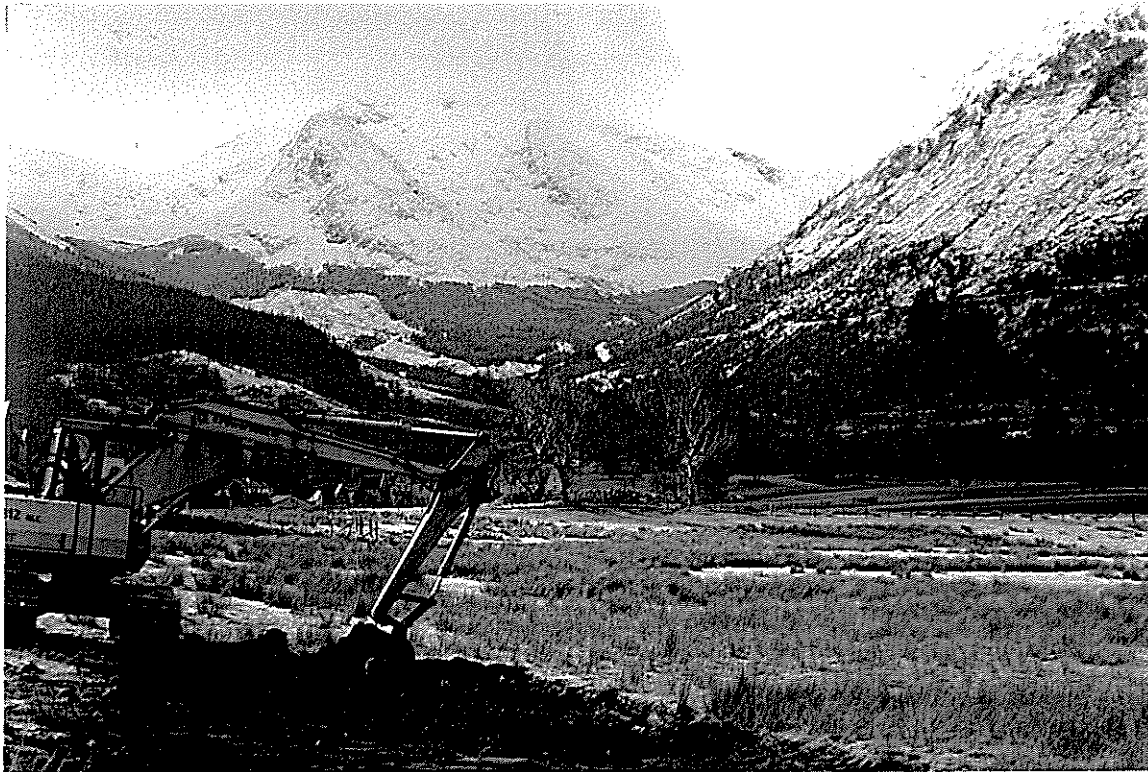
Fig 2 (i) **Stripping in Field 1 showing hollow excavated for road construction**
Looking South to *Carn Glas*

In the first field between Manholes 13 and 15 after the first 20 metres of iron panned surface a considerably disturbed subsoil was revealed. In discussion with local informants it became clear that considerable quantities of subsoil had been stripped from here to supply material for the new road. The contours of this field show a considerable hollow between the levels on either side (see **Fig 1**) and apparently this had previously been a near level terrace.

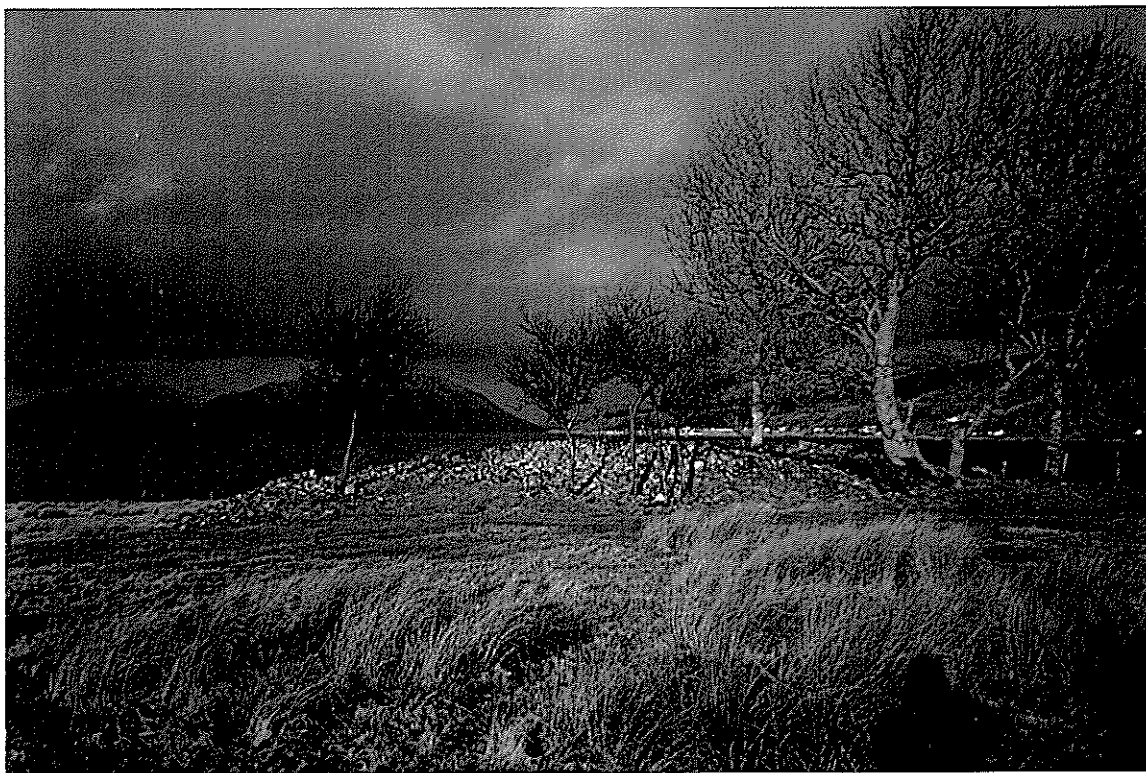
Fig 2 (ii) ***Carn Glas* as presently surviving**
Looking West

The watching brief was concentrated on two sides of a burial cairn, *Carn Glas*. This Scheduled Ancient Monument was badly mutilated in the 19th century when a local minister paid workmen to dig into the monument on its south west side. He reported finding a stone cist with calcined bones and ashes. The farmer also found a cist in digging into the cairn on the north east side. The present cairn is badly disturbed and was originally much larger as the same account dating to 1880 mentions that '*hundreds of loads of stone have been carted away for drain-making, dyke-building, road-making and piers.*'

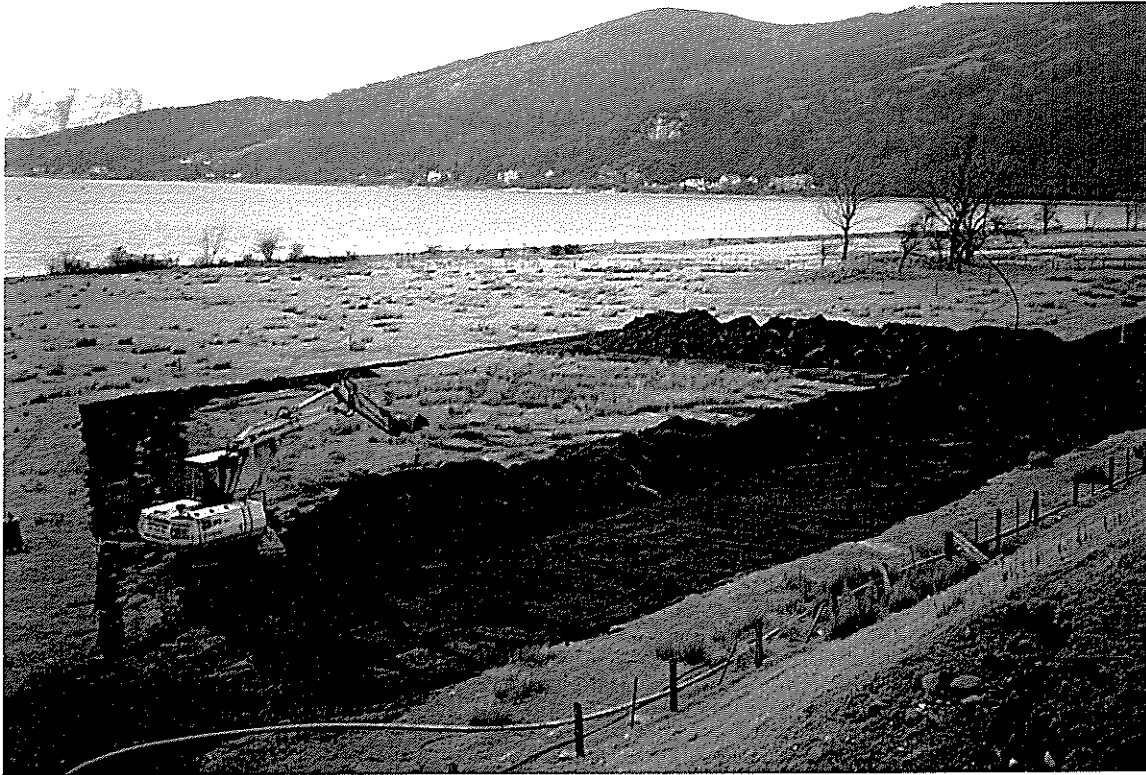
**Fig 3 (i) Extent of stripping on site of proposed Treatment Works
Looking West**

The majority of the treatment works site had been disturbed and this disturbance which included stone chips, rubber pipes, concrete had penetrated well down to the subsoil. The extent of this disturbance is shown on **Fig 1**. It was interpreted as a debris from the Ballachulish bridge and road construction camp operating from 1974-6. Because of this disturbance it was not considered worthwhile to strip the whole of the area of the proposed treatment works and work was limited to the area shown. The ground in this area sloped down from the terrace level with *Carn Glas* and there was a distinct gleying of the subsoil, making this area less suitable for settlement. Most of the gleyed material was removed but no

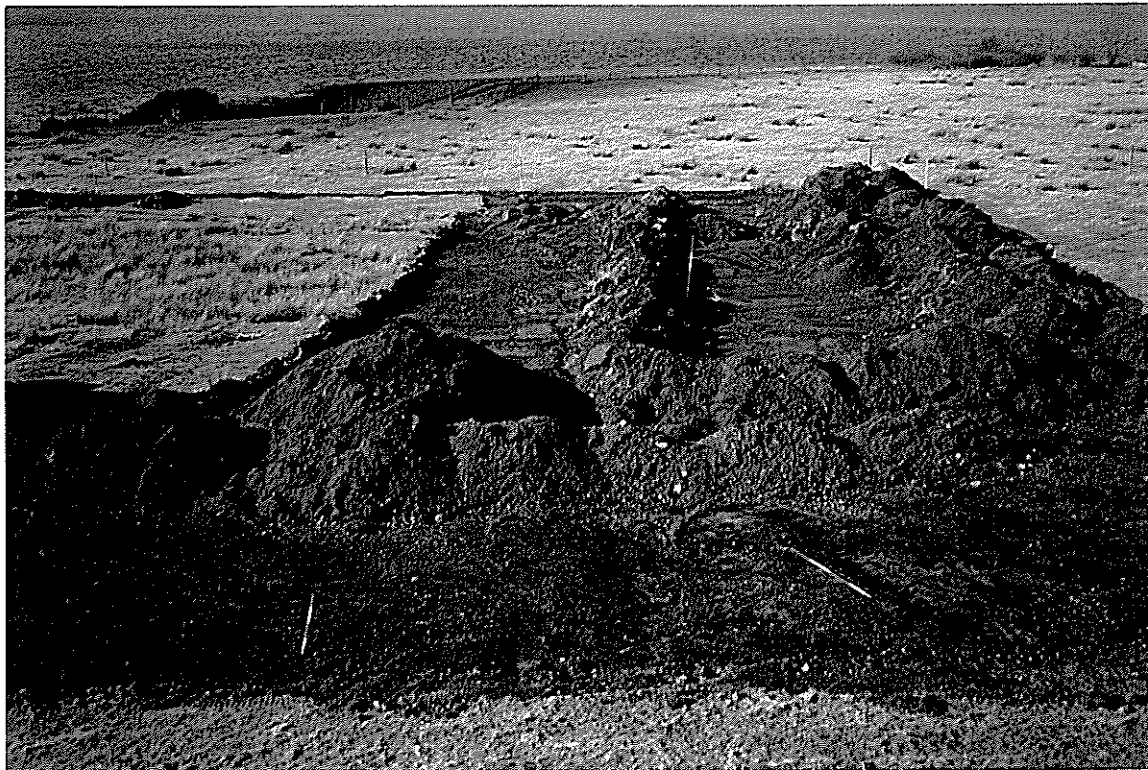
**Fig 3 (ii) Buried features, probably 19th century cultivation furrows, at site of
Treatment Works
Looking West**

In the area to the south of Manhole 15 the only features noted were three black gully fills in the north east corner of the treatment work site, as shown on **Fig 2**. These gullies were irregular in width, discontinuous and varied depth up to 60mm. They were c3.5m apart and were interpreted as the remains of rigs or lazy beds. Similar but much smaller deposits of leached black silts suggested that this whole field may once have been covered with rigs before the agricultural improvements of the mid to late 19th century. General Roy's Military Survey of 1747-56 shows no arable land in this area and so such rigs must date to the late 18th century. In view of the heavy iron-panning to be found here, raised beds whether of rigs or lazy beds would be a sensible method for dealing with the poor drainage.

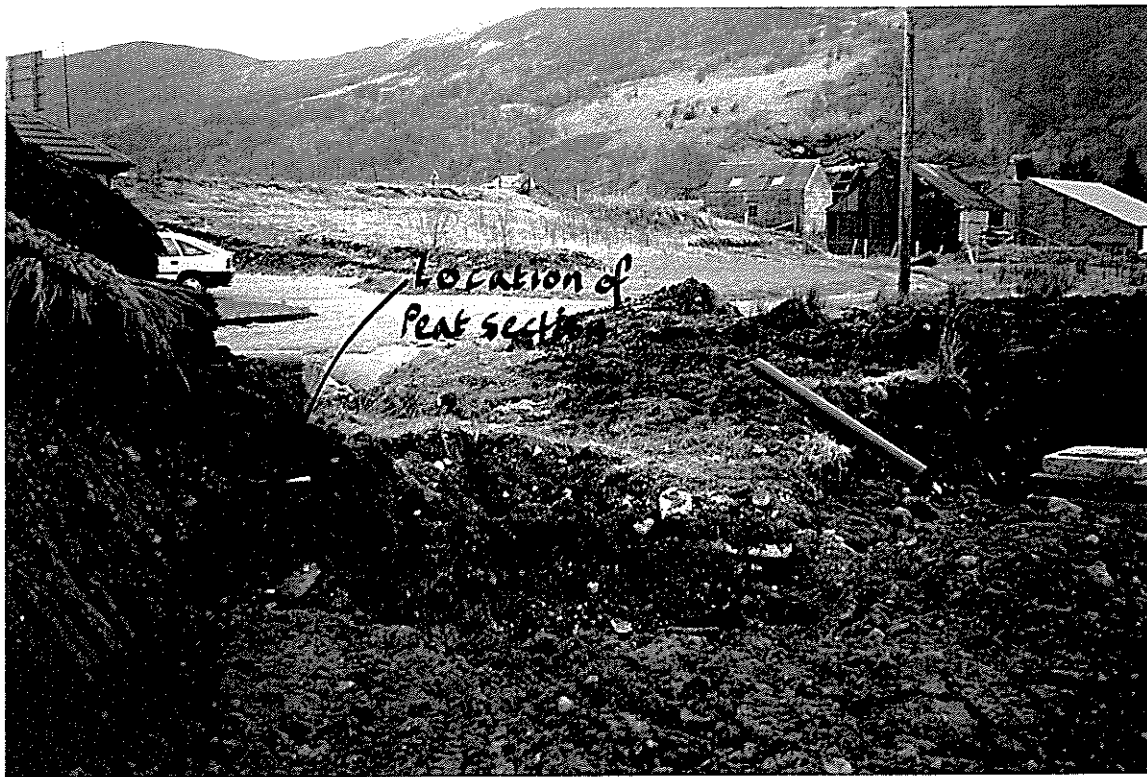
Fig 4 (i) **Location of peat section near Manhole 30A**
Looking North

Few other areas of the pipeline were still open to view, but a short stretch just south of Manhole 30A was open. A small deposit of peat 0.7m thick was exposed in section and from the upcast nearby 2 flint and 1 possible quartz flakes were found. They were in grey brown humic clay that lay below the peat and were probably stray finds. Examination of other pieces of upcast did not reveal any other finds and there was no obviously worked wood relating to this level, though a number of tree roots did survive. No samples were taken other than the flints because the contexts were unreliable.
