**Forestry Survey: Langwell - Rinsary Braes, Berriedale,  
Caithness**

WGS ref no 030/002127

**Stephen Carter & James Rideout**

**3 March 1999**

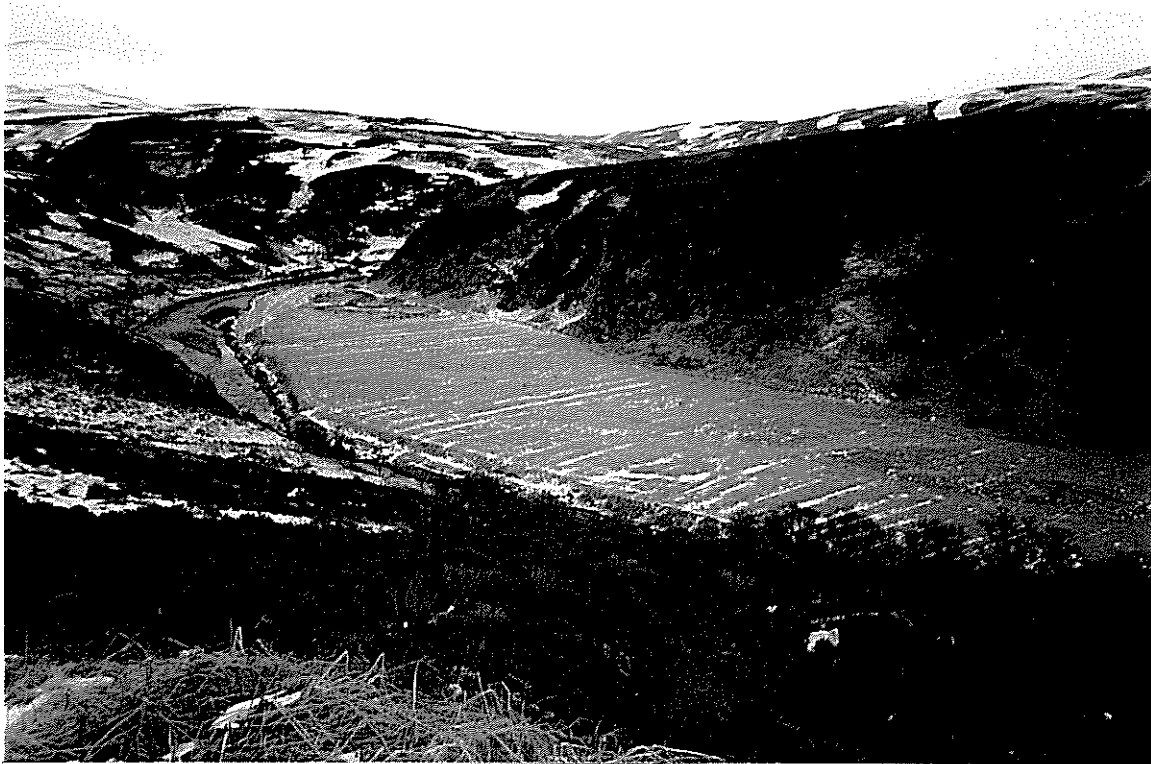
**Description:** A compact settlement with adjacent ridged fields (Plate 1). The settlement comprises five principal long houses (1a to 1e on Figure 2), two smaller rectangular buildings (1f and 1g), a kiln barn (1h) and attached enclosures. The adjacent river terraces are extensively ridged; ridge width varies between 4 and 9 m and more than one system appears to be superimposed. Roy (1747-55) records a settlement at this location named *Allandonagg* which corresponds with *Allandoninn* on Arrowsmith's map (1807). The settlement is mapped in its present deserted condition on the Ordnance Survey 1<sup>st</sup> Edition 1:10,560 map of 1871 but it is now named *Dailyoich*. The representation of the structures in Figure 2 is based on Ordnance Survey mapping supplemented by field notes.

**Condition:** The rubble walls of the settlement survive up to 1.5 m in height, they are apparently stable with no evidence for recent collapse and there is a complete cover of grassy vegetation surrounding the walls. Recent disturbance is limited to the cutting of a vehicle track from the bridge over the Berriedale Water to the north of the settlement through the north end of the field wall.

Plate 1: Langwell - Rinsary Brae WGS Site 1, Township of Dailyoich. General view from the south with the township in the background.

**Marking out:** Only the settlement core was marked out with bamboos roughly 20 from the limit of the structures. No bamboos were placed along the east side where the slope rises sharply beside the settlement.

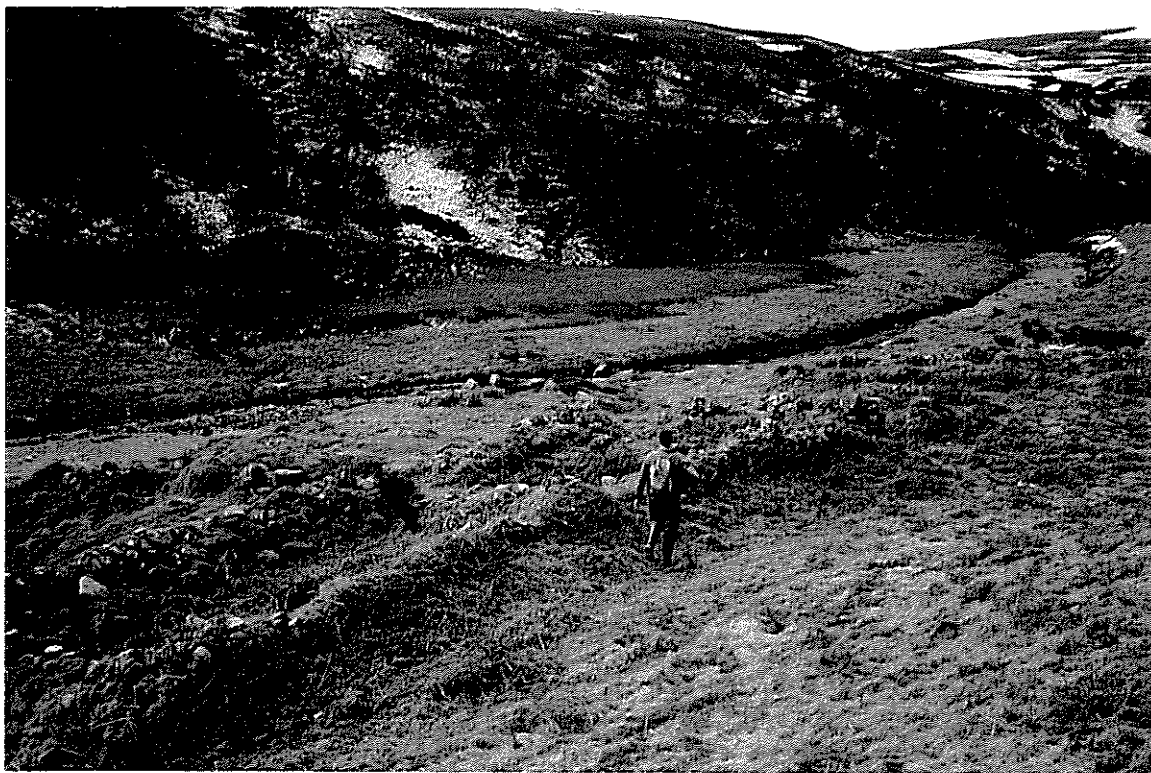
**Description:** A settlement on a prominent rocky knoll with adjacent ridged fields (Plate 2). The settlement comprises three principal buildings, a kiln barn (4b) and attached enclosures. There is an isolated square enclosure to the north-west of the settlement (4a). The adjacent river terraces contain areas of ridged field. Roy (1747-55) records an unnamed settlement at this location but it is named by Thomson (1822) as *Knockfin*. The settlement is mapped in its present deserted condition on the Ordnance Survey 1<sup>st</sup> Edition 1:10,560 map of 1871 and named *Cnoc Fionn*. The representation of the structures in Figure 2 is based on Ordnance Survey mapping supplemented by field notes.

**Condition:** The rubble walls of the settlement survive up to 1.0 m in height, they are apparently stable with no evidence for recent collapse and there is a complete cover of grassy vegetation surrounding the walls.

Plate 2: Langwell - Rinsary Brae WGS Site 4, Township of Cnoc Fionn. General view from north-east.

**Marking out:** Only the settlement core was marked out with bamboos roughly 20 from the limit of the structures. This places them at the foot of the knoll on which the settlement is situated.

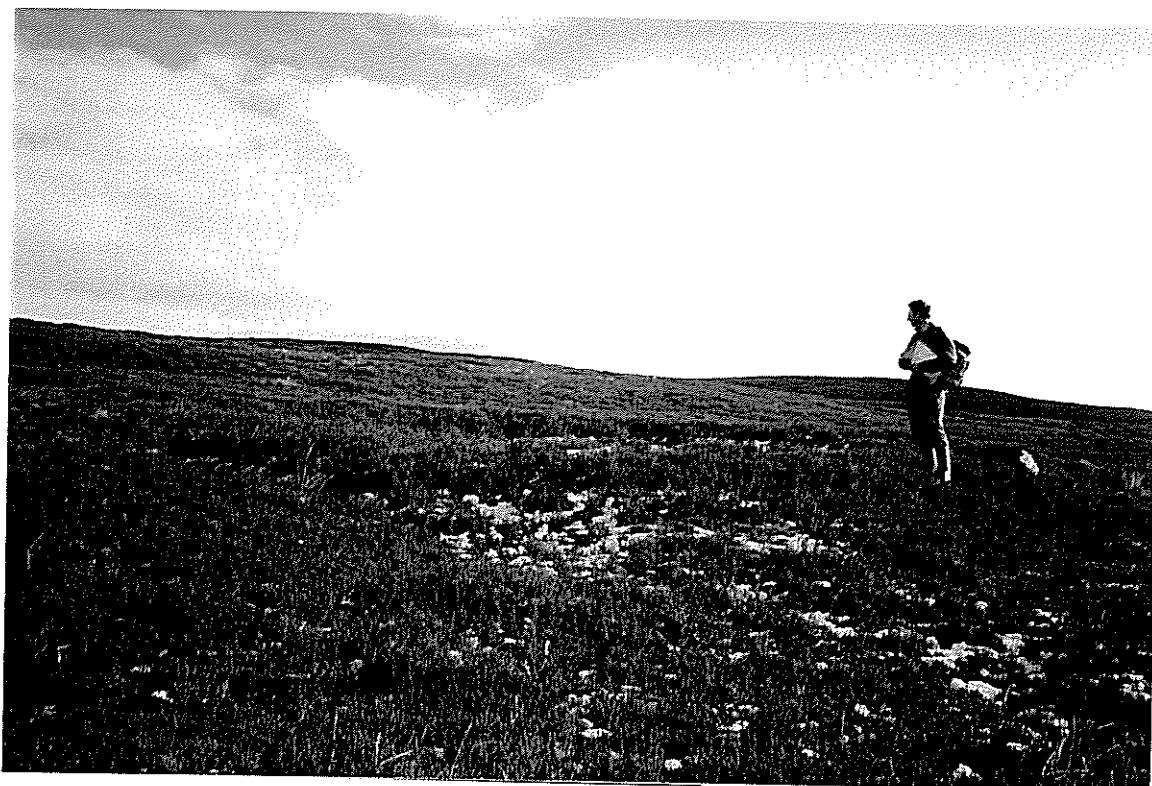
- 2a 12 x 14 m oval building with entrance to south
- 2b 12 m circular building with entrance to south (Plate 3)
- 2c 11 x 13 m oval building with entrance to south
- 2d/e 11 x 13 m oval building (d) partially overlain by a possible smaller structure (e)
- 2f 8 m circular structure with set stones visible in inner wall face, entrance to south-east
- 2g 9 m circular structure with no visible entrance

**Condition:** All structures have a continuous cover of low heather with only a few stones projecting (particularly in 2f). There is no evidence for recent disturbance (Plate 3).

Plate 3: Langwell - Rinsary Brae WGS Site 2, prehistoric settlement and field system. Building 2b from west

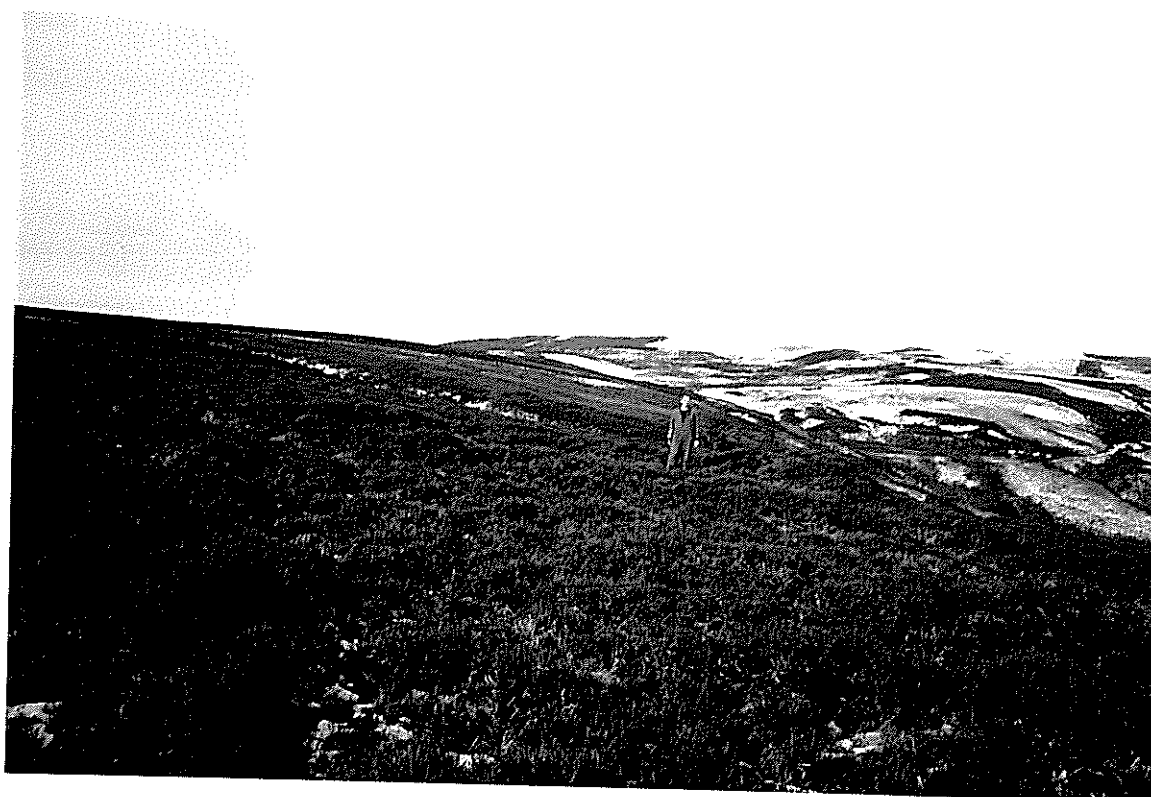
**Description:** This site was found to be as described in earlier reports although additional features were noted. There are three prominent oval prehistoric buildings (5a to c) at the locations noted in NMRS (Plate 4). A fourth building (5d) was identified during the present survey as a well-defined semi-circular platform, 12 m in diameter, bisected by a drystone dyke of the improved fields of Langwell House. There was no visible trace of the other half of the platform within the field. A total of eleven cairns were plotted for the first time, most lying between buildings 5a and 5b with only two to the north of 5b. Building 5c appears to be isolated, without any cairns nearby. Note that only two buildings have been scheduled: 5a (SAM 3559) and 5b (SAM 3537).

**Condition:** With the exception of 5d, all structures were stable with a complete cover of rather rank heather (Plate 4). 5d is traversed by a deer fence and animal tracks, following the fence, have created eroding paths across the platform.

Plate 4: Langwell - Rinsary Brae WGS Site 5, prehistoric settlement and field system. Building 5a from south-east with figure in interior.

**Marking out:** Bamboos were used to mark out the north-east side of this site, running along the top of the steep slope from 5d along to the gully north-west of 5b. The western limit of this site, which lies out of area, was not marked.

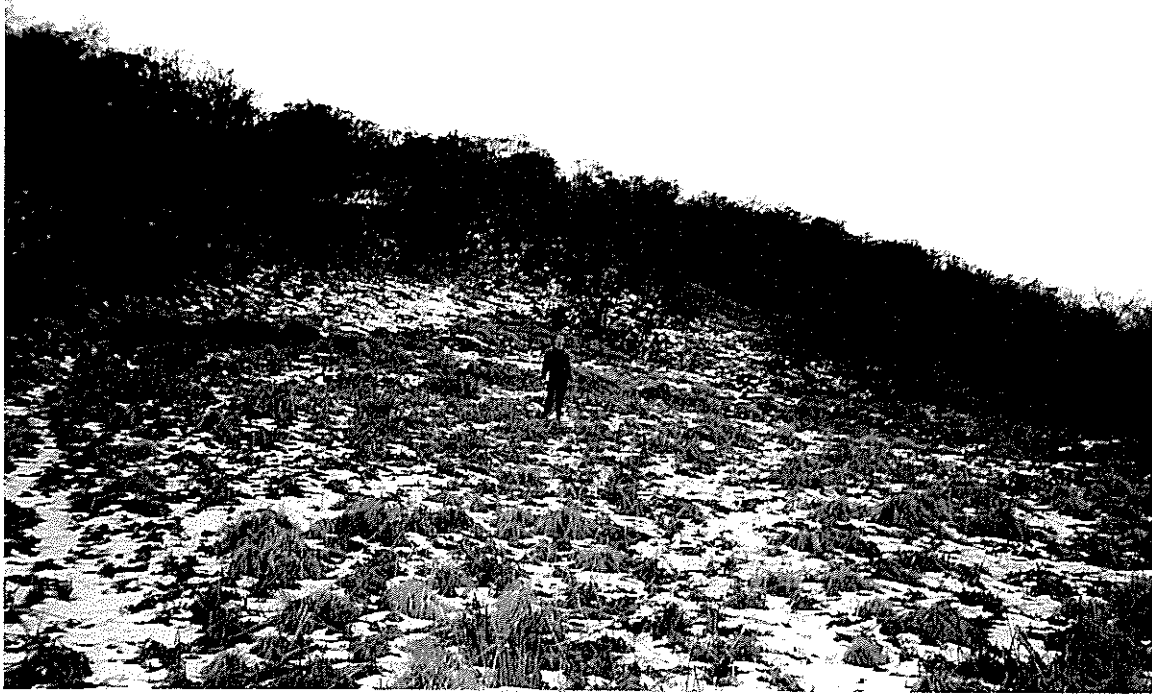
**Description:** A small farmstead comprising two attached rectangular buildings and an enclosure on a moderately sloping site above the river flood plain (Plate 5). The buildings survive as low rubble footings, the larger is 18 x 4 m and is upslope from the smaller which measures 12 x 3 m. The buildings are shown as roofless ruins on the OS 1st edition map surveyed in 1871 and the plotting of this structure in Figure 2 is based on OS mapping supplemented by field measurements.

**Condition:** The wall footings are in a stable condition with no evidence for recent disturbance. The area surrounding the farmstead is heavily infested with bracken.

Plate 5: Langwell - Rinsary Brae WGS Site 8, farmstead. Buildings viewed from the east with figure in front of east wall.

**Marking out:** The farmstead was marked out with bamboos and tell-tales on trees roughly 20 m from the visible structure.

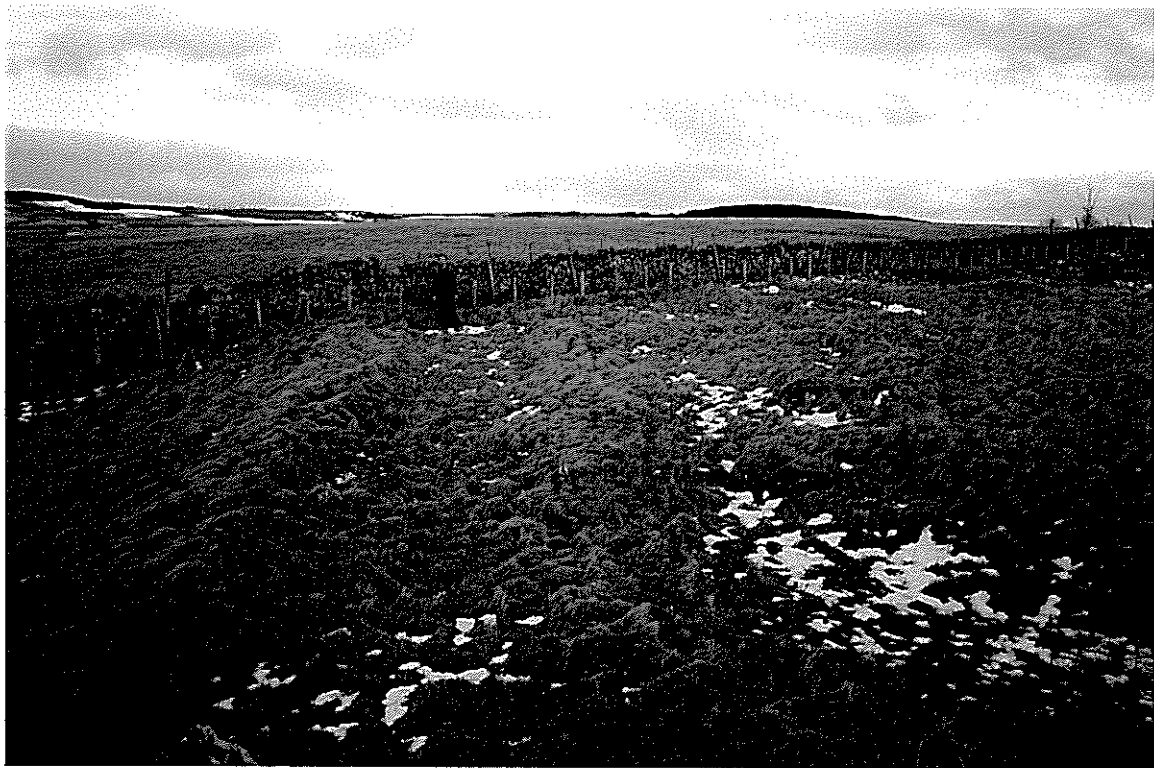
**Description:** A complex cluster of structures built around the remains of a broch (11a) which is the only scheduled element of the group. No structural details of the broch are visible except for the outer face which can be traced for over half of the circumference with an approximate diameter of 15 m. To the east of the broch, on the level ground between it and the modern wall, are the remains of a farmstead comprising two rectangular structures linked by a bank (Plate 6). The larger structure (11b) is 26 m long and 5 m wide and its west gable is formed by the outer face of the broch, the smaller structure (11c) is apparently 12 x 4 m although its original length may have been greater. The walls are entirely turf covered with no stone visible and no more than 0.4 m high. On the south-west side of the broch there is a kiln barn (11d) dug into the side of the broch mound; to the south of this there is a rectangular drystone enclosure (11e), 25 x 13 m maximum dimensions. This enclosure is mapped on the OS 1st edition survey of 1871 and along with the kiln appears to be of 19th century date; the turf covered remains of the farmstead are not mapped and appear to be significantly older.

**Condition:** There is a rectangular depression, roughly 5 x 3 m, in the south-east sector of the broch wall which appears to be the result of stone robbing but not in the immediate past; there is also a recent cairn built over the south side of the broch wall adjacent to the kiln. All walls of the farmstead (11b and 11c) are stable and completely covered with a grass turf. A modern fence and dyke crosses over the east end of the buildings. The kiln and adjacent enclosure

(11d and 11e) appear to be stable with no evidence for recent disturbance.

Plate 6: Langwell - Rinsary Brae WGS Site 11, broch and farmstead. View from top of the broch looking east along the larger rectangular building 11b (figure at east gable).

**Marking out:** This group of features was marked out as a single area with bamboo canes positioned roughly 20 m from the visible structures except to the north-east where the modern fence marked the limit of the area..
