Excavations at the
Deserted Settlement
of
Easter Raitts, Badenoch

1998 Interim Report:
Structures 6, 21, 26 and 15

Olivia Lelong

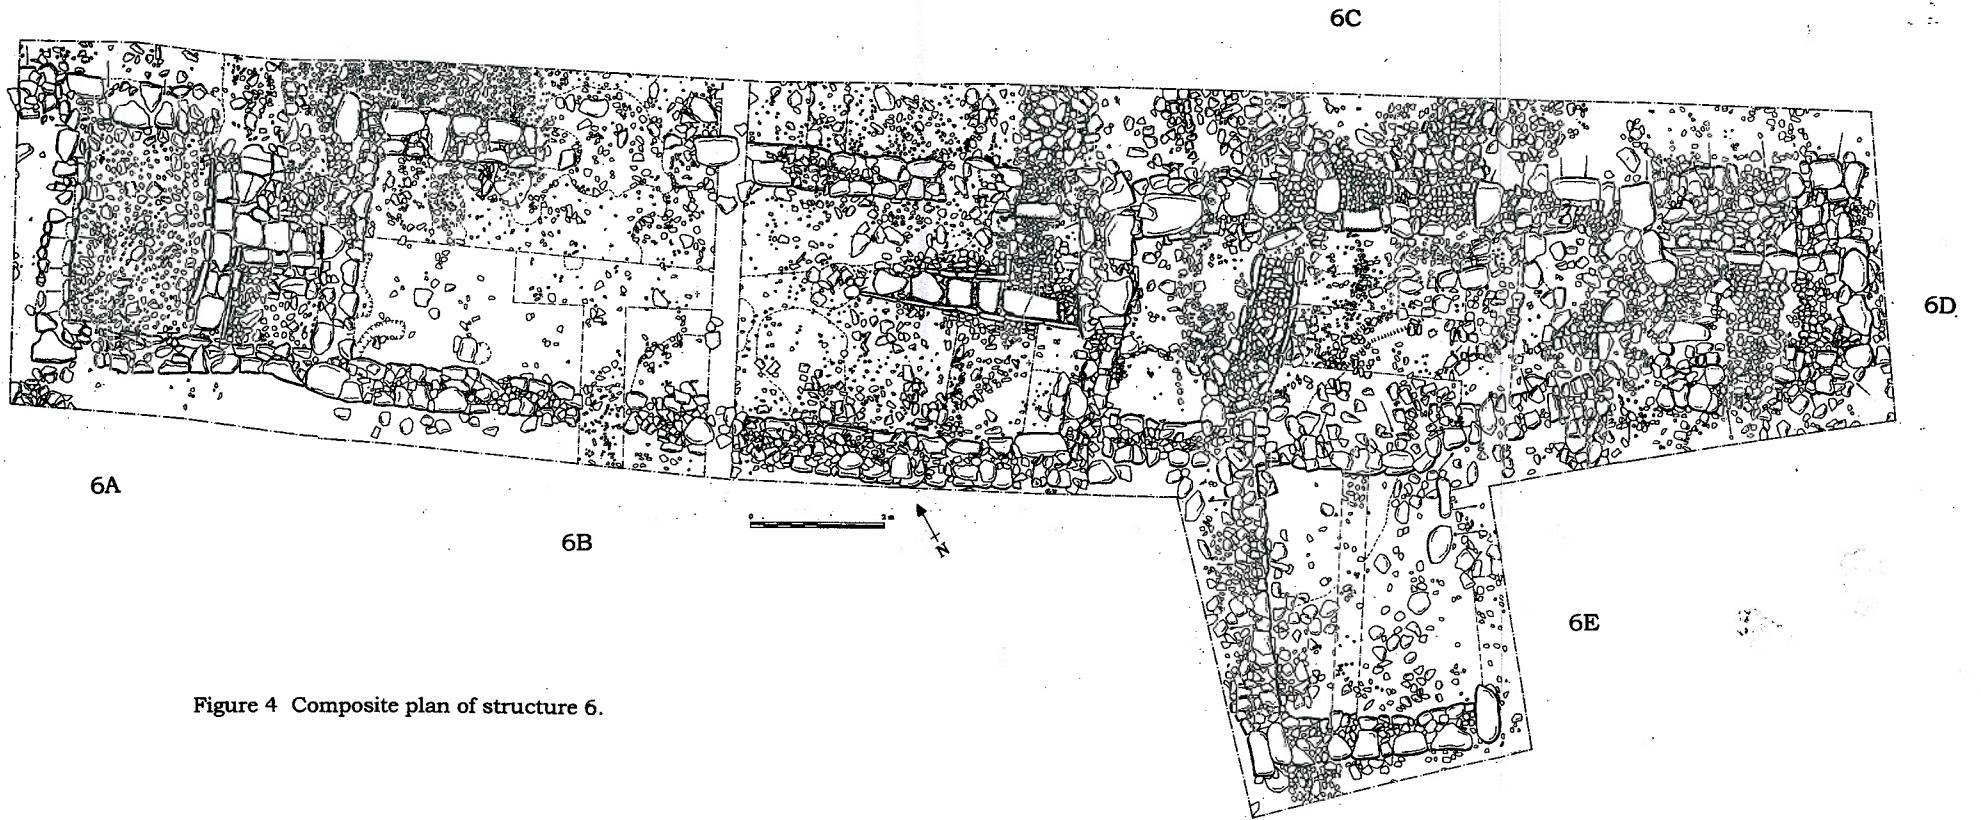
Figure 4 Composite plan of structure 6.

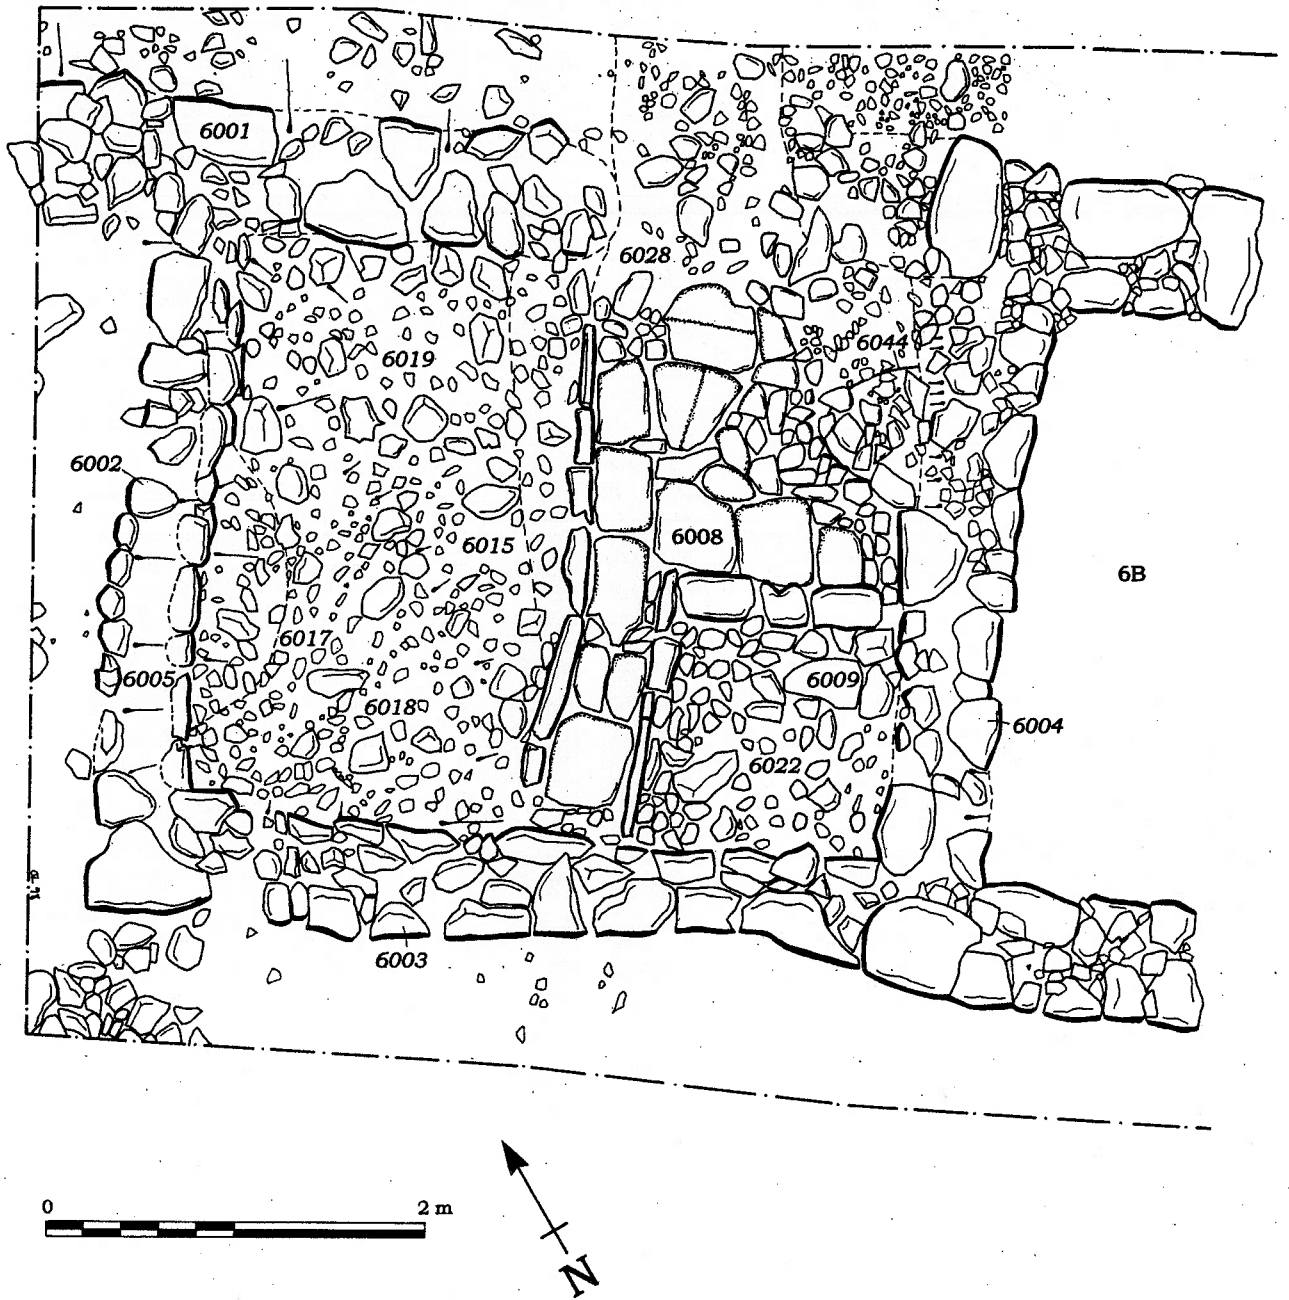
Figure 5 Plan of area 6A.

The entrance led onto a linear stone feature (6008) dominating the interior, with areas of cobbling on either side. It was defined on the east and west by brick-shaped stones set end-to-end on edge to form a raised margin to the flagged floor. The flags themselves were closely set and well worn at their edges. Grooves, apparently pecked out, ran across two flagstones, one running east/west across the threshold stone and the other running north/south across the adjacent flag to the south (see Figure 5). The former was interpreted either as having been worn by a door, habitually closed to the edge of the groove, or (given the apparent pecking) having been scuffed out by hooves as cattle passed in and out of the doorway. The latter groove was less explicable; it might have been deliberately pecked out to aid drainage toward the doorway, although it did not lead directly to a sump or outlet of any kind. It is possible that one or both stones were re-used here from an earlier floor elsewhere, and that the grooves had other origins.

The western part of the interior was covered with rough cobbling (6018), composed of irregularly-spaced, rounded stones lying in sporadic patches, the surface sloping down toward the central paving. They lay in a trampled, mid brown sandy silt (6019) with darker brown patches suggesting organic enrichment. In these deposits, associated with the cobbles, were found a few sherds of post-medieval pottery and an iron nail. The cobbles had been set into a gritty, red-brown sand and gravel deposit provisionally interpreted as the natural subsoil, although not excavated; the CFA evaluation had concluded this material was the subsoil (Cameron 1995). Deposits of mottled, light to dark brown sandy silt (6015) and compact, greasy dark brown silt (6017) lay along the east and west sides of the cobbled area, respectively, above the cobbling. These were both interpreted as remnants of occupation deposits, probably manure. The sandy silt (6015) might have been laid over the cobbles and later disturbed and mostly removed by mucking out, except for remnants trapped against the edge of the linear stones; the greasy dark brown silt (6017) may have been remnants of manure not completely removed along the west side, where it would have been more difficult to clear away from the inner wall face.

In the south-east corner of Area 6A was a roughly square area of cobbling, 1.6 m across and also defined by the linear stone margin of the flagged floor, forming a kind of stand. Upon it, a sandy deposit (6021) lay in a wedge against the south wall and partly sealed a compact, greasy brown silt with charcoal flecks (6022) which lay above and around a layer of cobbles (6009), concentrated along the western half of the square. A piece of bottle glass was found among them. The cobbles had been set into a compact, grey-brown sandy silt with diffuse dark patches (6031), possibly trampled around the cobbles. This in turn overlay a red-brown silty sand with sparse, sub-rounded stones (6032), apparently an earlier surface.

In the north-east corner of Area 6A, the flagged floor gave way to cobbling, overlain by at least two phases of greasy, organic-rich silt (6023 and 6024), both of which lay in wedges against the east wall (6004) as if they had been swept or shovelled off the flagstones. Beneath these, on the cobbles, lay a three-pronged, wrought-iron digging fork, with one prong broken off and missing (SF 1085). The fork is similar to one at Kingussie Museum, and probably is nineteenth century in date (B Powell, pers comm).

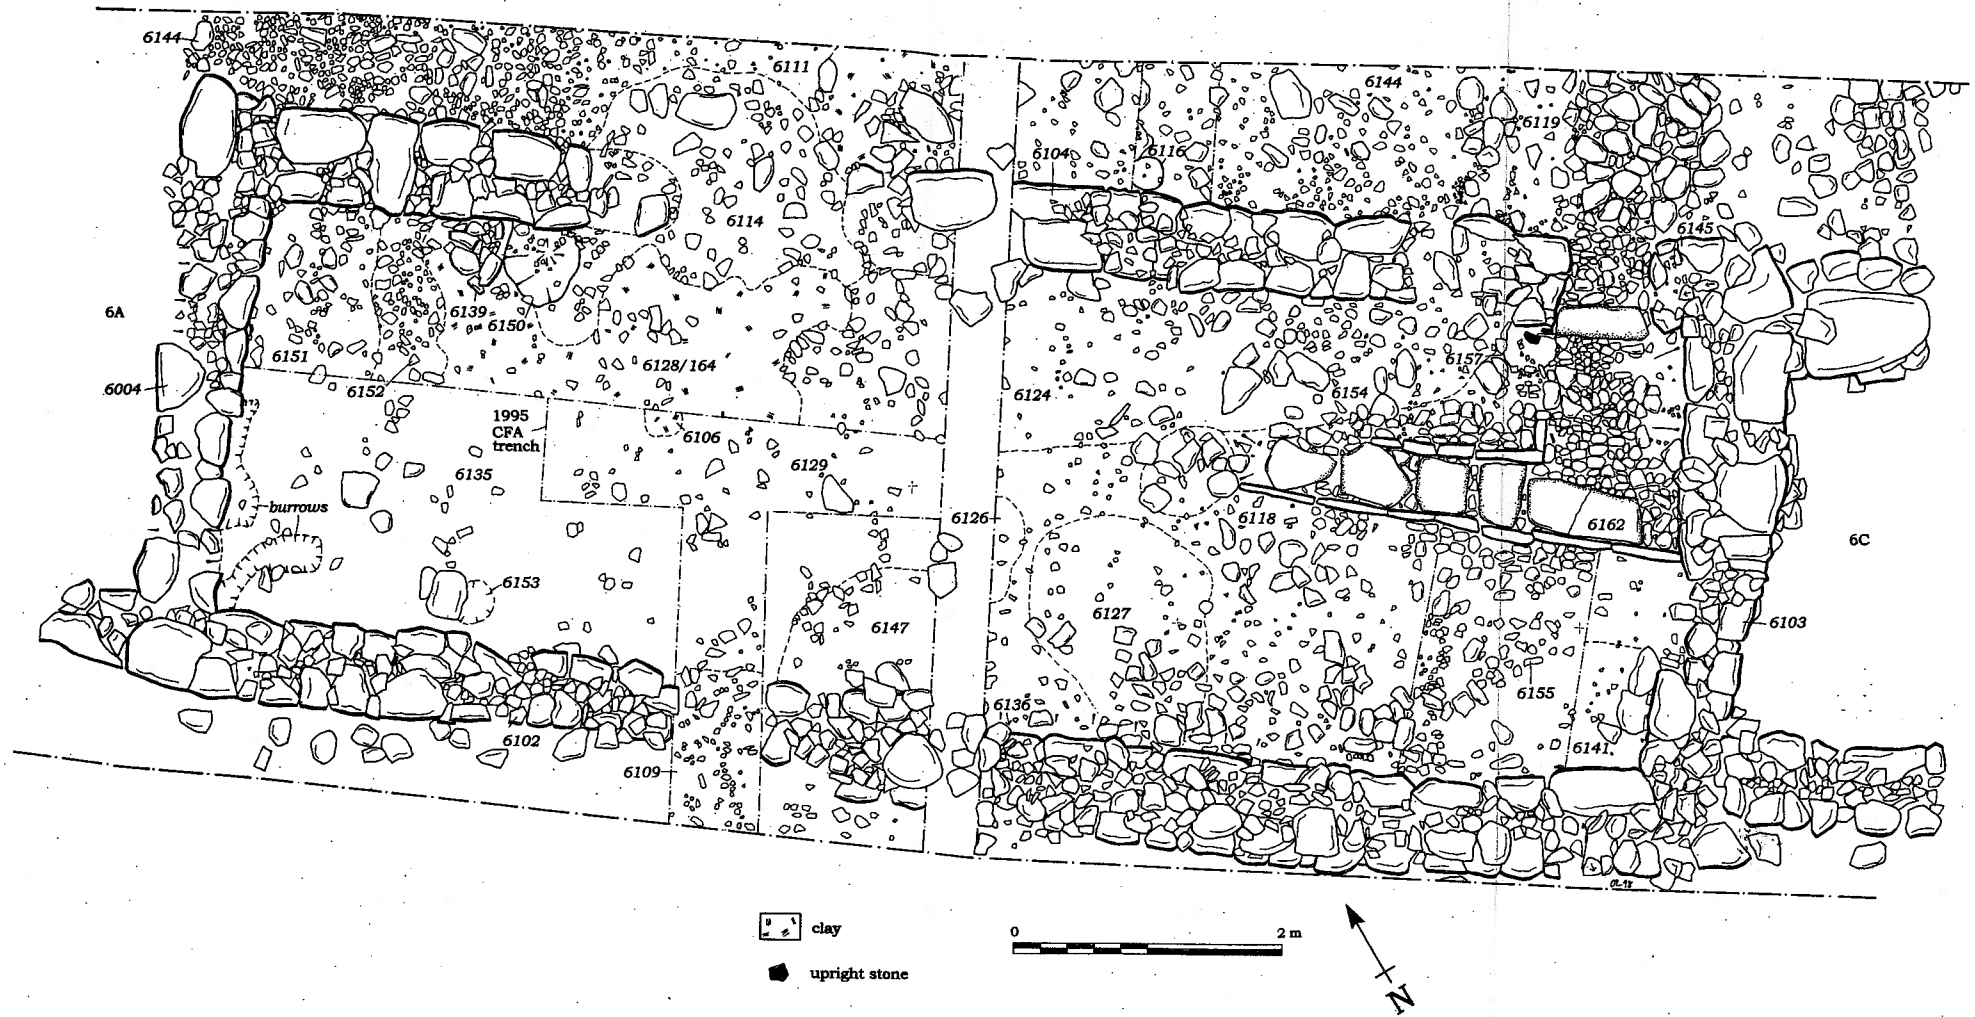
Figure 6 Plan of area 6B.

The underlying floor layers in the western interior were investigated through excavation of the northern part, with a running, north-facing section maintained across it. At the west end, the trampled silt (6135) covered a band of fine, compact, dark brown silty sand flecked with charcoal, clay and humic material, and containing many small stones. This silt lay in a band c 0.5 m wide along the west wall, and a section across it proved it filled a steep-sided hollow there. A piece of clay pipe was found in it. It was abutted on the east by a layer of cobbles; these extended across the interior in a swathe c 0.6 m wide. They were set or trampled into the natural subsoil.

In the centre of 6B's interior, east of the north/south baulk left in place throughout the excavation, a deposit of relatively clean, light yellow-brown fine sand (6124) covered much of the northern part, lying in hollows in the red-brown sandy subsoil. This appeared to have been laid to level up the surface of the subsoil; that the latter was exposed and uneven suggests it had been worn down through the use of the building, and that the sand had perhaps replaced earlier floor deposits which had worn away. The sand extended eastward to the edge of a cobbled surface and southward from the north wall, stopping at the edge of stone setting 6140 and in line with the stone-lined drain (6118)

That the area to the south of the drain was deeper, and that its cobbles appeared to have been replaced sporadically over time and were more disturbed toward the wall, suggested that animals had been tethered here -- probably horses or cattle, given the depth of the area (1.83 m from wall to drain), although see the discussion below (section 7.1). Their hindquarters must have been over the linear stone feature interpreted as a drain, which in its original state would have made mucking out easy.

Outside the well-worn threshold stone, more cobbles (6119) led out through the entranceway and formed a cobbled approach to the entrance; one sherd of post-medieval pottery was found among them. Notably, several of the stone footings of the wall (6104) at the west edge of the entrance stood out visually because of the large amounts of white quartz in them. These might have been chosen especially for this position, to highlight the entranceway if the interior were poorly lit.

Evidence for a door post was found in the form of a setting made of angular stones set on edge around a roughly square gap, 0.15 m across and floored with tightly packed stones (6145); it had been built into the wall footings along the east side of the entrance. Another post-hole lay just inside and to the west of the entrance. Framed by angular, upright stones set on edge, this proved to be a very shallow cut filled with dark brown silt (6157) and floored with a compact, red-brown silty, stony sand (6156) which appeared to be the dirty, exposed surface of the subsoil. Given its similar position (against the wall) to the cruck pads found in the western part of 6B, it may have been a cruck setting, with the cruck founded on a stony base and supported by stones wedged around its edges.

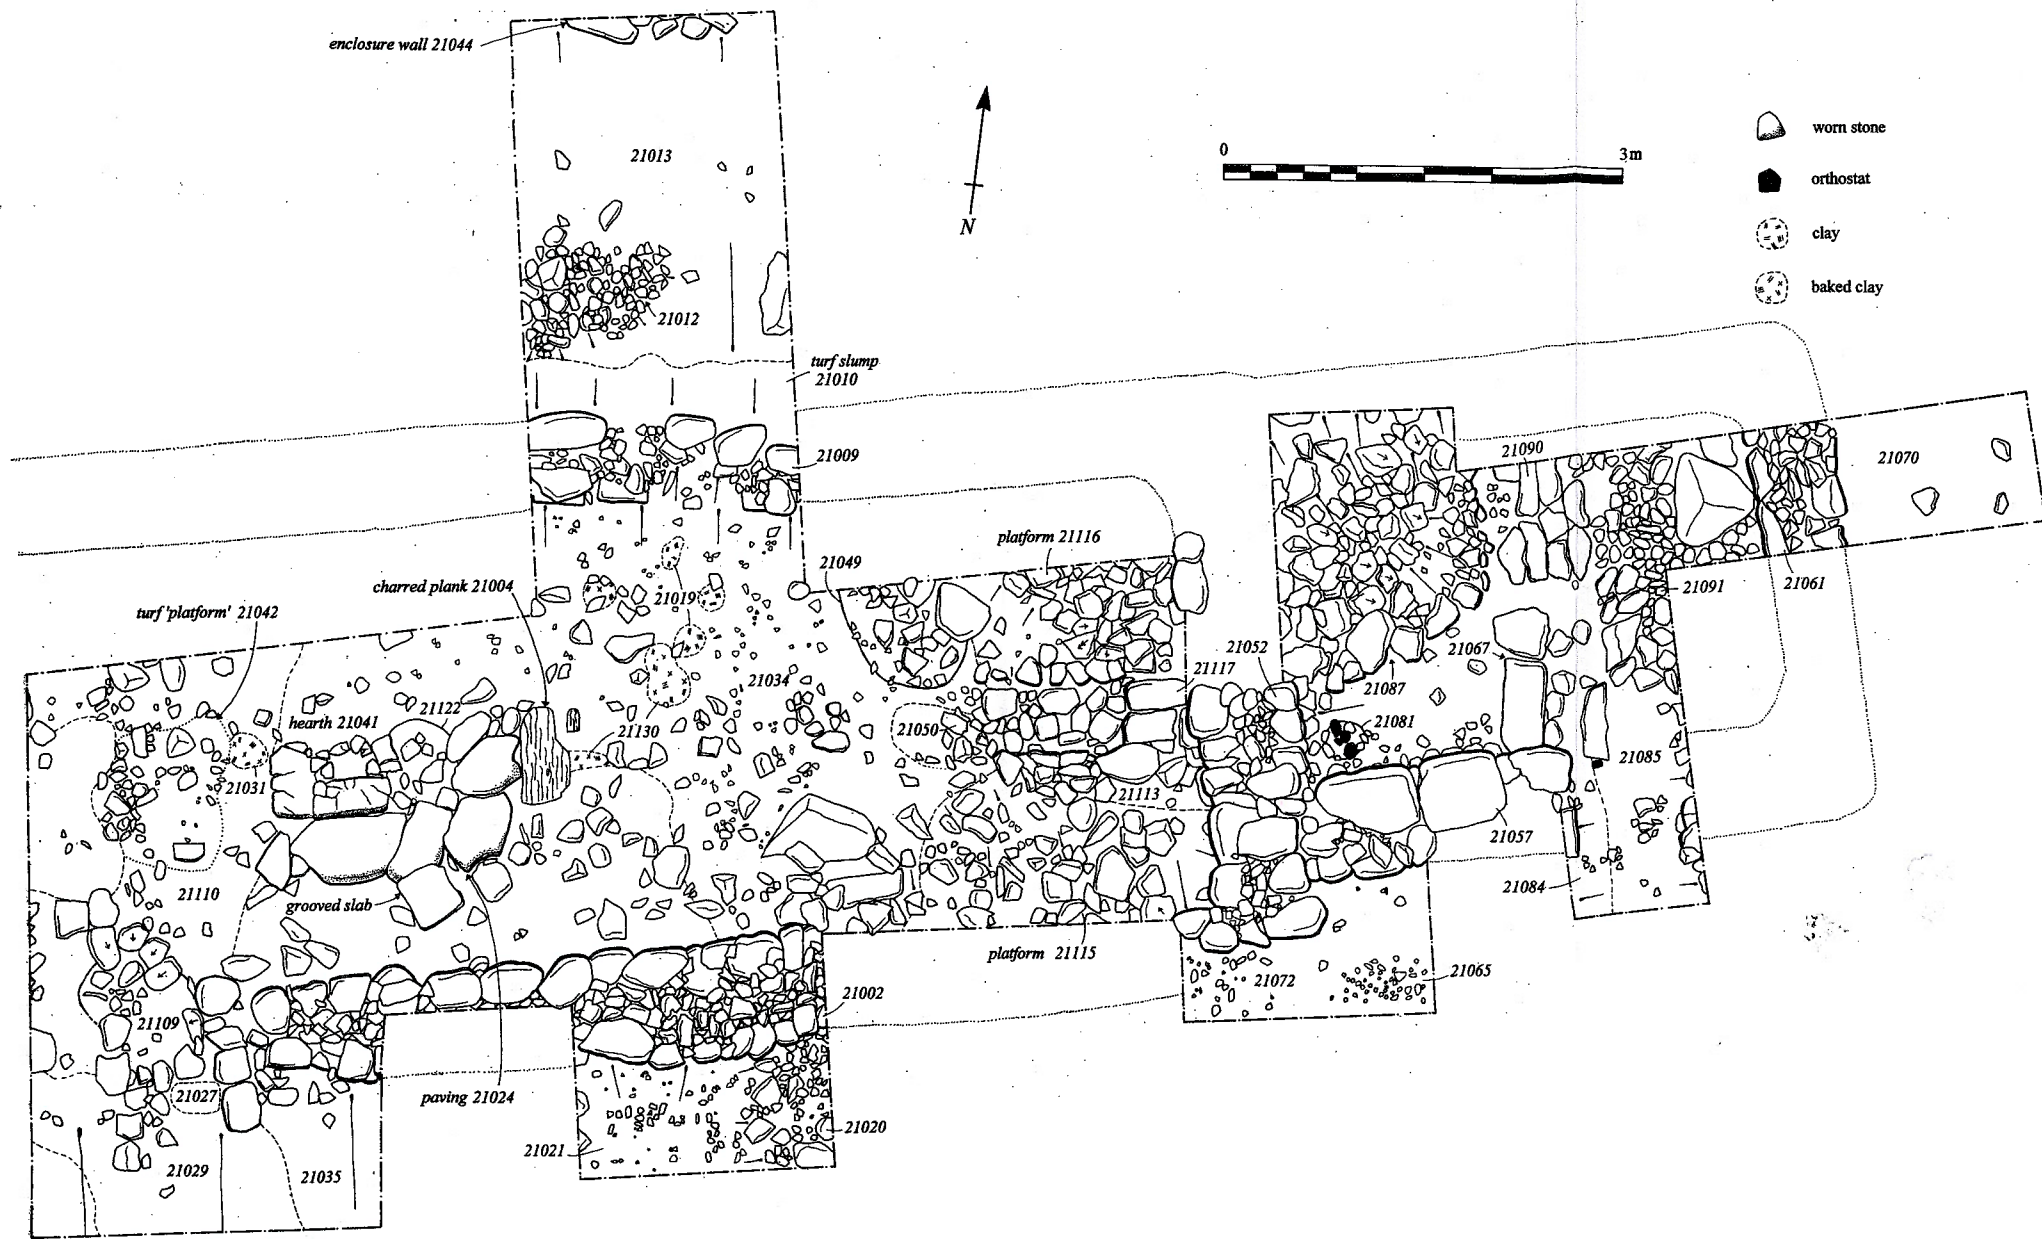
Figure 12 Plan of structure 21 (later phase).

The longhouse measured c 13.3 m long (east/west) by 3.4 m wide internally. It was divided into two parts: a main living area to the west, 8.9 m long internally, and a small annexe at its east end, 3.6 m long, with a separate entrance. All of the internal deposits were sealed by a layer rich in rubbish (21039), including many pieces of broken pottery, discarded iron implements, some fragments of what may have

In the eastern byre annexe, 21B, two phases of flooring were identified in 1997. The upper one consisted of a compact, greasy, grey-brown silt (21085) which covered the centre of the interior and lay around an area of cobbling (21091) and paving (21090) to the north and against a large, flat stone step (21067) to the west, just inside the entrance. This floor sealed an earlier one of gritty yellow clay sand (21086) in the central interior. In the south-west corner, above the stone step, the floor had been worn away to the gravely subsoil below the base of the wall footings, which had then been propped up with small stones (21092). A post-hole (21081) was found in the south-west corner, and another (21088) at the west edge of the hollowed entranceway, cut into the earlier, yellow clay floor.

In the north-west corner were the remains of a curving, drystone structure, formed of sub-rounded boulders (21087), which had collapsed inward upon a deposit of light brown sandy loam (21088) with lenses of charcoal. Below the loam was a sloping surface of orange-yellow clay-rich sand (21153). Set into this was a curving band of cobbles which lay directly below the outermost boulders of the collapsed structure. Large pieces of post-medieval pottery, including fragments of a teapot, were found among the tumbled stones -- a post-abandonment dump.
