An archaeological watching brief.

**DRUMBUIE**

## **ARCHAEOLOGICAL WATCHING BRIEF. DRUMBUIE SEWER, SEPT. 1996.**

An archaeological watching brief commissioned by The National Trust for Scotland in advance of the excavation of a new branch sewer. The site works being carried out for Mrs Charlene MacLeod of Drumbuie. ( NG 7755 3115 )

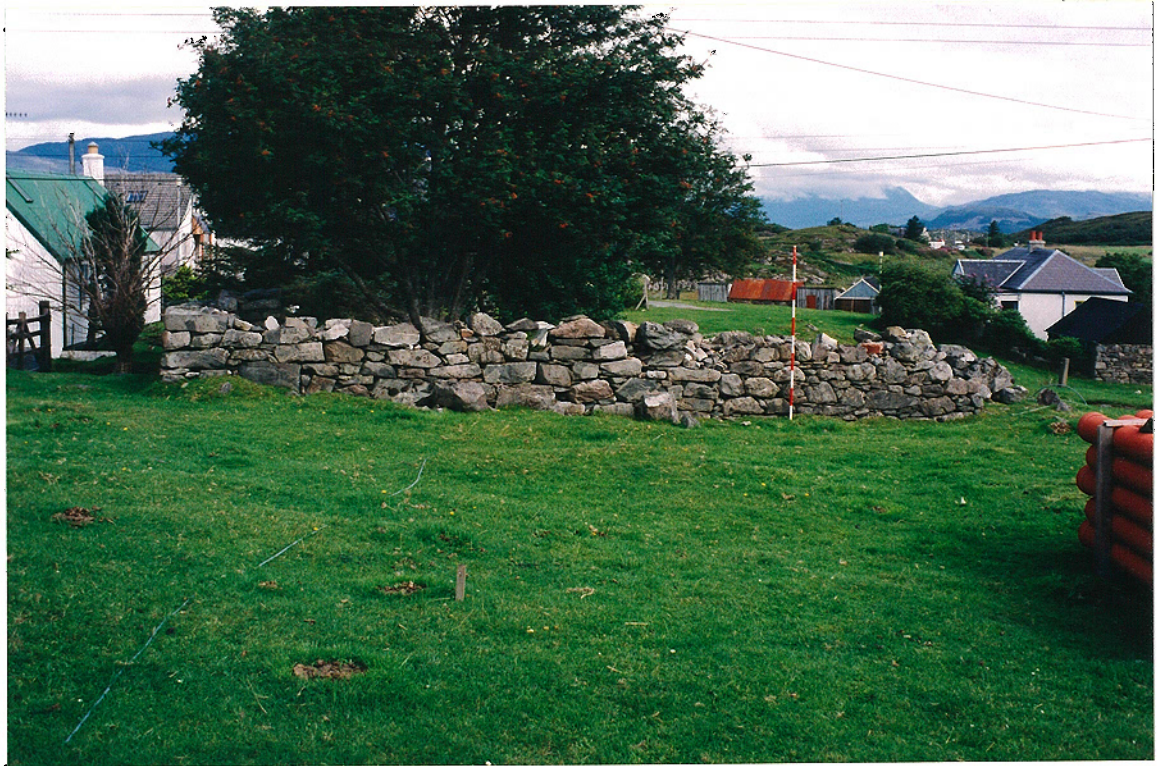
1. During the dismantling of the walls of the ruin it was noted that the bottom course rested directly on the old ground surface. There was no construction trench or prepared foundation.

1. **Drumbuie.** The ruin before dismantling of the walls. (scale = 2 meters)

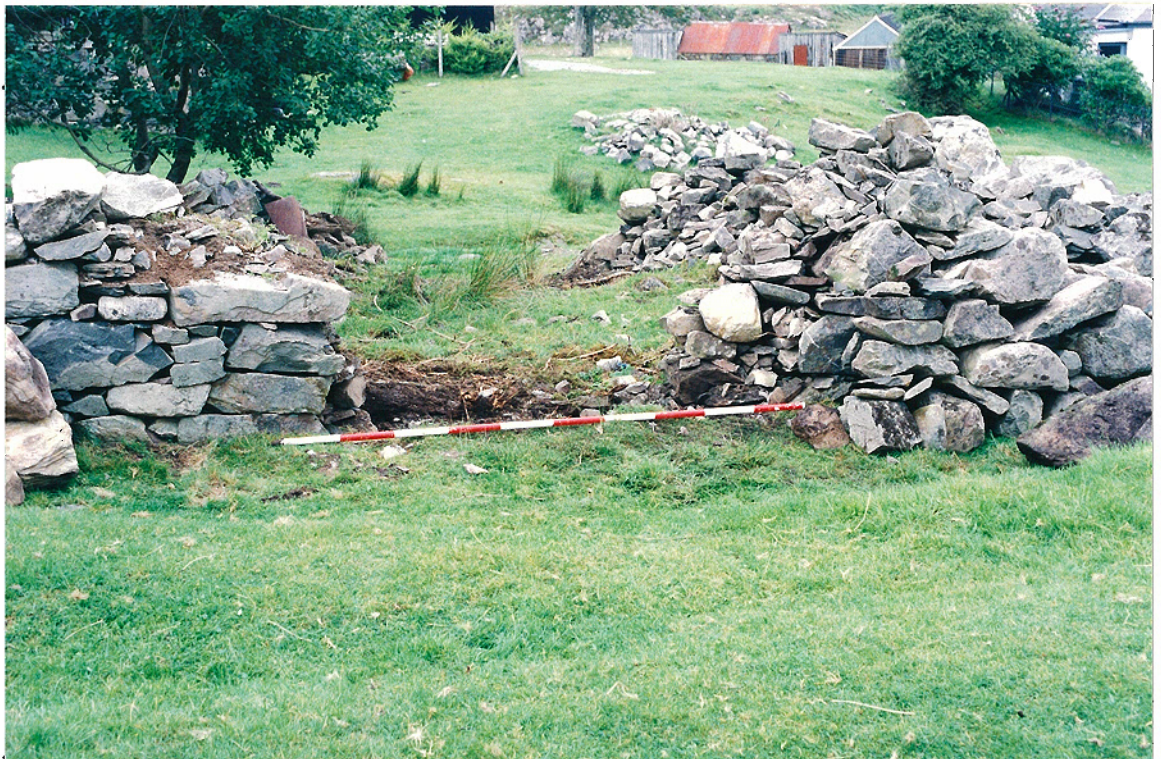
2. During the clearing of collapsed walling from the interior it was noted that the collapsed material rested directly on the gravel subsoil. There appeared to be no floor levels within the structure. This was later confirmed during excavation of the sewer trench.

2. **Drumbuie.** The ruin after dismantling of the walls. (scale = 2 meters)

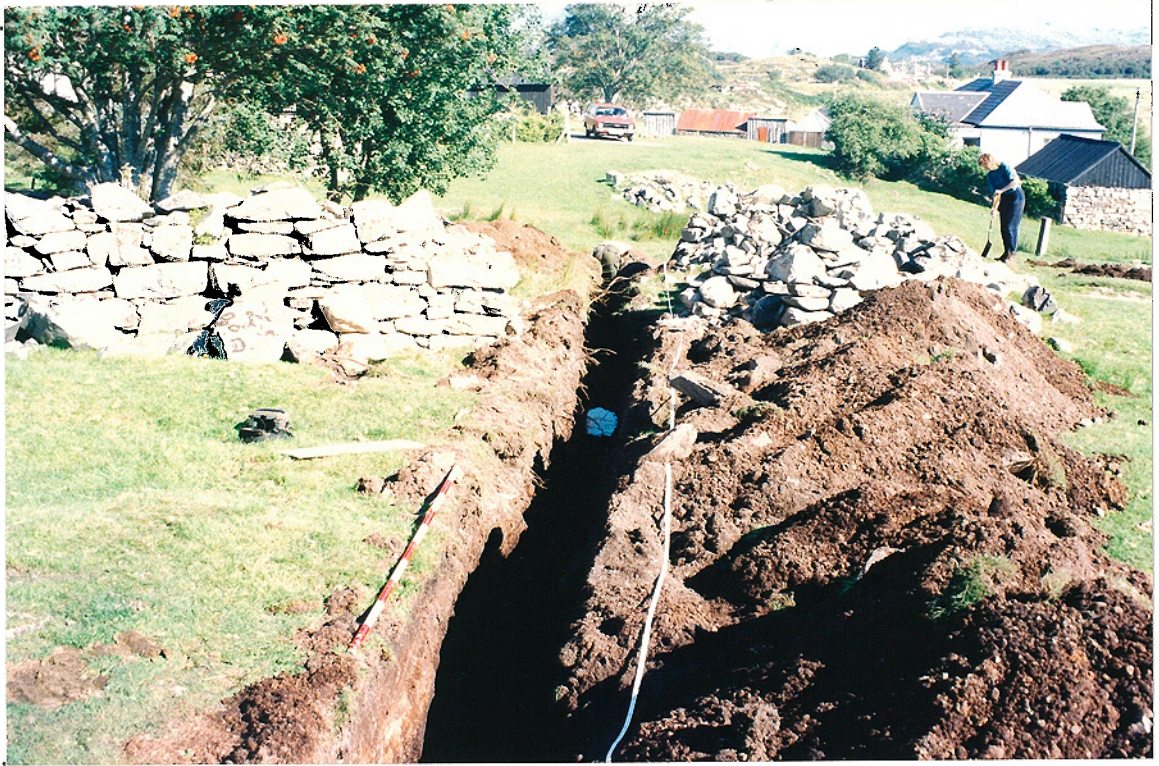
The evidence from the dismantled walls and the clearing of the interior indicate that the Black house had been constructed directly on the old ground surface. The interior had then been cleared of top-soil and the floor joists laid on supports ( pad stones ? ) placed directly on the gravel surface. It is possible that these were cleared away with the wall collapse prior to the cutting of the trench.

3. **Drumbuie.** The trench excavated through the ruin. (scale = 2 meters)

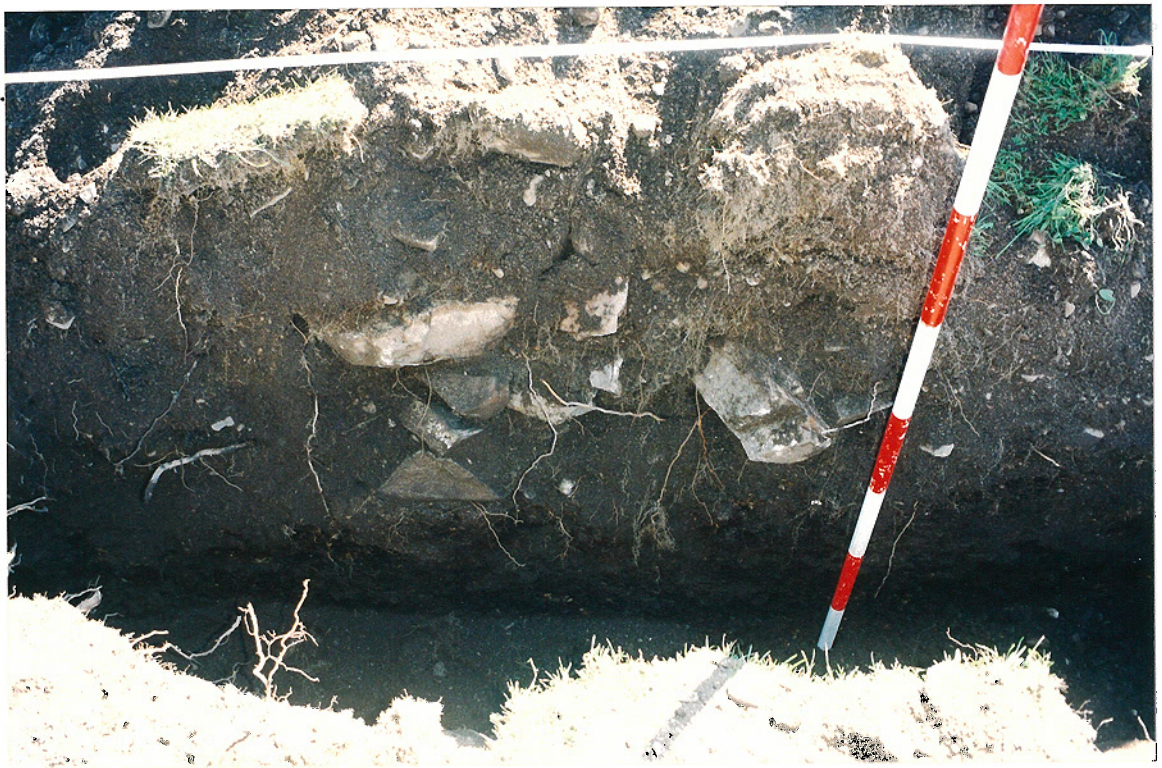
4. A slight rise in the ground, 2m to the south of the ruin, proved, upon cutting of the trench, to be the remains of a robbed out wall. The wall was originally 0.80m wide and ran in an east to west direction parallel to the south wall of the ruin.

4. **Drumbuie.** The remains of the robbed out wall . (scale = 2 meters)

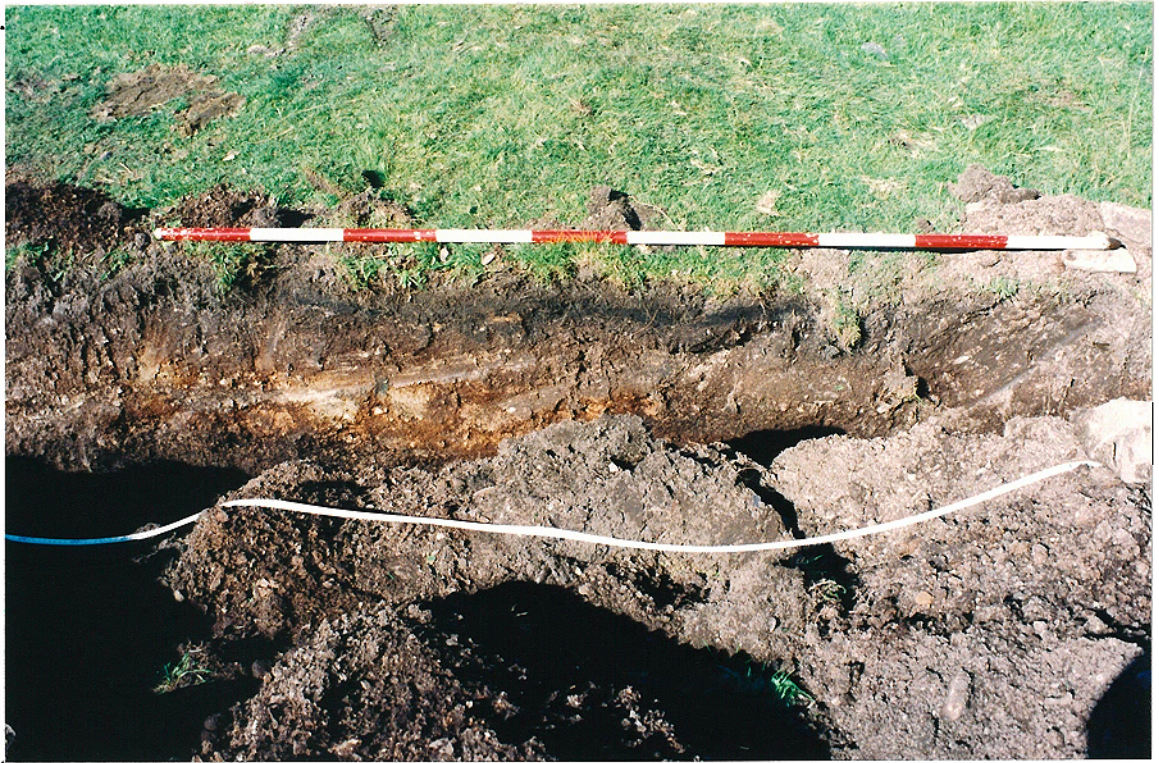
5. Approximately 3.90m to the south of the ruin the trench cut through the remains of a small peat stack. This had not been visible prior to cutting of the trench.
6. Approximately 5.90m to the south of the ruin the trench encountered the clay sewer pipe currently serving Mr England's house. ( 0.40m below the present ground level.)
7. Finally, 10.40m to the south of the ruin, the trench cut through a complex build up of successive access roads to Mr England's House.

A small peat stack which once stood to the south of the black house may or may not be of contemporary date.

5. **Drumbuie.** The evidence for the peat stack. (scale = 2 meters)

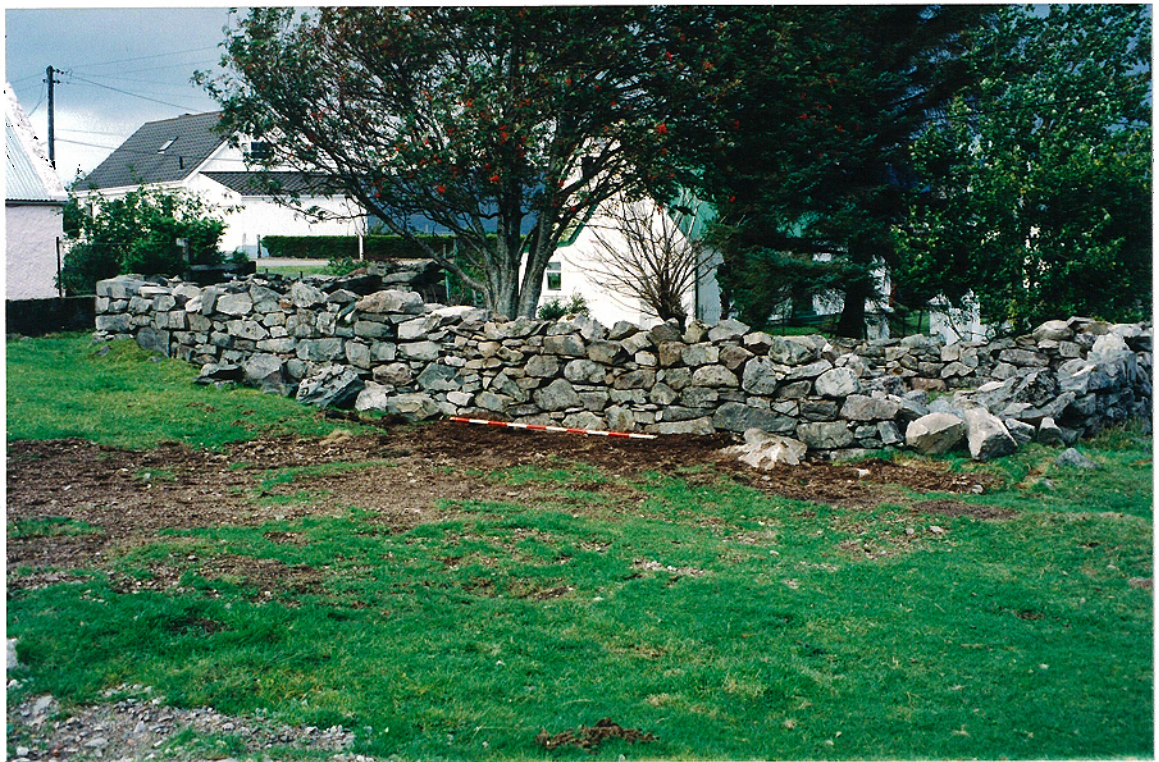
6. **Drumbuie.** The ruin after rebuilding. (scale = 2 meters)

The affected sections of wall were dismantled by hand and stacked to one side of the proposed line of the sewer. The excavation of the trench was then monitored as the work progressed. The west face of the trench was recorded at a scale of 1:20, ( section ). Upon completion of the works the trench was back filled and allowed to settle for 3 weeks. The walls of the ruin were then rebuilt.

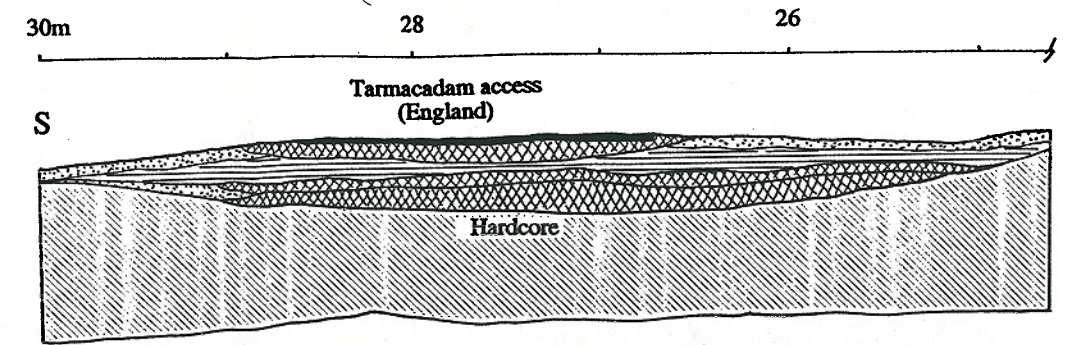
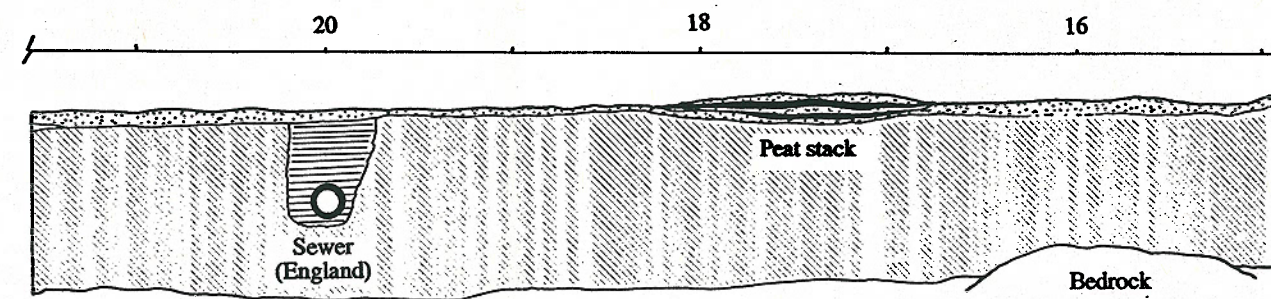
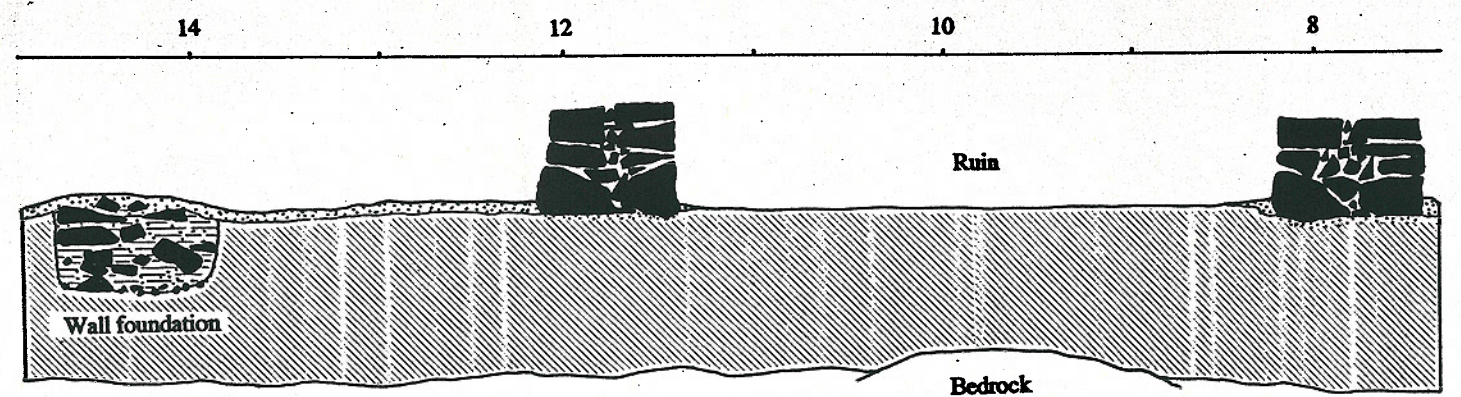
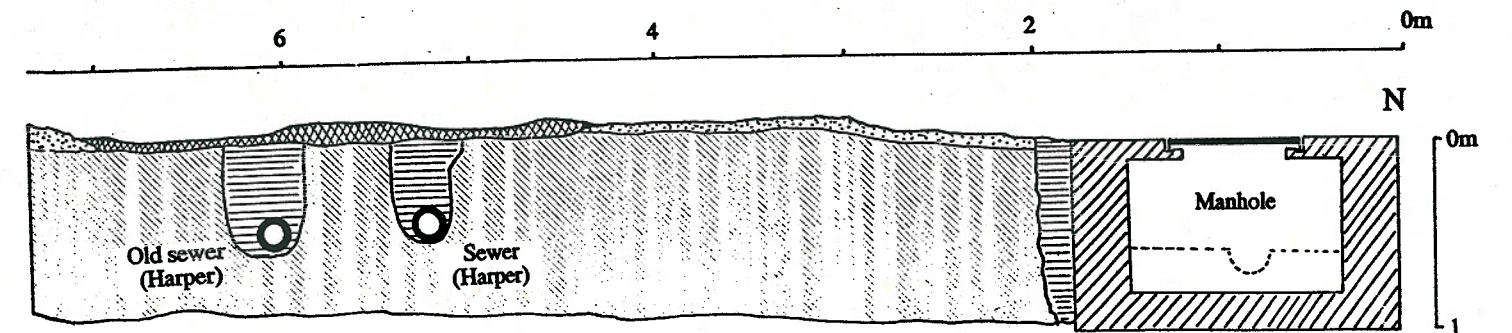
New sewer for Mrs Charlene MacLeod  
(Section : West face of trench)

3. To the north side of the ruin the trench cut through the make-up of the access road to Mr Harper's house. This consisted of a spread of hard-core 2.8m wide and from 0.05 - 0.10m thick. Below the hard-core were two back filled trenches, running across the trench, containing clay sewer pipes. The southern pipe, ( 0.46m below present ground level ), was broken and no longer in use. The northern pipe, ( 0.42m below present ground level ), was that currently serving Mr Harper's house.

There were no significant archaeological remains visible in the trench cut by the excavator. The subsoil consisted entirely of stratified alluvial gravel's lying directly on the underlying bedrock. The only features cut into this gravel were the foundations of an enclosure wall situated some 2.0m to the south of the ruin and the trenches for 3 sewer pipes. ( see section )
