A FILE ON
THE CAMORE-SYDERA WOODS SETTLEMENT
OF HUT-CIRCLES,
DORNOCH
1993.

FOR DORNOCH HERITAGE SOCIETY.

THE CAMORE AND SYDERA WOOD HUT CIRCLES.

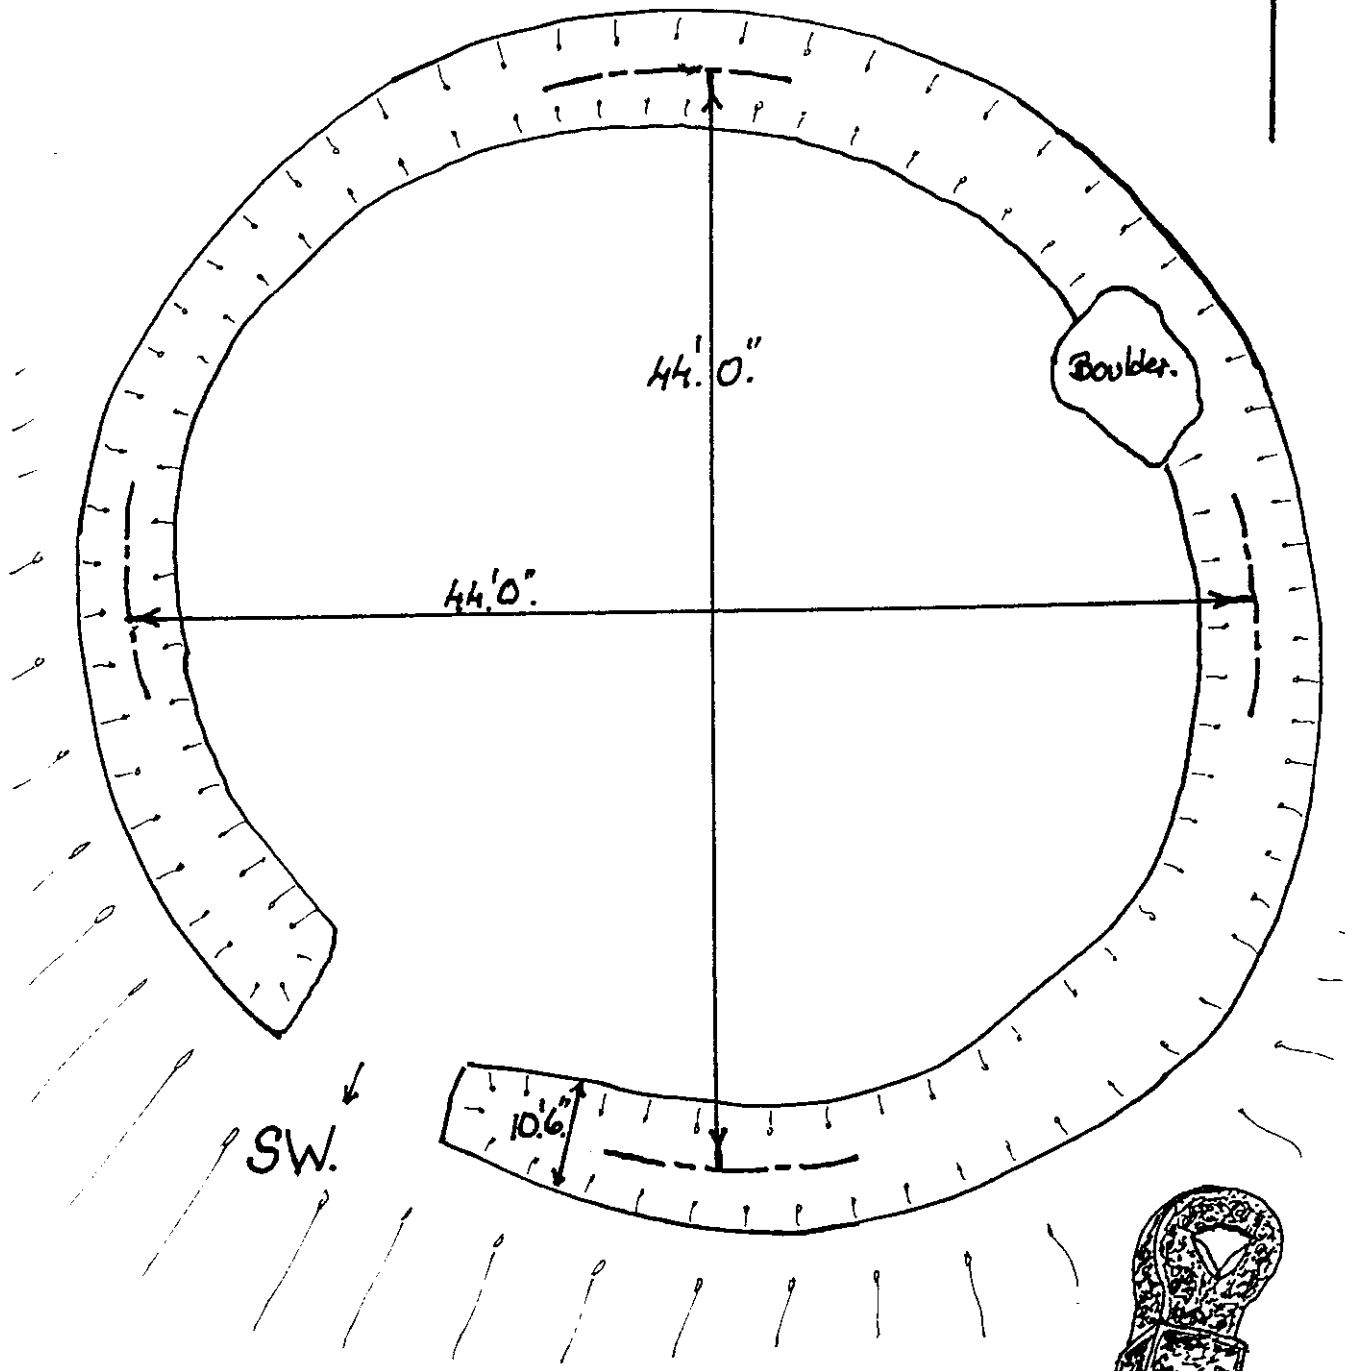
HUT CIRCLE, DRUMDIVEN FIELD (E). D.H.S.Nº2. O/S 7804 8961
HUT "A".

R.C.A.H.M.S ALPHABETICAL CLASSIFICATION	ORDNANCE SURVEY GRID REFERENCE NUMBERS.	D.H. Sec No.	R.C.A.H.M.S (1911) DESCRIPTION.
✓ A.	NH. 7807 8960.	2.	Hut 'A' measures \bar{c} 13.5m (\bar{c} 44ft) in diameter with the wall spread to \bar{c} 2.5m (\bar{c} 8ft). The 'simple' entrance in the S.W. is \bar{c} 1.5m (5ft) wide.
✓ B.	NH. 7806 8936.	4.	"B" is the same size as "A" and has a "simple" entrance in the NE. \bar{c} 1.5m (5ft) wide. A boulder immediately outside the entrance appears to be displaced from the NW side of the entrance. Around the S arc, outside the hut wall are traces of what is possibly a drainage ditch.
✓ —	NH 7800 8926.	5.	At NH 7800 8926, about 115.0m (126 yards) SSW of "B", in an SW facing slope is a possible hut formed by a circular hollow \bar{c} 6.5m (21ft) in diameter by a turf covered bank of earth and stone in the N, W and S, and by an irregular scarp in the E. The bank varies in width from \bar{c} 3.5m (11ft 6ins) in the N. to \bar{c} 5.0m (17ft) where it ends on the S.

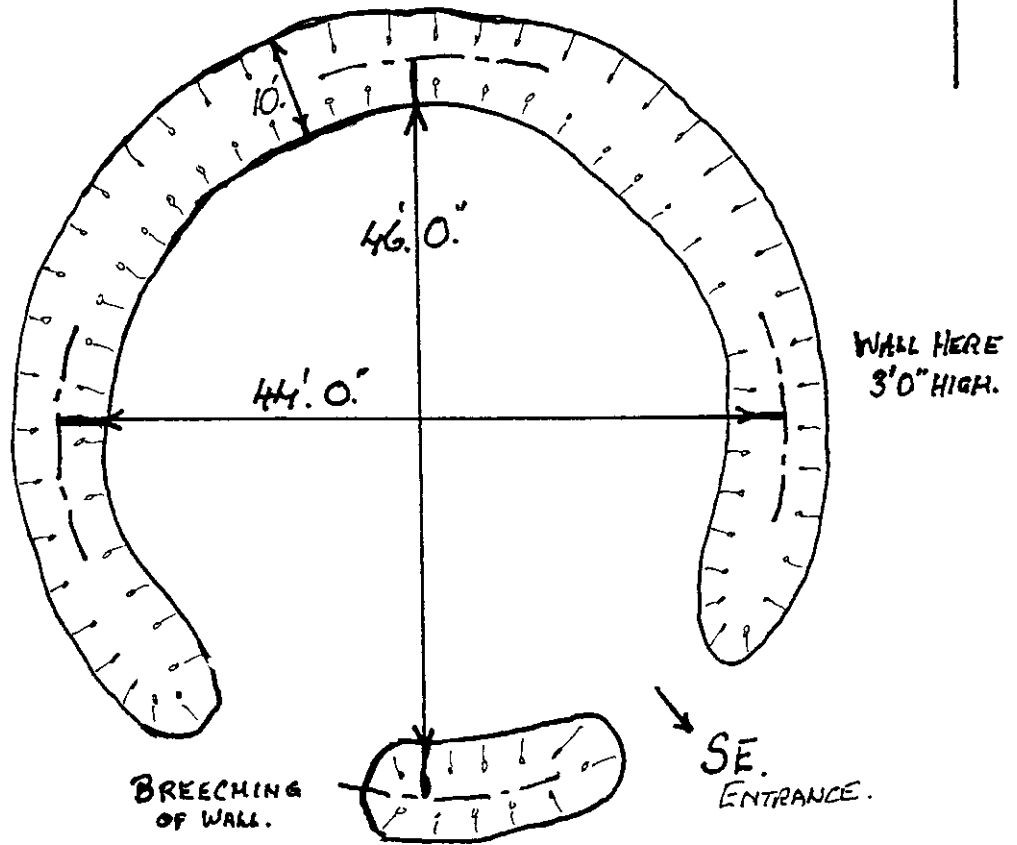
CAMORE WOOD HUT CIRCLE. D.H. Soc. No 7. HUT "D".
FORESTRY COMM. REF No 55 (North). O/SGRID REF: NH 7762 8953

✓ C.	NH 7778 8950	6.	"C" is the same size as "A" and "B", but the entrance is not evident.
✓ D.	NH 7762 8952.	7.	"D" has no facing stones evident but the interior appears to be circular, \bar{c} 11.5m (\bar{c} 38ft) in diameter, and is bounded by a wall spread to \bar{c} 3.0m (10ft) at the rear, widening to \bar{c} 5.5m (\bar{c} 25ft) at the "clotted" entrance in the SE.
✓ E.	NH 7752 8946	8.	"E" measures \bar{c} 14.0m (\bar{c} 46ft) in diameter with the wall spread to \bar{c} 2.5m (\bar{c} 8ft) in the N, but too reduced to measure elsewhere. The entrance, in the S. is poorly defined.
✓ F & G. F.	—————	9.	— are contiguous, lying N to S. "F" measures \bar{c} 13.5m (\bar{c} 45ft) in diameter with the wall spread to \bar{c} 3.0m (10ft). The entrance, in the E, is mutilated.
✓ G.	NH 7742 8938	10.	"G", to the south of "F", may be an enclosure associated with "F", rather than a hut. It is formed by a sub-circular wall spread to \bar{c} 3.0m (10ft) but the N arc is missing; the wall stops short of "F" by about 1.5m (\bar{c} 5ft) on both sides. It measures \bar{c} 14m (\bar{c} 46ft) from the NW through the entrance in the SE on both sides of which is a mound extending SE for \bar{c} 5.0m (\bar{c} 17ft). In the interior is a circular depression \bar{c} 4.5m (\bar{c} 15ft) in diameter.

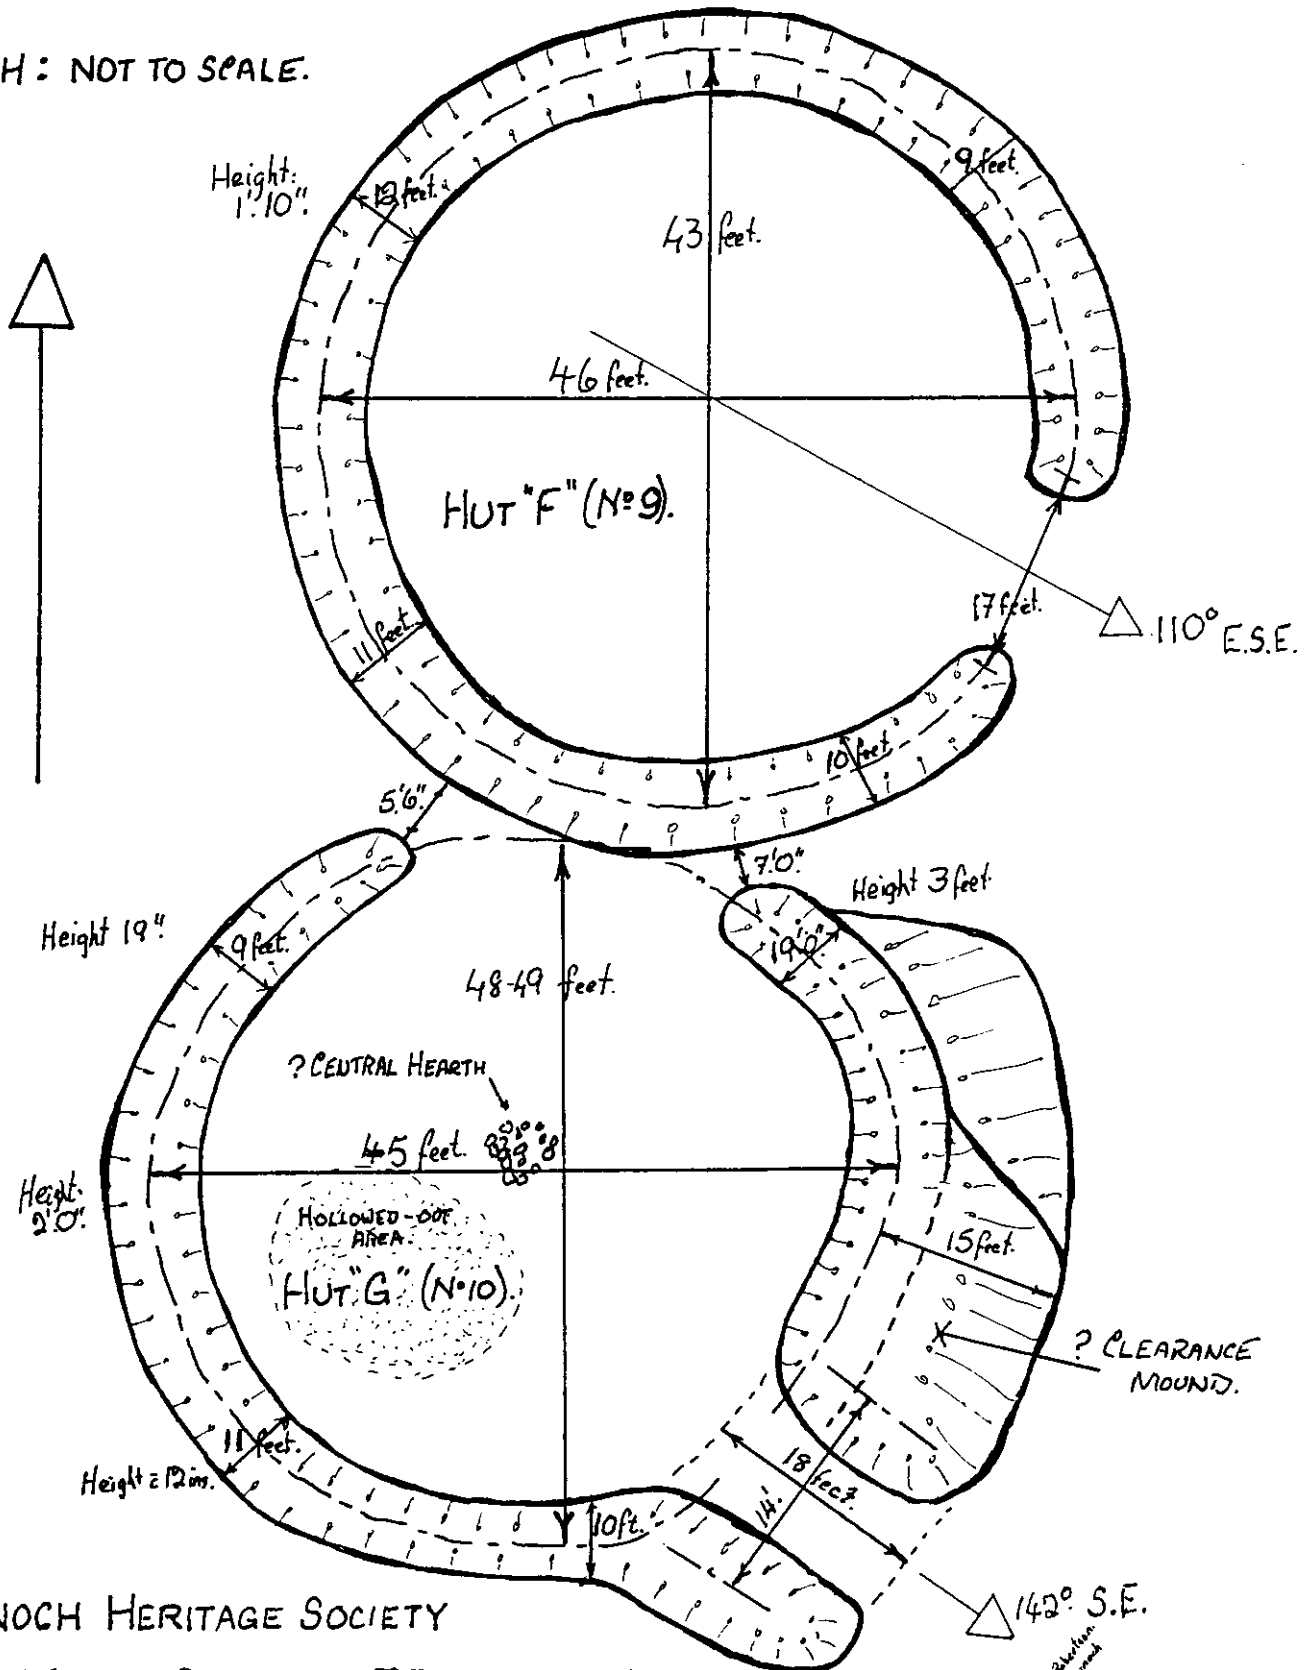
TWIN HUT-CIRCLES "F&G" (R.C.A.M.), CAMORE WOOD, DORNOCH.
 DORNOCH HERITAGE SOCIETY ENUMERATION N^{os} 9&10.
 ORDNANCE SURVEY 1:10,000 - 7745 8939 (CENTRED).

NOTE: R.C.A.M. GRADES HUT "G" AS CATTLE ENCLOSURE - BUT D.H.SOC POSTULATE A CENTRAL HEARTH FEATURE

'G', to the S of 'F', may be an enclosure associated with 'F' rather than a hut. It is formed by a sub-circular wall spread to c. 3.0m, but the N arc is missing; the wall stops short of 'F' by about 1.5m on both sides. It measures c. 14.0m from the NE through the entrance in the SE on both sides of which is a mound extending SE for c. 5.0m. In the interior is a circular depression c. 4.5m in diameter.

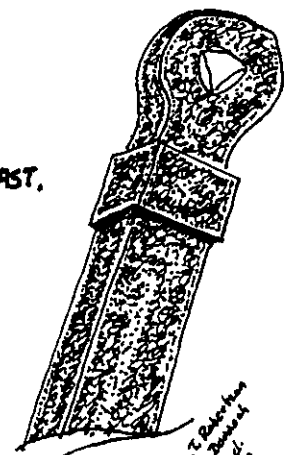
Sketched by S. Robertson
 28-4-93
 2

HUT CIRCLE, CAMORE WOOD, DORNOCH. D.H.Soc. N° 12.
 FORESTRY COMMISSION REF: 53(NORTH). GRID REF: NH 7738 8933.
 HUT "H" IN R.C.A.H.M.S. COMPUTER PRINT-OUT.

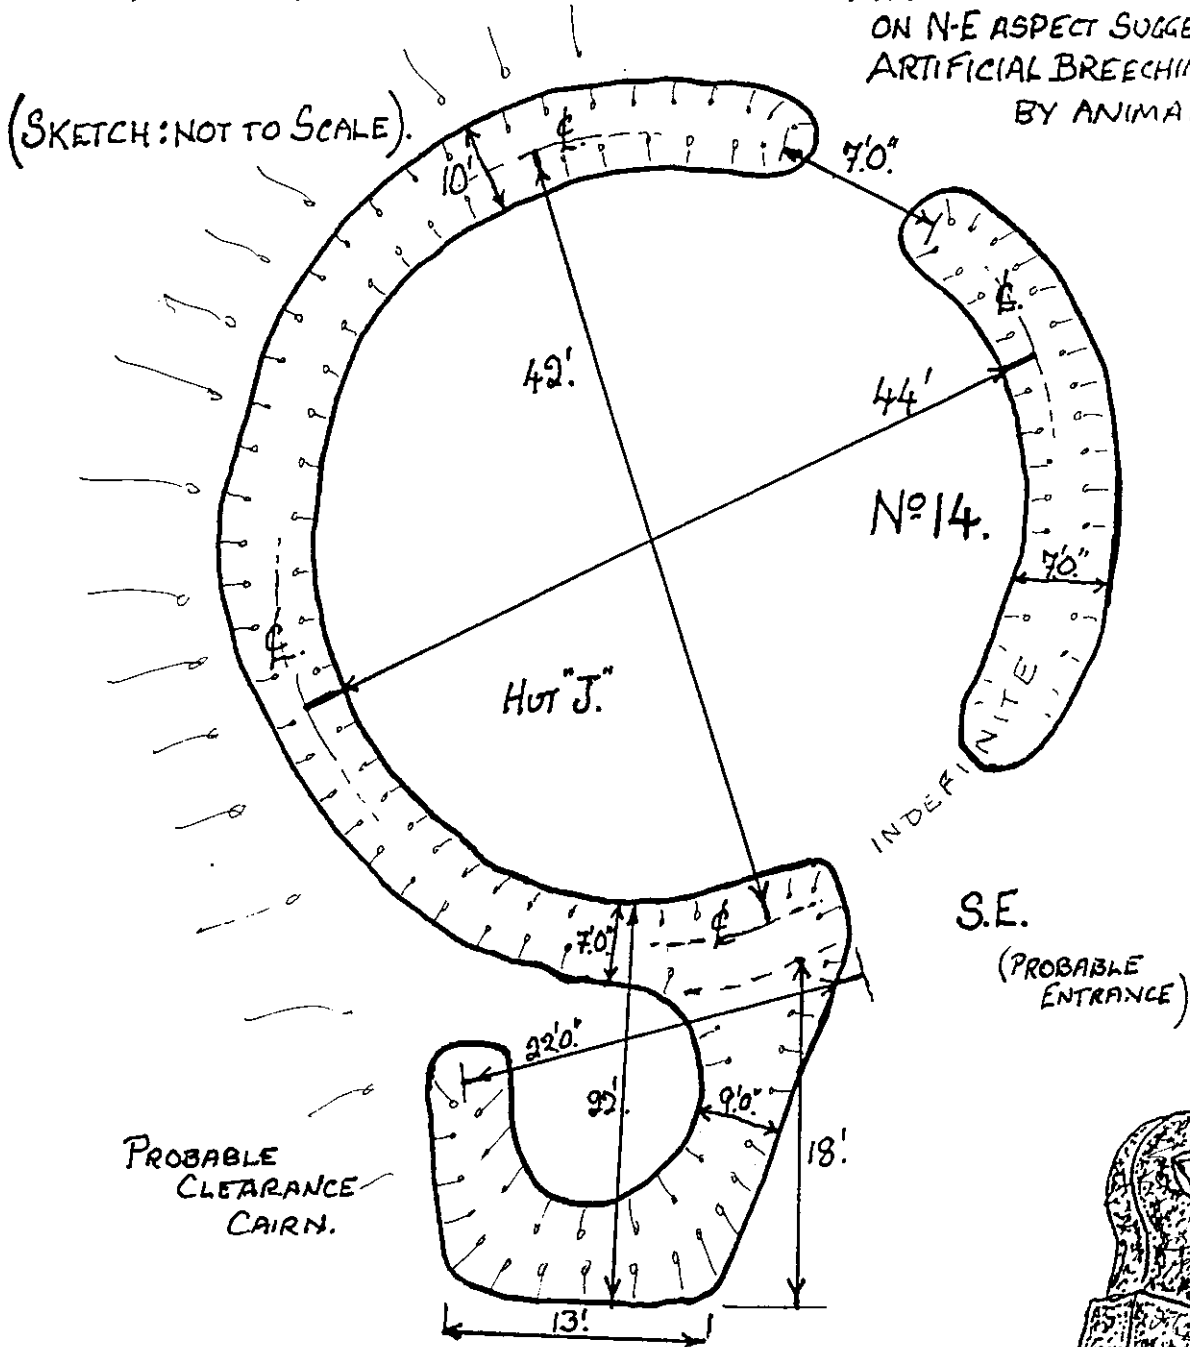
WITH CAIRN-LIKE EXTENSION
OUTSIDE ENTRANCE, AND
? FALSE NARROW ENTRANCE
TOWARDS N-E.

? FALSE ENTRANCE IN WALL
ON N-E ASPECT SUGGESTS
ARTIFICIAL BREECHING
BY ANIMALS.

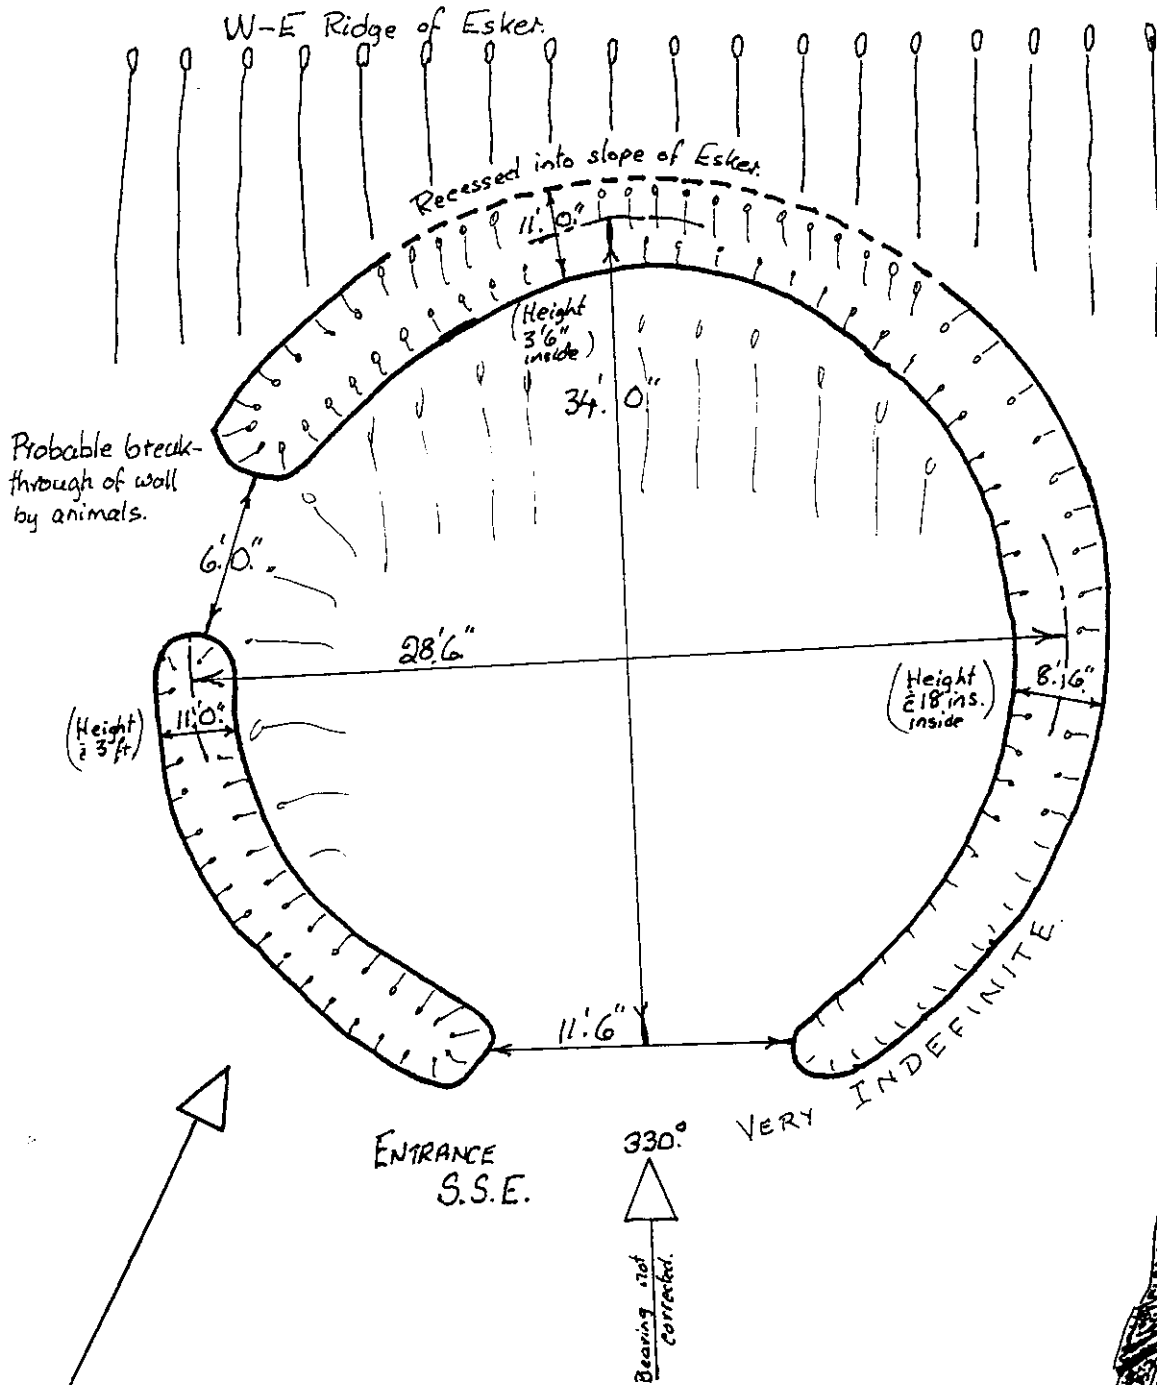
HUT CIRCLE, CAMORE WOOD, DORNOCH. D.H.Soc.No: 15.
 NO FORESTRY COMMISSION REF. O/S GRID REF: 7717 8948.
 HUT "K" IN R.C.A.H.M.S. COMPUTER PRINT-OUT.

K.	—————	15.	"K" measures $\approx 14.0\text{m}$ ($\approx 46\text{ft}$) in diameter with the wall spread to $\approx 3.0\text{m}$ (10ft). The entrance in the ESE is mutilated. A lynchet curves to the W from the NW arc of the hut.

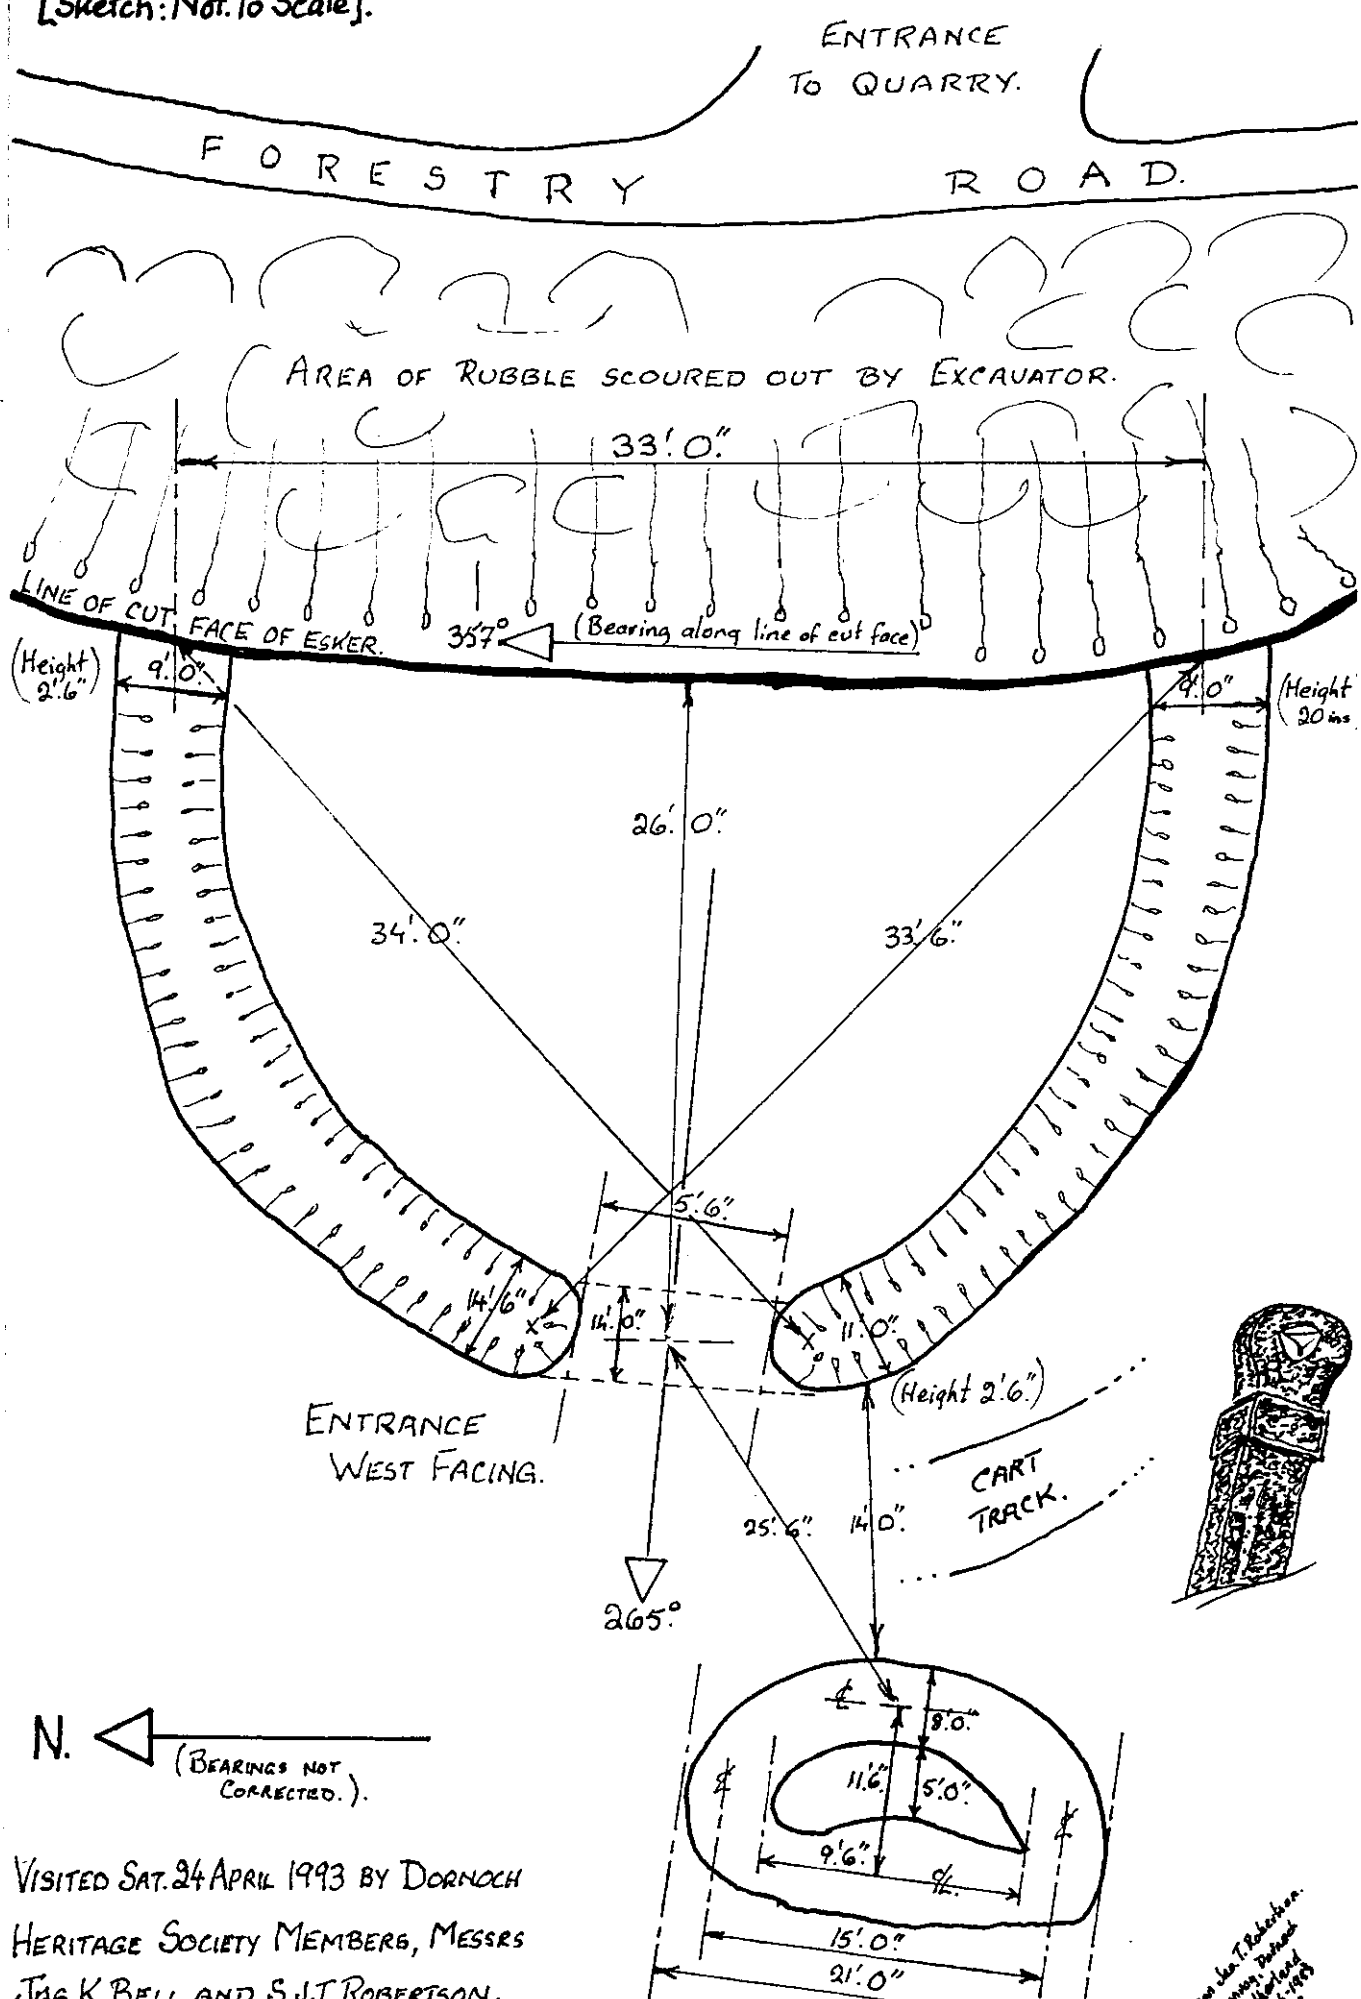
HALF HUT CIRCLE, CAMORE WOOD, DORNOCH. D.H.Soc. No. 18.
 NO FORESTRY COMMISSION REFERENCE. O/S.GRID. NH 7703.8936
 HUT "M."

M.	NH 7703 8936	18.	"M" measures $\approx 9.5\text{m}$ ($\approx 31\text{ft}$) N to S with the wall spread to $\approx 4.0\text{m}$. (13ft). The entrance in the W. is mutilated. The E arc of the hut has been destroyed by a quarry.
N & O N.	NH 7715 8933.	19.	"N" and "O", set into the top of a knoll, are contiguous, lying E to W. "N" measures $\approx 11.0\text{m}$ (36ft) in diameter with the wall spread to ≈ 3.0 ($\approx 10\text{ft}$). The "simple" entrance in the E is $\approx 1.5\text{m}$ (5ft) wide.

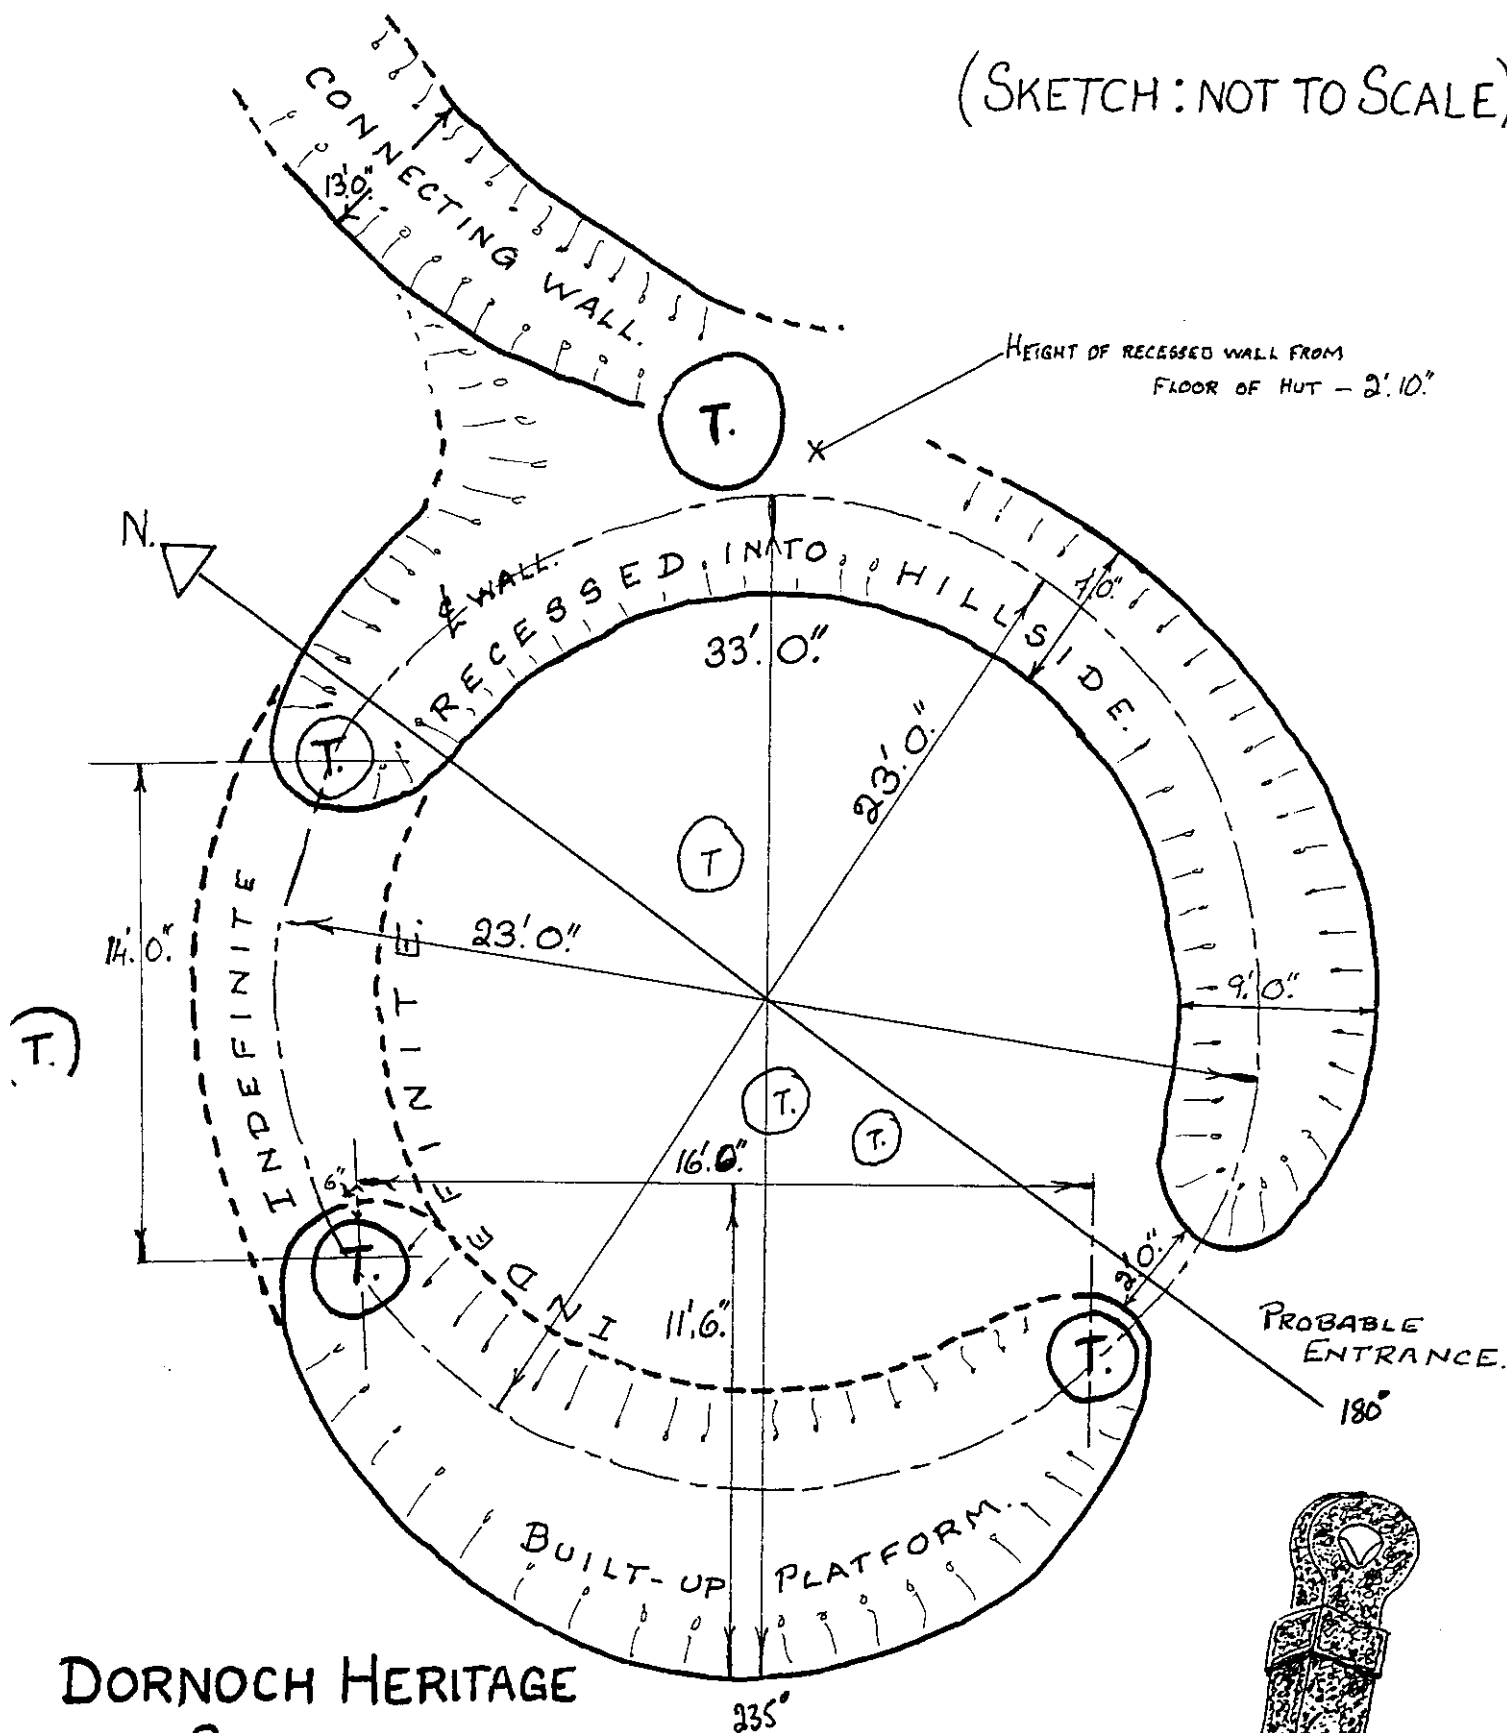
HUT CIRCLE "P": CAMORE WOOD, DORNOCH : D.H.Soc. №21.
 ORDNANCE SURVEY (1:10560 GRID REF. 7715 8933).

P.	—————	21.	"P" is joined to "O" by a wall and is visible as a platform $\approx 6.5\text{m}$ ($\approx 22\text{ft}$) in diameter, set into a W-facing slope, and is surrounded by traces of a wall. The entrance is not apparent.

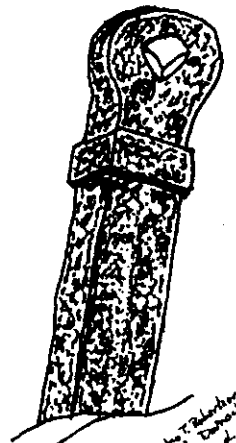
Sketch by Jas. K. Bell
 Dornoch Heritage Society
 16/12/1993

HUT CIRCLE, CAMORE WOOD, DORNOCH. D.H. Soc. No: 23.
 FORESTRY COMMISSION REF: O/S. GRID REF: SEE COMMENTS.
 HUT "R" IN R.C.A.H.M.S COMPUTER PRINT-OUT:

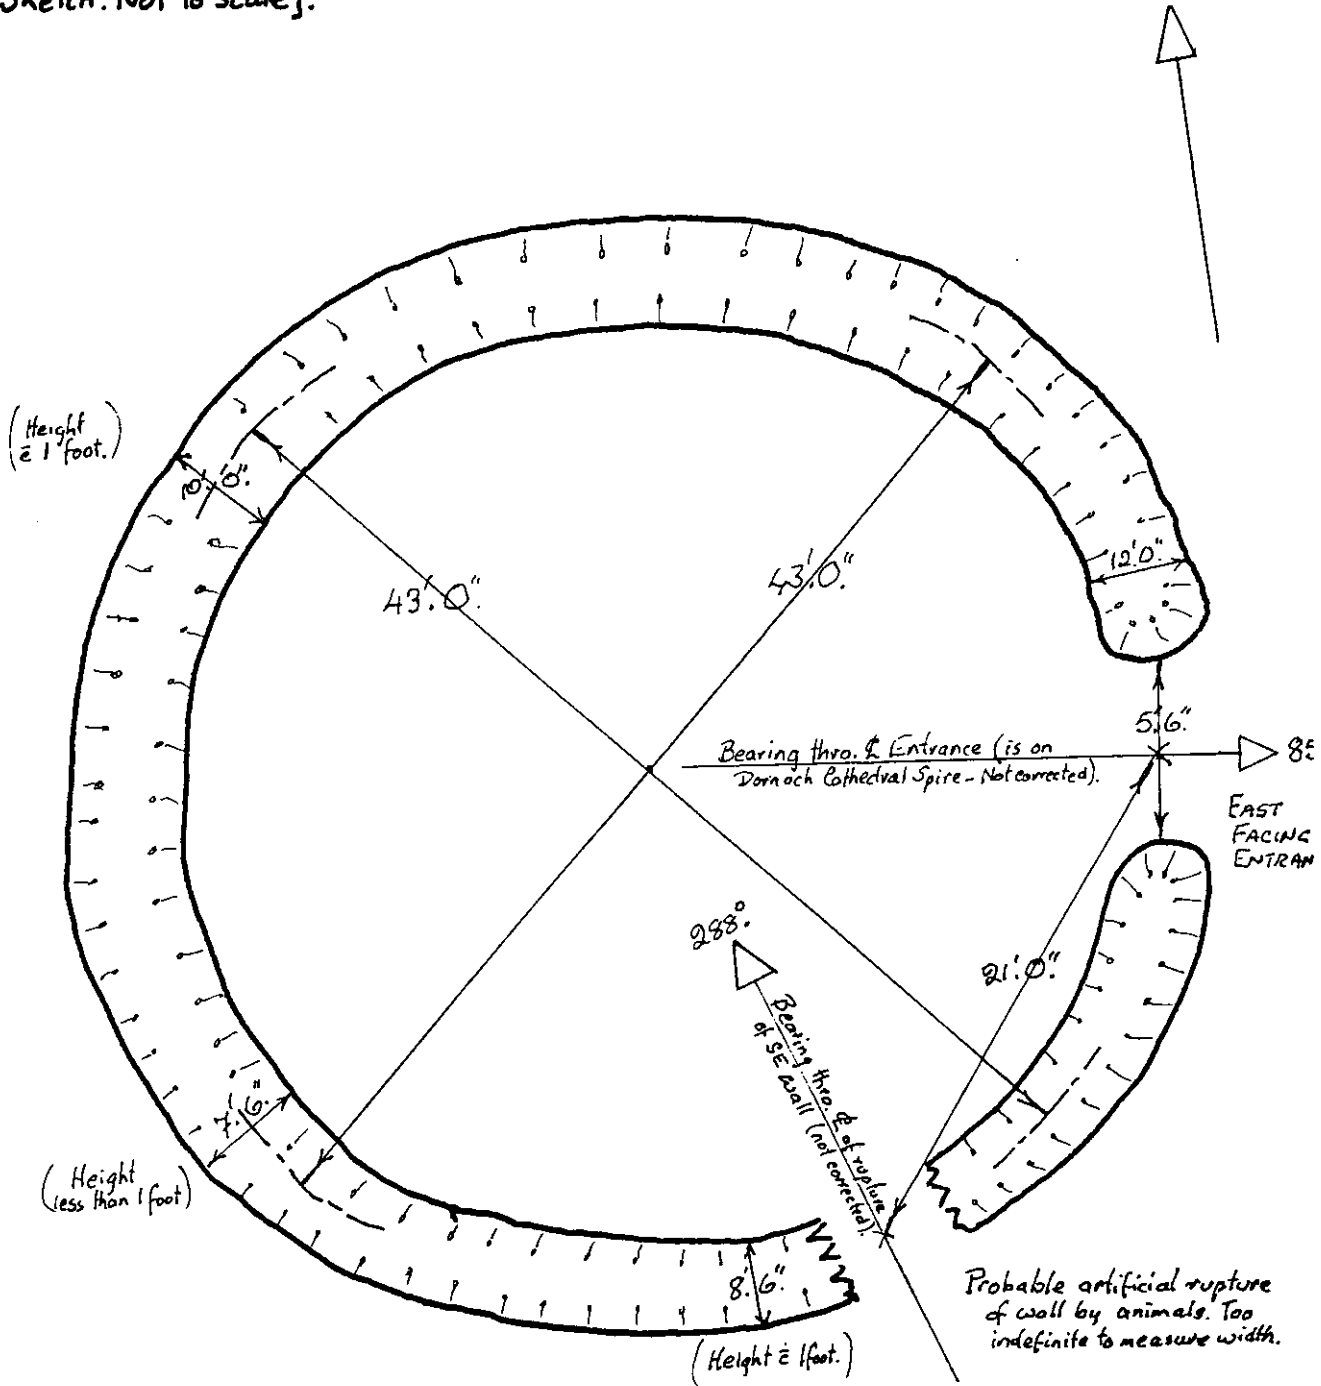
HUT "T." IN R.C.A.H.M.S. COMPUTER PRINT-OUT.

T.	NH 7724 8921.	25.	"T" is the same size as 'A', 'B' and 'C' [13.5m ($\approx 44\text{ft}$) in diameter] and has a "simple" entrance in the E.
U.	NH 7722 8900 and 7721 8903	26.	"U" measures $\approx 10.0\text{m}$ (33ft) in diameter with the wall spread to $\approx 3.0\text{m}$ ($\approx 10\text{ft}$). The W quadrant has been destroyed.

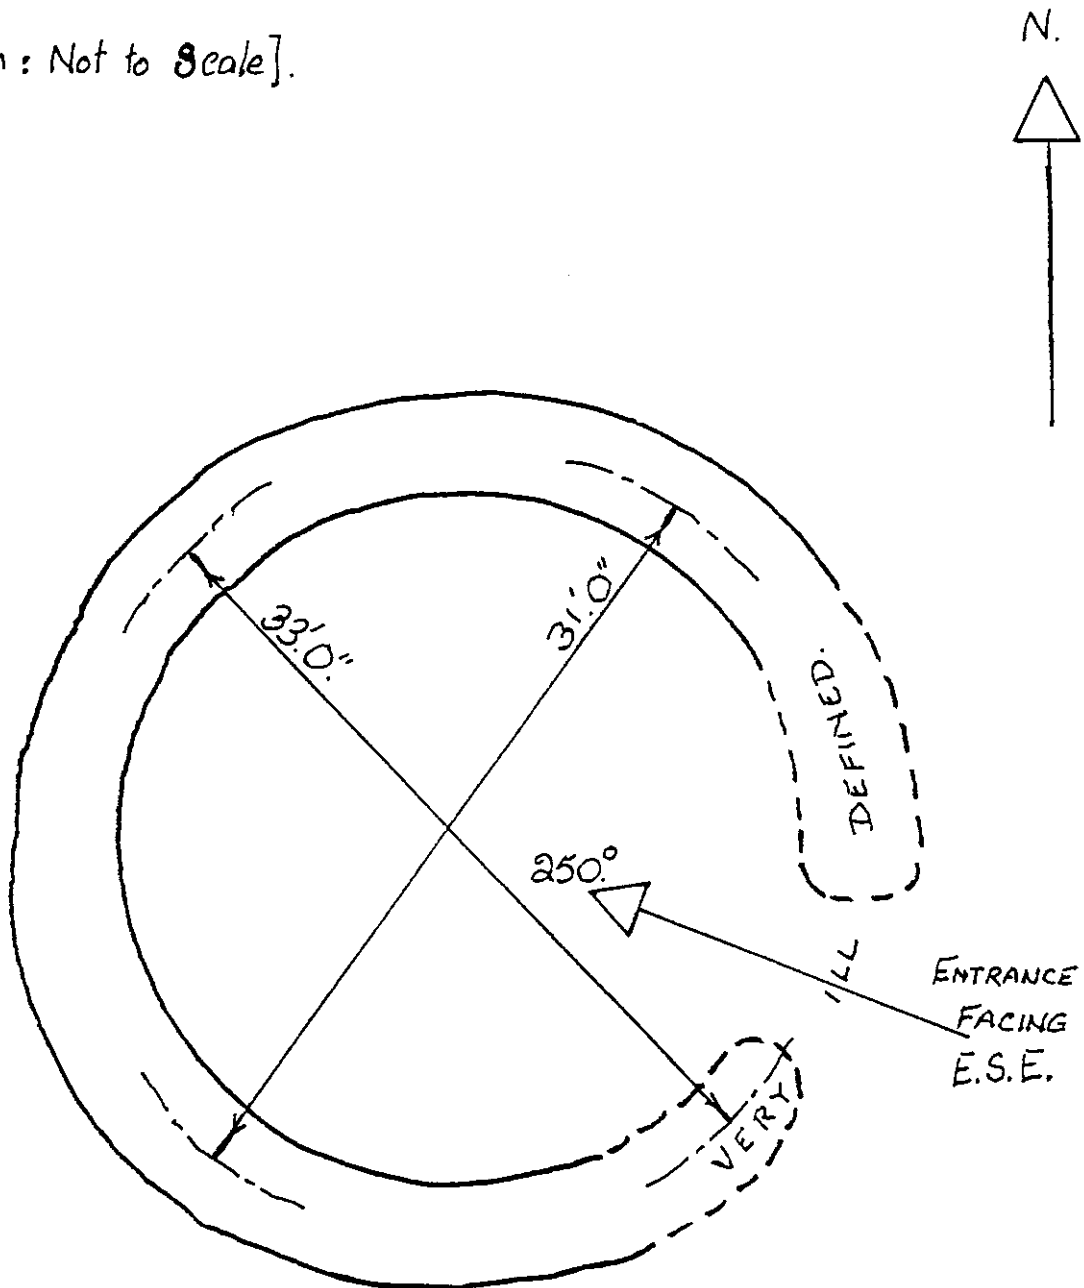
THE CUTHILL LINKS, DORNOCH, HUT-CIRCLE. D.H.Soc. SITE N^o 40.
 NOT RECORDED BY R.C.A.M. O.S. GRID REF: NH 7512 8735 (1:25000)
 THIS SITE REQUIRES CONFIRMATION.

Situated SSW by S from Cuthill Farm House, on the sea-side of a post-and-wire field boundary fence, on Cuthill Links. The Hut-circle has suffered great mutilation and scatter from grazing animals. The walls are less than a foot high, greatly disturbed, and impossible to gauge the margin of scatter, and difficult to recognise.

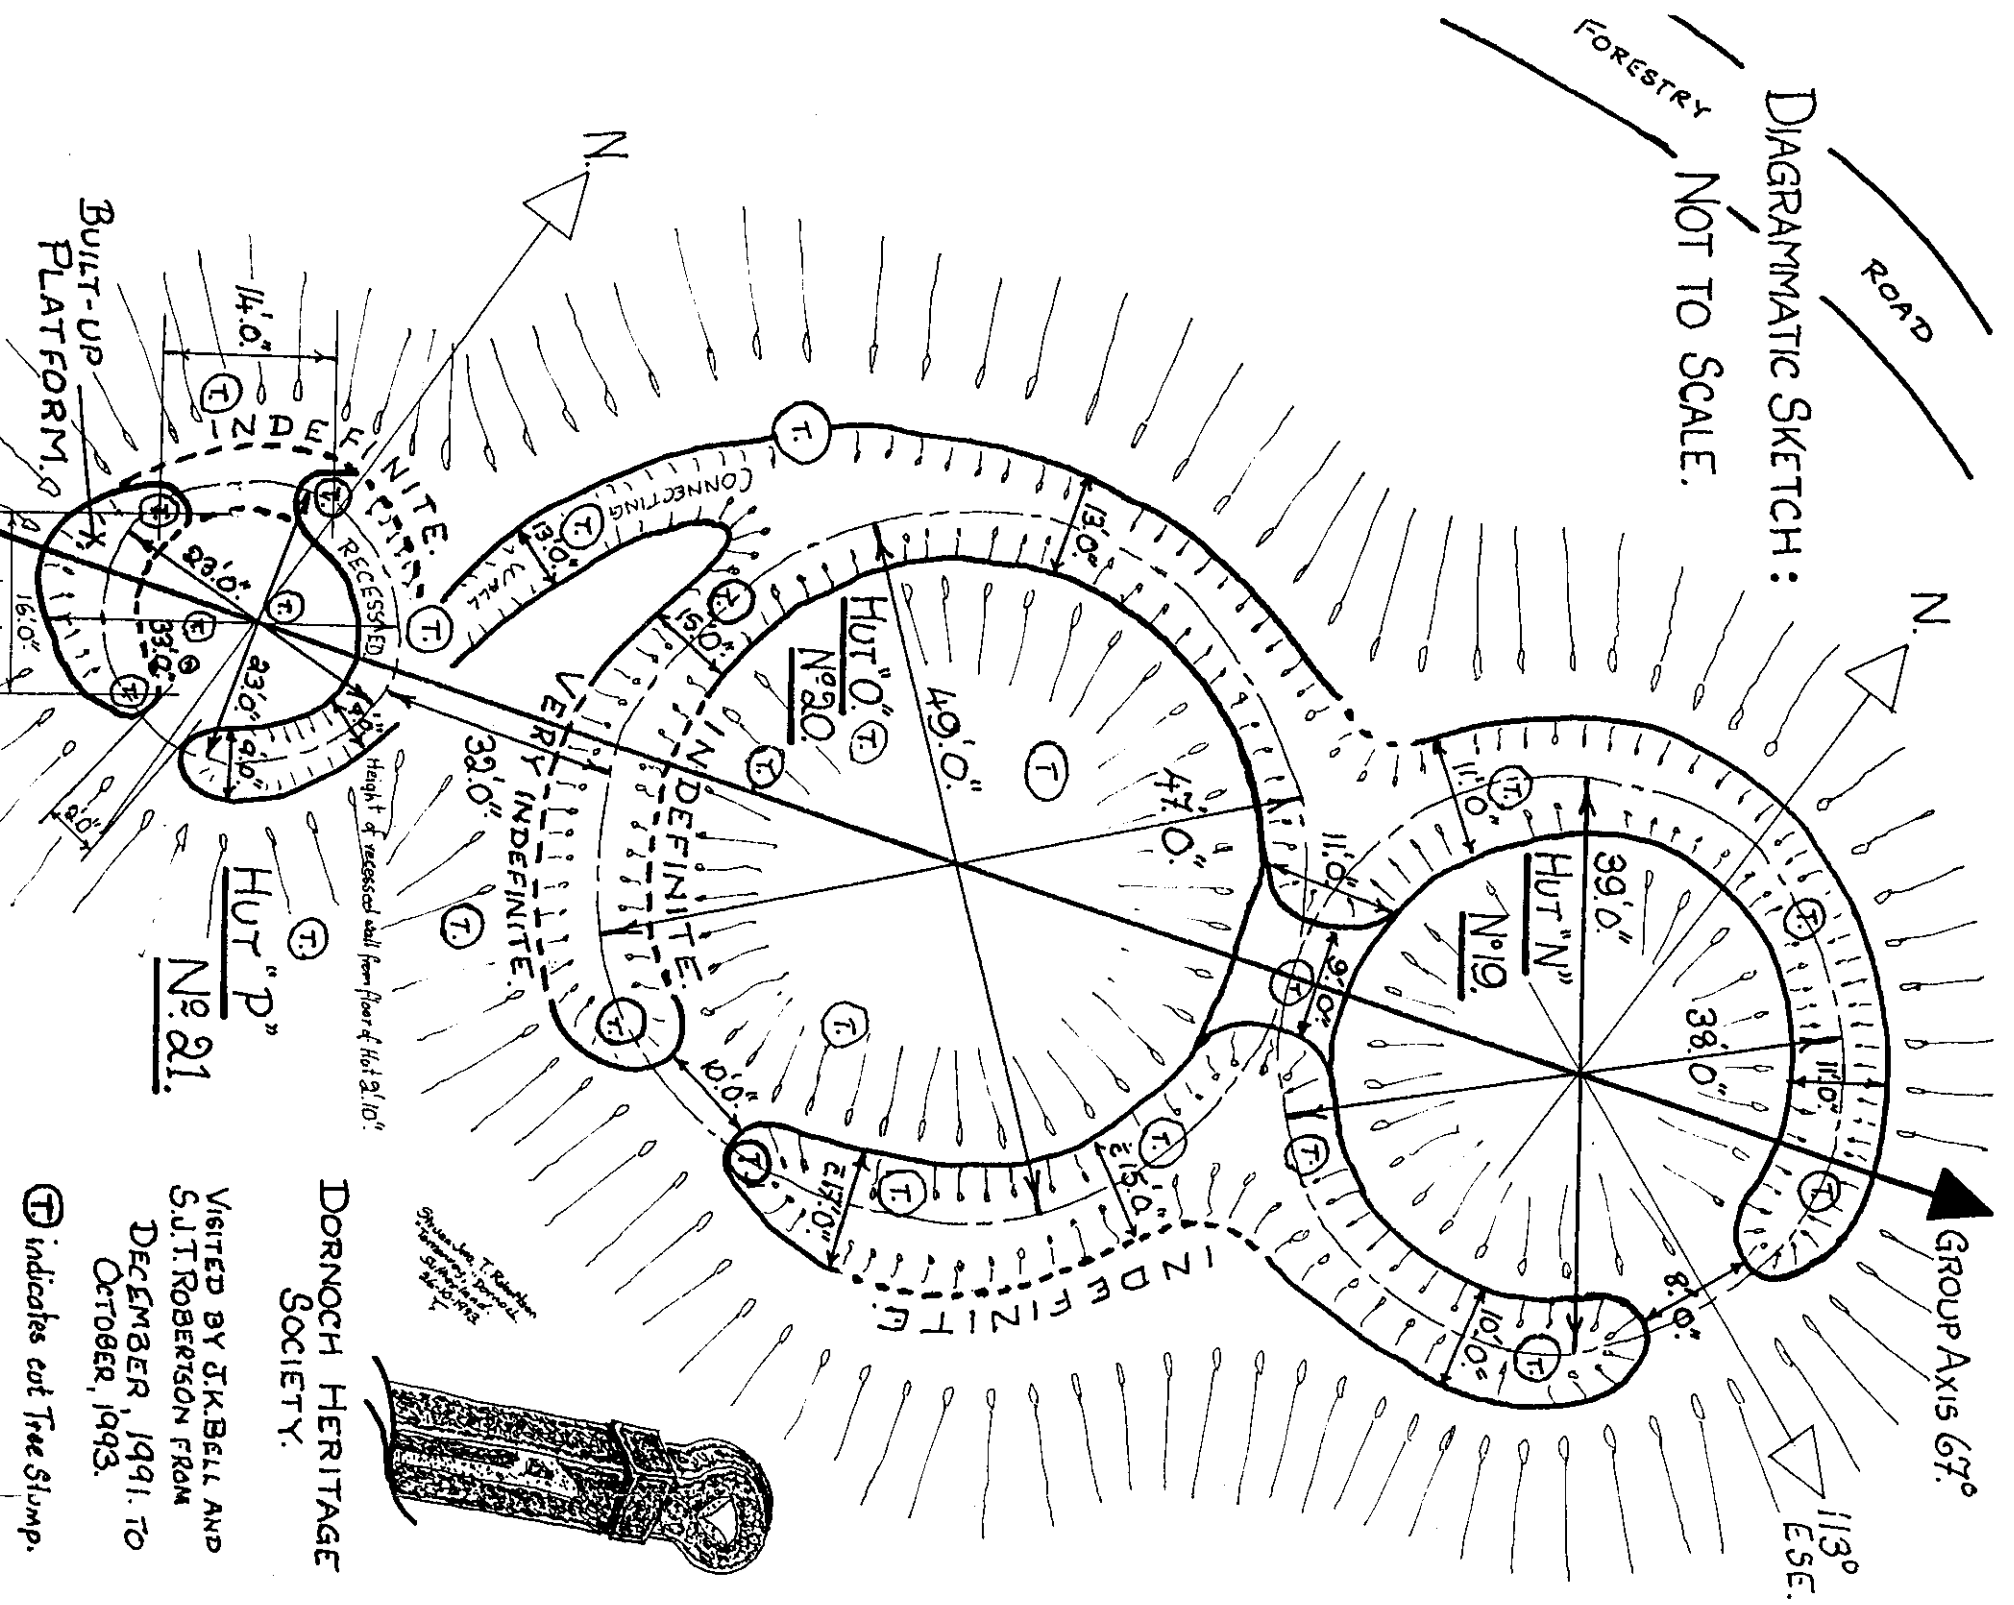
TRIPLE HUT-CIRCLES "N, O & P", D.H.S.O.C. Nos 19-21, CAMORE WOOD, DORNOCH.
 ORDNANCE SURVEY (1:10560) GRID REF 7715 3933.

This Group, of three hut-circles, is set on the top of a short E.N. WSW-lying esker, to the S side of the forestry road, at its bend at the E end of the central gravel quarry.

HUT "N" (No 19), has probably the most complete wall structure of all the local hut-circles, despite deliberate implantation with trees. This, the highest hut-circle, though smaller in size, has its floor hollowed-out to a depth of about 3 to 5 feet, suggesting the possibility of a low-roofed (Kilphedir No 1) type Hut-circle on account of its exposed position. (Against this is the probable thinness of the walls).

A small holly bush is growing in the centre of hut circle N. The roots of this tree will be disturbing the archaeological deposits relating to the occupation and use of the hut circle, and it must be felled to prevent further damage occurring.

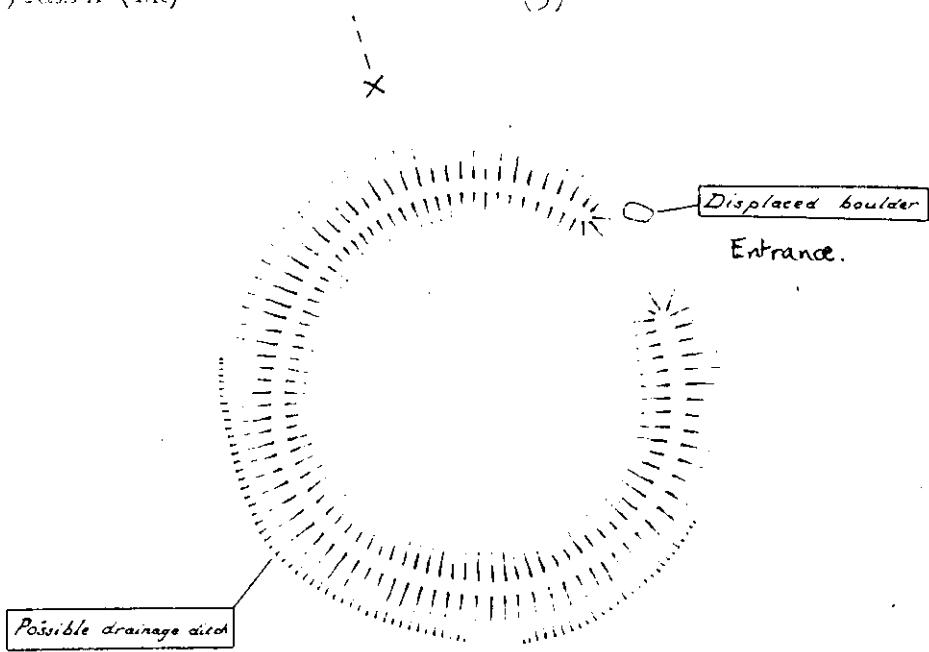
Hut 'B'

MORE LIKELY TO BE MATERIAL RESULT OF WATER DRAINING DOWN SLOPE AND BEING DEFLECTED ROUND WALL OF HUT.
