A FILE ON
THE CAMORE-SYDERA WOODS SETTLEMENT
OF HUT-CIRCLES,
DORNOCH
1993.

FOR DORNOCH HERITAGE SOCIETY.

THE CAMORE AND SYDERA WOOD HUT CIRCLES.

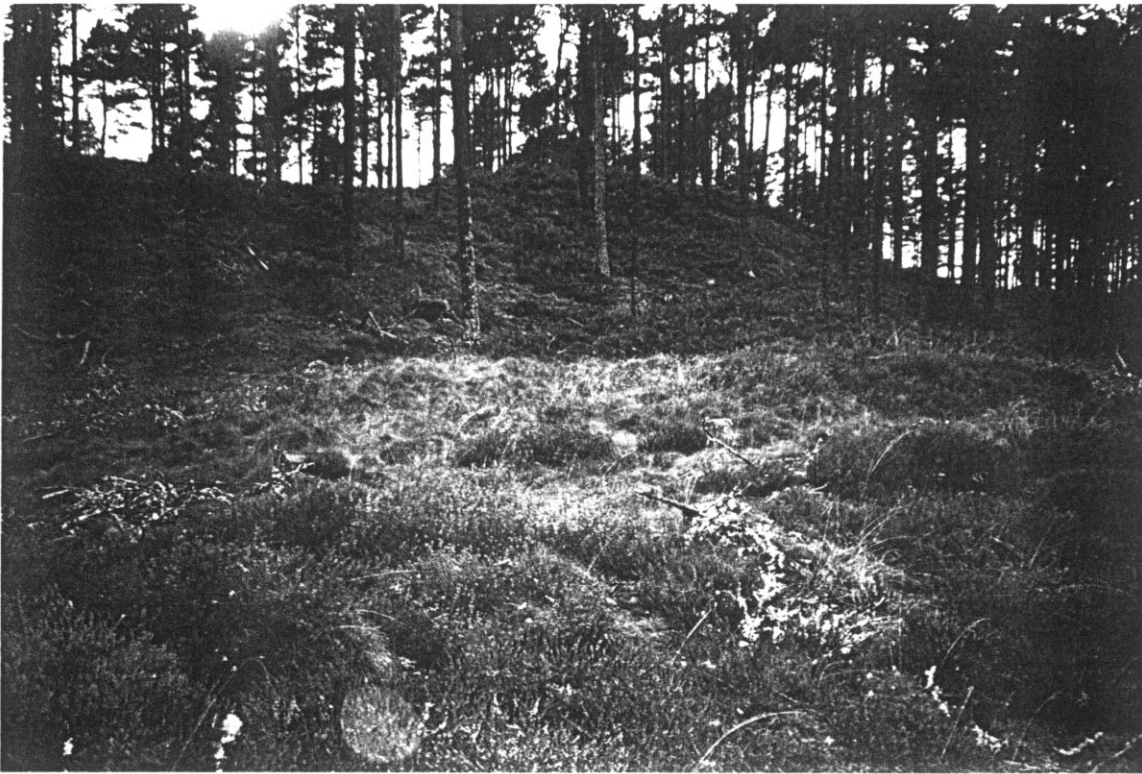
Bracken exists on hut circles L, J/I, E and N/O/P and very dense bracken exists on hut circles S, R/T and X/W. The bracken will be causing active damage to the archaeological remains, and should be treated as soon as possible to prevent further damage.

PHOTO 1. Hut circle L from the SE.

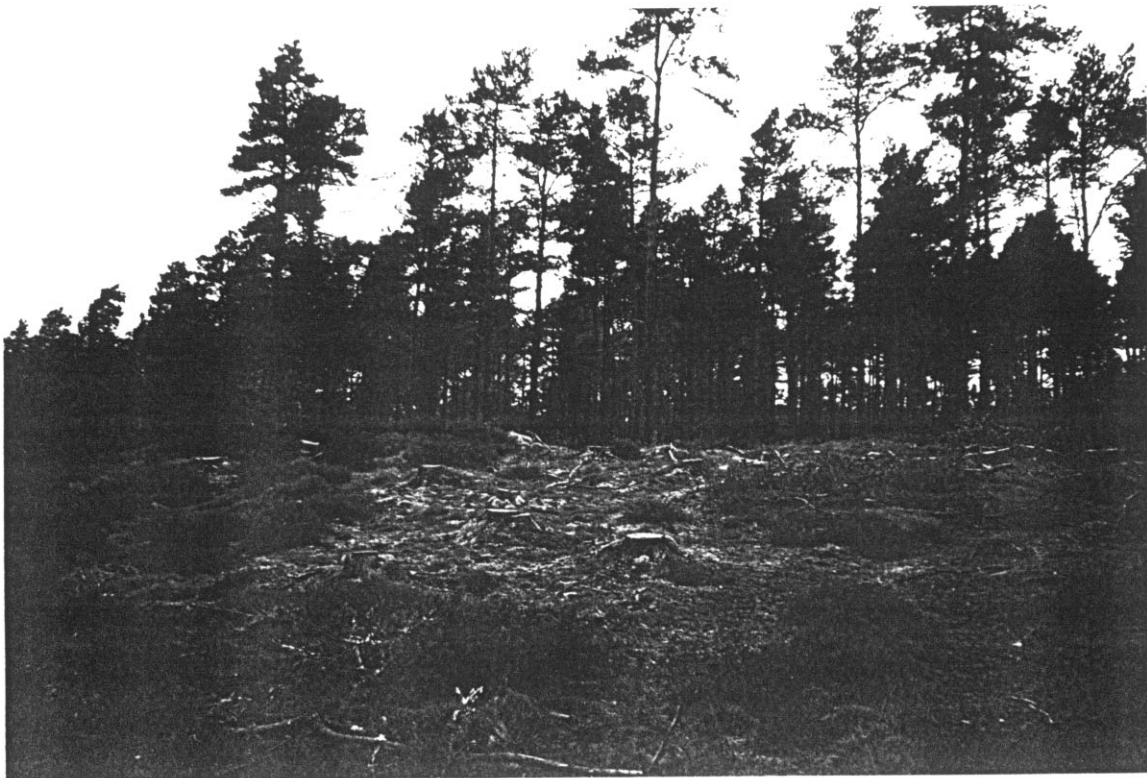
PHOTO 2. Hut circle J from the south.

The spruce and pine trees which are up to 2m high on the west side of hut circle J should be cleared back to the quarry fence. All other natural regeneration should be removed from the scheduled areas and a zone 20m beyond to prevent damage to the archaeological remains.

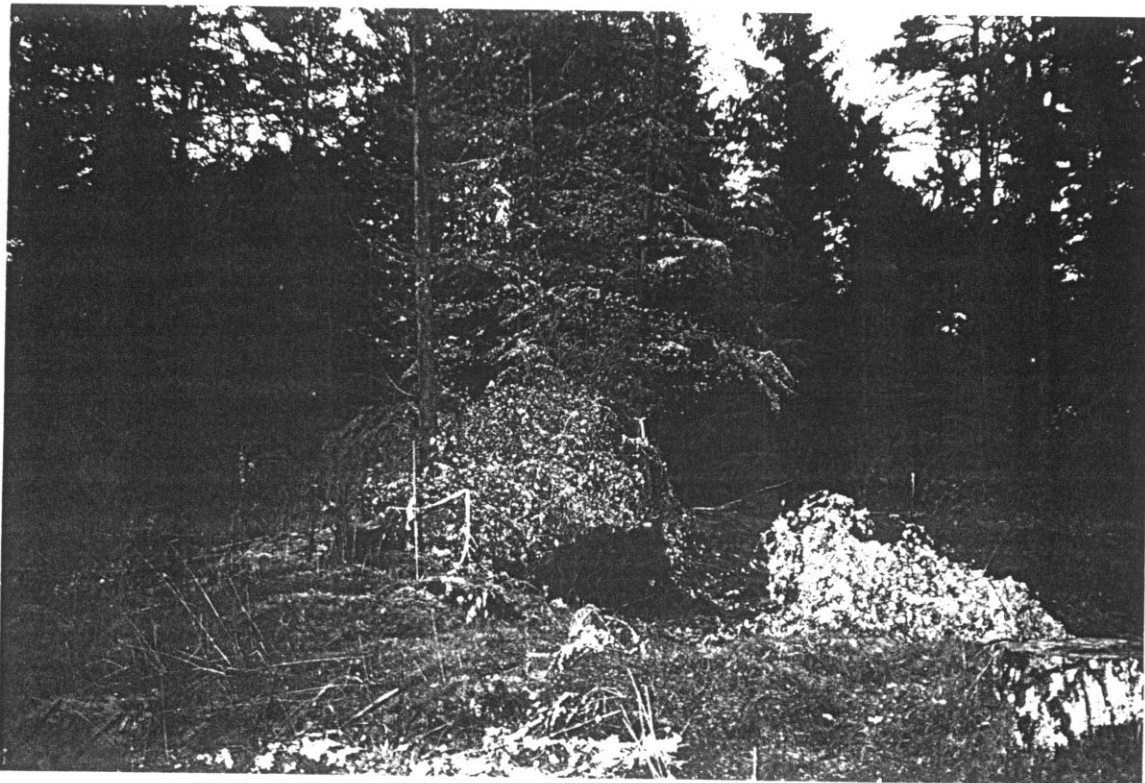
PHOTO 6. Hut circle E from the SW.

Hut circle E has not been fully cleared and the trees on the wall are beginning to blow. The trees on the wall should be felled to waste before further damage occurs. A photograph in Appendix IV shows the upturned root plate of the blown tree.

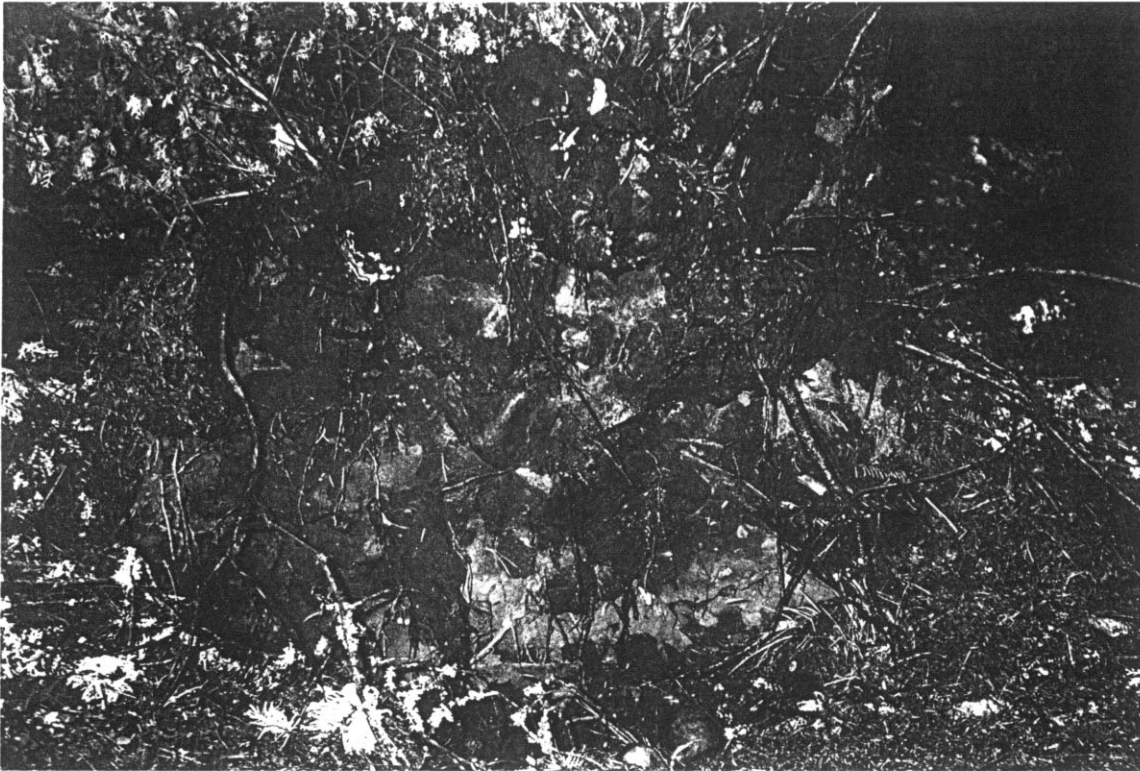
PHOTO 7. A close-up of the blown root plate on hut circle E.

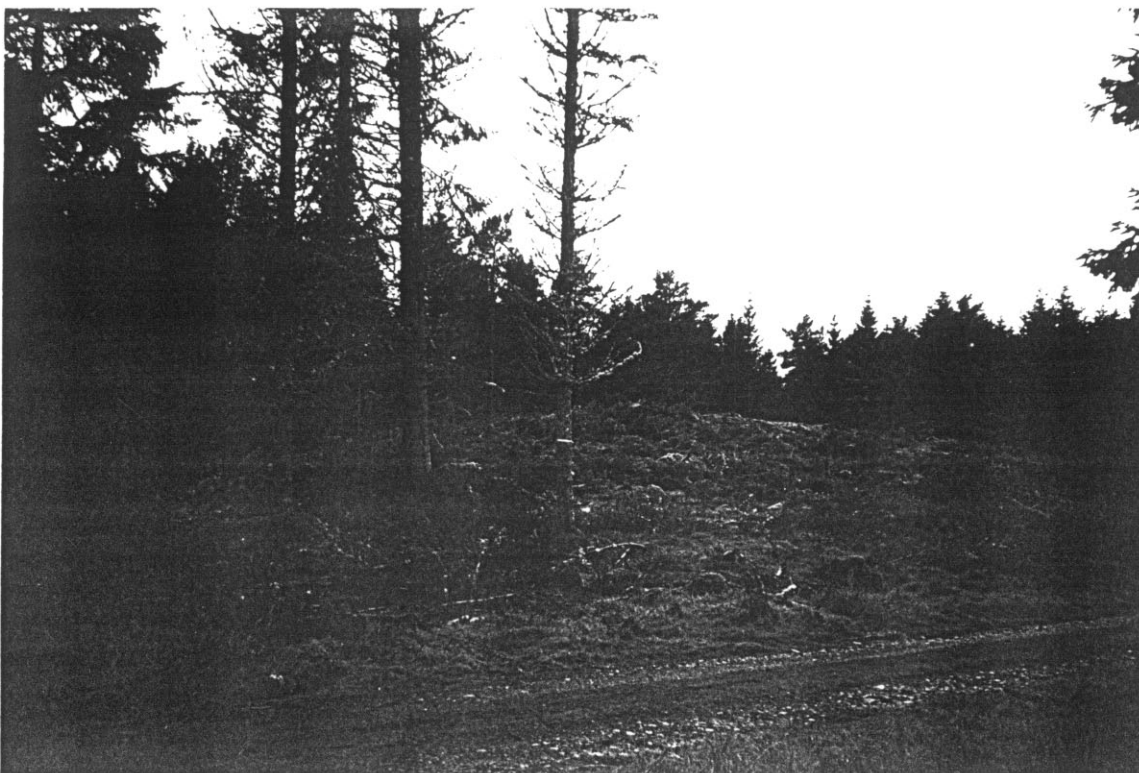
PHOTO 12. Hut circle N/O/P from the NE.

A small holly bush is growing in the centre of hut circle N. The roots of this tree will be disturbing the archaeological deposits relating to the occupation and use of the hut circle, and it must be felled to prevent further damage occurring.

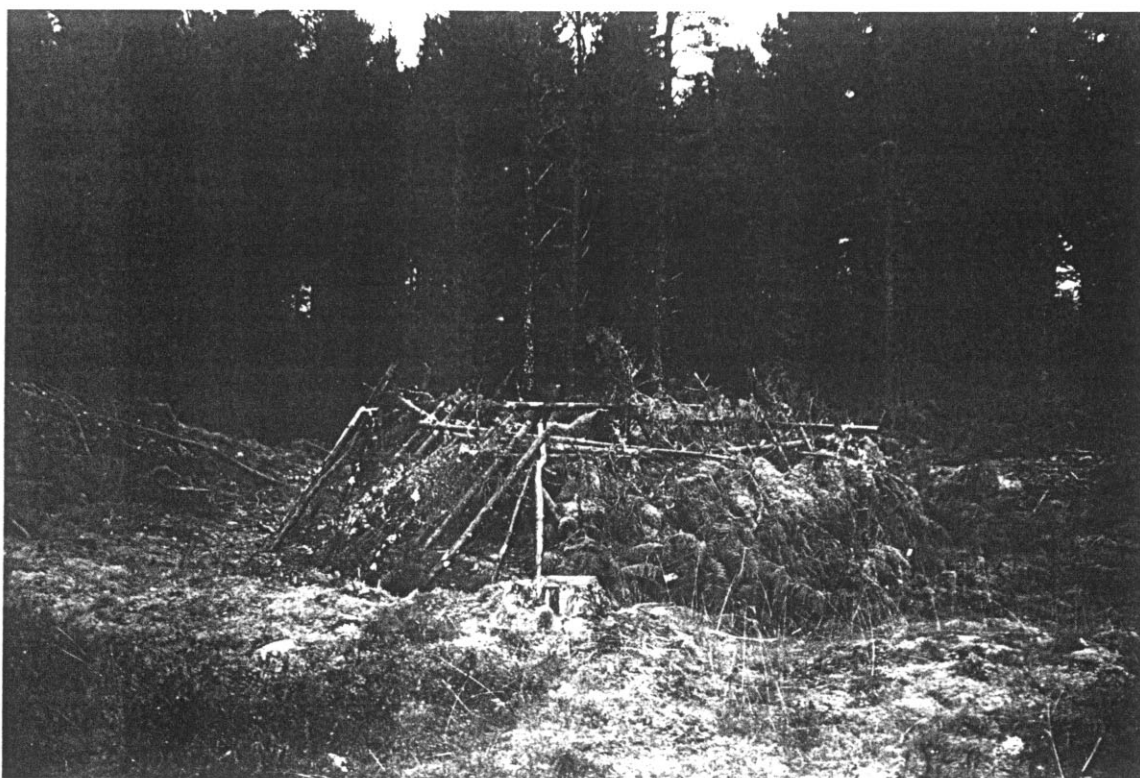
PHOTO 13. Teepee built in hut circle N by children presumably

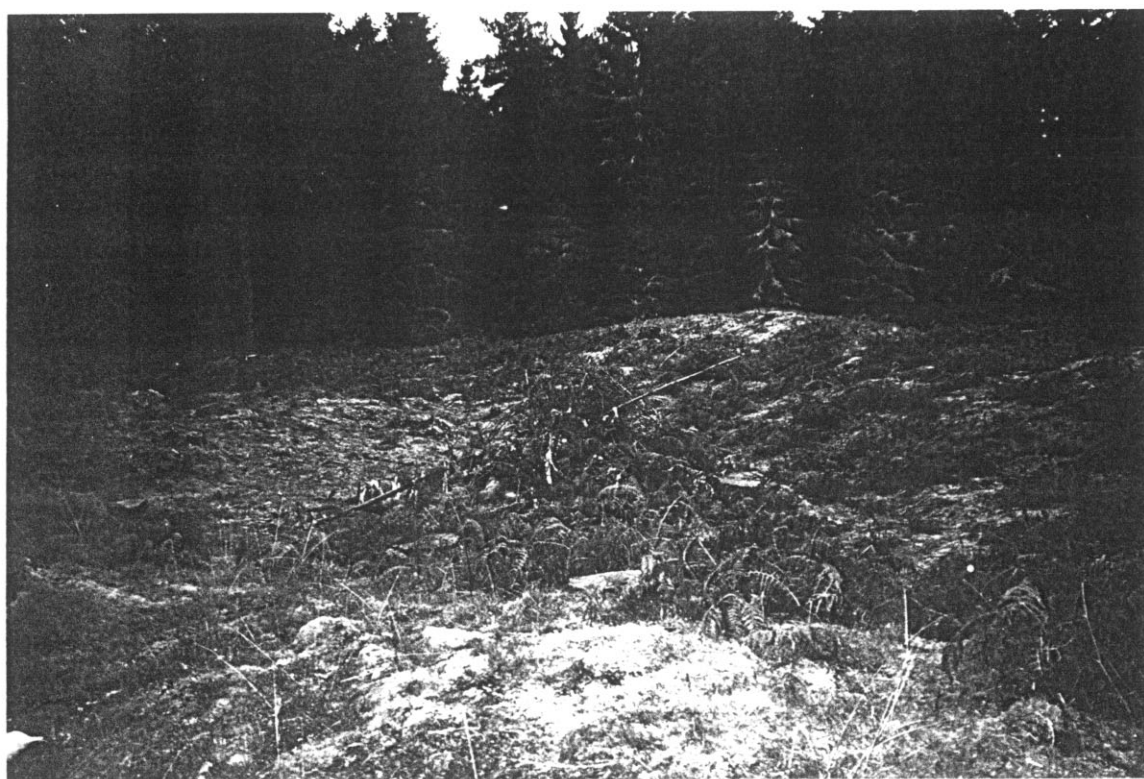
PHOTO 14. Smaller teepee in hut circle O

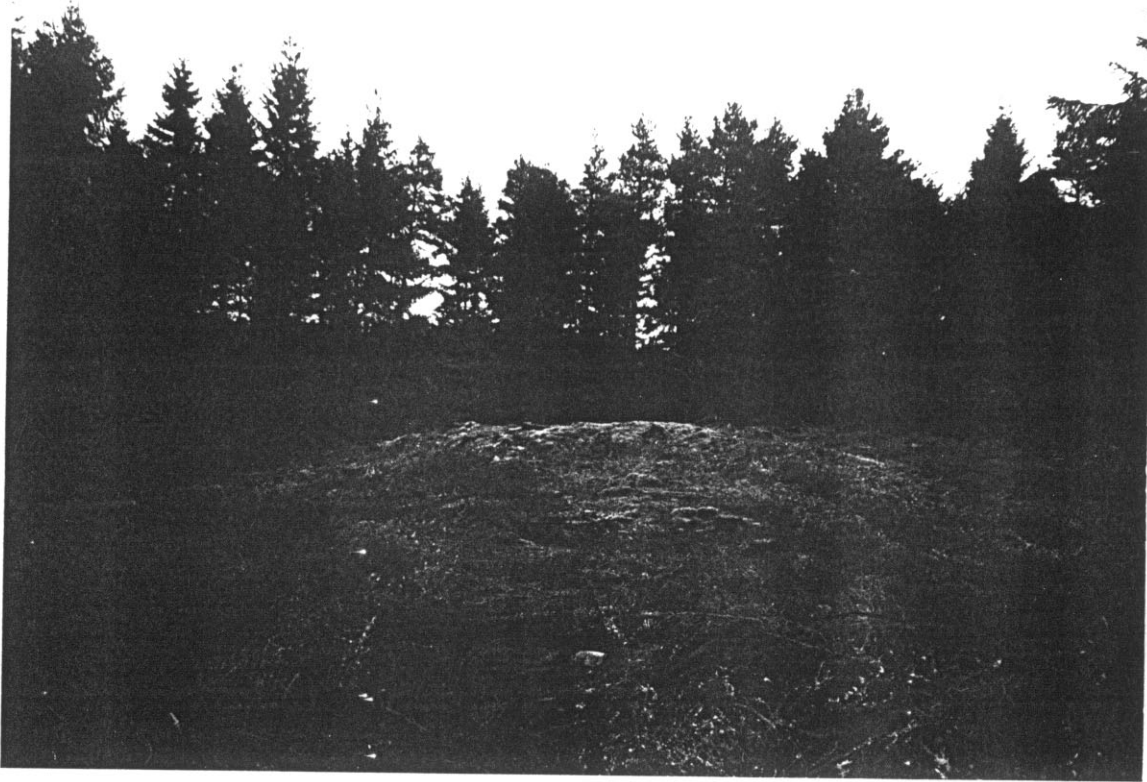
PHOTO 15. Hut circle Q from the SW.

Hut circles L, N/O/P, Q and Q1 are directly adjacent to forest roads. The forest road network is not due for upgrade within the plan period but maintenance works could take place. The scheduled areas are recorded in the conservation plan which the Area Civil Engineer has a copy of and therefore no damage should occur to the scheduled areas.

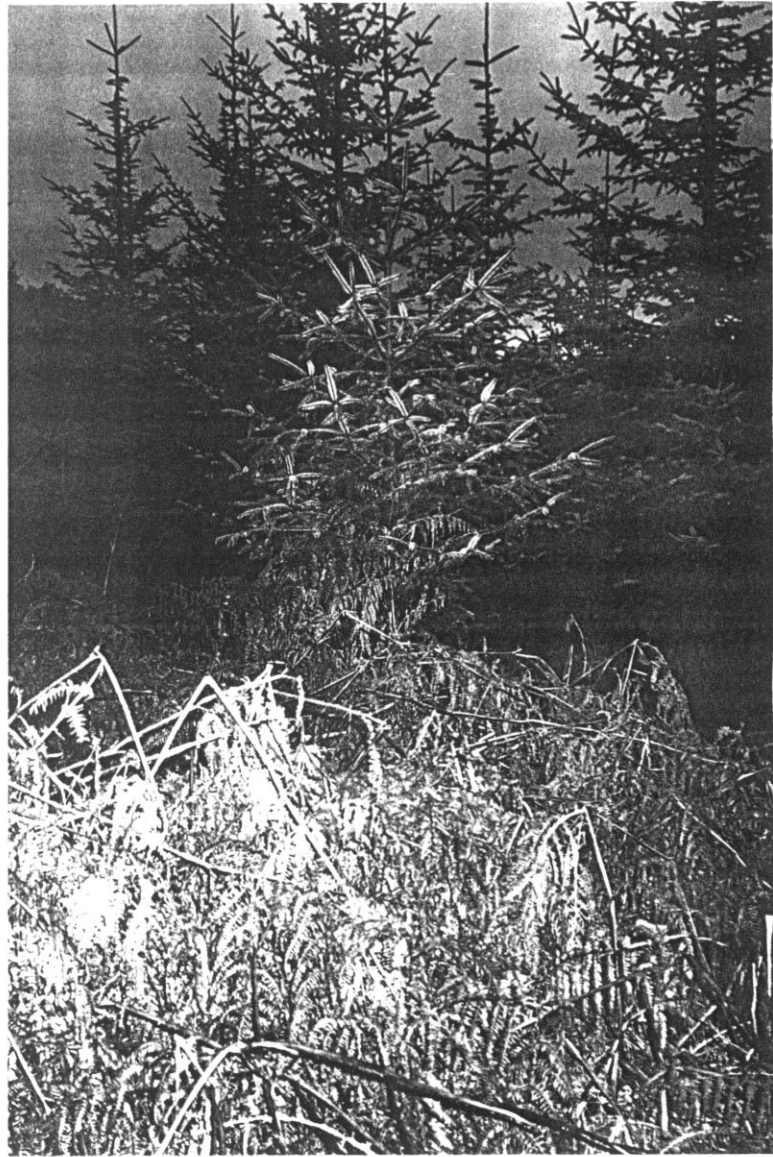
PHOTO 21. Hut circle W from the SW. Showing the tree on the outside wall.

MANAGEMENT REQUIREMENTS The trees need to be removed from the hut circles and taken back to a minimum of 10m where necessary. The bracken requires regular spraying to control it and the regenerated trees need to be removed before they cause damage or become too big.
