**Land 150m SE of Achingale Bridge, Watten,  
Caithness**

**Erection of new house, installation of septic tank and  
soakaway, upgrade existing vehicular access**

**Ref no. 08/00068/REMCA**

**Archaeological Watching Brief**

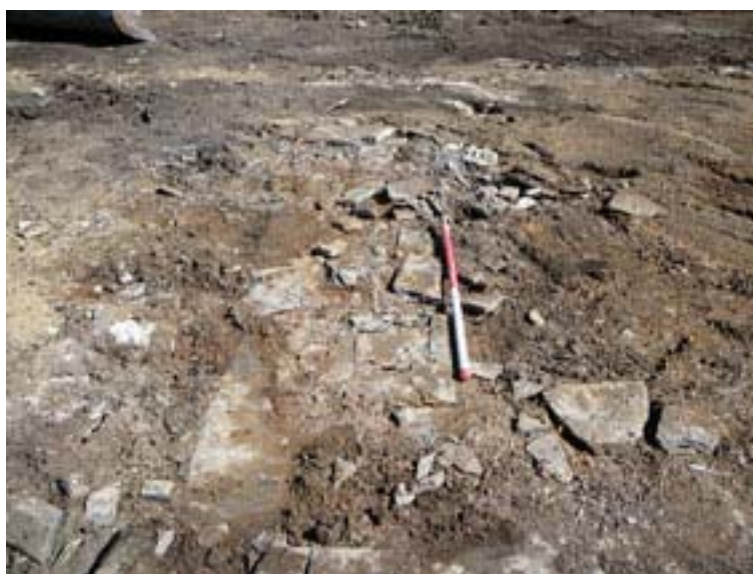
This was carried out on 4.6.08 in dry and sunny weather conditions. Removal of the overlying rubble and soil exposed the footprint of the former building, clearly visible initially as an orange sandy and stony rectangle surrounded by darker, brown and more organic soil (Photos 6-8) The lowest courses of the outer walls were still evident as thin, broad slabs (Photos 9-12) forming a wall base 0.6m in width.

**Footings of south wall of former building**

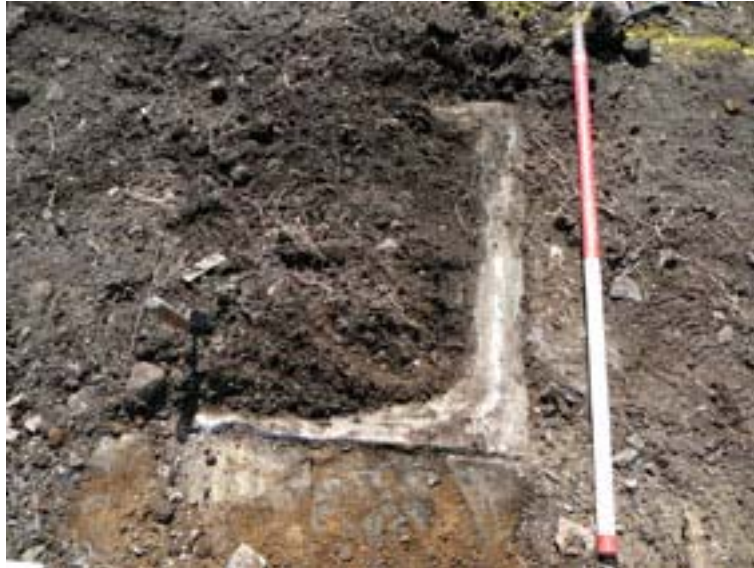
Excavation of the foundation trenches exposed a large concrete trough, measuring 3m long by 0.75m wide inserted into the floor within the internal doorway (Photos 16-18) This is presumably the sheep dip noted before the building was demolished. As this lay between trenches, it was not lifted.

**Edge of concrete sheep dip trough exposed during excavation of foundation trench**

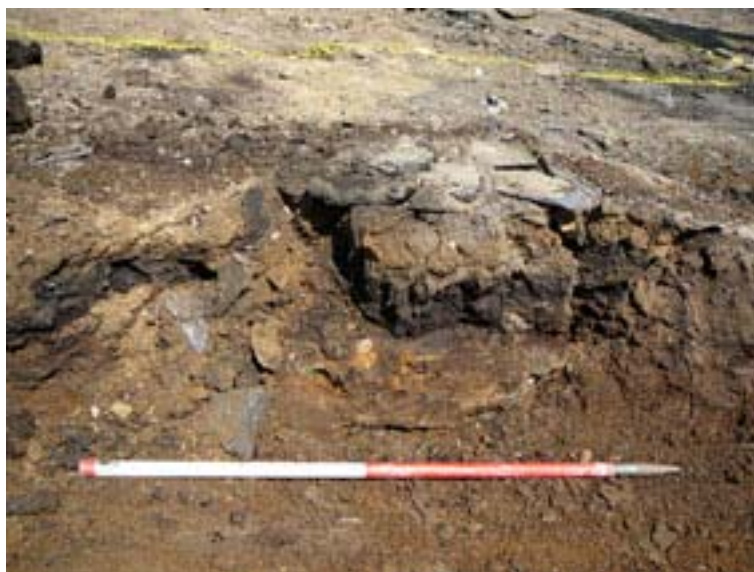
Removal of the floor slabs revealed that they were laid on a gritty red-orange subsoil material, possibly re-deposited. However, where the foundation trench crossed the south outer wall of the former building a more complex stratigraphy was noted: (Photo no. 19)

1. Floor slabs
2. Yellow-brown gritty-sandy re-deposited subsoil to a thickness of 100mm
3. Dark, black-brown material to a thickness of 100mm. This material had a clay content and appeared to be fibrous
4. Natural subsoil and one large stone measuring 500mm in width, 300mm deep

**Stratigraphy under floor slabs in east part of building, including stone in layer 4**

This suggests a previous use of the site or building. The dark layer, no. 3, may be the residual deposit of a byre or the remains of a collapsed roof. This may have been later covered with a layer of sterile subsoil to seal the floor and level it in order to lay paving. It is unlikely that the present building had a byre on its east side as the site drains to the west and livestock would have been housed west of the living space. This offers the possibility that the most recent building replaced an earlier, although the foundations of that have not survived. Alternatively, the dark material represents an earlier activity on the site unrelated to farm cottages.

The single large stone found in the lowest layer is also curious as it is, although sandstone, not the more typical Caithness slab. Its presence may be natural or it may be the single relict stone of a previous structure

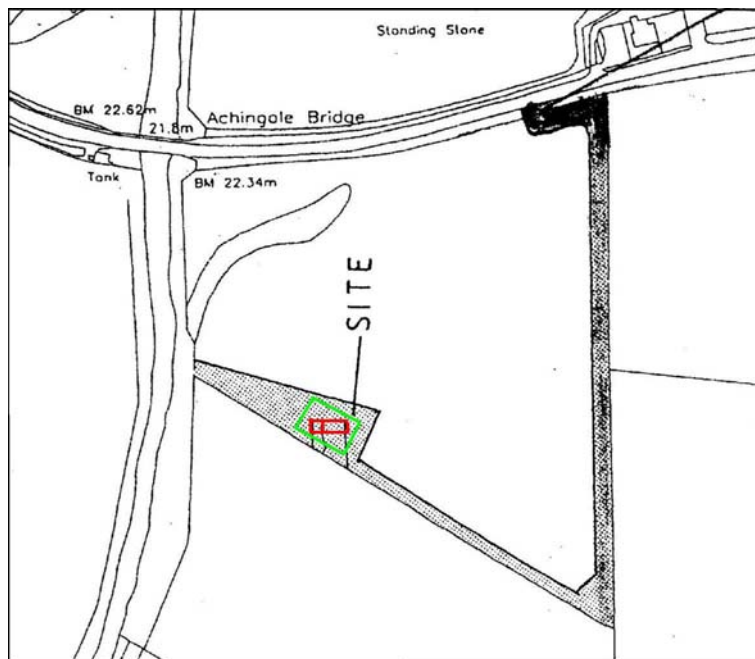
**Fig 3. Site Plan**

Red = footprint of former building  
Green = footprint of new building
