Hilliclay Stemster Water Main Replacement

Watching Brief

Report No.	HAS090101
Project code	HCS08
Client	Scottish Water Solutions
Date	19 January 2009
Authors	Paul Humphreys, Cait McCullagh and John Wood

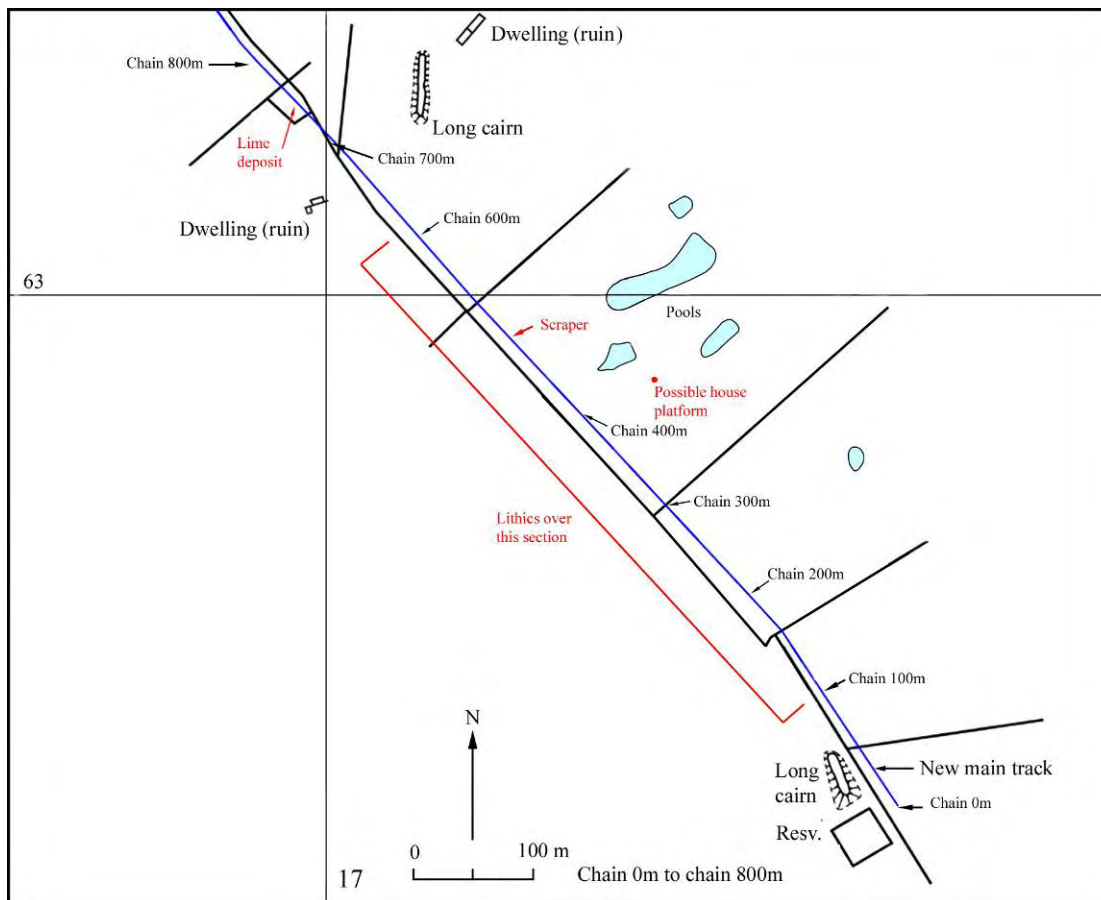
Figure 4 Chain 0m - 800m

At chain 700m the pipe track passed approximately 600 m west of the long cairn (photo 12)(ND 1702 6320).

At this point the pipe track crossed a fence line into an area of poorly drained rough pasture colonised by patches of Gorse (*Ulex europaeus*). The topsoil in this area was peatier than the improved pasture; it varied between 100mm and 200mm deep and overlaid an oxidised stony till interspersed with friable bedrock.

The long cairn (photo 12) and adjacent byre-dwelling (ND 1708 6315) were inspected and photographed as a matter of course (photos 13 to 17). The long cairn had clearly been extensively dug into at some time in the past, leaving the orthostats of the chamber exposed (photo 18).

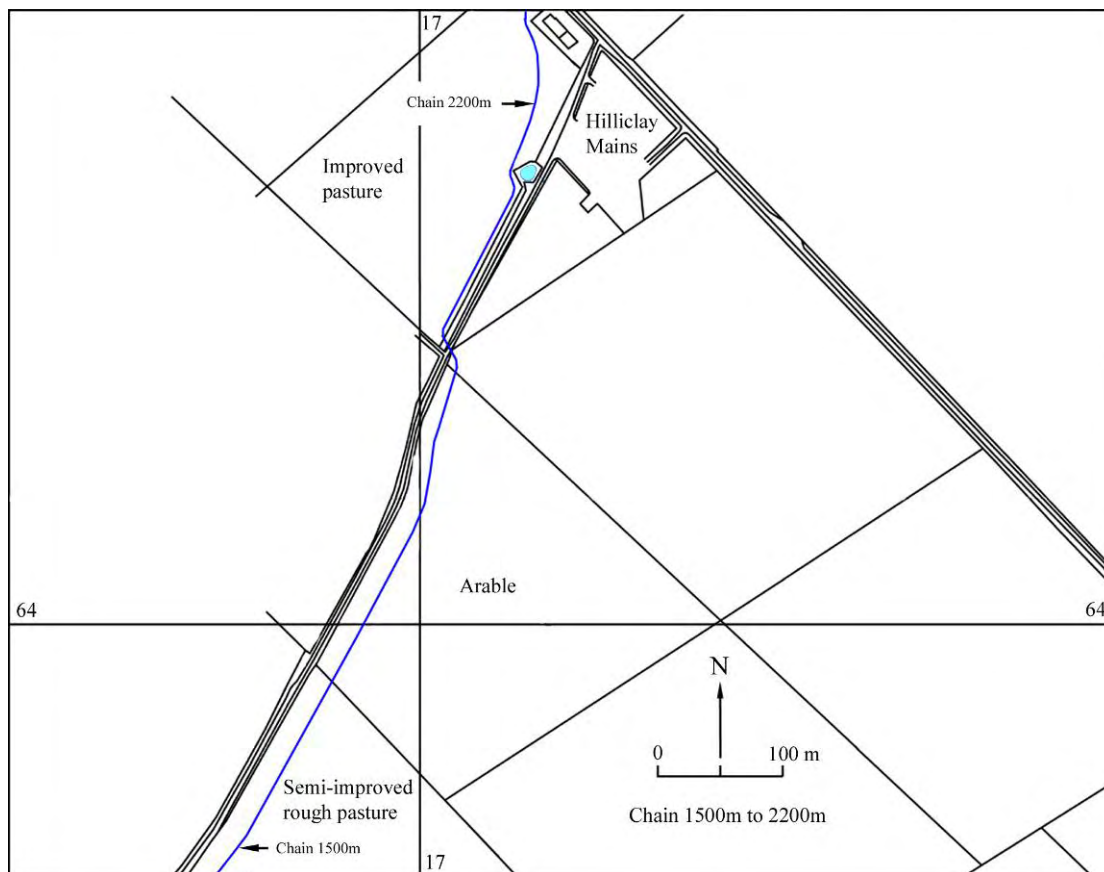
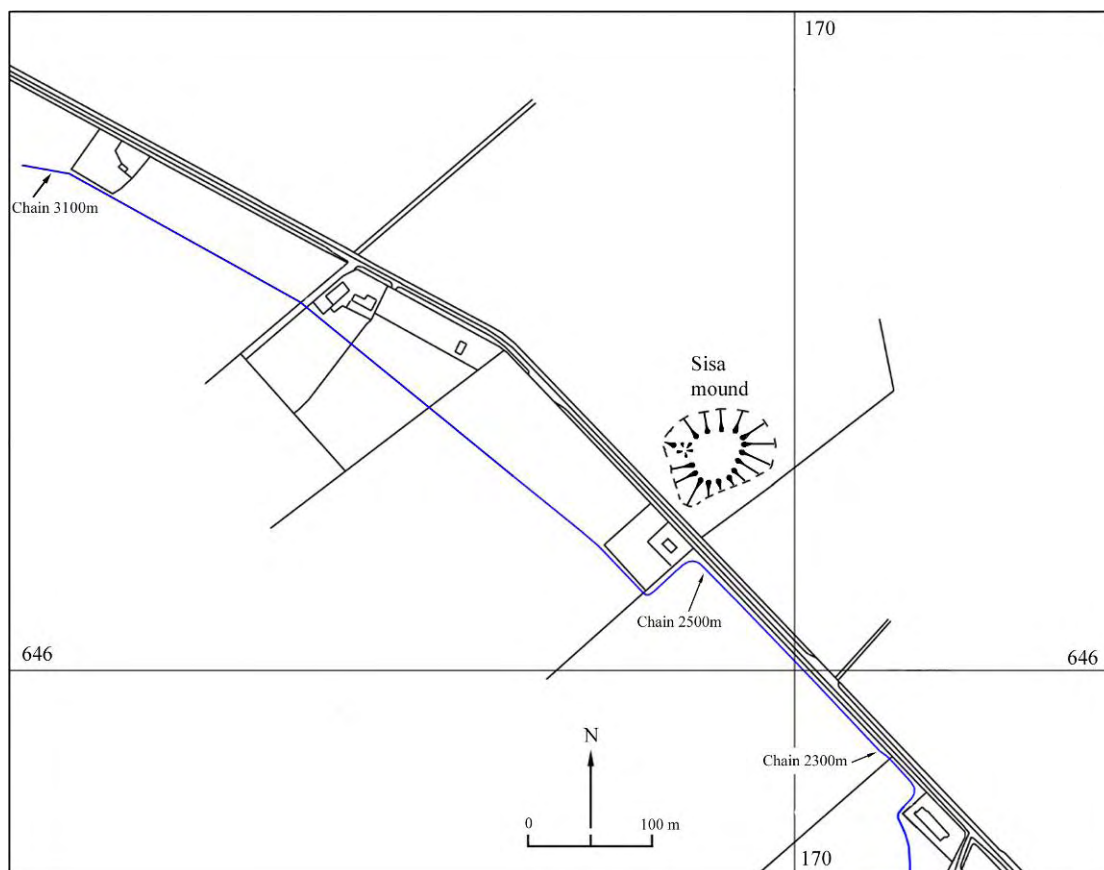
The final section of the pipe route is indicated on figures 5 and 6 below, passing relatively close to the Sisa mound but separated from it by a public road (photo 55). No evidence was found for the supposed road block at ND 1700 6460: the only features encountered were occasional field drains. The bedrock was very close to the surface over most of this section (photo 56).

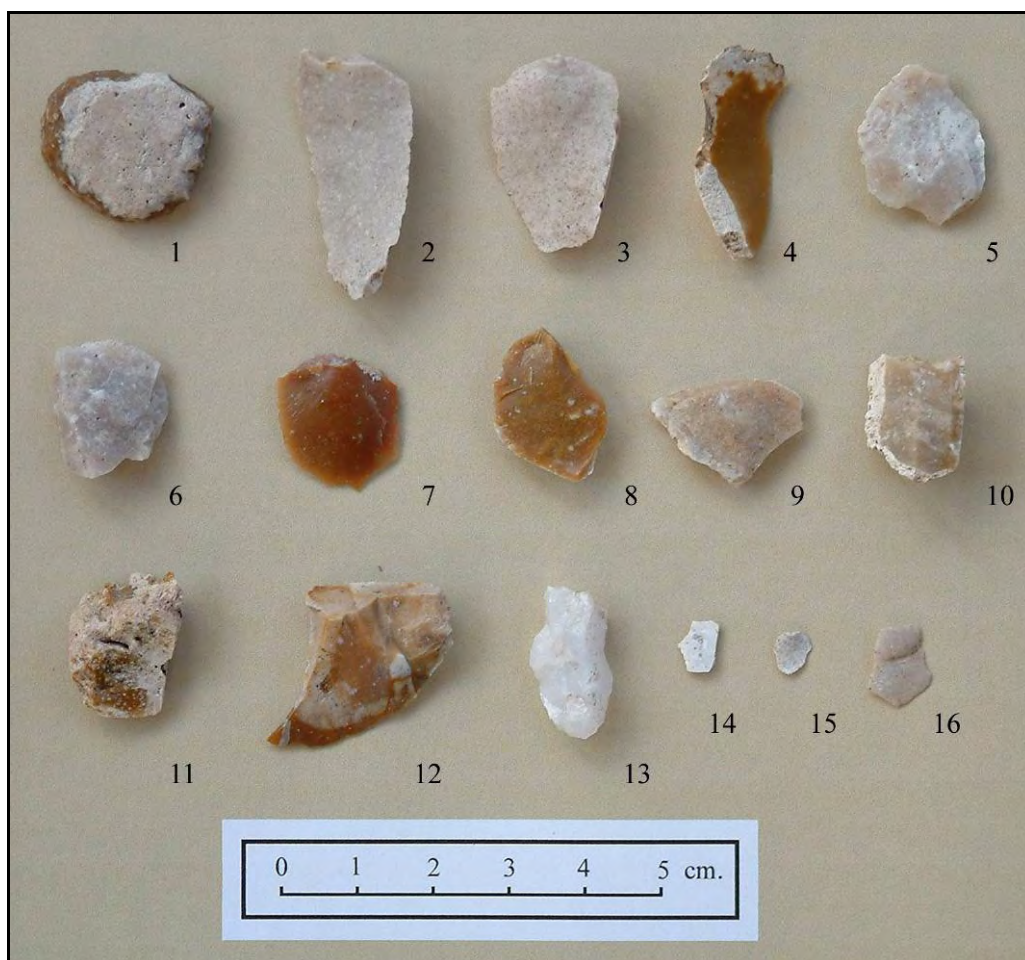
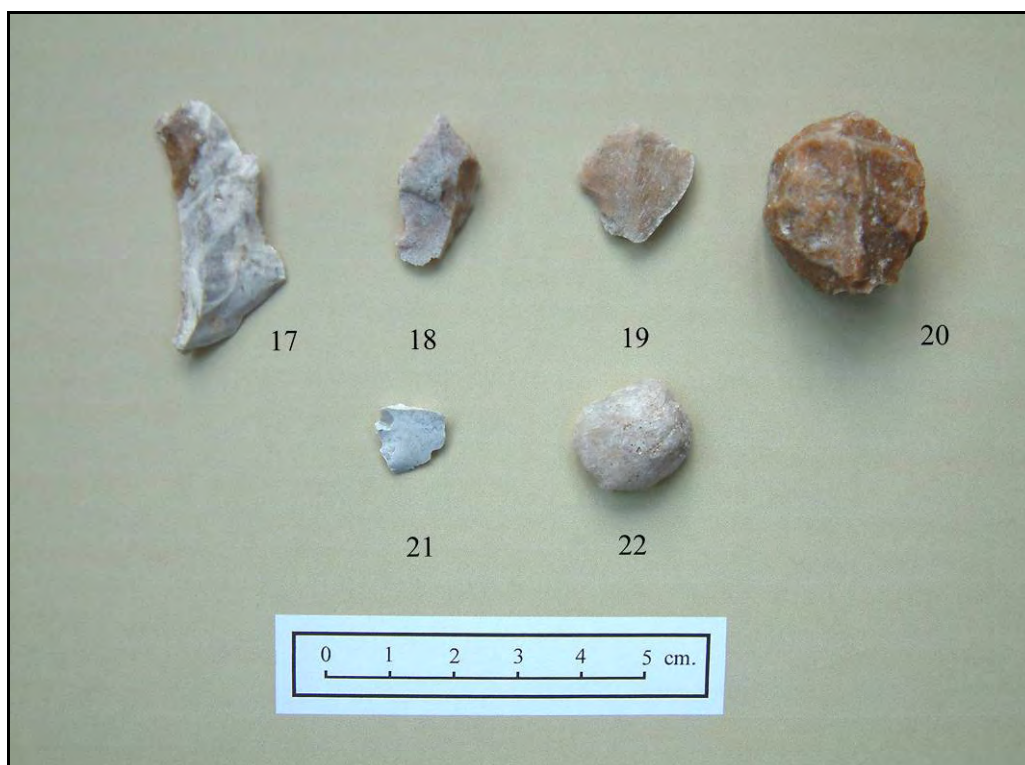
Plate 1 Lithic debitage (Photo 57)

Plate 2 Lithic debitage (Photo 58)

Item (Plates 1 and 2 above) (Photos 57 and 58)

- 1 Material; flint – blank; pebble - flake L 20, W 22, T 7.7 – colour; dark brown – platform; intermediate, retouched – termination; hinge – primary cortex on dorsal surface – retouch to proximal end and sides - thumbnail scraper.

- 2 Material; oolitic chert – blank; pebble – flake (blade proportions) L 31, W 15, T 7.1 – colour; light grey – platform; complex – termination; feathered – primary cortex on dorsal surface – retouch; none – primary core reduction flake.

- 3 Material; oolitic chert – blank; pebble - flake L 25, W 17, T 5.5 – colour; light grey – platform; cortical – termination; feathered – secondary cortex 80% on one edge – retouch; none – core reduction flake.

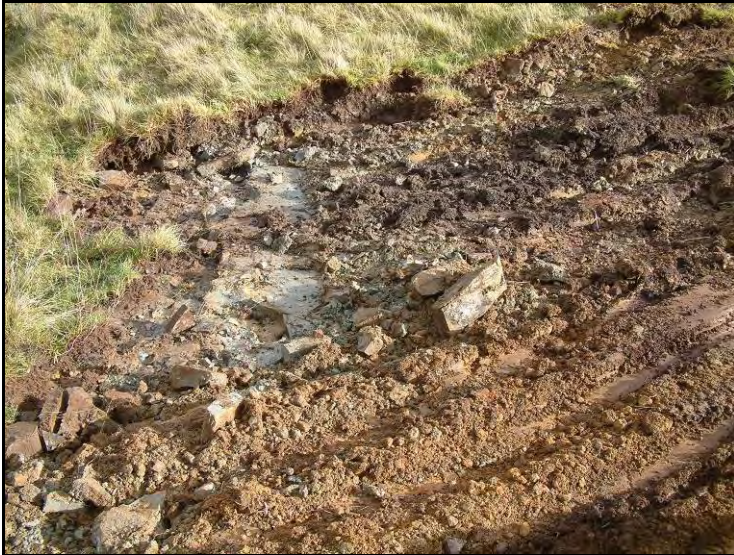
Plate 3 Bedrock and till Mickle Burn (Photo 1)

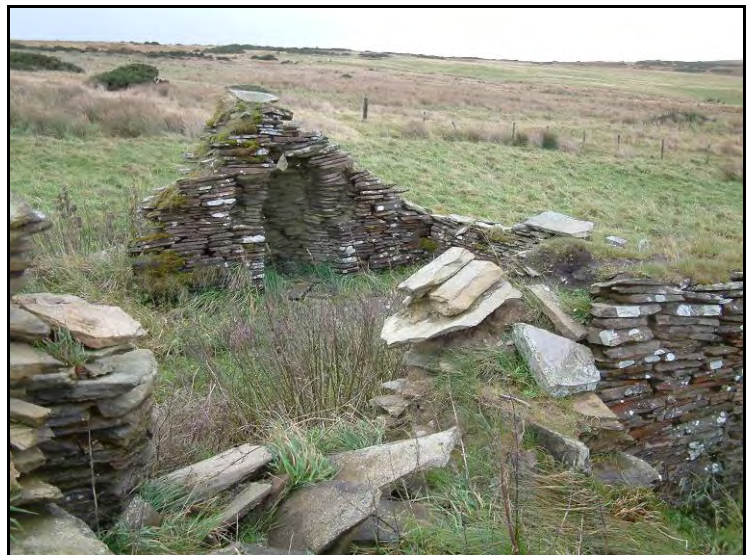
Plate 4 Byre-house ND 1700 6308 extension looking SW (Photo 9)

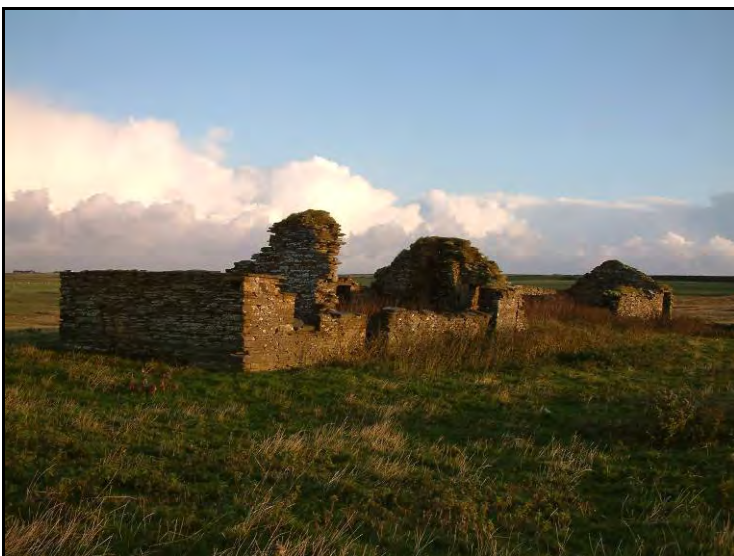
Plate 5 Byre-house ND 1708 6315 looking N (Photo 13)

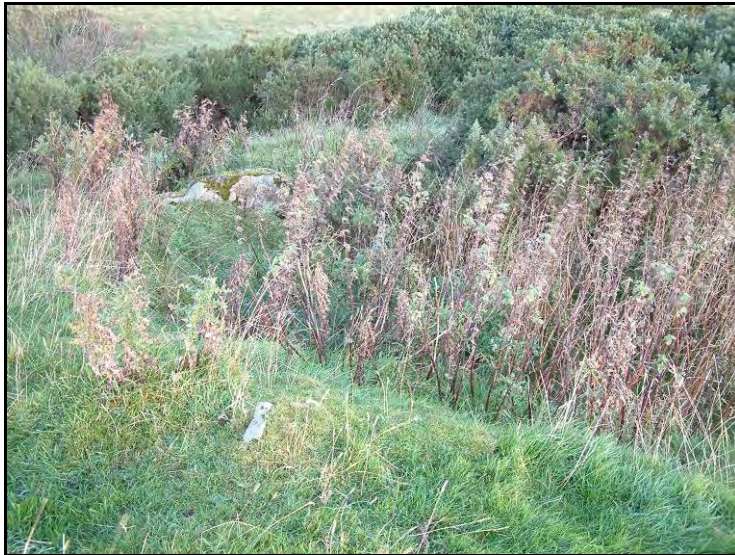
Plate 6 Long cairn ND 1702 6320 – past chamber damage, looking W (Photo 18)

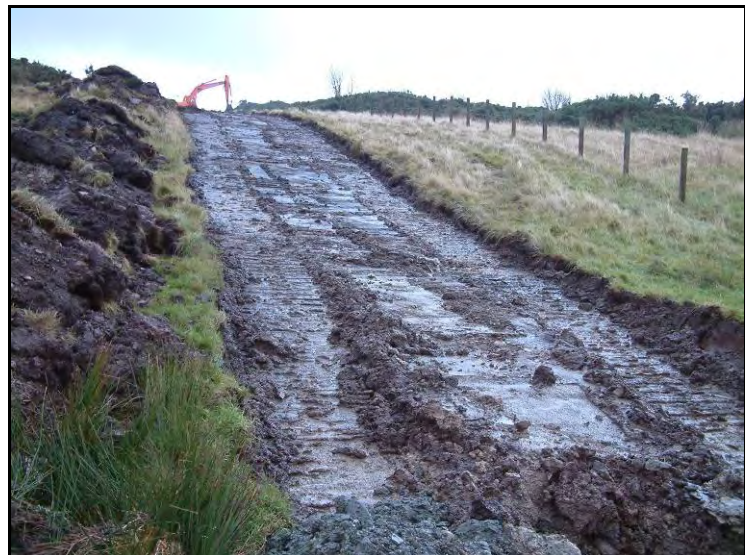
Nothing other than 19th century pottery was noted in the stripped area closest to the long cairn. At circa chain 600m, the land started to rise towards the reservoir (photo 20). The thin top soil over this section was noticeably peaty; overlaying bedrock (photo 21).

Plate 7 Trench stripping at chain 600m (Photo 20)

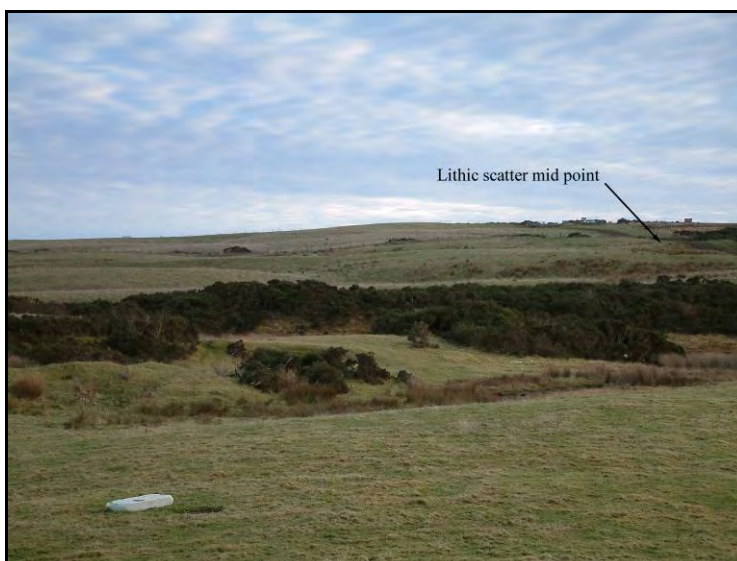
Plate 8 Topography; looking S from byre-house ND 1708 6315 (Photo 24)

The topography just to the east of mid point of the lithic scatter (chain 400m)(ND 6320 7190) comprised a series of natural mounds interspersed with water filled hollows (photos 22 and 23). On one of these mounds the vestiges of a possible house platform (ND 1727 6294) could be discerned (photo 24 to 26). Nothing was noted between chain 100m and chain 0m. The thin topsoil over bedrock continued over the section (photo 27).

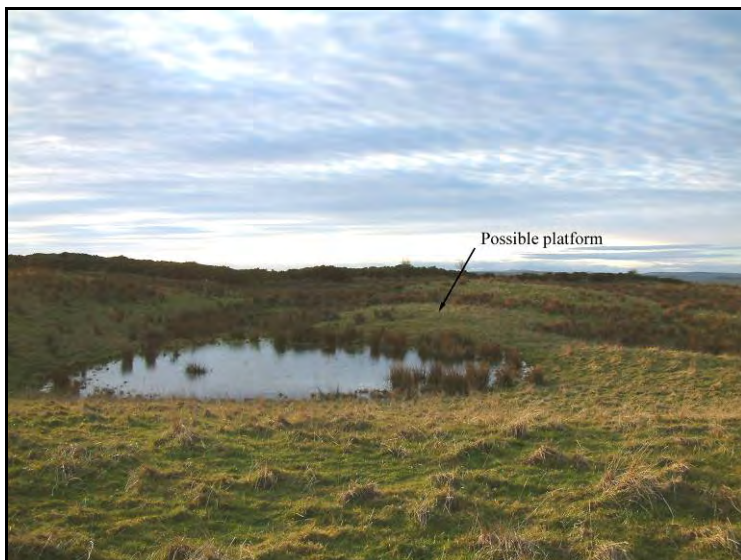
Plate 9 Possible house platform at chain 400m looking NW (Photo 25)

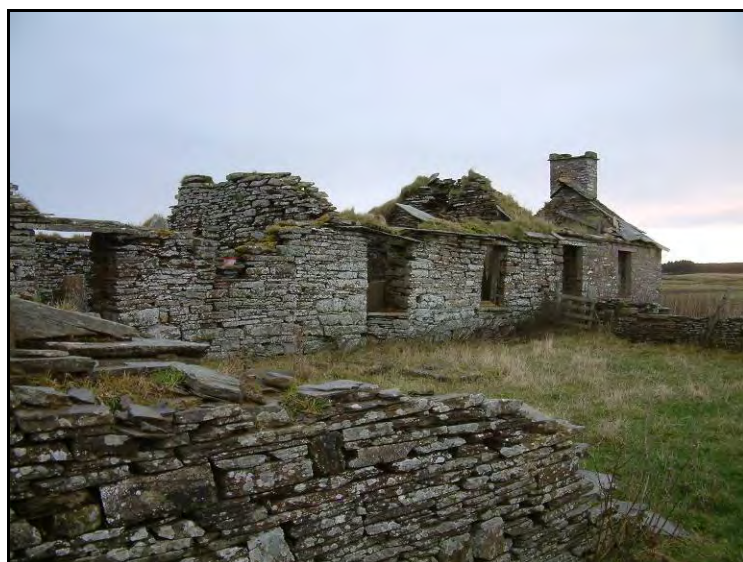
This section crossed the Mickle Burn to the east of the ruined byre-house at ND 1670 6350 (photos 28 to 39) and traversed two fields of improved pasture before turning north into an area of, poorly drained, rough pasture (figure 2). A broch (now ploughed away) is known to have been sited close to the chain 1220m (photo 40). The position of the broch as recorded on the 1st edition OS map was transposed onto a modern edition to allow comparison with the OS grid reference recorded for the broch location (ND 1679 6360). It was noted that the planned trench path ran through the centre of the most likely position of the broch. A re-routing of the pipeline path 30 m to the west of the supposed location was agreed with the contractor. Subsequent stripping and trenching revealed nothing of note suggesting that the broch site had been successfully avoided (photo 41). The only finds over the whole section were very occasional sherds of modern pottery.

Plate 10 Byre-house ND 1670 6350 looking E (Photo 28)

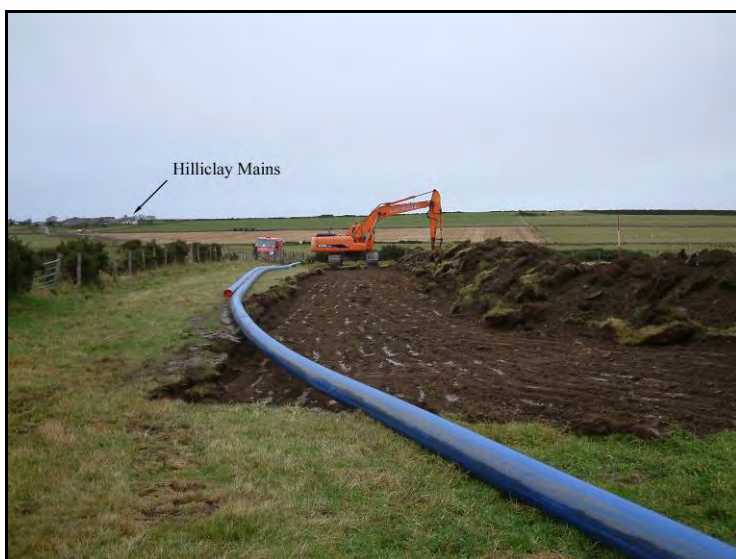
Plate 11 Route up to Hilliclay looking NE (Photo 42)

The trench track continued, though rough pasture, rising through a field of arable towards a ridge running NW / SE and Hilliclay Mains farm (ND 1710 6430)(Figure 4; photo 42). The trend of thin topsoil over bedrock and thin rocky till continued over the whole section (photo 43). Most of the buildings comprising Hilliclay mains were relatively modern however the Hilliclay mill building and wheel pit are still extant and were photographed as a matter of course (photos 44 to 46).

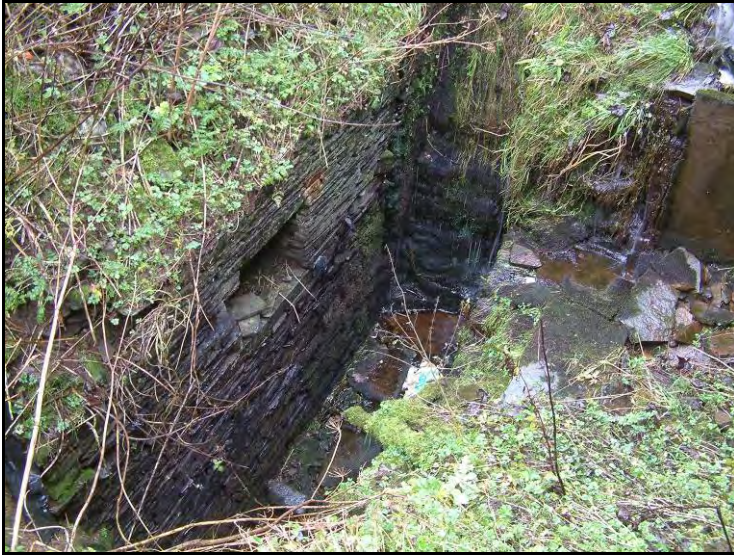
Plate 12 Watermill wheel pit at Hilliclay Mains (Photo 46)

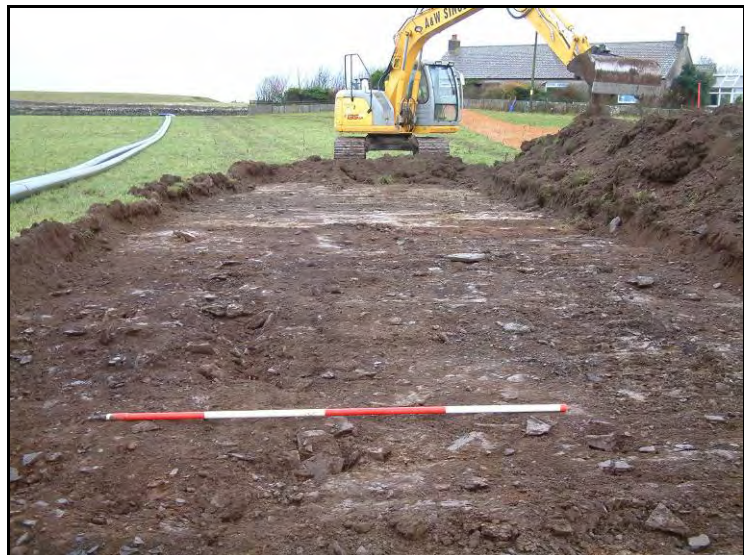
An area of disturbance was noted beneath the top soil on the crest of a slight ridge (ND 1707 6437) (photos 47 to 49). The loose small stones were most likely ripped from the bedrock crest by ploughing; however cuts containing red and black stained clay deposits were also noted (photos 50 and 51). The usual interpretation would be 19th century field drains containing deposits of iron and manganese oxides, however the disposition of the 'drains' on the ridge was unusual. It is also conceivable that the feature represents robbed out wall footings of a rectilinear building (photo 53). A further cut, several metres to the north of the feature, was more convincing as a field drain (photo 54).

Plate 13 Disturbed area; Hilliclay Mains, looking NE (Photo 50)

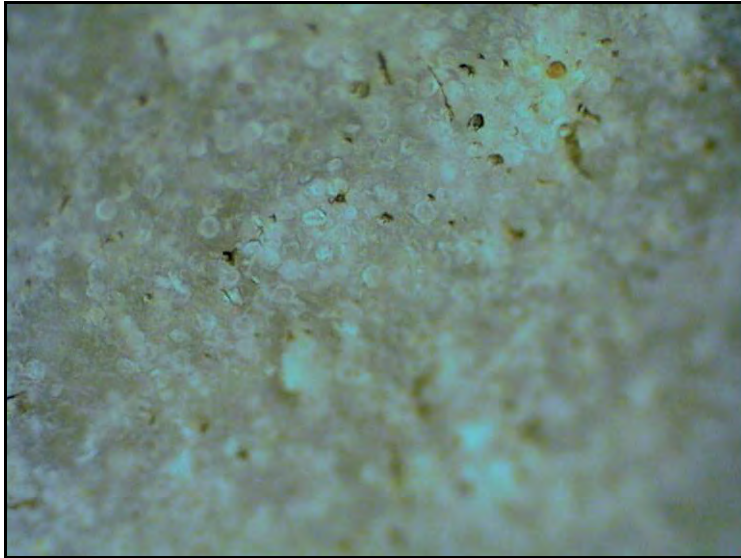
Plate 15 (x40) - item 2, photo 57 - close packed, sub-spherical oolites, ranging in diameter from circa 60 to 120 microns (Photo 59)

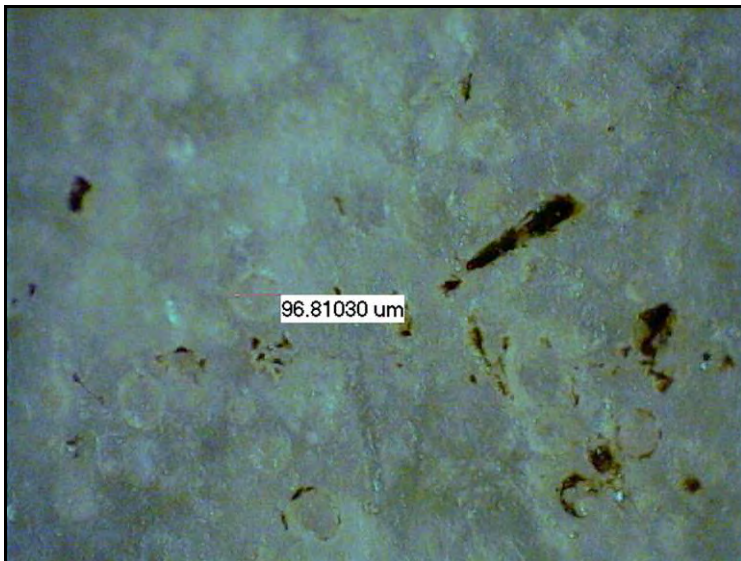
Plate 16 (x100) - item 2, photo 57 - close packed, sub-spherical oolites, ranging in diameter from circa 60 to 120 microns. (Photo 60)

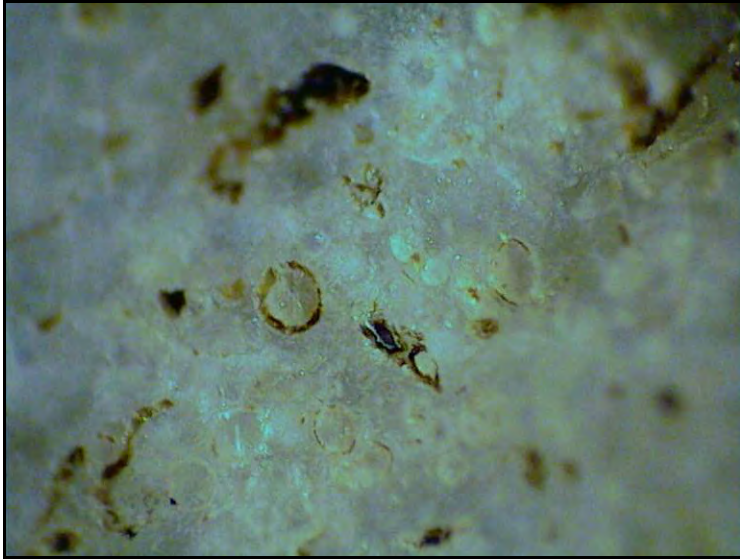
Plate 17 (x100) - item 3, photo 57 - similar to item 2. (Photo 61)

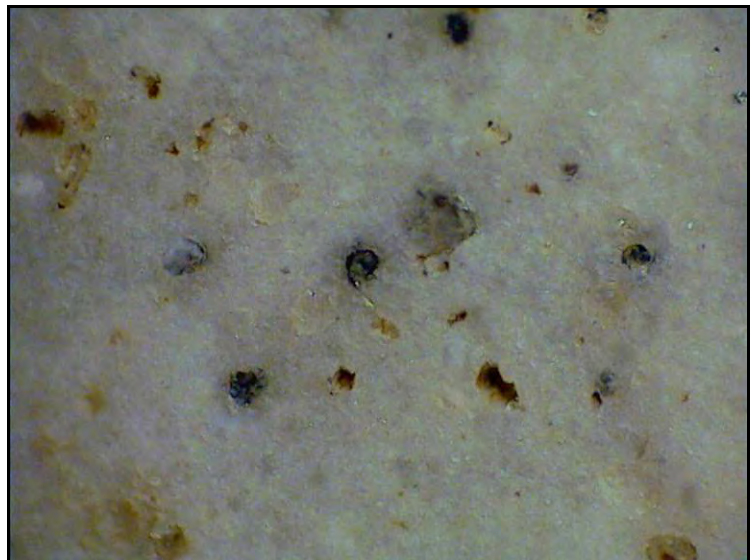
Plate 18 (x100) - item 15, photo 57 - incorporates dark oolitic particles giving a speckled appearance (Photo 62)

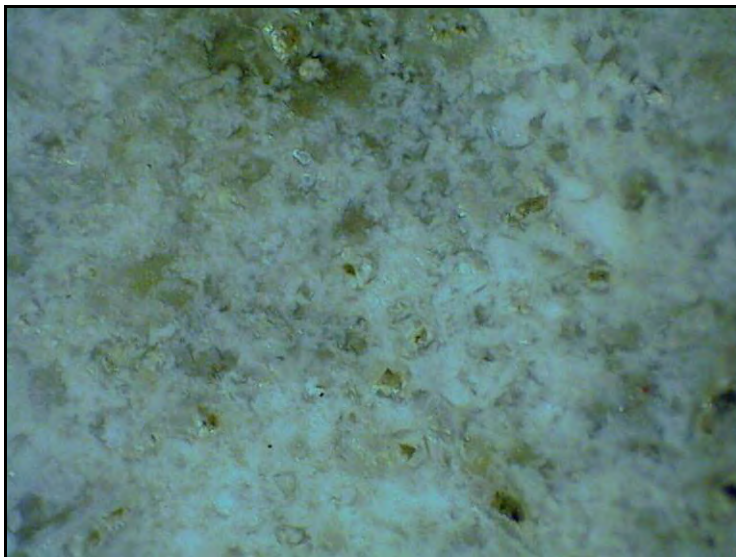
Plate 19 (x100) - item 17, photo 58 - close packed mix of more angular crystals as well as sub-spherical oolites (Photo 63)

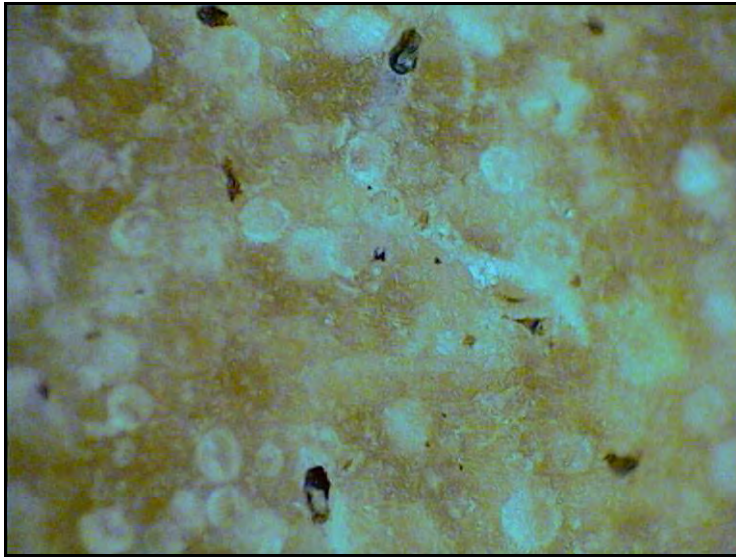
Plate 20 (x100) - item 19, photo 58 – similar to item 2 but having iron stained matrix material (Photo 64)

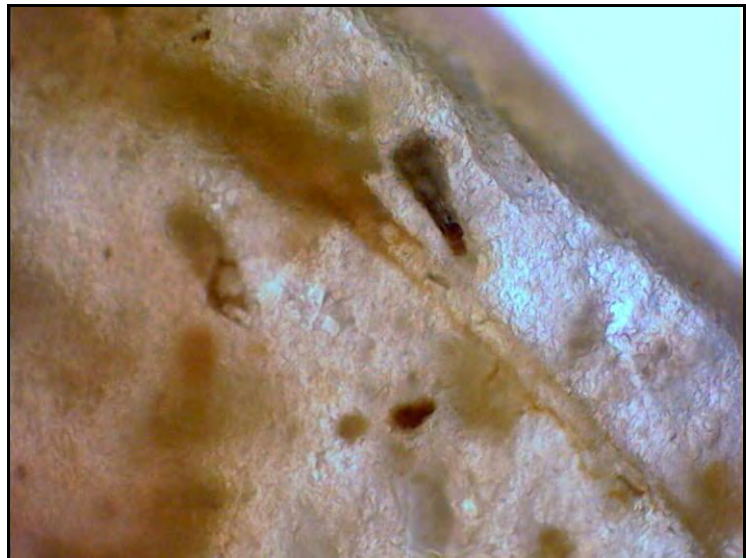
Plate 21 (x100) - item 7 (photo 57) - translucent microcrystalline flint reference material (Photo 65)
