*Archaeological Survey & Photographic Recording at
Fearn Free Church,
Planning Application SU-08-412
Highland Council Archaeology Unit brief 31 October 2008,
Aspire Project UID HH 2009/01*

**Standard Building Survey at Fearn Free Church, Fearn, prior to alteration and change
of use of church to form family house with annex
Planning Application SU-08-412
as detailed in a brief by Highland Council Archaeology Unit (HCAU) 31 October 2008,
Aspire Project UID HH 2009/01**

Building Survey at Fearn Free Church

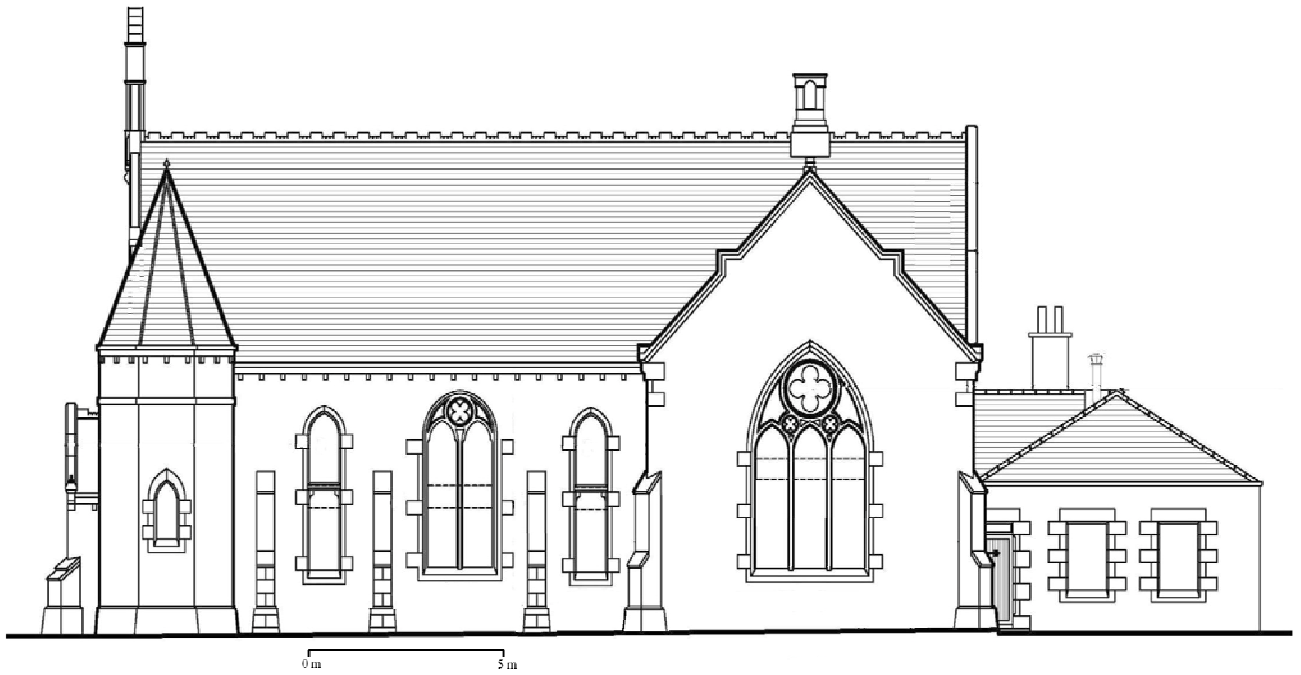
- Figure 2 - scale drawing of south elevation page 12
photograph 2 - south elevation
shows: rendered stonework with three buttresses on the wall and two on the transept;
two single light windows with mullions W 14 & W 16;
one double light window W 15; and one triple light window W 17 in the transept

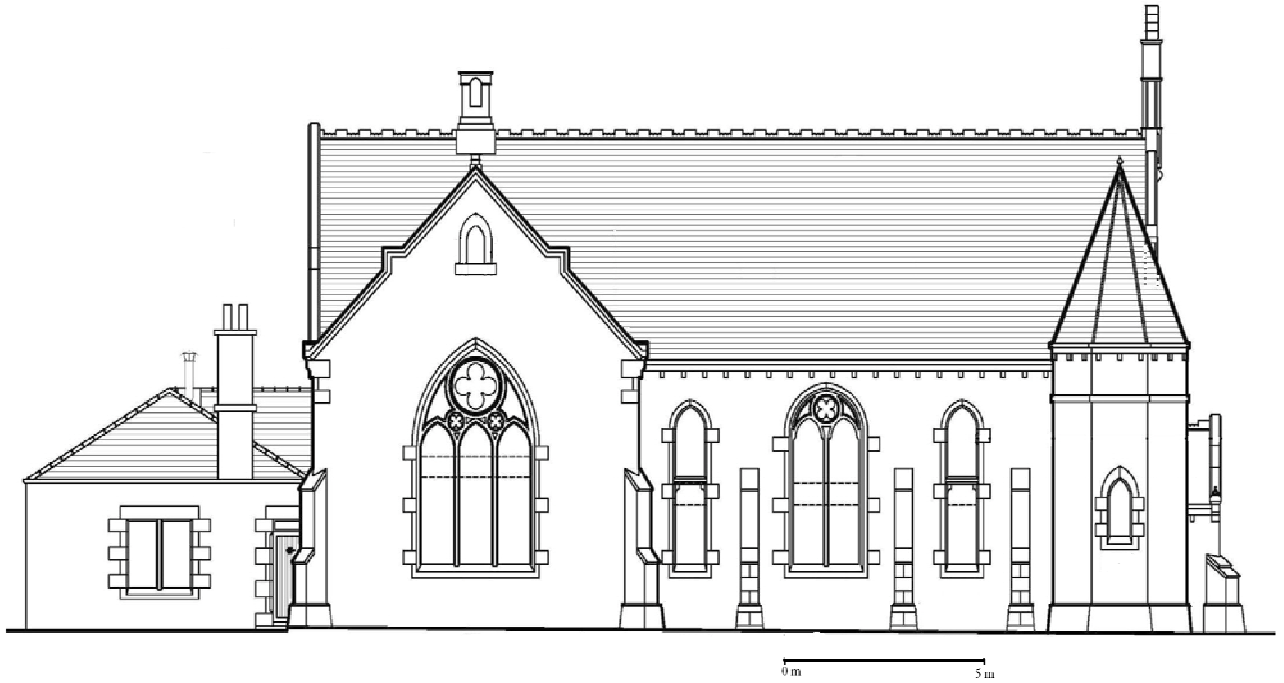
- Figure 3 - scale drawing of north elevation page 13
photograph 3 - north elevation
shows: unrendered stonework with three buttresses on the wall and two on the
transept; two single light windows with mullions W 2 & W 4; one double light
window W 3; and one triple light window W 1 in the transept

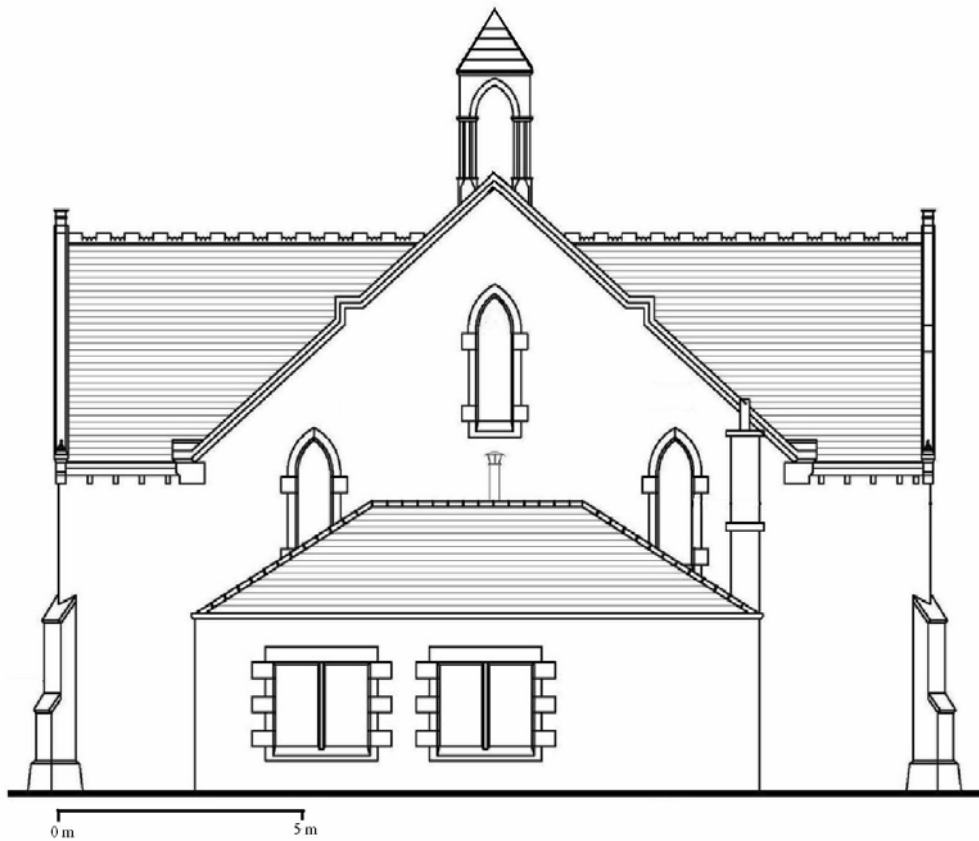
Figure 4 - scale drawing of the rear or east elevation

- the upper transept 'window' is a blank
- the buttresses on the north and south elevations are probably decorative additions
- Figure 4 - scale drawing of rear or east elevation page 14
photograph 4 - rear or east elevation
shows: rendered stonework; windows W 18 & W 19: the upper gable 'window' is a blank

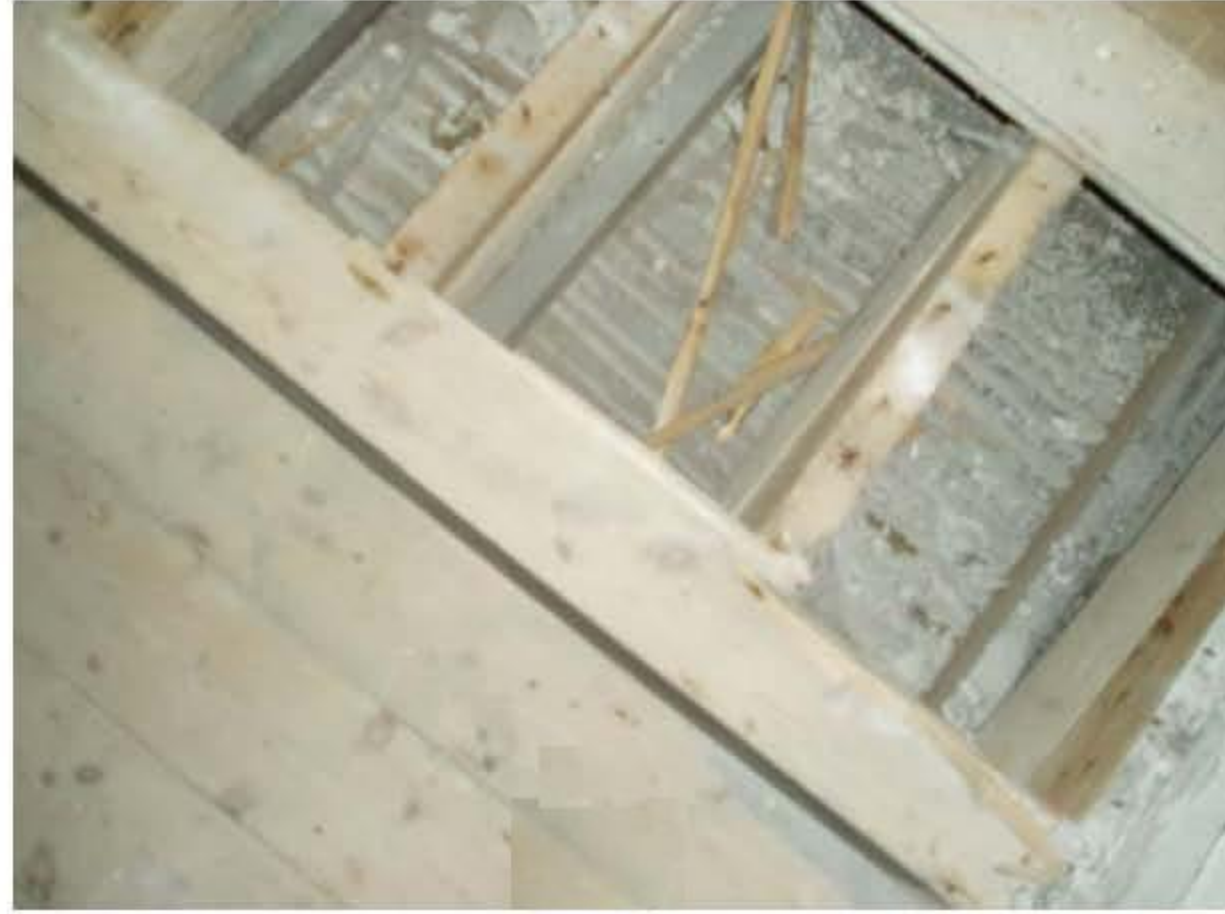
12 - structure revealed of balcony over N transept

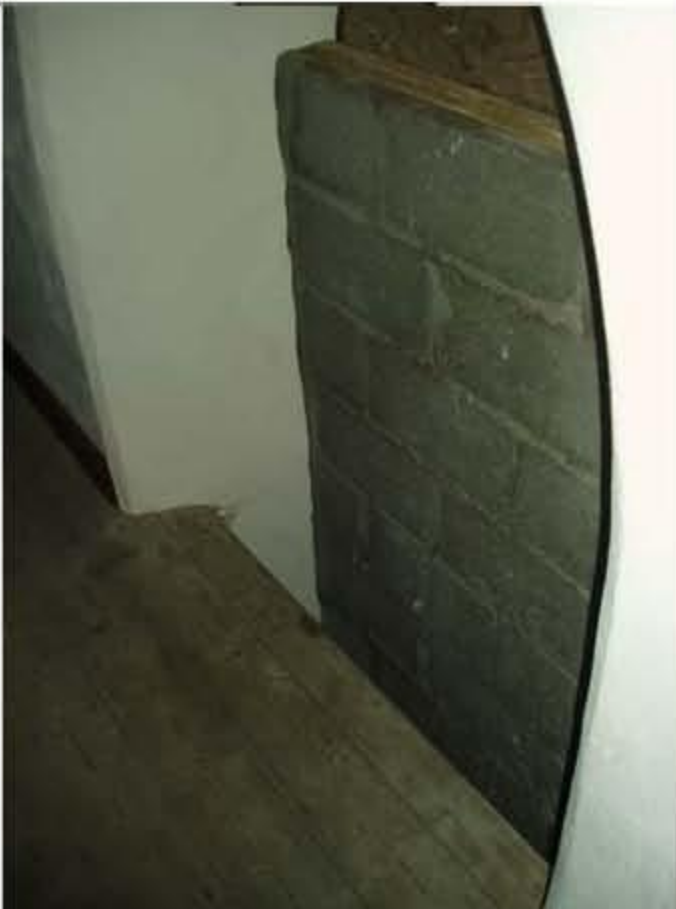
13 - gap between upper balcony wooden floor and window

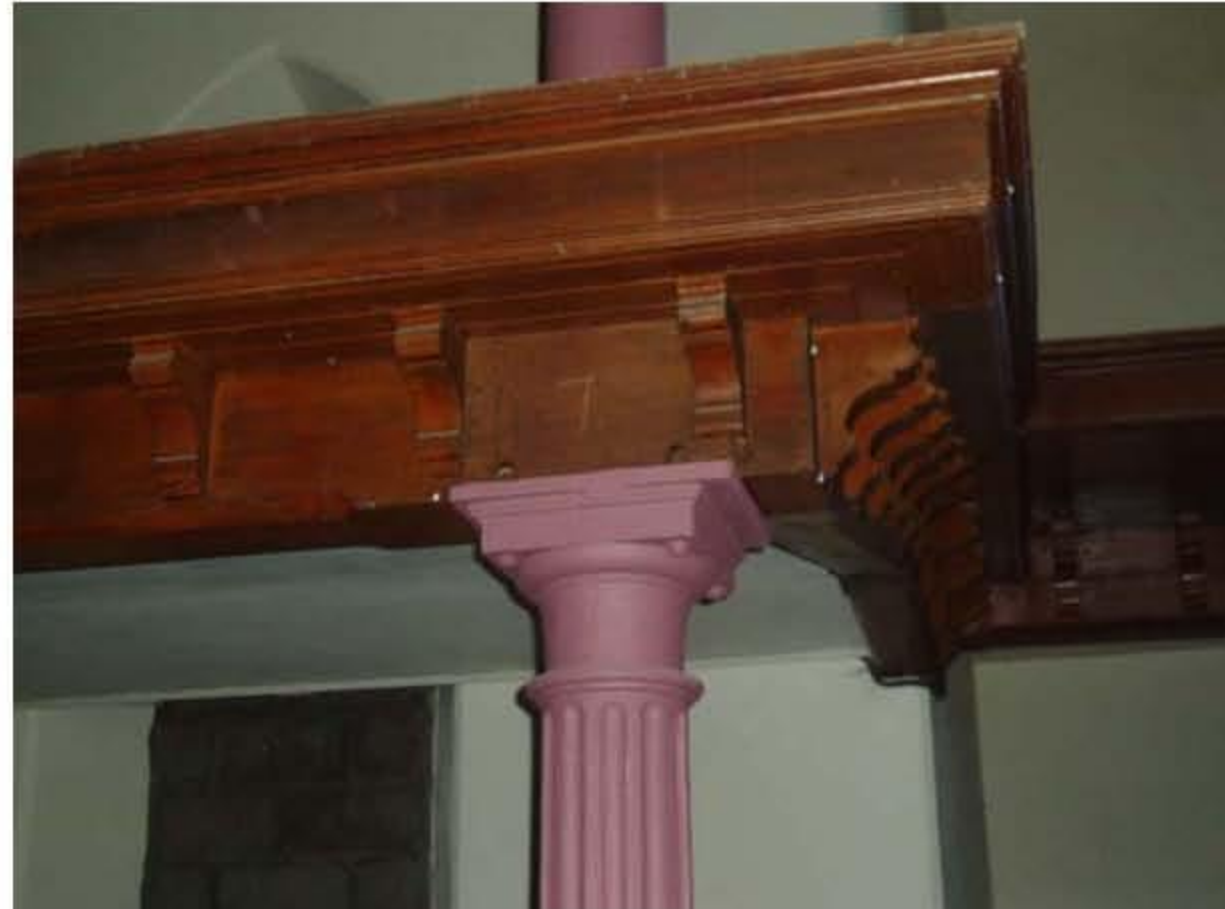
14 - detail of capital of column LP1 and corner of balcony

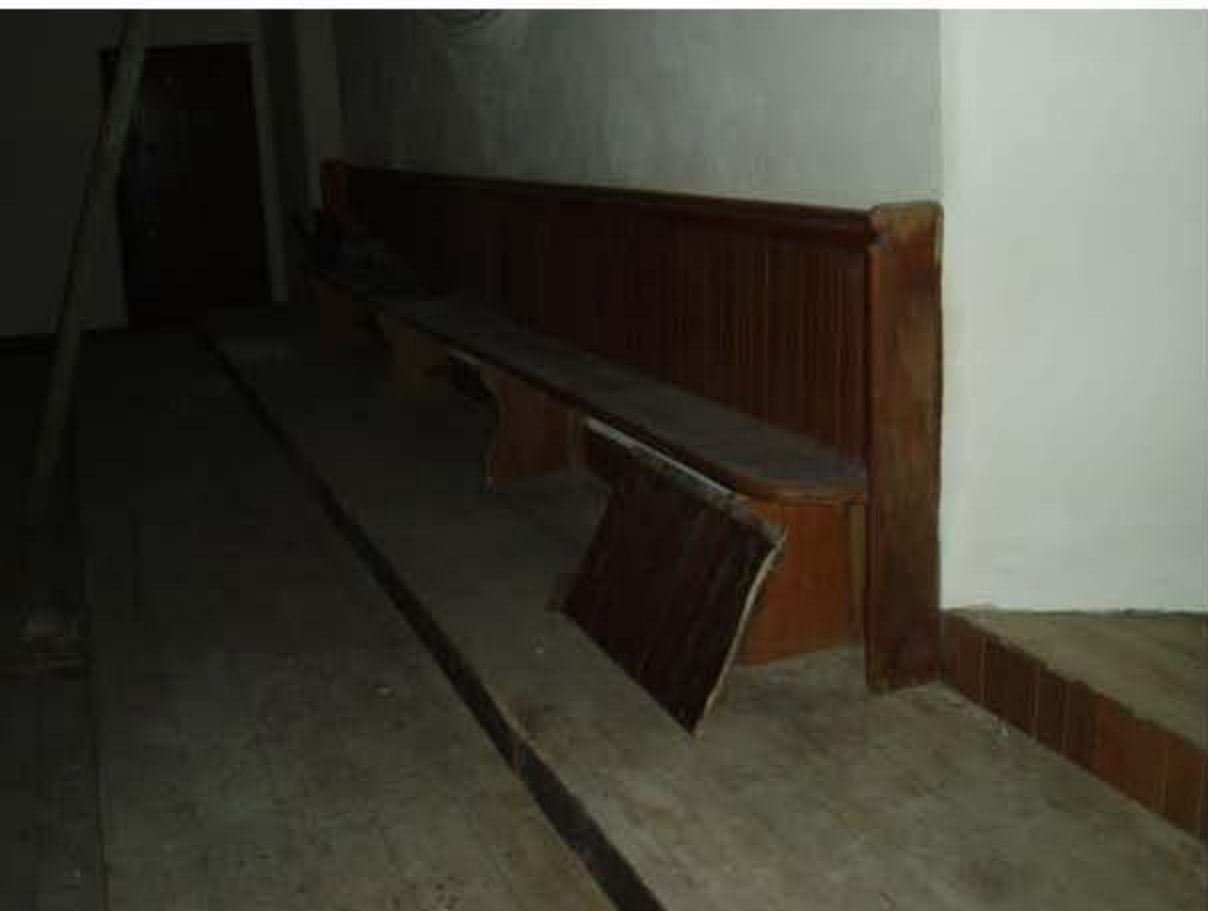
The interior is essentially in sound undamaged condition, however it has been stripped of all non-structural items leaving an empty shell - the sole exception is a single bench pew attached to upper west wall (photograph 15). All window glass has been removed; and the openings blocked with brick and wood panels, except for upper sections of the transept windows W 1 & W 17 (photograph 21). The style may best be described as the surviving original classically influenced Georgian simplicity, with plain wall surfaces, large windows and careful attention to proportion and relationship between features. This contrasts but does not clash with the restyled Gothic exterior - and the two styles are in surprising harmony.

15 - only surviving bench pew

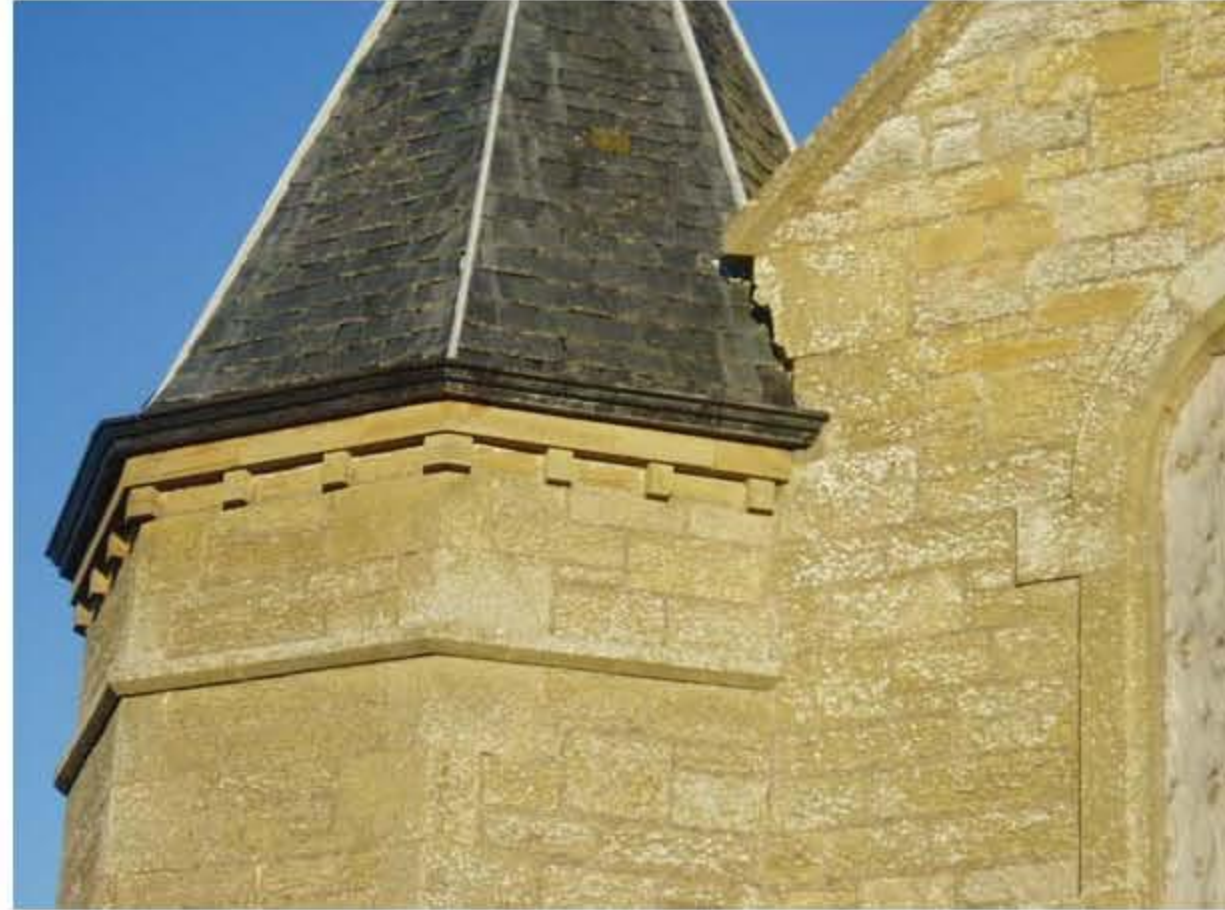
Photographs 6 (NW tower) and 7 (SW tower) show how the towers are less than perfectly keyed into the original west gable and side wall and roof lines - the compromise height appearing slightly too high or too low according to the line of view. Photograph 8 shows a good join between the SW tower and the south wall but none of the stones are keyed in. The original corner shown in photograph 6 would have looked like the new corner he created for the SE corner of the south transept (photograph 10). There was more success when the new transept east wall was keyed into the east gable (photograph 9) and the join is hardly noticeable.

6 - join between upper NW tower and W gable roof line

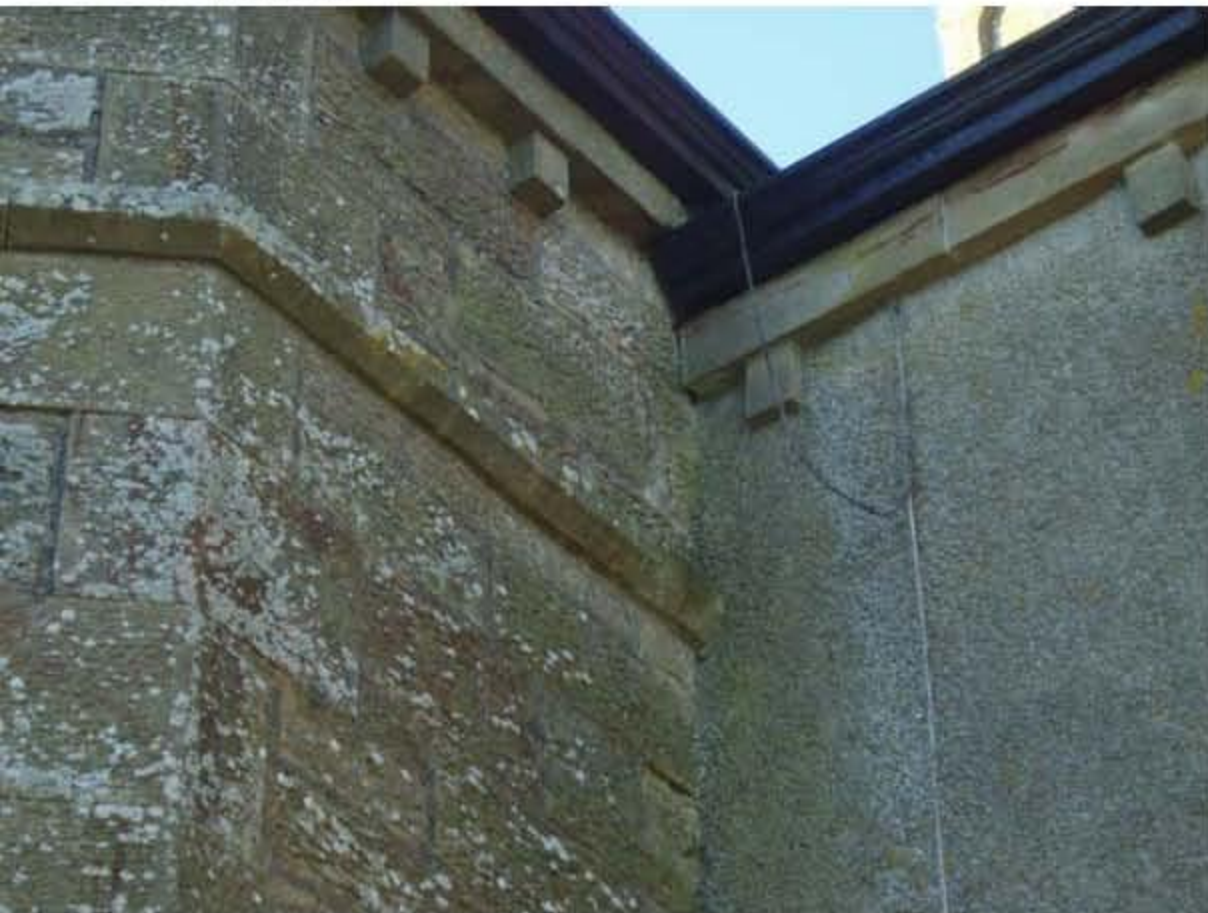
7 - join between upper SW tower and S wall

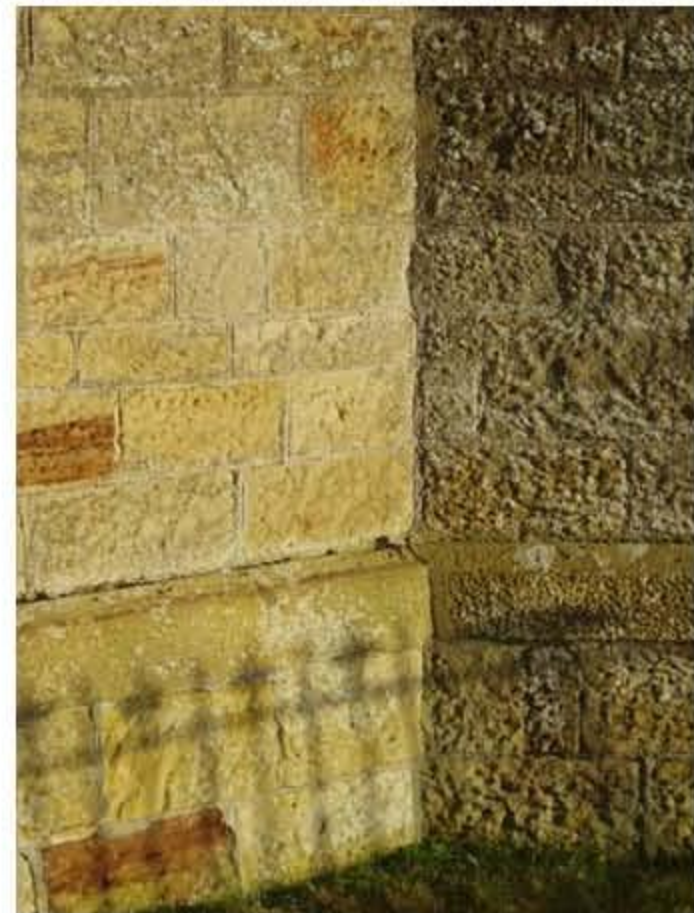
8 - join at base of SW tower

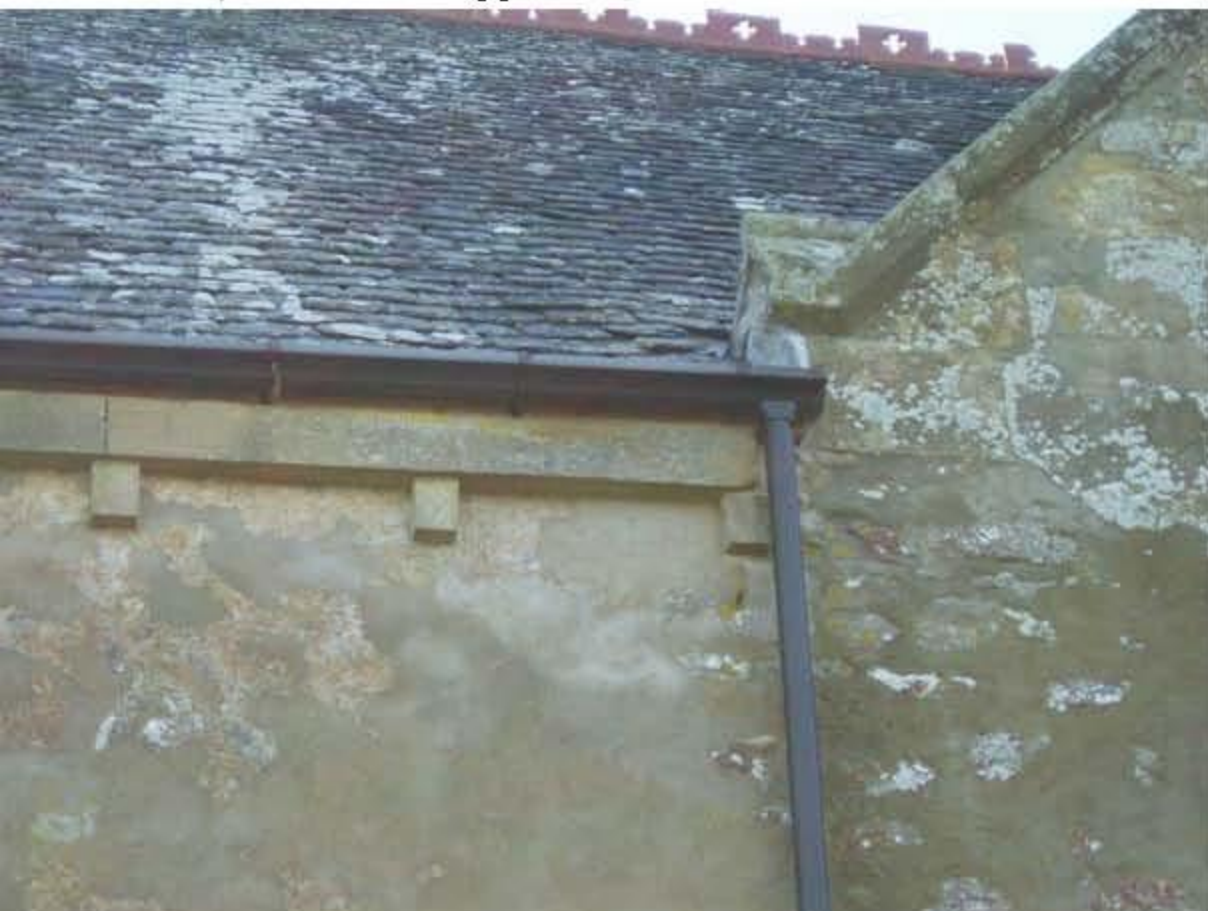
9 - join at E gable and E transept
