Loch Tearnait Hydro Scheme, Ardtornish Estate, Morvern, Lochaber, Highland.

Report on the protection of archaeological sites, for Hydroplan UK.

Jennifer G. Robertson, MA PhD FSA Scot MIFA. 8th September 2009.

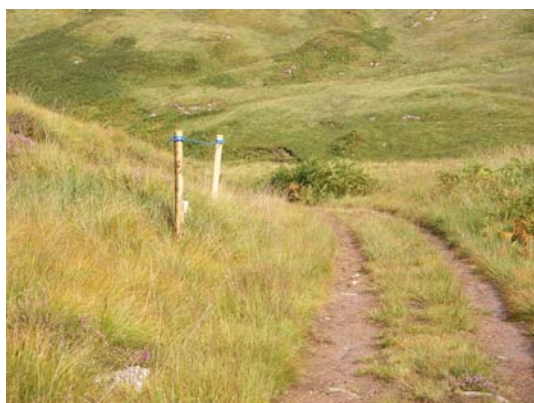
Site 9, the Head Dyke of Clais Bhreac settlement: This dyke had already been cut by the existing access road and was marked of on each side of this road. The new access road will need to be slightly wider and a few stones of the basal layer will be sacrificed on the South side.

Site 9, North side of the road, from W.

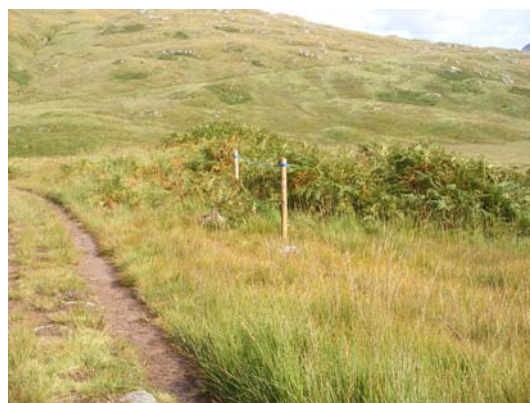
Site 9, South side of the road, from W.

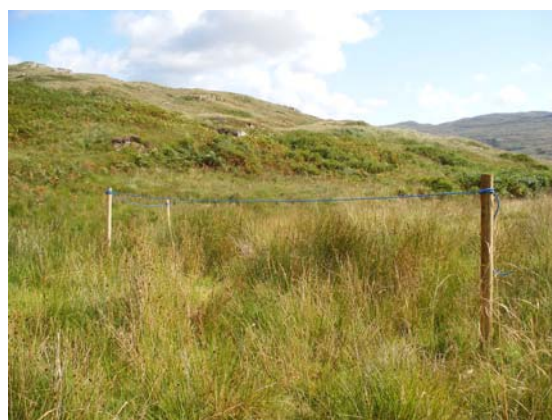
An area was roped off to protect the rudimentary remains of this settlement, as well as potential buried remains. The area immediately adjacent to the existing road has already been disturbed by earlier road building.

Site 11, Clais Bhreac, from W.

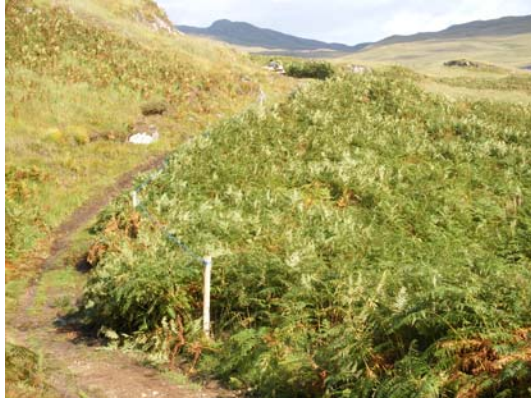
Sites 16-18, House, enclosure and boundary dyke: The house, **Site 16**, had already been disturbed by earlier road construction and is situated immediately South of the access road. The enclosure, **Site 17**, lies 3m ESE of the house. The boundary dyke, **Site 18**, runs along the West side of a burn, to the West of the house and enclosure. A single fence was erected along the South side of the road to protect all these sites.

Sites 16-18, from W.

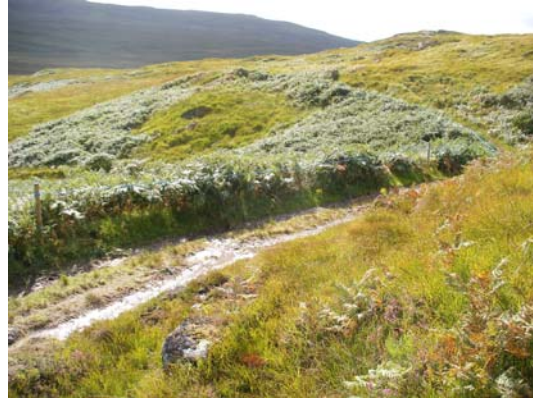
Sites 16-18, from E.

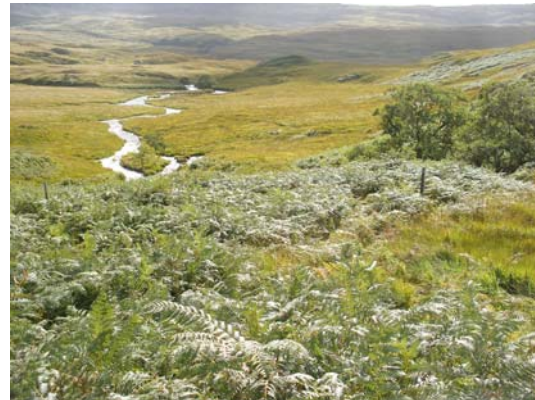
Site 20, Wall: this earth and stone bank, 20m long, was impossible to see in dense bracken. A rope was erected across the route of the wall to indicate its presence and the writer will return when the vegetation allows.

Site 20, area of wall marked, from NE.
