Lot 12, Lower Pulteneytown, Wick

(Northern Refrigeration and Larnach sites)

Photographic Record and Standard Building Survey

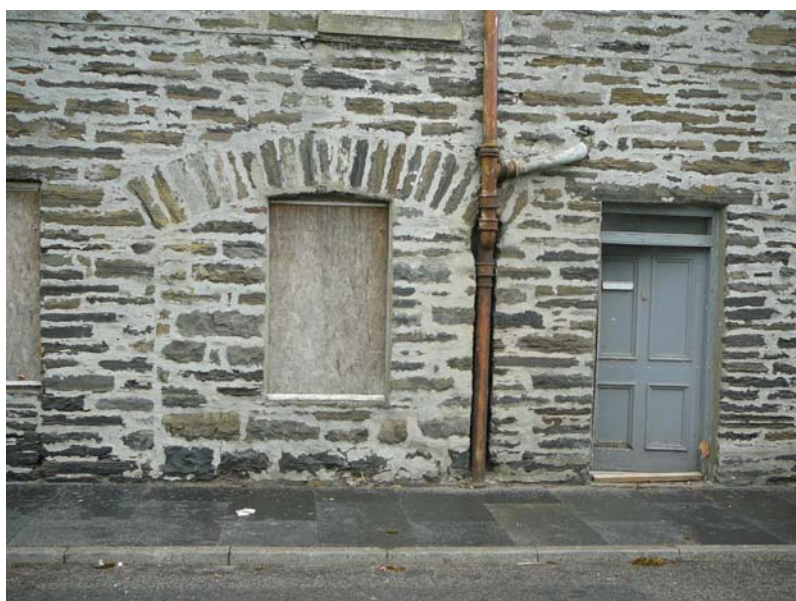
Exterior: shallow-arched broad entrance of typical Lower Pulteneytown design, infilled with stone leaving one window of the same dimensions as its neighbours other than that the arch takes the place of a lintel, the sill is of stone. The stonework is pointed, as is the whole frontage. There are a number of similarly infilled pends in the neighbouring streets, also some which still serve as access to the yards. It seems that a pend was of standard design during the initial 1813 build, despite access to the no 12 yard being from Telford St, and it is possible that the infilling is early. None of the available street plans indicate that the pend was open. Cast iron drain pipe from no. 6 is set into east side of arch

11. Infilled pend and entrance to no. 6 Saltoun St

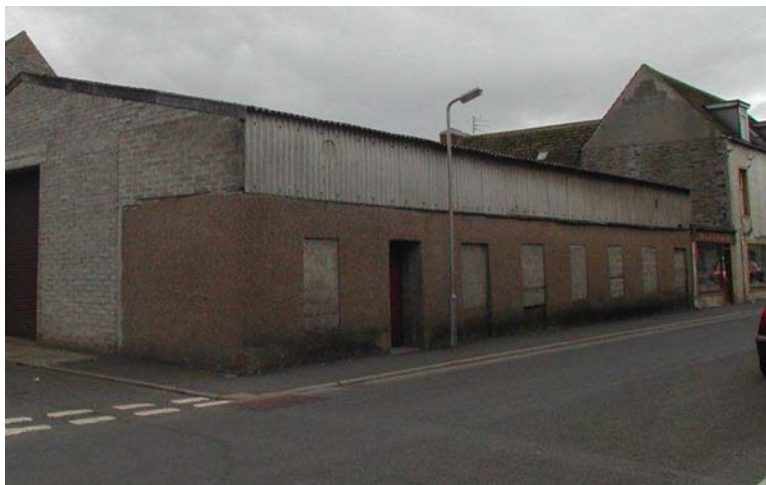
Exterior: The frontage onto Williamson Street consists of the west elevations of the former cottages and the lower part of the west gable of the smithy, all brown harled. The wallhead is capped with stone slabs. Built onto this is the blockwork and corrugated sheeting of the engineering shed.

12. Williamson Street: frontage of former smithy and cottages

It is assumed that the north window and door belong to the smithy, then one door and two windows of no. 18, two windows and a door of no. 16. However, the third and fourth openings both appear to be blocked in doorways, as is the southernmost opening. The walling of the smithy returns into Telford Street for 3m.
