194 Migdale

Archaeological Watching Brief

Report

Site Number	AN2			
OS Grid Reference	NH 6336 9201			
Author	Pete Higgins with a contribution by Anne			
	Johnston			
Date Produced	20/09/10			
Date revised	22/09/10; 15/10/10

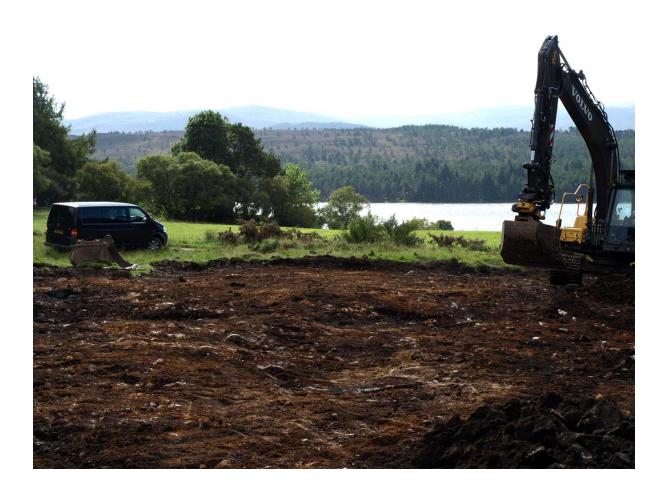
Photograph shows the footprint of the house after stripping; Loch Migdale is in the background

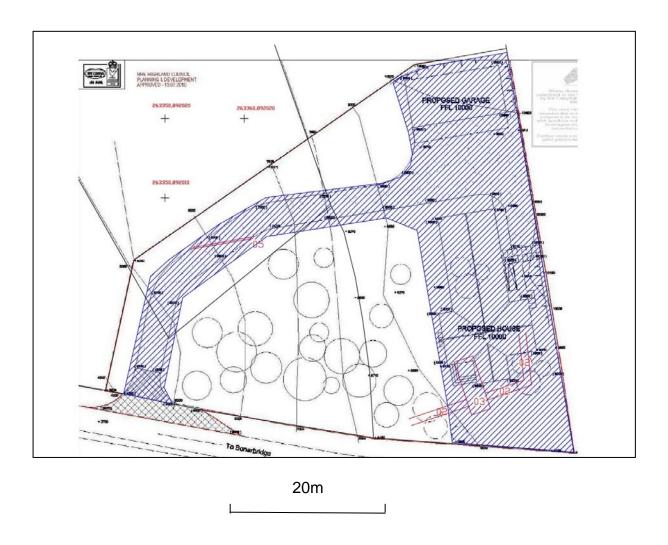
Figure 2 Plan of site, showing stripped area (blue), archaeological feature (red)s, and OS grid reference points

Table 1 lists the contexts recorded, together with their descriptions and interpretations. Their position is plotted on figure 2. The maximum depth of the strip was 0.45m, although this included removal of 0.25m of natural deposits. The road frontage of the site lies at approximately 60m aOD,; the ground rises to c. 62m aOD at the north-east corner.

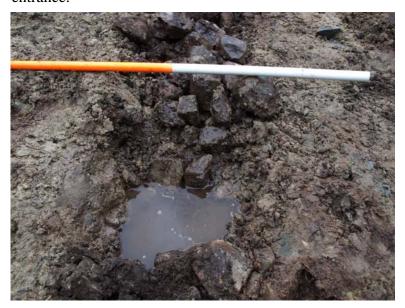
Figure 5 Section across the French drain

- 6.6. A French drain, **05** (filled by **06**), was also recorded. No dating evidence was recovered from the sample excavated, and French drains have been in use for many years, so it is difficult to date its origin. However, since it lies just within the enclosure shown on the 1874 map, and is oriented approximately parallel to the southern boundary of, it may well be contemporary with that, and thus form part of the mid-19th century land improvements mentioned in the Documentary Background above.

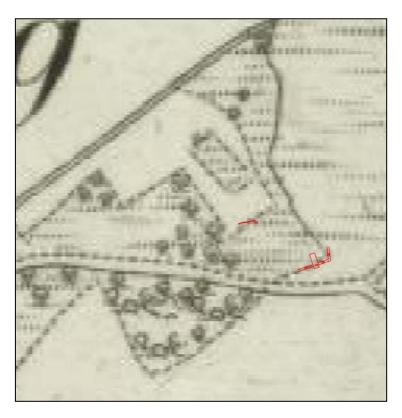
Figure 6. Recorded features plotted on $1^{\rm st}$ edition OS map, 1874

6.4. A stane dyke, **02** was recorded in the southeast corner of the site, with a possible return, see figure 2. This corresponds with the edge of an enclosure marked on the 1874 map; no other trace of the enclosure boundary was found. Since **02** survived with at most two courses of stone it is probable the most of the wall had been robbed out at some point.

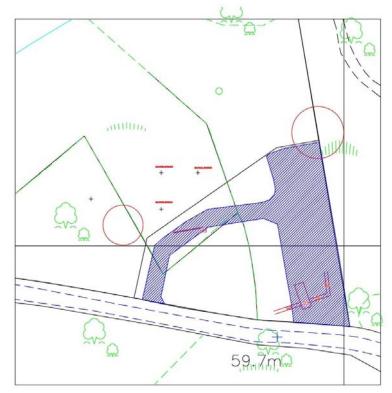
Figure 7. Site plan showing the location of the natural mounds (red circles).

- 6.7. One of the mounds mentioned in 3.2 above, lying at the northern end of the garage location, was partly excavated, see figures 7 and 8. It proved to be composed of till and is presumably a glacial feature. The other mounds in and around the site are of similar size and shape, and it is assumed that they are of the same nature. No mounds were observed to the north, in the improved land; presumably either only land without mounds was improved, or they were reduced during improvement.
