## HIGHLAND KIRKYARDS: Ross and Cromarty Pilot Proforma

1. Name of Kirkyard: Annat, graveyard  
From HER (Annat Old Burial Ground and Annat New Burial Ground–Highland Council)

2. National Grid Reference: NG 8981 5467

3. Civil Parish: Applecross

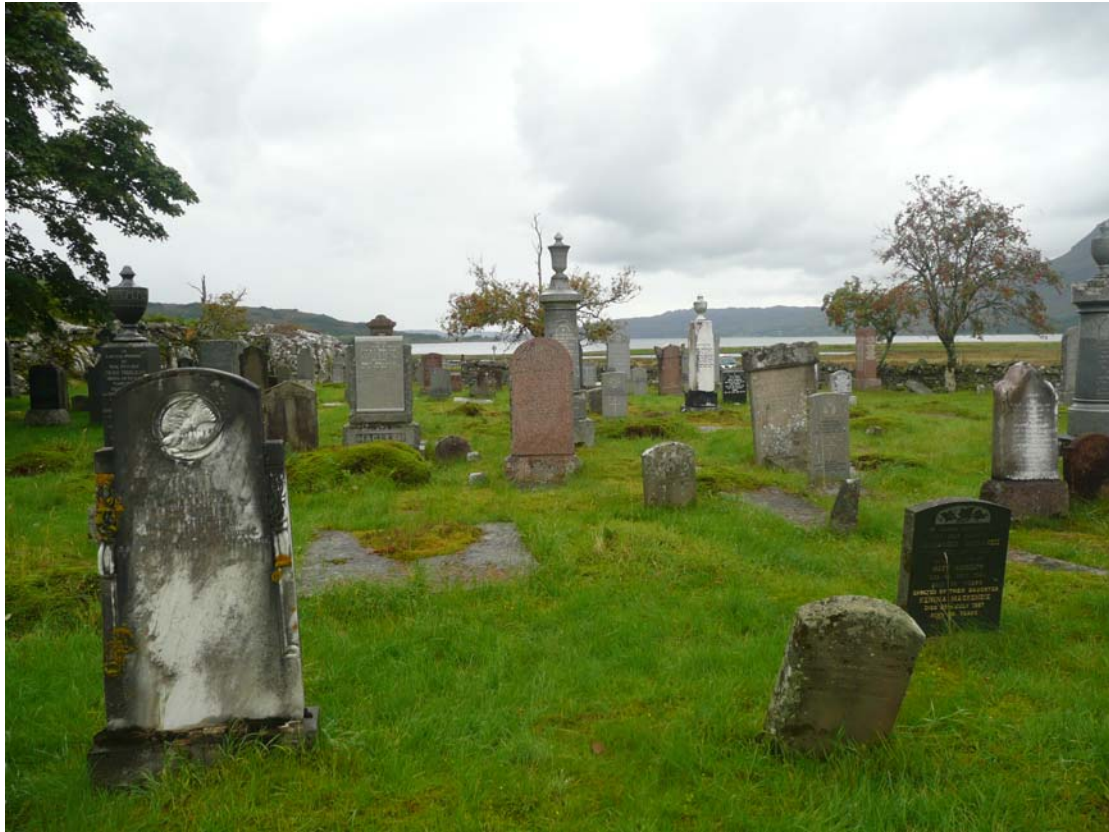
4. Description: Rural graveyard with modern extension to west. There is no church in use or redundant church. The modern section, Annat New Burial Ground, is rectangular in shape, with 20<sup>th</sup> century upright gravestones laid out in rows facing east. The grass is short and there are gravel paths. The older section, Annat Old Burial Ground, has uneven ground and long grass with many mossy patches. There are many flat slabs which are often overgrown with moss and/or grass, as well as uprights from the 19<sup>th</sup> and 20<sup>th</sup> centuries.
