HIGHLAND KIRKYARDS: Ross and Cromarty Pilot Project

1. Name of Kirkyard: Urquhart Old Parish Burial Ground
From HER

2. National Grid Reference: NH 5802 5849

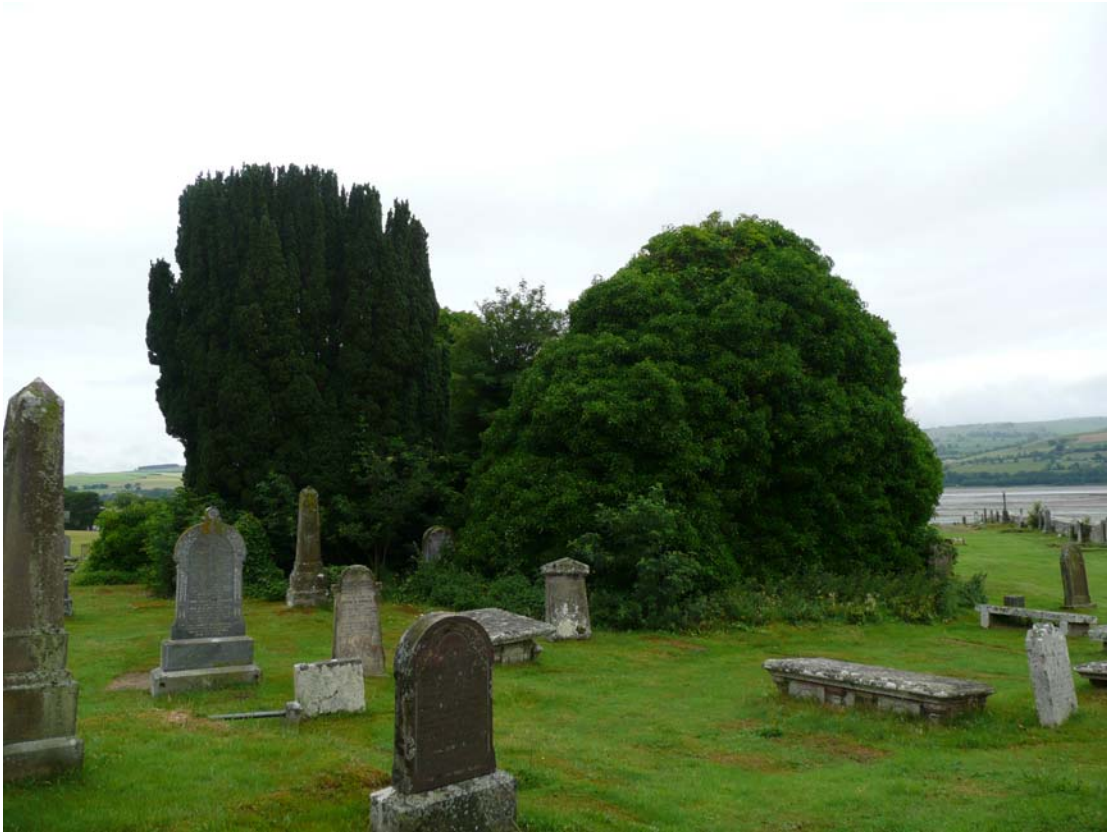
Old kirkyard with vegetation covered ruined chapel on the south shore of the Cromarty Firth. The ruined church dates to 1747-51, and was abandoned in 1795. There are many flat slabs underfoot in the area surrounding the chapel site and the raised ground indicates many burials over time. Many different styles and dates of gravestones including early 18th century uprights.

The more recent portion of the graveyard lies to the north, where the gravestones are mostly upright, often with low iron railings surrounding them and date from the 19th and 20th centuries.
