Land at Caulfield Road South, Cradlehall, Inverness

Archaeological Evaluation

| Report No. | HAS110304 |
| Date | 15/03/2011 |

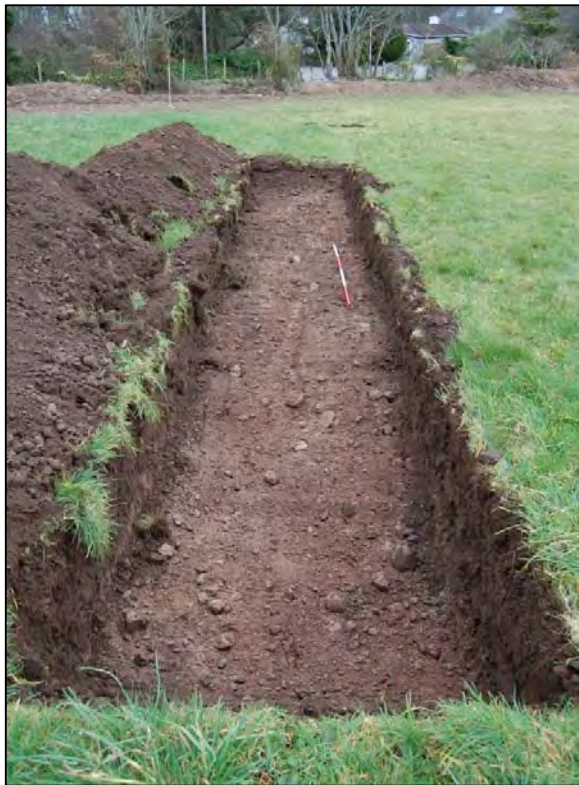
This encountered clean, pale grey/ brown silts and gravels. The depth from the adjoining ground surface at the SE end was 0.32m; at the NW end, 0.75m. No archaeological features.

Plate 1 Trench 1 from NW

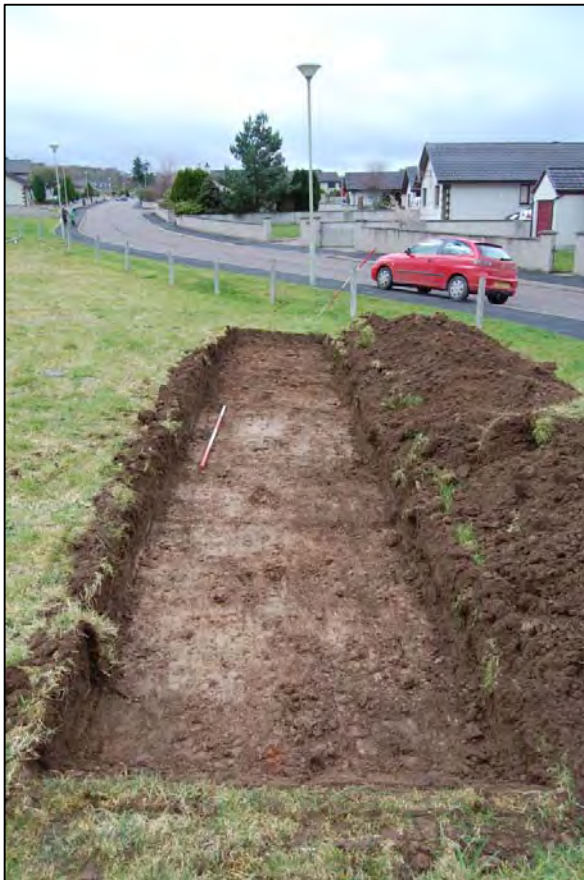
This encountered clean, brown gravels with areas of clay. The depth from the adjoining ground surface was 0.3m throughout. No archaeological features.

Plate 2 Trench 2 from E

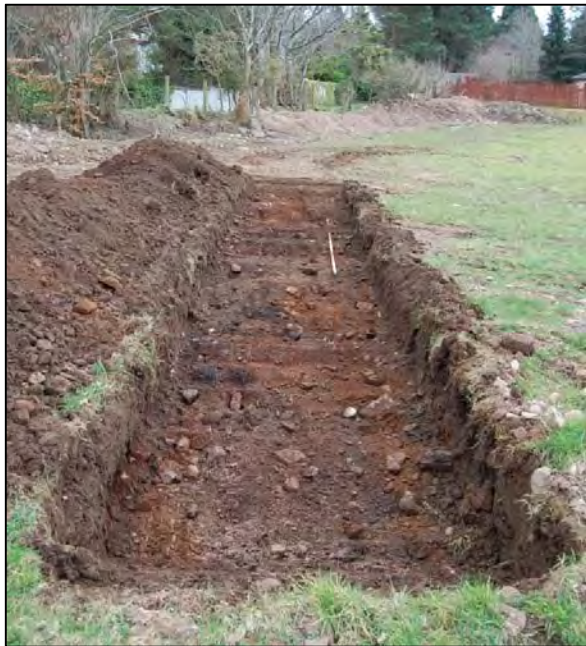
This encountered re-deposited and disturbed mixed stones and gravel. The depth from the adjoining ground surface was 0.6m at the NW end; 0.25m at the SE. No archaeological features.

Plate 3 Trench 3 from NW

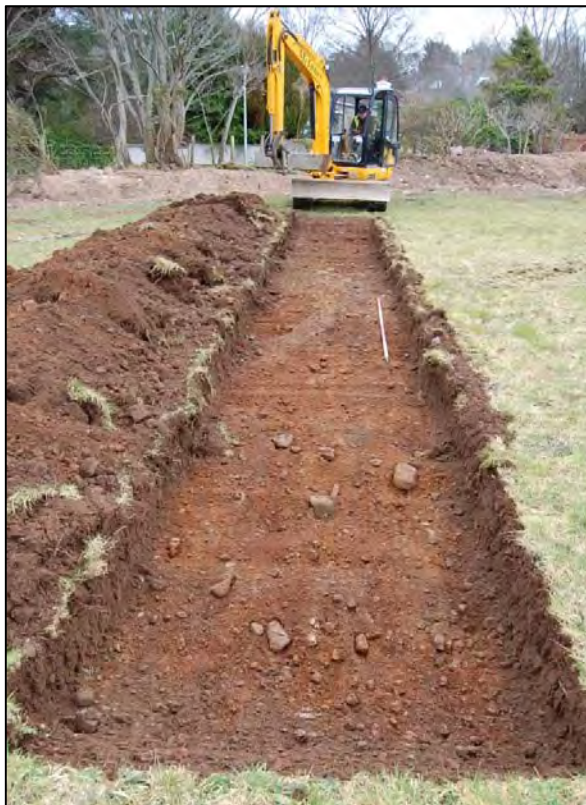
This encountered clean, stony, orange-brown gravels. The depth from the adjoining ground surface was 0.3m throughout. Feature 1 was a drain comprising red fired clay round drainage pipes, outside diameter 10cm; laid in a machine-cut trench 0.3m wide. The top of the pipe was 0.3m below the level of the subsoil; 0.6m below the present ground surface. This may have been an outflow from a septic tank or similar. The drainage pipe was not disturbed.

Plate 4 Trench 4 from NW

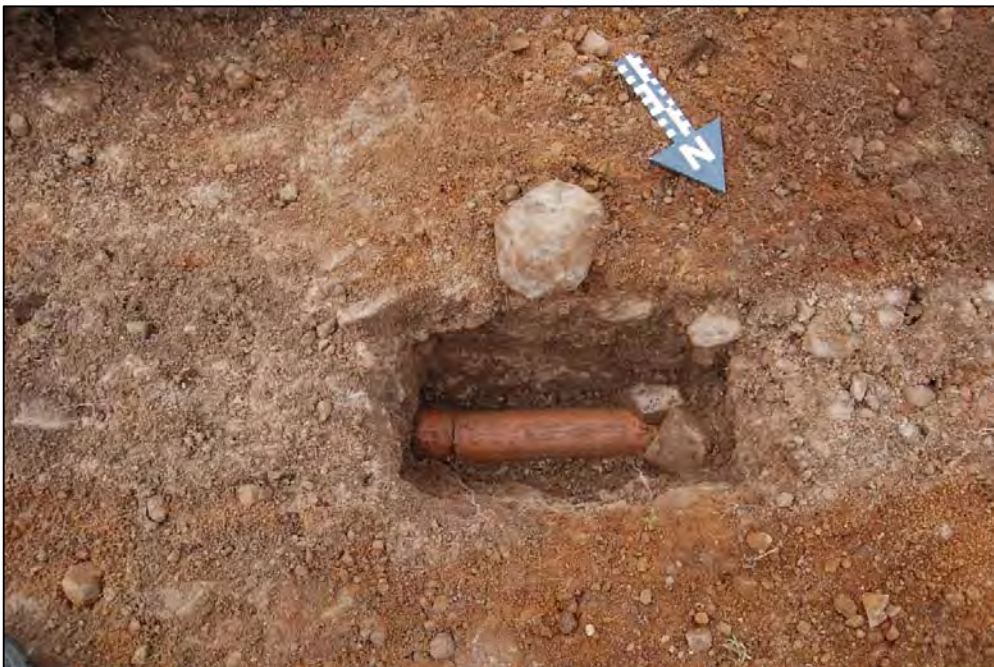
Plate 5: feature 1, showing drainage pipe

| Trench No. | Width x Length | Depth | Features |
|---|---|---|--|
| Trench 4 | 1.5m x 13m | 0.3m | No archaeology. Feature 1 was a machine-cut trench containing round, fired clay drainage pipe. |

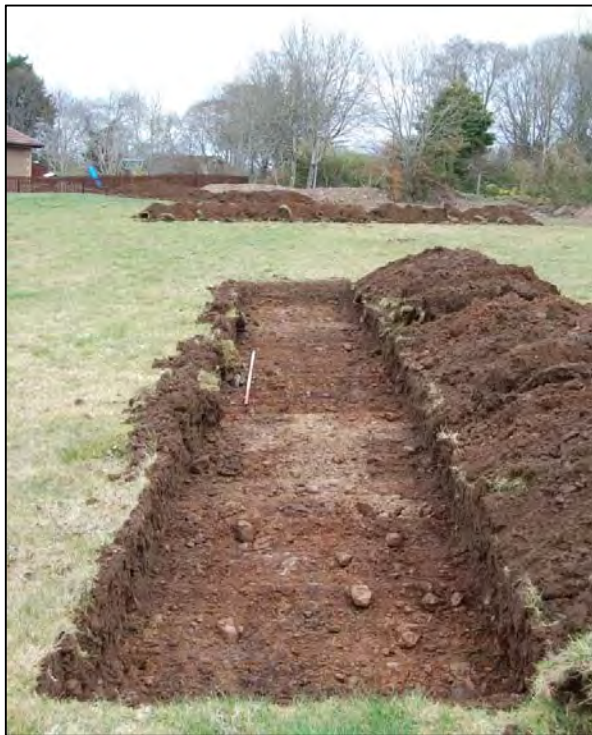
Plate 6 Trench 5 from SW

This encountered clean, brown gravels with areas of clay. The depth from the adjoining ground surface was 0.3m throughout. No archaeological features.

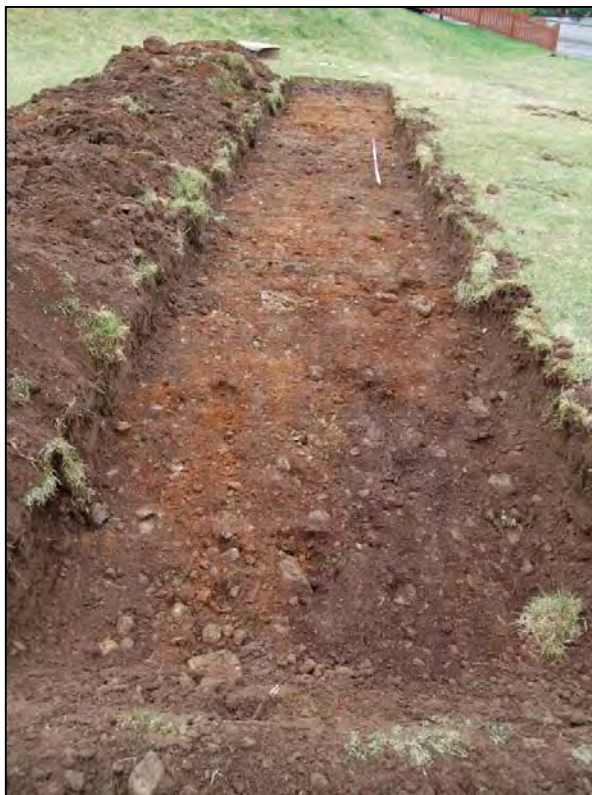
Plate 7 Trench 6 from NE

This encountered clean, stony, orange-brown gravels. The depth from the adjoining ground surface was 0.3m at the E end; 0.2m at the W.. No archaeological features.
