TWO NEW PROPOSED HOUSE SITES

ARCHAEOLOGICAL DESK-BASED ASSESSMENT AND DETAILED SURVEY

Jock Gordon Design and Planning 67 North Duntulm, Trotternish, Isle of Skye

TWO PROPOSED HOUSE SITES
Archaeological Desk-Based Assessment and Detailed Survey
North Duntulm, Trotternish, Isle of Skye

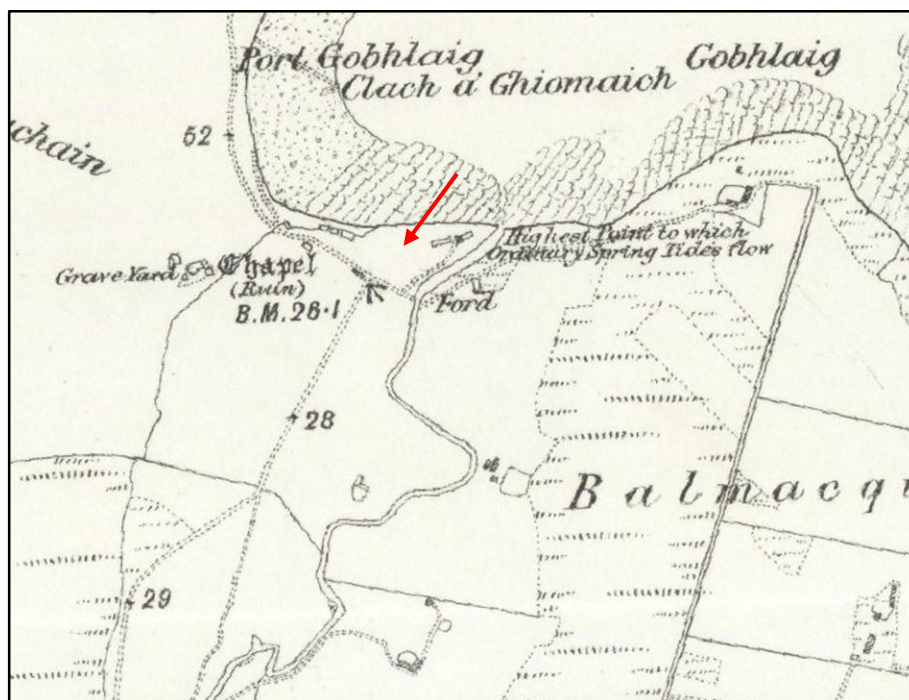
Figure 4 - Extract from the Ordnance Survey 1st edition 6-inch map (courtesy NLS)

The Ordnance Survey was carried out in 1875-1877. The map published in 1878 depicts six unroofed buildings, one of which is partially roofed, within the development site. Within the proposed Site A (west grouping), three unroofed buildings are linked by a boundary wall from the shoreline to the road. Within the proposed Site C development, a side road leads to two unroofed buildings, the eastern one which appears to be partially roofed (Fig.4).

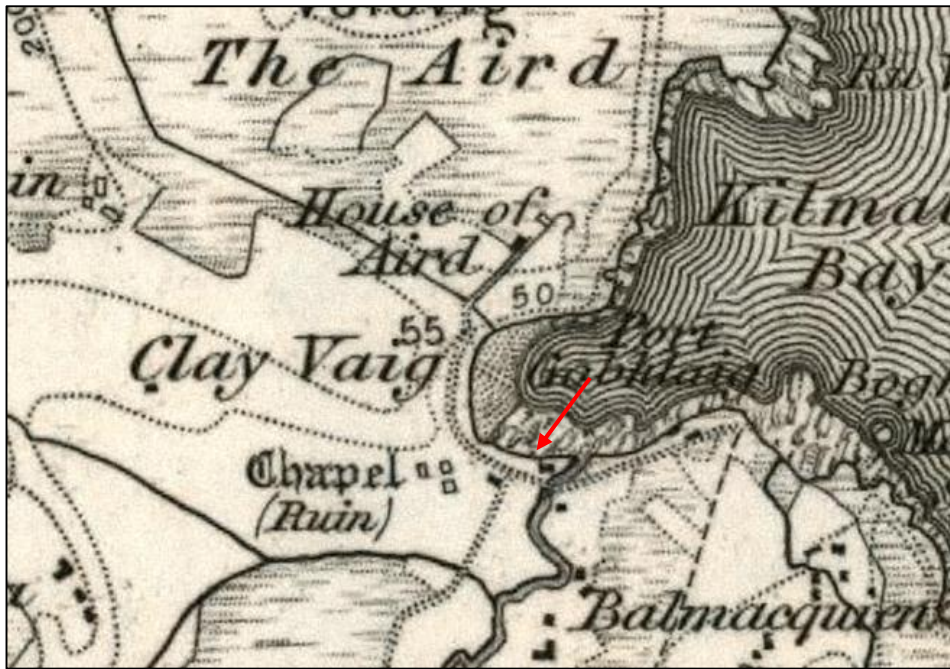
Figure 5 - Extract from the Ordnance Survey 2nd edition 1-inch map (courtesy NLS)

The map published in 1896 depicts one roofed building within the proposed Site C development, and a side road leading past the site and crossing the river to the east (Fig. 5).

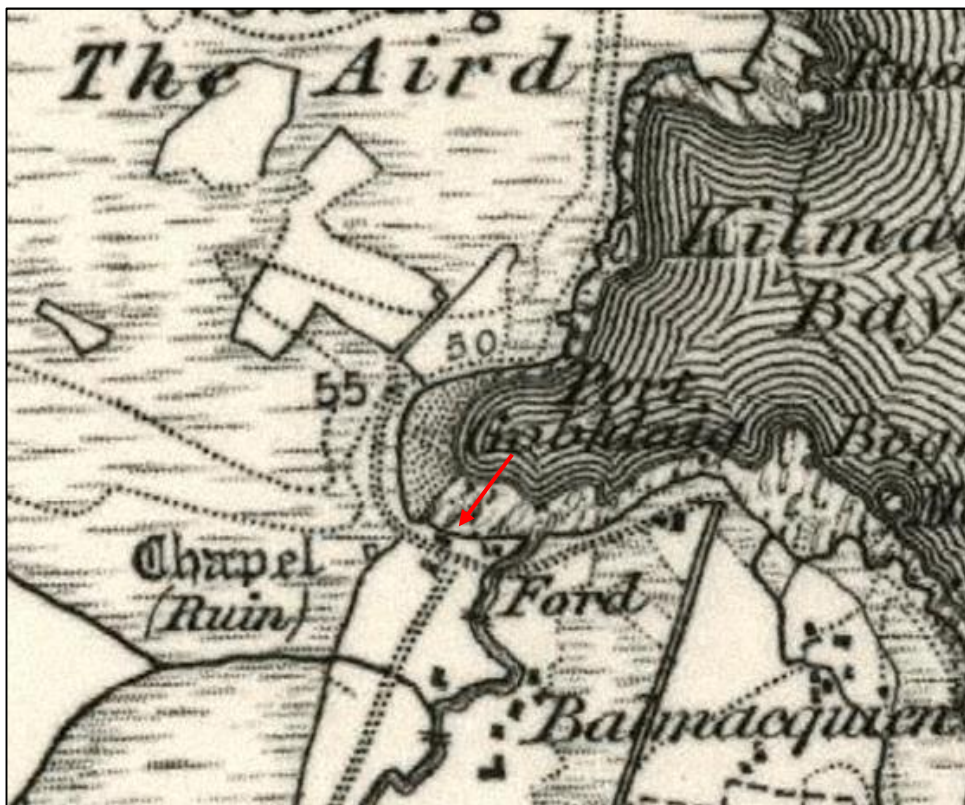
Figure 6 - Extract from the Ordnance Survey 3rd edition 1-inch map (courtesy NLS)

The map published in 1908 depicts one roofed building within the proposed Site A development, and two roofed buildings within the proposed Site C development. The side road runs past the east site and crosses the river to the east (Fig. 6). The historical Ordnance Survey mapping shows the changes to existing structures and the construction of new buildings over time in Balmacqueen.

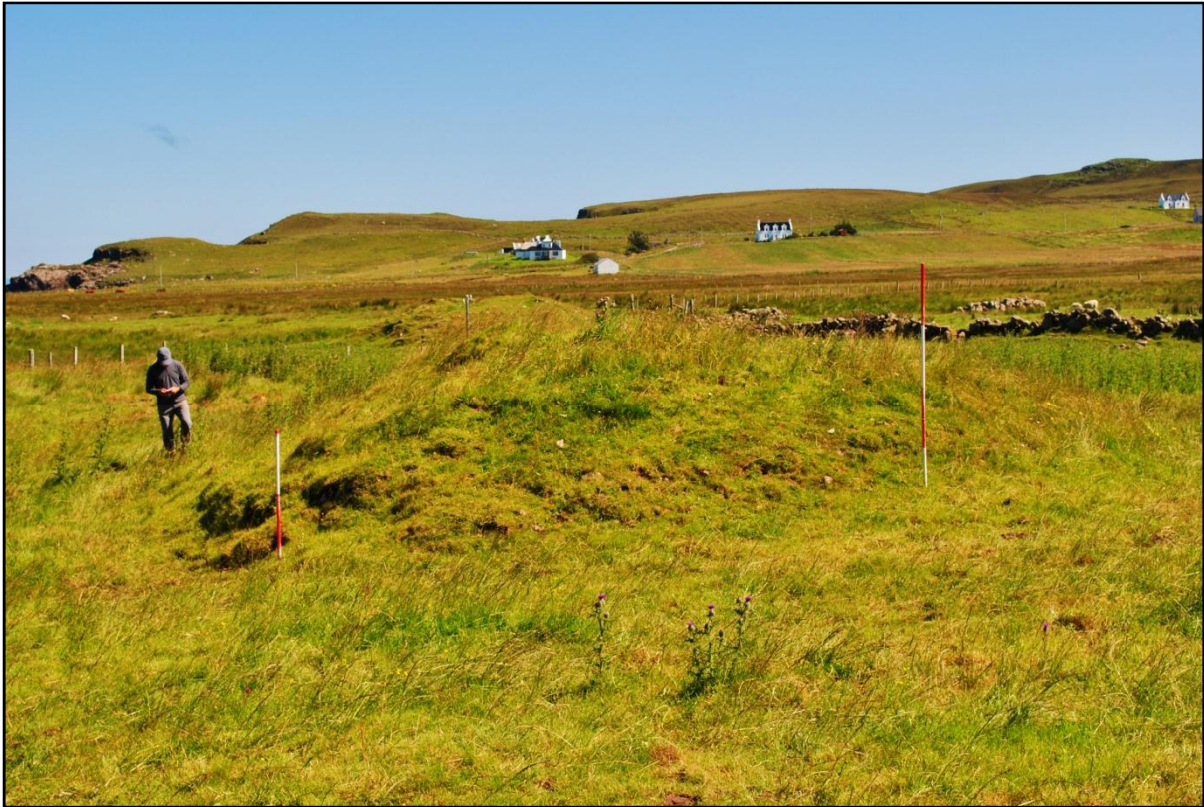
Plate 1 – Site C6 with Site C9 in background (facing SE, Kilmaluag Bay is to left)

A turf-covered stony mound measuring approximately 15m in diameter, which has been quarried from the E. This site corresponds with the cairn, Site C6, recorded during the archaeological survey described below.

8.3.2 We recommend that the route of the access track should be moved to the south/southeast to provide an additional buffer zone around the cairn (Site C6) and that the parking area is moved east-southeast to also provide an additional buffer zone around the cairn.

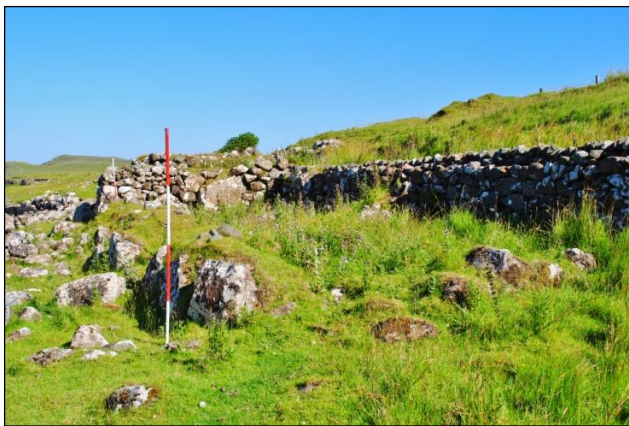
Plate 2 - Site A1 (facing SE)

- 6.2.2.1 Site A1 is a drystone building surviving up to 0.6m high with several courses still surviving comprising large stones and some large orthostat boulders. The building had rounded corners and survives to 0.6m overall. Though there is visible evidence for a central partition wall and entrance in the N wall, the structure is mostly collapsed, leaving individual orthostats and rubble facing stones in place. The S wall, like the other four buildings is revetted into the hillslope. It appears to be in good condition, although in reality it is masked by the rebuilt drystone boundary wall (Site A9) overlying the original footings. A small section of boulder walling extending from the northwest corner of the building may be the remains of an earlier enclosure wall or porch.

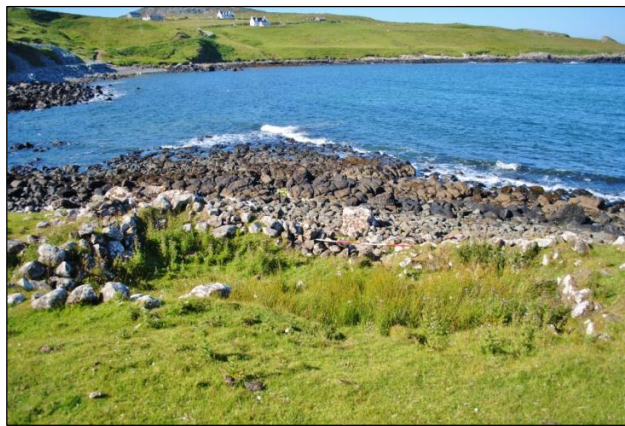
Plate 3 - Site A2 (facing N)

- 6.2.2.2 Site A2 is joined to the west to Site A1, which sits slightly north of A2, by a length of stone walling and joined to the east to Site A3, which is on a slightly different alignment, by revetted stone walling forming a turf-covered platform. As at Site A1, the building has rounded external corners and consists of stonework with some large stones at the base of the walls. It survives up to 1.2m high, although the back wall is collapsed at the E end.

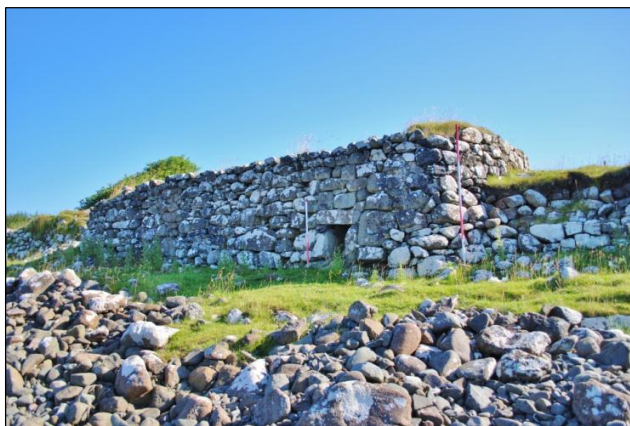
Plate 4 - Site A3 (facing SE), showing one drain

6.2.2.3 Site **A3** is a well-preserved stone-built subrectangular byre standing to 1.9m high at full height (to the roof plate). In contrast to the other buildings in Site A, the walling comprises bonded beach cobbles with lime mortar and there is an entrance in the E wall rather than the N wall. Two well-preserved drains, or creeps, capped with lintel stones penetrate the seaward (N) wall and two faces of an opening, possibly a vent or small window, were visible in the top of the S wall (see Photos 58 and 59).

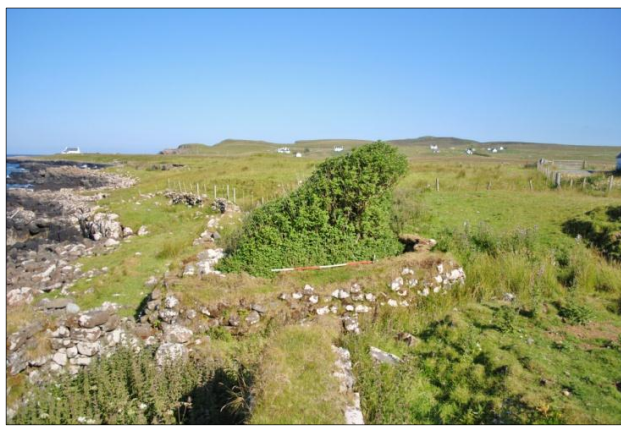
Plate 5 - Site A4 (facing WNW)

6.2.2.4 Site **A4** is a double-faced stone-built structure with rounded corners, similar in construction to Site A3, although surviving in places up to 1.6m high. However, the S wall only survives partially and it appears to have been robbed out, possibly for stone to rebuild the N wall and extend it to form a boundary wall ending further eastward at the shoreline. Nettles and a small tree have completely overgrown the interior of the structure, which has been partially in-filled with dumped material.

The new house site will impact on structure A4, while the associated parking facilities will impact on structure A5. We recommend that a detailed photographic recording of Sites A4 and A5 be carried out, followed by the evaluation of both structure as follows.

8.2.1 Site A4 will be dismantled during which any hidden details will be recorded. Once the structure is cleared to foundation level, two evaluation trenches will be excavated to the natural subsoil to record the foundation structure of the building and to ascertain the presence or absence of earlier archaeological features.

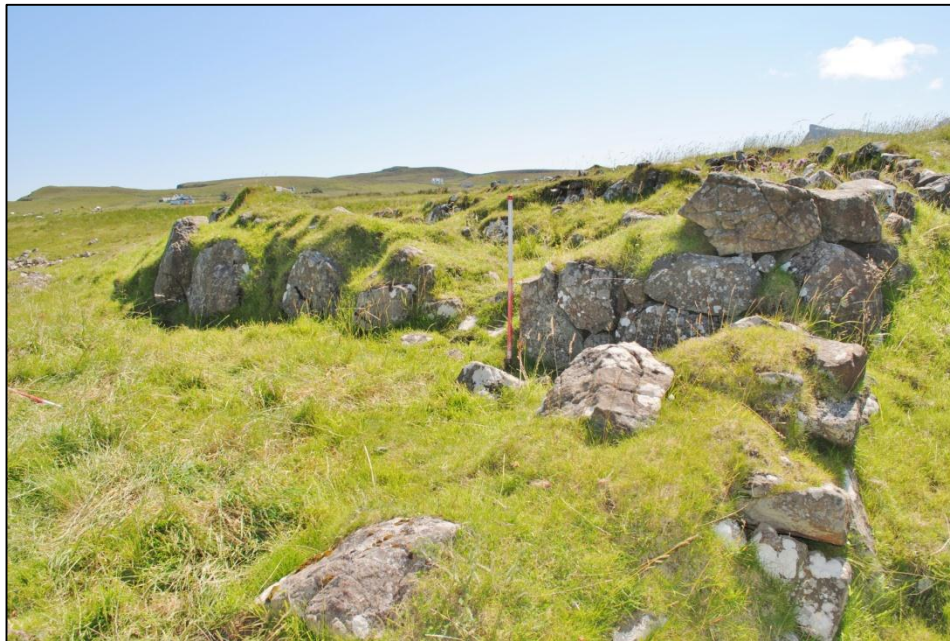
Plate 6 - Site C1 (facing SE), showing the N wall and attached walling at NW corner

6.2.3.1 Site C1, the easternmost structure in Site C, is a ruinous, double-faced stone structure comprising large stones and boulders which survives up to 1.4m high in the N wall. The building has slightly rounded corners at the NW and NE and a rounded inside corner in the SE. A rubble stone and boulder wall is attached to the NW corner and runs towards the shoreline and another length of very degraded boulder walling attached to the NE corner of the building runs towards the burn.

There may have been two phases of construction: the wall base is double-faced with large stones and orthostats and measures 1.4-1.7m wide; however, the wall head where it survives consists of small stone rubble build measuring 0.7-0.8m wide. This may indicate a later rebuilding of the structure's walls to reuse the site, possibly as a byre or pen. A 'ledge' in the S wall of the building may have supported a roof or may have been the wall head in the primary structure. A higher concentration of stone rubble inside the W wall of the building could be the remains of a twinning pen and would support the reuse of the building as a pen.

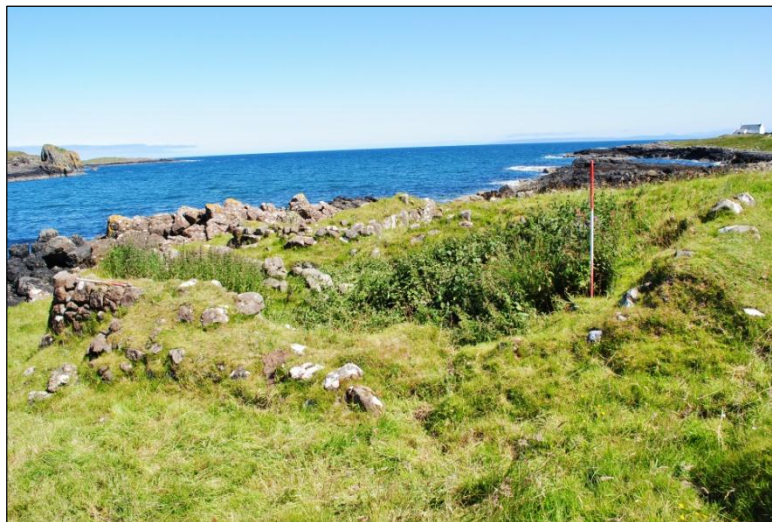
Plate 7 - Site C2 (facing NE), showing the attached skin of walling and Site C3 built into left side

6.2.3.2 Site C2 and C3, both ruinous, are attached to the west side of Site C1. Site C2 is a drystone building attached to the W wall of C1: the north half of the E wall was formed by Site C1 and the south half of the E wall was attached to revetted walling, as in the structure's S wall, which is partially revetted into the hillslope.

There is evidence for multiple phases of construction on the building. The S wall stands up to 1.3m, but at 0.7m high there is a 'ledge' in this wall, which may have supported a roof or may have been the wall head in the primary structure. This indicates that the upper courses of the S wall are rebuilt. A possible primary entrance 0.8m wide to the east side of the N wall, has been blocked up inside the structure to fill the gap between Site C1 and Site C3. A secondary skin of walling 0.5m wide has also been built against the exterior of the W wall, probably to function as extra structural support in later phases of occupation. The W and N walls are completely freestanding and the N wall is best preserved, standing up to 1.45m high, having been partially rebuilt to construct Site C3, a later subcircular drystone pen or bothy built into the north half of this structure. The fact that the ruins were full of nettles, in contrast to the adjacent sites, may suggest that this structure was a byre later used as a pen.

The lower 'ledge' in the S walls of Sites C1 and C2 may indicate there were two phases of building on these walls, and possibly that both were built at the same time. It is certain, however, that Site C3 is a secondary phase of use of Site C2 as a pen which may coincide with the secondary reuse of Site C1, probably as a pen, and this is further supported by the possible twinning pen in the NW corner of C1.

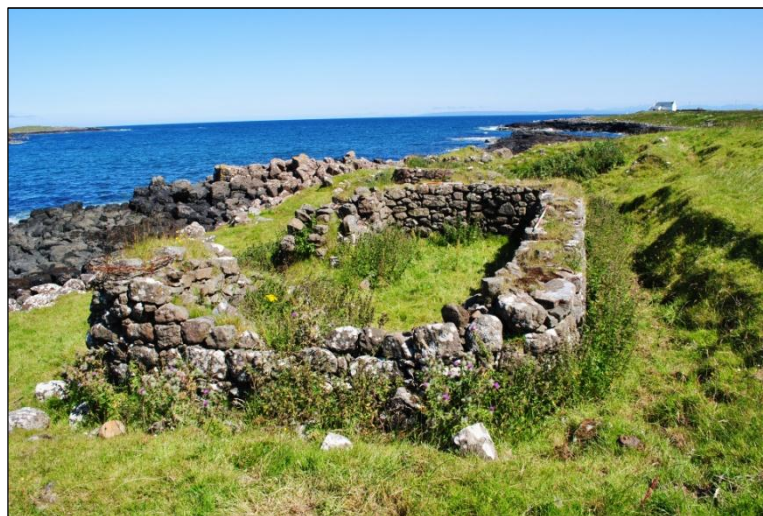
Plate 8 - Site C4 (facing ENE), showing the well-built stone house with rounded corners

- 6.2.3.3 Site **C4** is linked to Site **C3** by the faint remains of a wall footing 5.2m long, which may have been a revetment of the slope to form a platform, similar to Site **A5**. Site **C4** is a well-preserved, mostly upstanding drystone subrectangular building. The walls, of double-faced, drystone construction, show some signs of mortaring on the outer face and within the wall core, although none is visible on the inner face. The building, which survives to 1.3-1.6m high, has rounded external corners and rounded internal corners in the NE and NW, but squared internal corners in the SE and SW. The base of the S wall is revetted into the sloped ground surface, although the rest of the wall is mostly upstanding, and a 1m-wide exterior drainage ditch was cut beyond the S wall. There are two splayed windows to either side of the entrance.

8.3.1 We recommend that a detailed photographic recording of Site C4 be carried out prior to dismantling. During the dismantling of the building, the walling and any hidden details will be recorded. Following this, two evaluation trenches will be excavated to the natural subsoil to record the foundation structure of the building and to ascertain the presence or absence of earlier archaeological features.

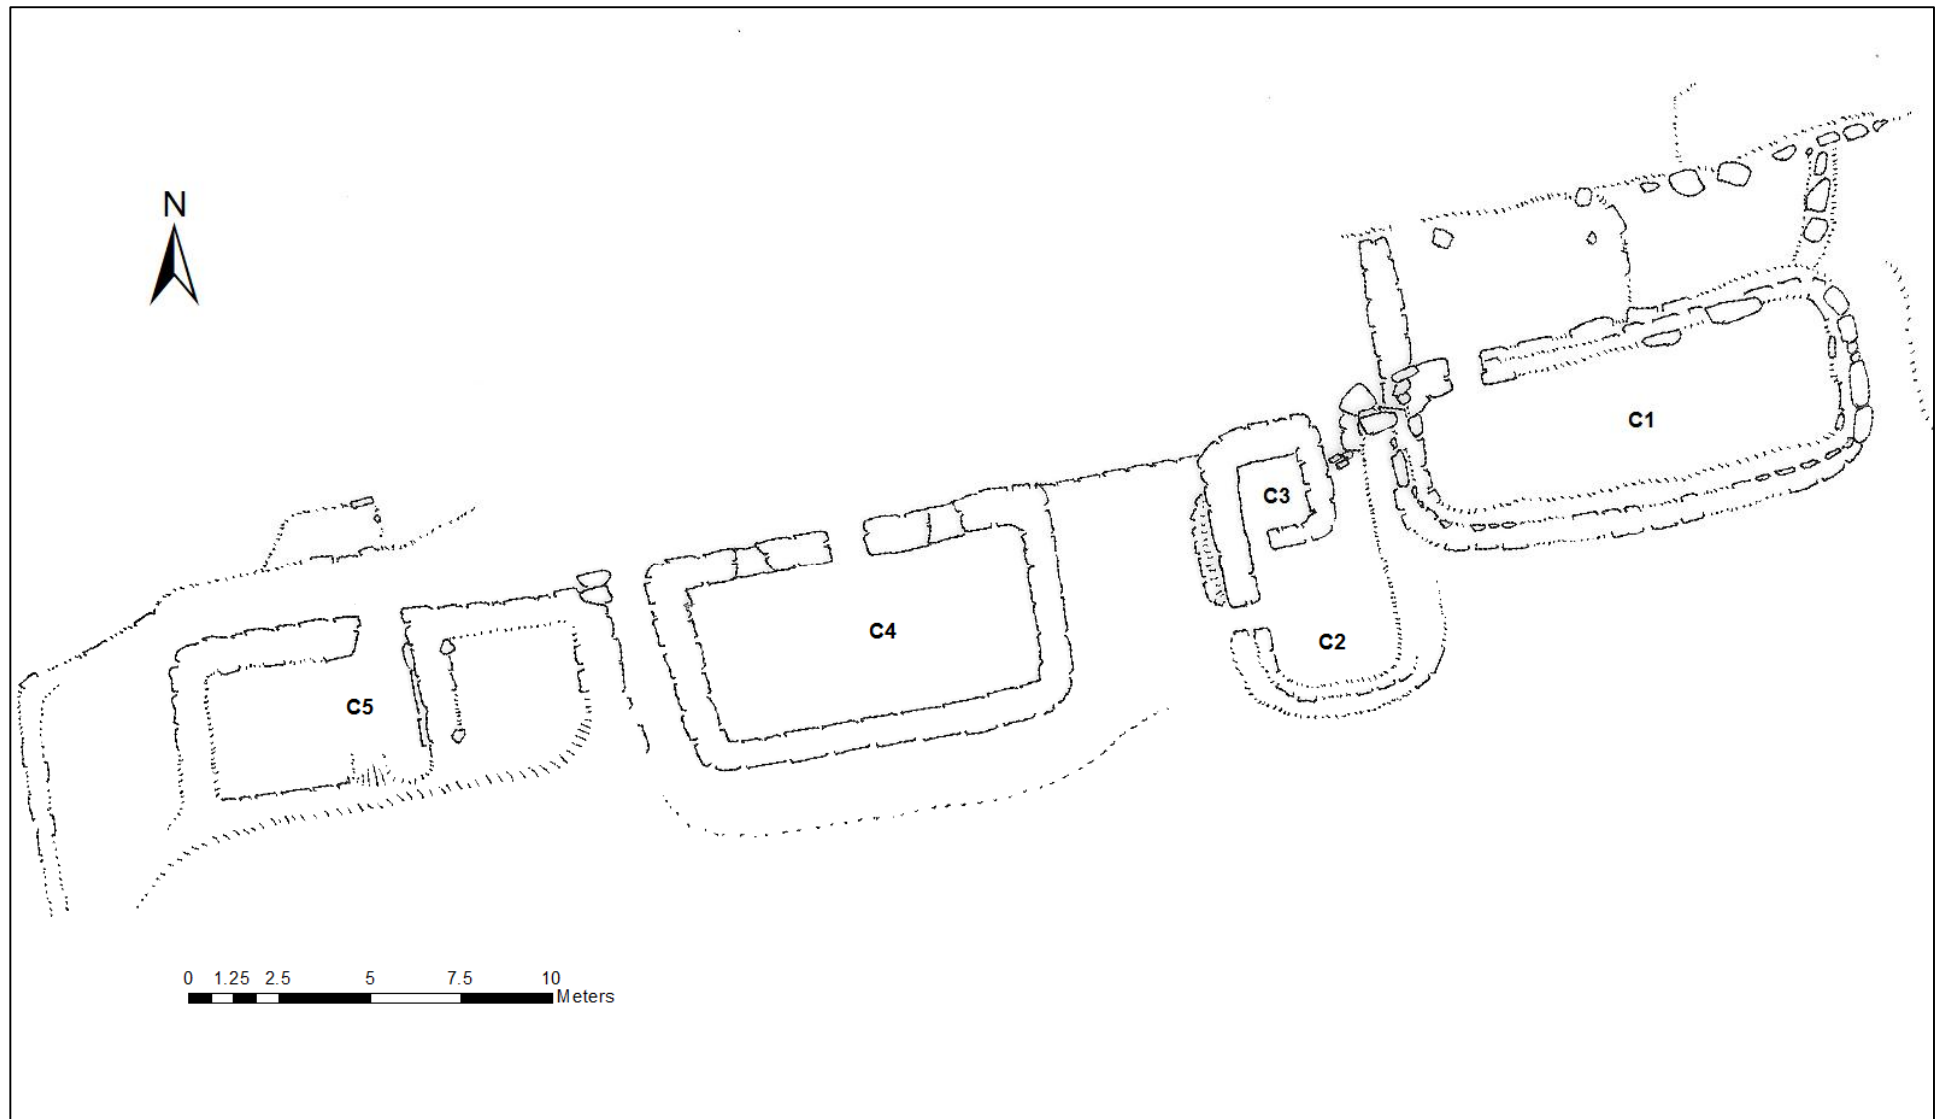
Figure 9 – Plan drawing of the upstanding Post Medieval settlement ruins in Site C

It is difficult to be certain about which structural remains correspond with which phases of occupation and abandonment shown on the various OS maps. Given the well-preserved condition and attributes (mortaring and splayed windows) of Site **C4**, it is possible that it was the latest built structure which is shown on the Second and Third OS maps. Furthermore, Site **C4** may overlie earlier foundations that formed part of Site **C5**, which has at least been partially infilled (see section **6.2.3.4** above). This could be the unroofed structure to the west side of Site **C** showed in the First Edition OS map.

The eastern unroofed structure on the First Edition OS map may be the earlier foundation of Site **C1** and Site **C2**, which appear to have undergone multiple phases of change (see section **6.2.3.2** above). The reuse of Site **C2** to form a byre may be the eastern roofed structure on the Third Edition OS map.

- 6.2.3.6 Four other sites were recorded within Site **C** and the two prehistoric cairns are discussed above (see section **6.2.1**). The two other sites, **C7** and **C8**, are the remains of a degraded drystone enclosure and boundary walls which, given their state of preservation, possibly relate to earlier phases of settlement on the site.
