Auchtertipper

Archaeological Survey

Report No.	HAS101007
Project Code	HAS-ACT10
Client	Cawdor Estate
Planning Ref	N/A
NGR (approx centre)	NH 9238 2785
OASIS	highland4-85666
Date/ revision	03/11/2020
Authors	John Wombell and John Wood

A rapid walk-over survey was carried out ahead of a tree-planting scheme at Auchtertipper, Cawdor. A large number of archaeological sites and features was recorded: these were all of medieval or post-medieval date.

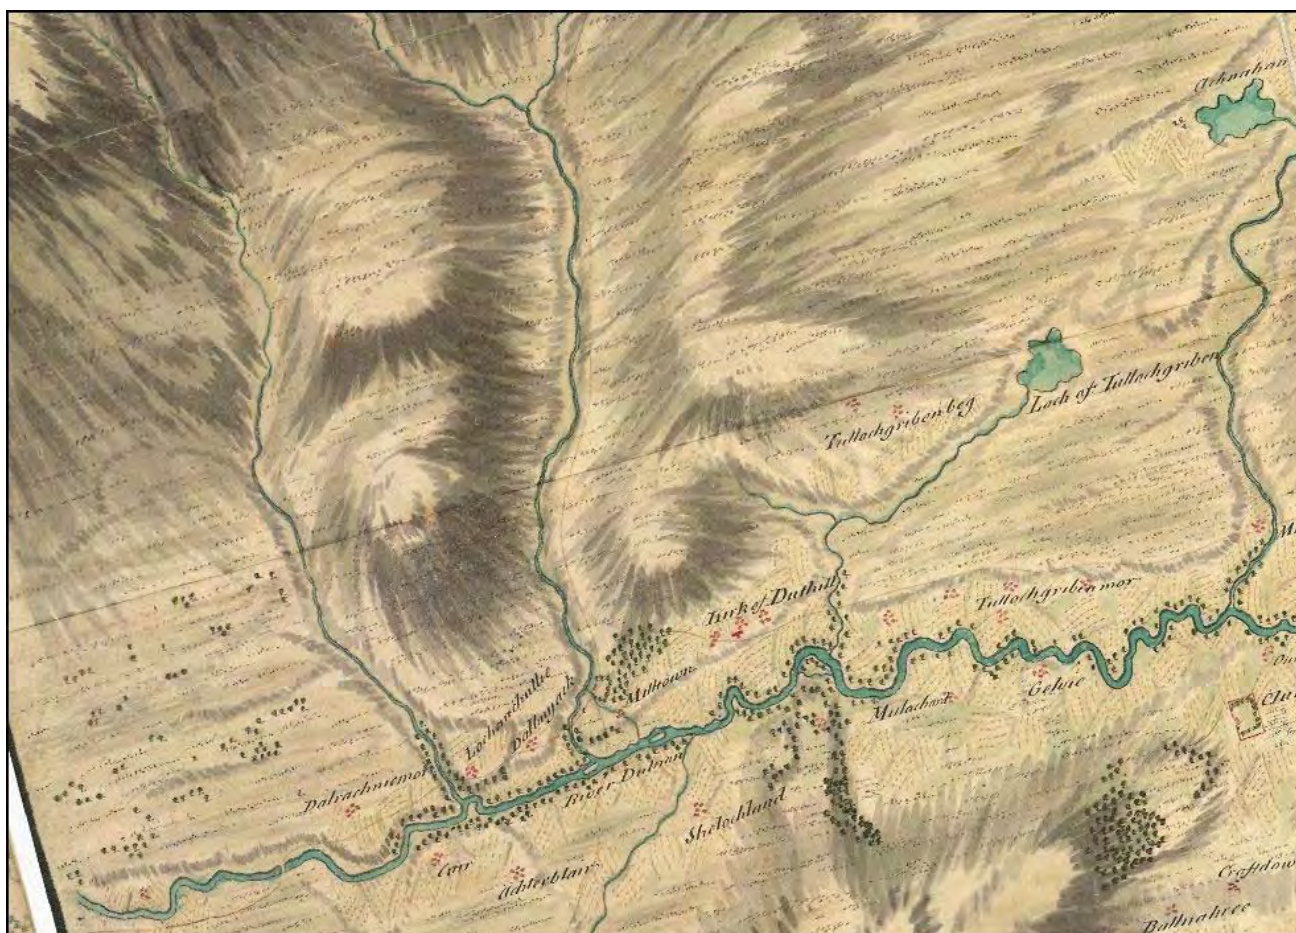
Figure 3 Extract from Roy's Map 1747-55

It is notable that very little is shown in this area on the early maps.

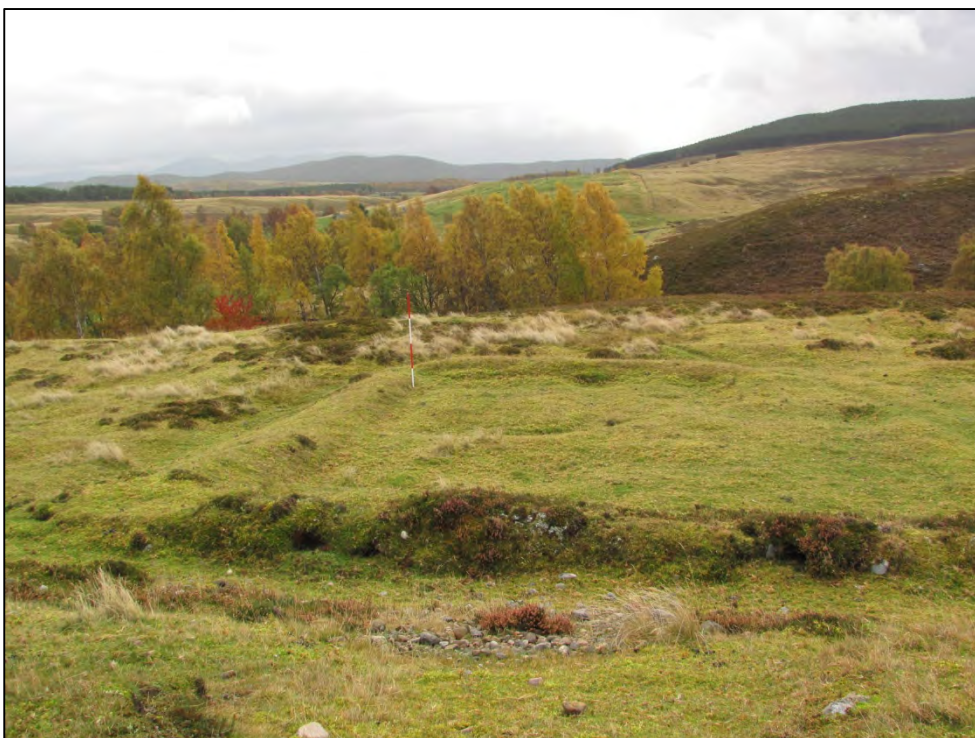
Plate 2 Auchterteang: Enclosure (Site LM15)

LM15 A substantial but ruined enclosure c17m E/W x 12m internally, at NH 92318 26581, walls of stone and turf, spread to c2m, stand to 1.3m on the N side, entrance on the S side. Several compartments within the enclosure, interpretation unclear. May have been an enclosure with wooden huts inside, may also have been a kail yard at some time as there are 2 large storage pits just outwith the enclosure on the S side. See scale drawing (Fig 16) and photos PL2 and PL3.

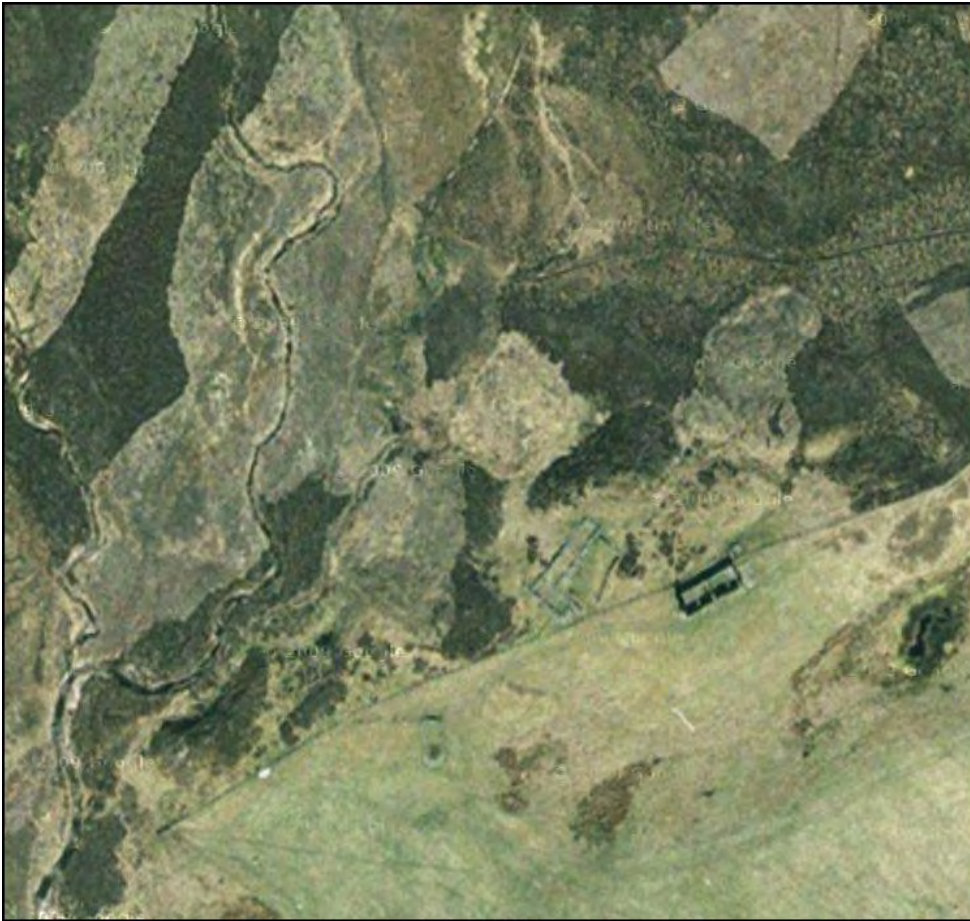
Plate 3 Aerial view of Auchtertipper
(Google Maps)

In the survey 21 archaeological features are attributed to Auchtertipper, approx half in a cluster forming the farmstead, with others, including a single sample from each line of disused grouse butts, stretching out onto the moorland. The dwelling house as drawn on the 1st Ed OS was some 36m in overall length, whilst today the now roofless farmhouse is just 16m in overall length, with some 10m of smaller earlier footing visible beyond the E gable. This suggests that the standing remains of the ruined farmhouse today were built after the 1st Ed OS was surveyed, and that its predecessor on the same site was a traditional long house. The fine but flood wasted remains of a family sized sheiling hut lay close to the burn below the farmstead, whilst on the ridge where the farmstead sits are the remains of two long houses, quite probably of different periods, and other features most likely of turf wall construction.

The lime kiln at Auchtertipper is reasonably well preserved, the best in the survey area, but all of the lintels and most of the front wall have been robbed out.

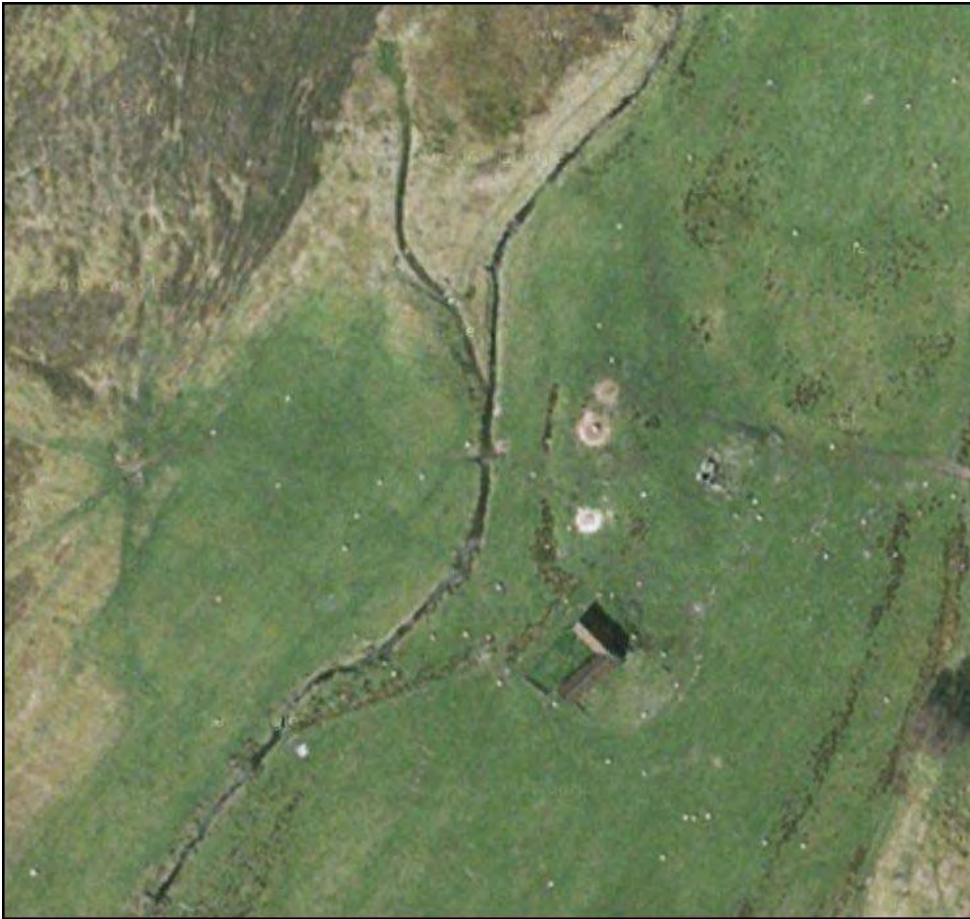
Plate 6 Aerial view of Ess
(*Google Maps*)

The only other building at Ess is very ruinous and again we suspect the use of a machine to flatten all but one corner with a lean-to against it, possibly a kitchen or scullery at one time, which was retained as a pen.

On the steep bank below the public road at Ess a well built track from the ruined lime kiln crosses the access track to Ess then ends abruptly against a small ditch and bank enclosure whose extent is unclear. This small enclosure may possibly have been a later potato patch, truncating the track which possibly continued to the double enclosure shown clearly of the 1st Ed OS some 200m to the north, built on a small terrace on the same steep bank. The enclosures remain extant today but are covered in mature birch trees. From the car parking area and track leading to Ess Farmstead a footpath runs north to the picturesque Ess falls, where a wooden dam has been built above the falls apparently to create a pool for recreational purposes, though today it is choked with gravel.

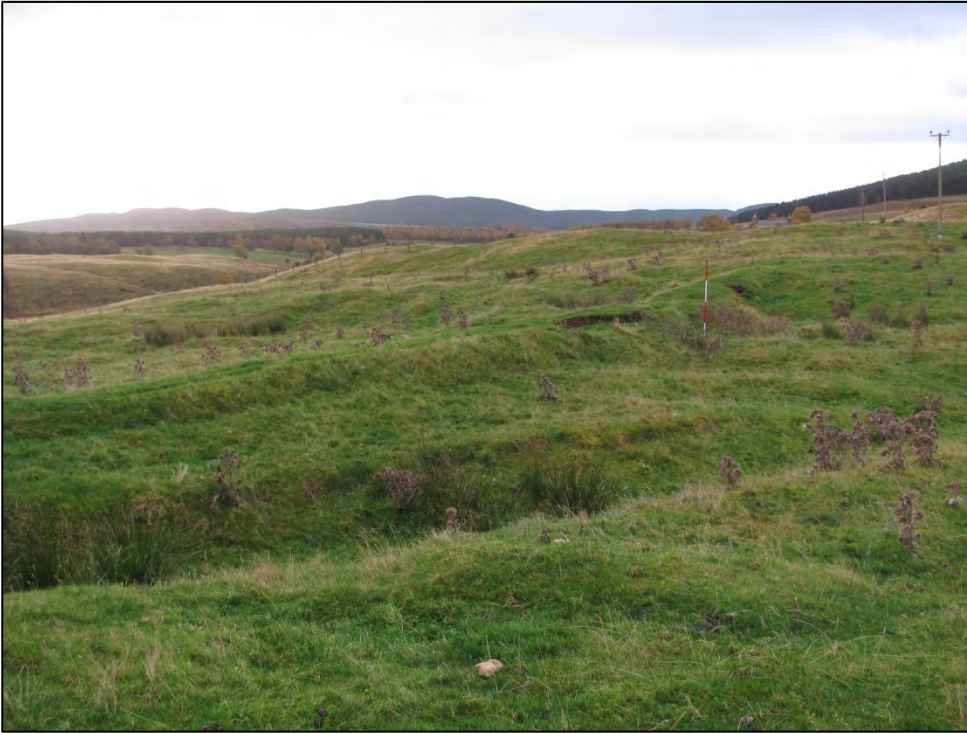
Plate 10 Mill lade (Site LM22)

There is much of archaeological interest at Rysaurie. Firstly there is the site of a probable horizontal mill, with its mill pond set up on a dry ridge, to be fed by a hand dug ditch 2 km in length, the weir being c10m from the western boundary of the survey area. Near to the mill pond there is a spill-way and a further 200m or thereby of hand dug ditch to divert water once the mill pond was full. The large timber built stable block has a date of 1903 on a door and is very well preserved. One later add-on of inferior construction has collapsed and a second is not far behind. This building – the older part that is, is worthy of conservation.

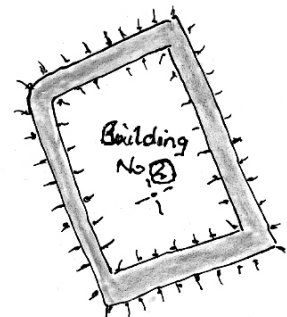
Figure 16 Badenargit sites LM31, JW15

BADENARGIT FARMSTEAD (WEST)
 SITE LM31 CENTRES:
 No 1 291938 826324 No 2 291958 826334
 Date 18/10/2010 Drawn by L.M. at 1:200
 2, possibly 3 FOOTINGS IN STONE
 OF BUILDINGS SHOWN ROOFED
 ON 1st Ed OS.
