Archaeological survey of Dalchork Forest

Lairg, Sutherland

Archaeological Walkover Survey

Author: Mary Peteranna
Report Date: 14 February 2011
Report code: 2011-02/DAL10
NGR (centre): NC 587 156
OASIS entry: rosscrom1-101505

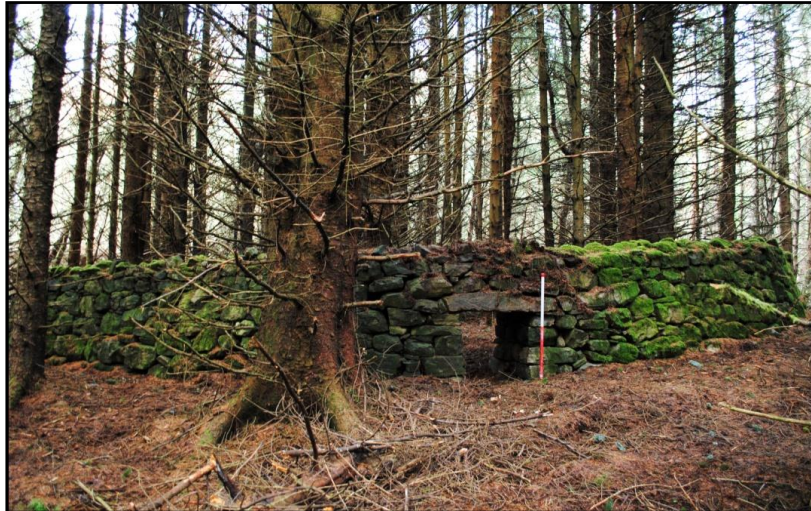
Plate 1 Sheepfold, Site 35

This well-preserved sheepfold measures 10m in diameter and is situated within dense forestry plantation. The walls measure 0.5m at top to 0.7m at base and 1.2-1.5m high. There is a creep built with a dressed lintel stone on the south side of the structure.

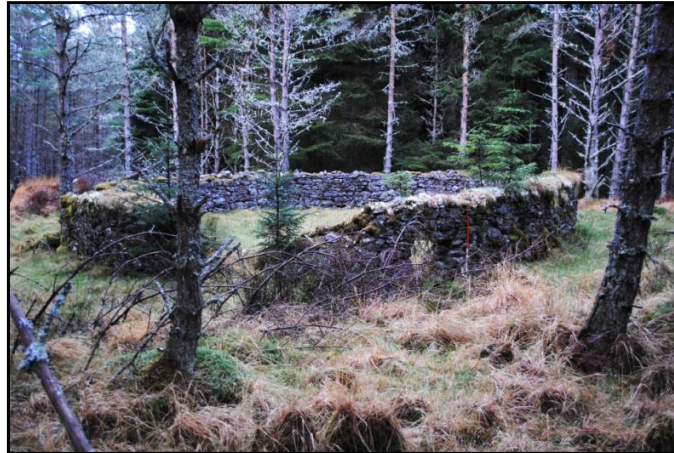
Plate 2 Sheepfold, Site 220

A well-preserved circular, drystone sheepfold with an internal diameter of 10m was located within a clearing in dense forestry plantation. The walls survive to 1.5m high and measured 0.7m wide. The creep is located to the south side of the structure.

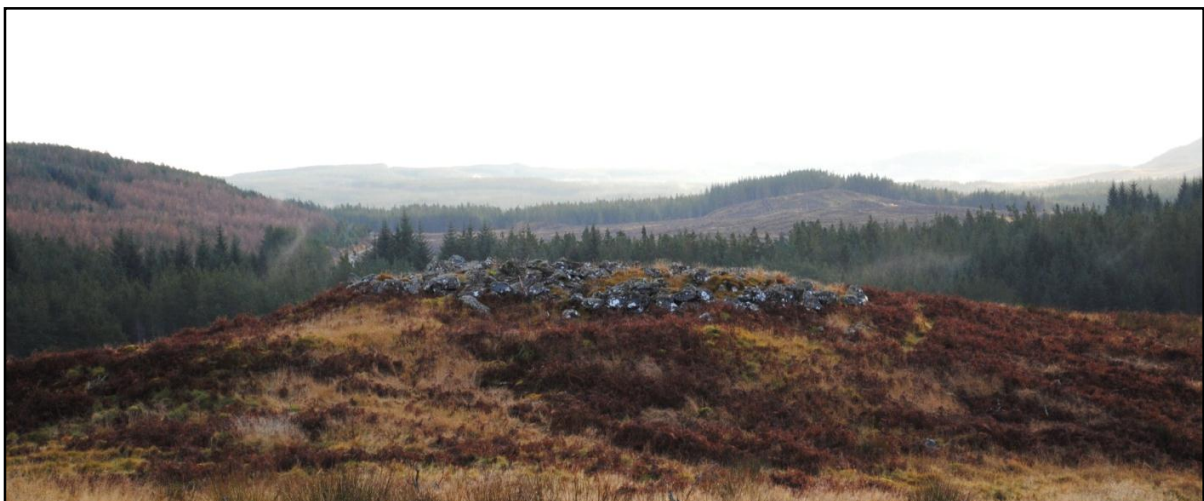
Plate 3 Alltbreac broch, Site 14

The broch (NGR NC 59108 10351) is in a degraded state, although the outer wall and part of the inner face of the inner wall is still visible. The broch overall diameter is 18.5m. There was no convincing evidence of an entrance, although a gap between the rubble on the SW quadrant could suggest this. The site has had post Medieval occupation, including re-use of the courtyard space for two twinning/lambing pens within the rubble. The broch rubble had also been used to construct a D-shaped enclosure (Site 245) attached to the NW side of the structure. A very degraded drystone enclosure (Site 248) wall runs from the NE side of the broch site and the remains of the wall suggest it encircled the base of the knoll. There were also hints of structural evidence adjacent to the E quadrant of the broch, although there was no convincing structure discernable within the dense grass and bracken.

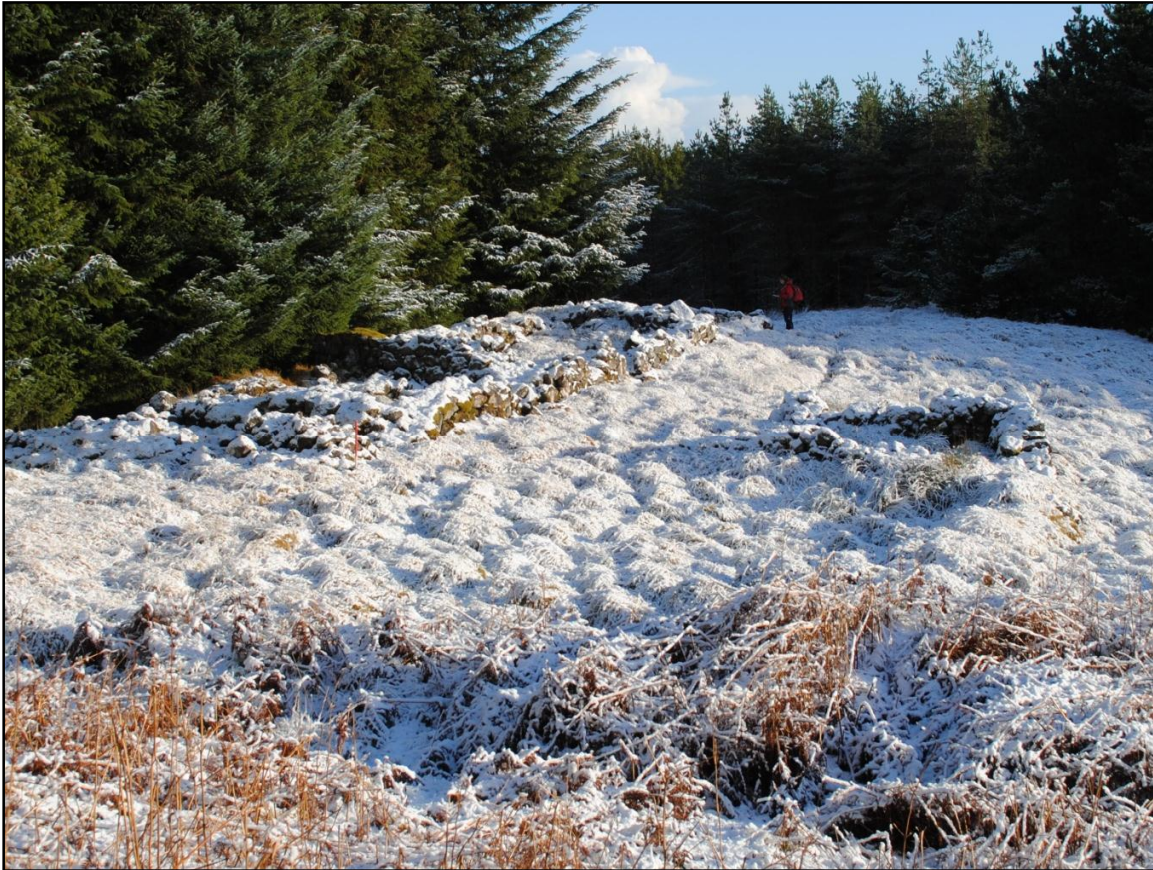
Plate 5 Torbreac farmstead, Site 82

The degraded ruins of a settlement known as Torbreac comprised four detached structures and associated boundaries and enclosures. The settlement area was divided in two by a tract of forested land and was surveyed as two sites, Site 82, centred at NGR NC 60472 09288. It was located east of Site 83, centred on NGR NC 60329 09288.

A degraded drystone wall, with walls 0.8m wide and standing up to 1m high, was attached to the westernmost building and formed a subrectangular enclosure to the west of the buildings. This enclosure had a small attached pen or bothy 4m by 4m at the east end of the wall, which was not well-built like the house. The walls were 0.6m wide and stood 0.8m high, and it appeared to have been a later structure, possibly contemporary with the twinning pen.

A degraded drystone boundary wall runs southward downslope from a boulder outcrop west of Site 82a to Allt Chaiseagail burn. It continues at the north end above the boulder outcrop edge northward through forested land. The bracken-covered walls are 0.4-0.6m high and 0.8m wide. The N-S alignment of the wall runs parallel to Site 82c.

A second degraded drystone boundary wall runs parallel to the Site 82b wall which is located twenty-five metres to its west. The bracken-covered walls, on a N-S alignment, survive to 0.8m wide and 0.6m high, and end to the south near Allt Chaiseagail burn.

To the southeast of the settlement a small field clearance cairn, 3m by 4m, was located in dense bracken. It was probably associated with field cultivation and there were probably other cairns which were not visible in the dense bracken.

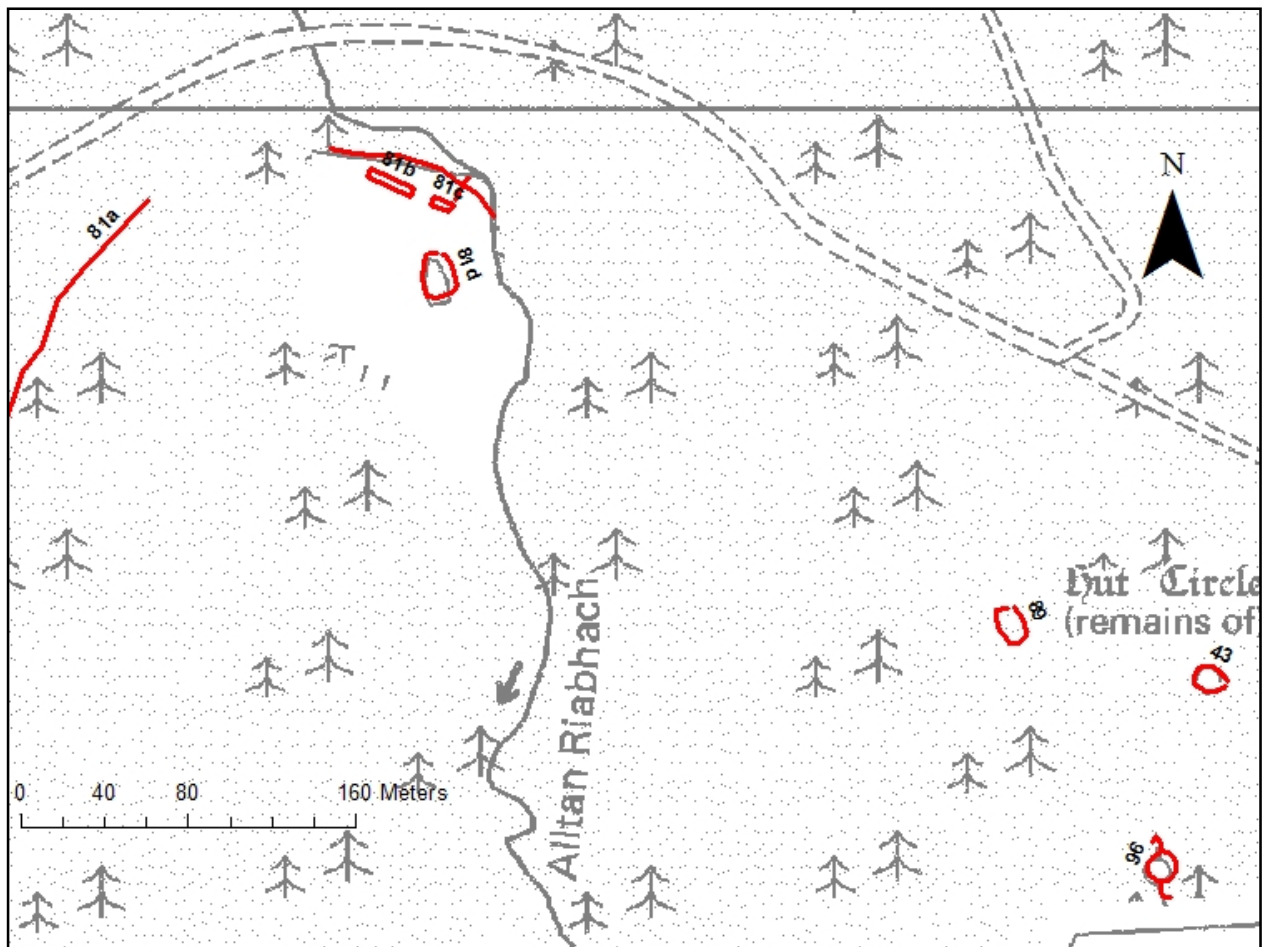
Figure 5 Loch Tigh na Creige, Sites 81, 43, 96 and 89

Site 81, a very degraded settlement site, centred on NC 61489 09955, comprises low drystone footings of two rectilinear house/byres, a subcircular enclosure and a head-dyke. It was situated on a small knoll south of the Alltan Riabhach, with south-facing aspect overlooking Loch Tigh na Creige at approximately 220m OD.

Within a clearing on a small hill was the turf-covered very degraded remains of long, rectilinear house surviving to a height of 0.3m. It appears that the structures were built of turf with stone footings and the overall length of the house was 22m ESE-WNW (external) by 3.5m (internal). This structure would have either been partitioned internally or have comprised individual buildings. However, there were no other structural footings discerned and the wall structure and width is uncertain due to dense turf and 2cm of snow covering the site at the time of survey.

Situated east of Site 81b was a turf-covered, very degraded rectilinear house surviving to a height of 0.3m. The width of the walling was uncertain, but the structures appeared to have stone footings. The overall length of the building is 9m ESE-WNW(external) by 4m (internal).

A degraded suboval drystone enclosure, measuring 20m N-S by 14m E-W, is situated south of the two house structures. The wall spread is between 0.6-0.9m and survives to 0.5m high with a possible north-facing entrance.

A subrectangular grass-covered stone and turf enclosure measuring 19m NNW-SSE by 10m was situated on a natural plateau on a south-facing slope. It had been much degraded by forestry ploughing and mounding.

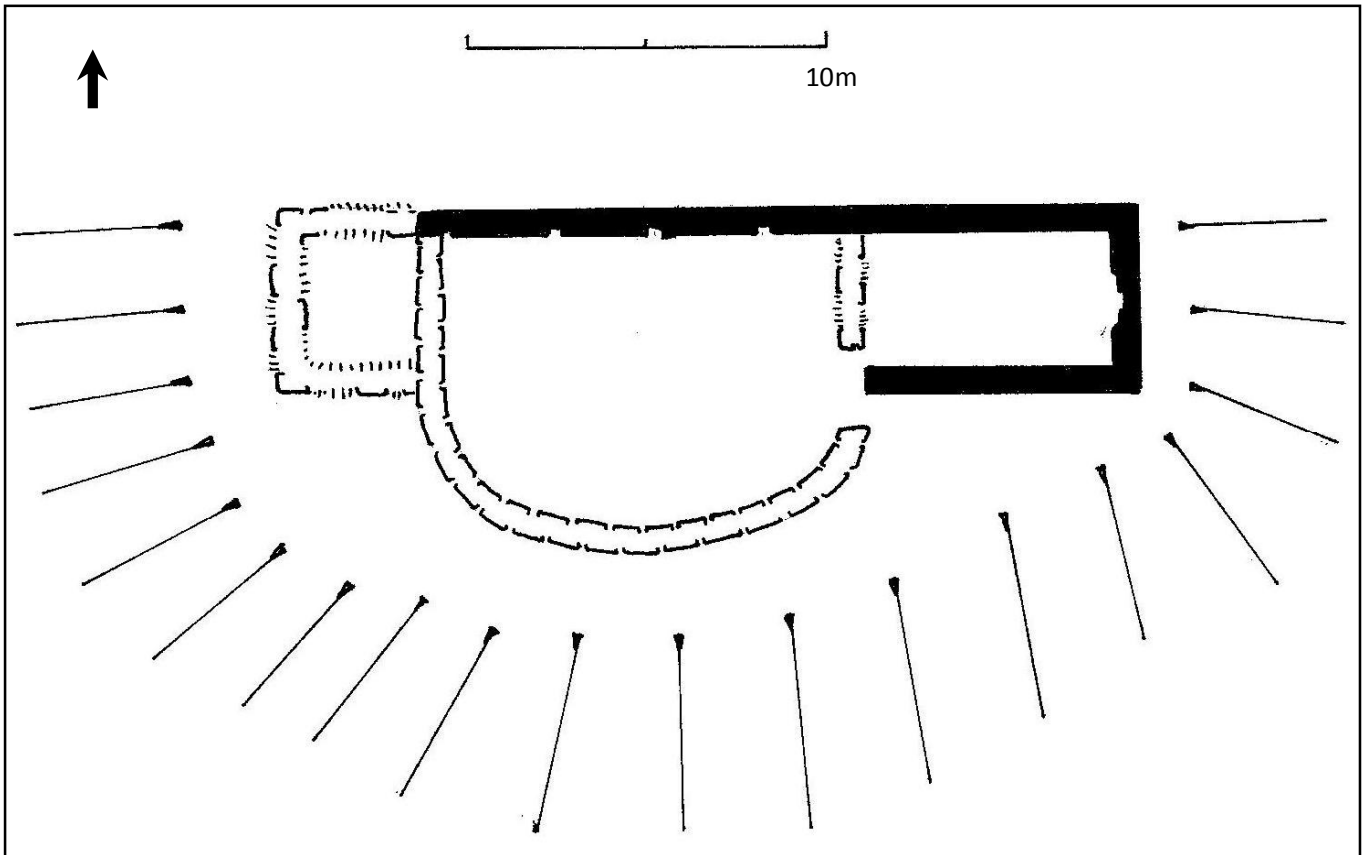
Figure 6 Tigh na Creige house and later sheepfold, Site 74

The house had been latterly rebuilt into a sheepfold, a drystone D-shaped enclosure attached to the house north and east walls. There was an entrance into the pen on the east side of the D-shaped wall.

A very degraded drystone square bothy, 2m across was located west of the house/sheepfold situated next to small water course. The dense grass and turf cover made it difficult to distinguish structure from natural turf.

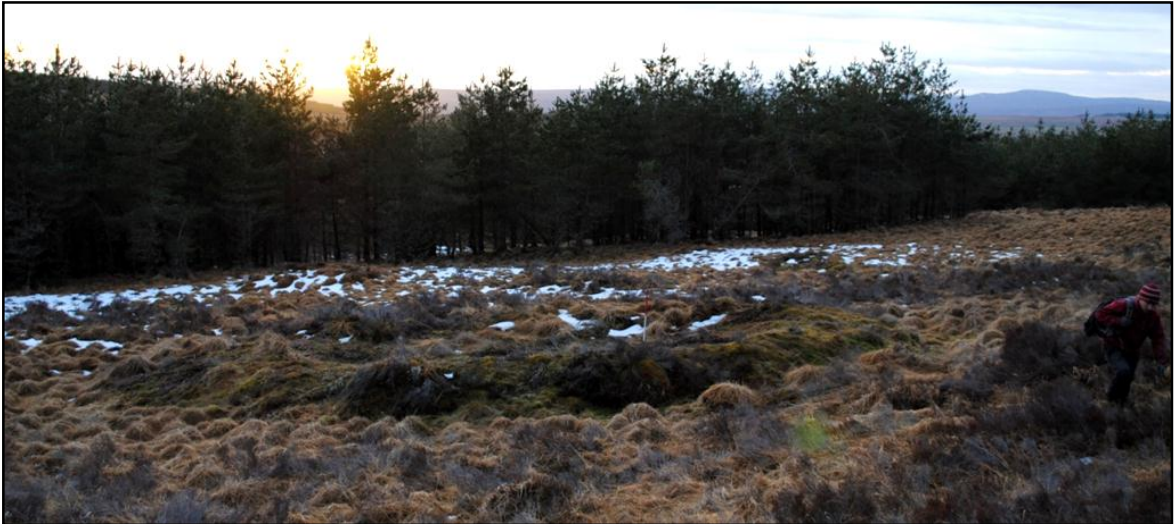
Plate 7 Feith Osdail hut circle, Site 65

A hut circle is situated on a built-up mound on a south-facing slope. It consists of a grass-covered stone and earth bank measuring 1.0m wide with 1.0m spread and measures internally 9.0m E-W by 8.0m.

Two clearance cairns standing to 1.0m high and measuring 3-4m wide form part of the remains of a field system. Associated with it is a drystone wall comprising large stones and boulders running along the top edge of the slope to the north side of the hut circle.

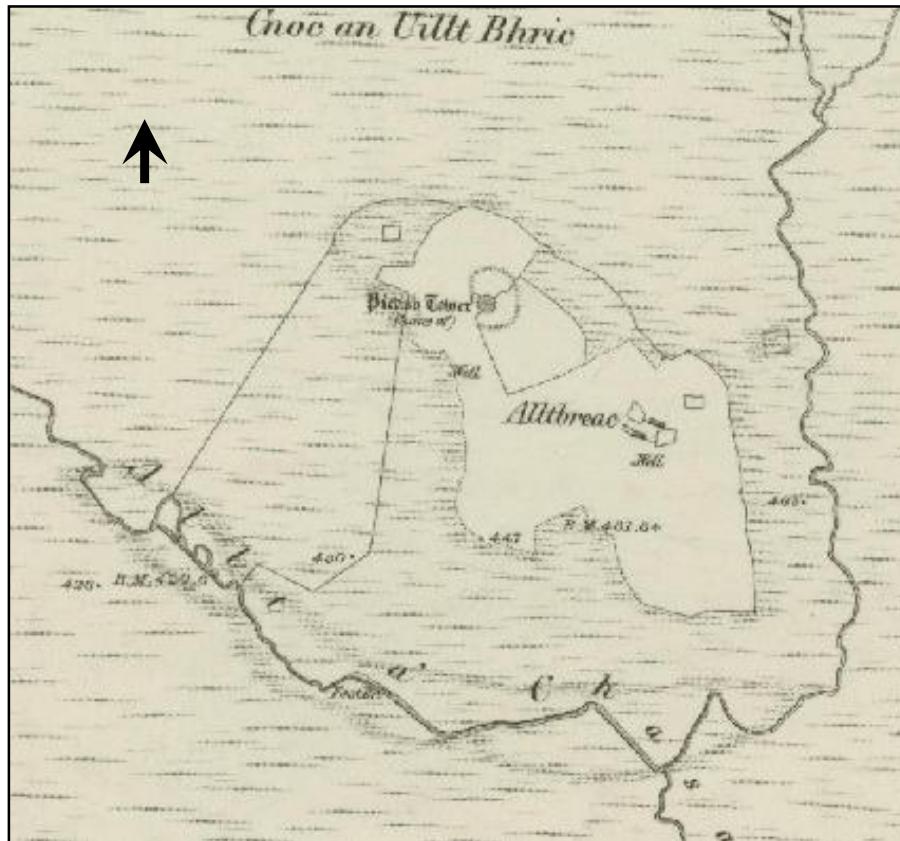
Figure 10 Alltbreac settlement depicted on the 1st Ed OS Six-inch map¹²

Certainly, the highly visible broch structure (HHER #MHG12837) was shown on the First Ed map (Figure 10), and it would have been an important location if only for the amount of readily available building material it provided. The present surveyors agreed with the general dimensions of the site and the attached D-shaped enclosure, which was more ruinous than previously description and no comment could be made about the location of galleries or passages. The 1963 and 1976 surveys had also recorded an oval, scooped enclosure on the east side of the broch and the site of this was noted during the present survey, although dense bracken and grass made the structure impossible to discern.

To the southeast of the broch, Alltbreac settlement (HHER #MHG12165) was recorded as five buildings and other enclosures in 1963. During the previous survey, only the bare footings of one very degraded structure (Site 100) were visible and this is probably all that remains of the settlement.

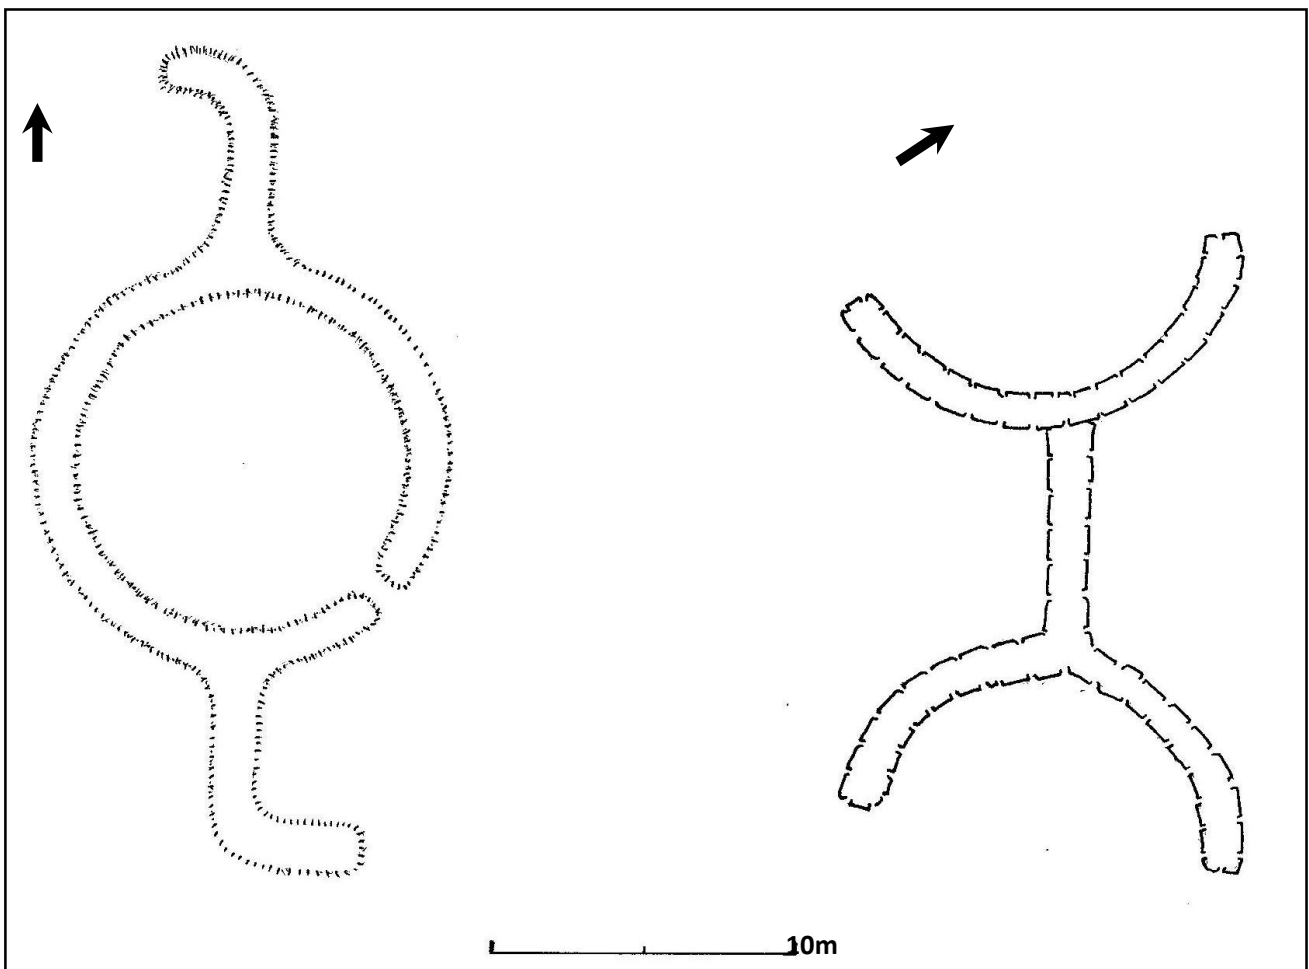
Figure 12 Sheepfold, Site 96, with attached shelter walls (left) and Sheepfold, Site 156, C-shaped shelter walling (right)

The second type of sheepfold consisted of the circular drystone stell with one or two hook-shaped arms attached as shelter walling. This type of structure was surveyed at Site 96 (see Figure 12), Site 97 and Site 151.

The third type, of which there was only one, Site 156 (Figure 12), consisted of two C-shaped walls linked by a length of walling. This was probably built as shelter walling.
