Excavations at the
Deserted Settlement
of
Easter Raitts, Badenoch

1997 Interim Report:
Structures 21 and 24 and Feature 14

Olivia Lelong

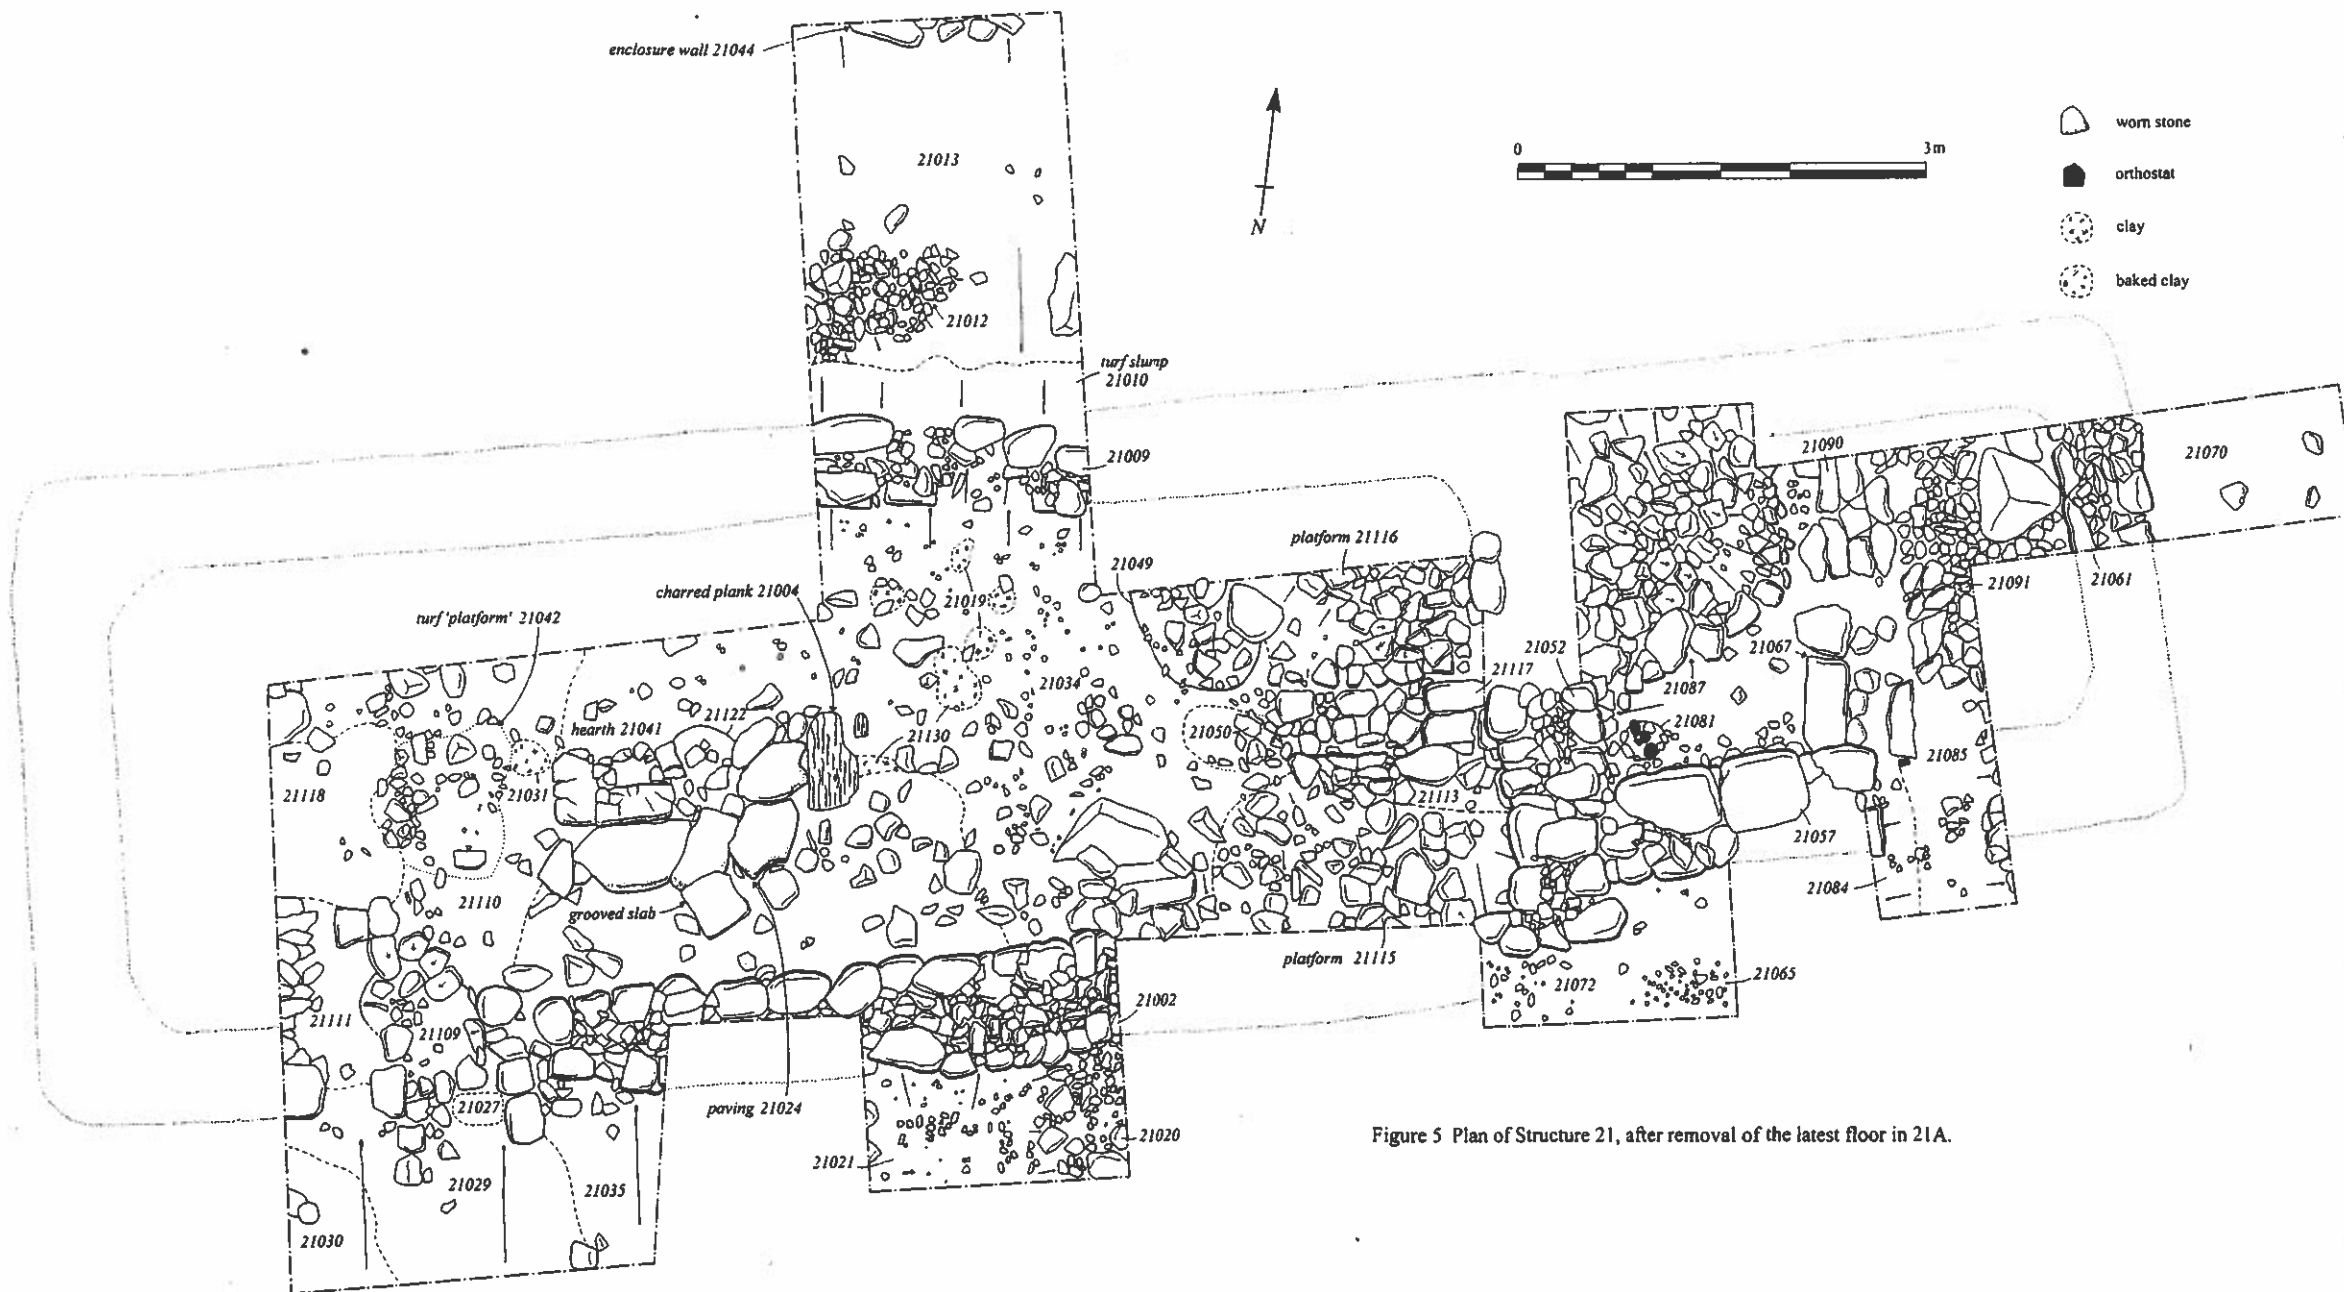
Figure 5 Plan of Structure 21, after removal of the latest floor in 21A.

Outside, echoing the line of the wall and abutting the stone footings, was a sloping deposit of dark brown compact silt (21010) which ran beneath a concentration of cobbles (21012) to the north (see Fig 5). Excavation of these deposits showed the dark brown silt to be the latest in a series of turf slumps, each earlier slump more leached than the next (see Fig 8). These suggest that the walls consisted of turf built against (and then above) the stone footings as a battered outer skin; the walls were regularly replaced as they slumped, each time leaving some residue on the ground beside the footings.
