Report of Archaeological Watching Brief October 2004 – March 2005. Culloden Area Water Mains Renewal Project Highland.

Client: Halcrow Group Ltd on behalf of Scottish Water.

By Stuart Farrell B.A A.I.F.A F.S.A.Scot. April 2005

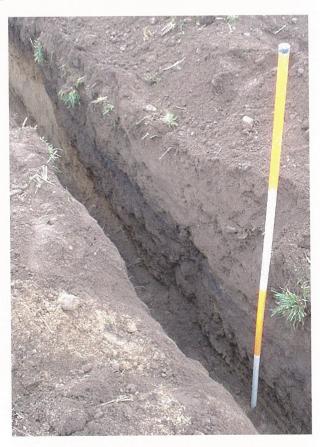
Work revealed one archaeological feature at NH 85876/53476, being 1.5m E of existing fence line. Deposit was a charcoal stained black fill over natural ground of orange-brown sandy-gravel, with inclusions of small cobbles. At a depth of 0.5m below existing ground surface, 2.1m in length and of a maximum depth of 0.2m. Deposit was not visible on W-facing section of trench, no indication of any cut and may only be a deposit. No finds made, though likely to be prehistoric in date.

Below: View of deposit facing SW - scale 2m.
