Building Element	Item	Significance	Reason		Image
External Elevations					
north	Whole elevation	EXCEPTIONAL	<p>Dominated by the Carruthers extension encapsulating the concept of Scotch Baronial with its two flanking projecting circular towers, crow stepped gable and crenellations. Intentionally Not quite symmetrical with the second floor bathroom window being offset and the different roofing styles of the two towers. The rear of the house projects to the west and the small sunken outbuilding is visible in the views as well as the unsightly electricity pylon. The largest architectural feature is the loggia – located not for sunny weather, but for views down to Loch Ness</p>

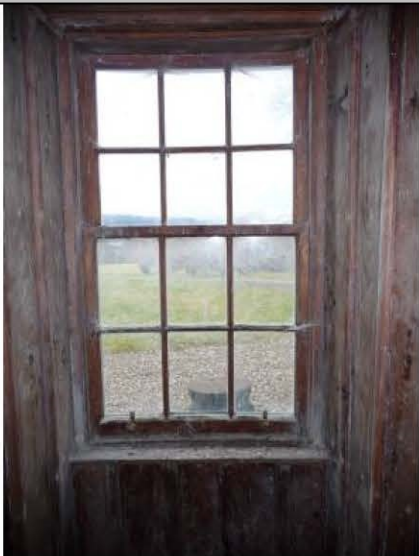
Building Element	Item	Significance	Reason		Image
	windows	EXCEPTIONAL	The use throughout of multi-pane sashes (except in the attic) introduces a stylistic harmony – this is an early style of window normally not much used after the mid 19 th century, Scotch Baronial houses often favouring plate glass sashes. Carruthers intentionally chose this style in order to blend in with the earlier house.

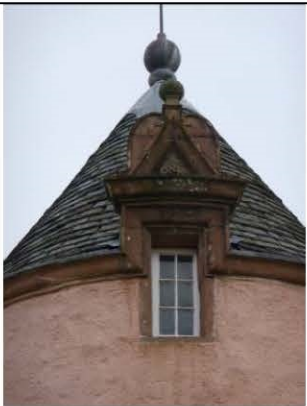
Dormer window pediments	EXCEPTIONAL	Throughout, the windows are surrounded with high quality red sandstone. Feature windows such as those at the top of the tower, are more ornate – at Culachy they incorporate the date of Carruther's remodelling - 1894

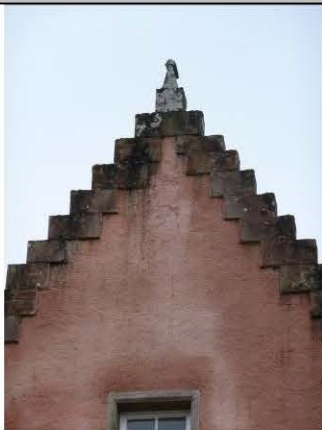
Building Element	Item	Significance	Reason		Image
	crow stepped gables	EXCEPTIONAL	A distinctive Scotch Baronial style

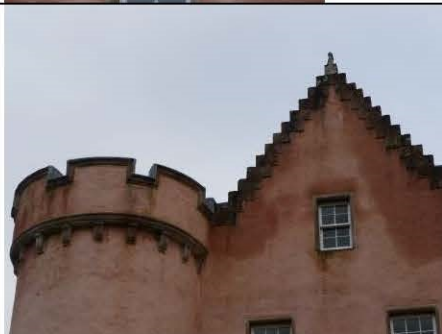
string courses and below eaves corbelling	EXCEPTIONAL	Adds to the character of baronialism by using a medieval feature which divides the elevation and adds interest

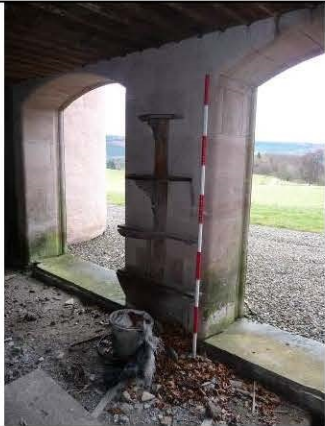
Building Element	Item	Significance	Reason		Image
			debate. Early harling seen in hidden locations is a pale ochre.		
	loggia entrance	EXCEPTIONAL	Arched loggias became increasingly fashionable in the late 19 th century and were a revival of an earlier feature. There are metal gate loops in the stone jambs to the exterior suggesting that the loggia could once be secured with gates.

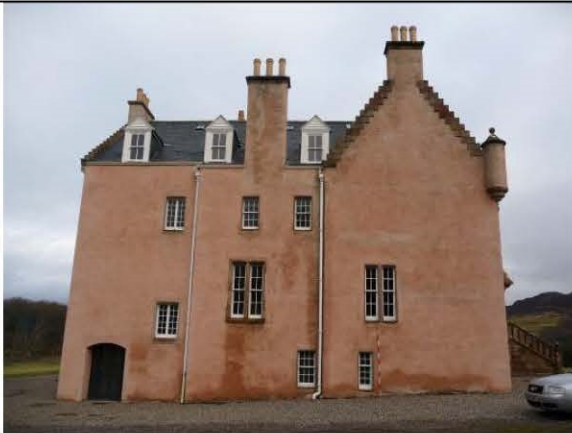
roofing styles and materials	EXCEPTIONAL	A typical mixture of the Scottish baronial ideal of pointed circular towers, crenellations and roofed with slate probably from Ballaculish.		
south	whole elevation	EXCEPTIONAL	A mixture of Carruthers additions and pre-Carruthers design, made baronial by the crow stepped gables and bartizan, but with the more recent dormer windows. The tall chimneys add elegance and height (as well as being practical) and the recent cast iron rain water goods are an outward sign of quality if perhaps oversized visually, but in this case are not of historic interest. The whole elevation is asymmetrical not just in terms

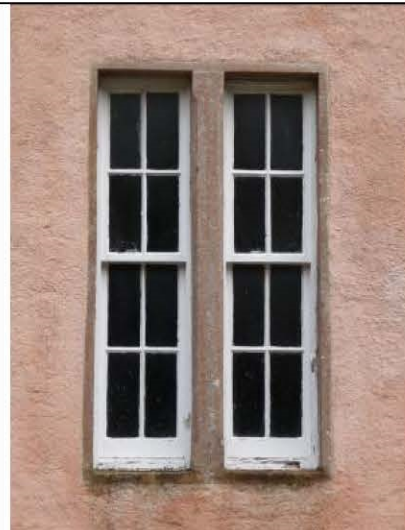
Building Element	Item	Significance	Reason		Image
			of the positioning of the window apertures, but there are a total of five different window styles used too		
	dormer windows	EXCEPTIONAL	A Carruthers addition, but these appear to be replacements		see above
	other windows	EXCEPTIONAL	A mixture of styles varying from the grand double sashes with stone central mullion for the major public rooms to casements and multi-pane sashes. However all are set within quality dressed sandstone and are all multi-pane therefore drawing the styles together. The front (south) double window has a central mullion with stop chamfer which is different to the other windows, perhaps earlier. Some ripple tooling on window surrounds

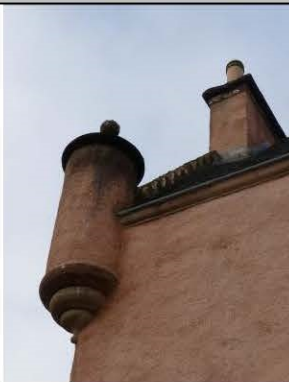
Building Element	Item	Significance	Reason		Image
	bartizan	EXCEPTIONAL	Particularly distinctive of Scotch baronial architecture – pre-Carruthers and most likely of the 1820-40 rebuilding. Matching Bartizan at north end of east elevation removed by Carruthers in extensions of 1894

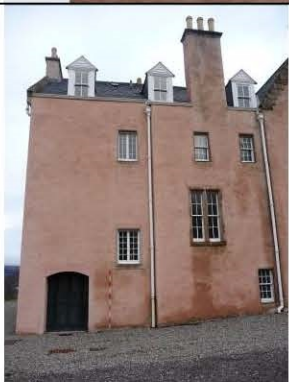
door	SOME	A more recent addition to an altered part of the house in 1893. Left half in picture rebuilt c.2003.

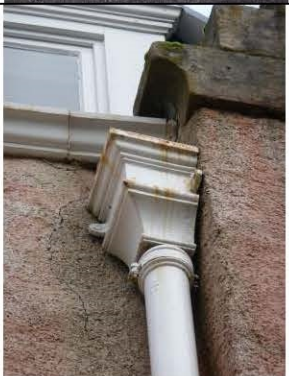
cast iron piping	SOME	Quality rainwater goods in cast iron, but not of any antiquity. Down pipes appear over sized and do not match rainwater goods seen in photos c.1881-5.

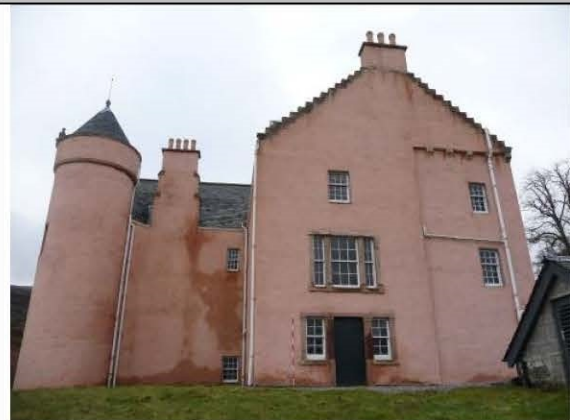
Building Element	Item	Significance	Reason		Image
west	whole elevation	EXCEPTIONAL	An elevation which is very much a rear view with less detailing and more recent interventions. This is in fact the elevation that would have been seen first when the original approach was used from the military road. The view is also diminished a little by the small late 19 th century outbuilding. At the base there are signs of rubble foundations possibly of the earliest building on the site, although the 4 pot chimney stack was only added in 1894. The position of the house on a mound is very visible from this angle. The tri-partite windows/door are significant as they may belong to the late 18 th century house extensions.

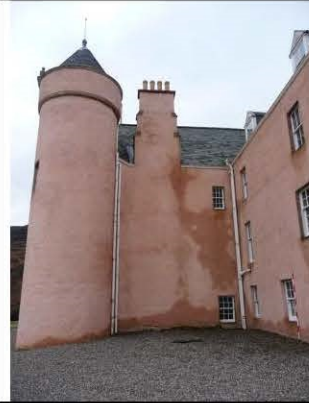
Building Element	Item	Significance	Reason		Image
	crow step gable	EXCEPTIONAL	A classic baronial feature and distinctive of Scottish architecture		see above
	chimneys	CONSIDERABLE	Tall chimney where it is required, shorter on the gable end. Pots all identical		
	harling	EXCEPTIONAL	Distinctive to the area as it reflects the lack of quality building materials locally, and pulls together the different phases of building into a coherent whole. Stylistically it harks back to Scottish Renaissance castles and was increasingly used in the late 19 th century, although colour schemes have traditionally been the subject of much debate. The harling on this elevation shows differential drying which may relate to earlier phases of building works		see below
	Drum tower	EXCEPTIONAL	Encapsulates the concept of Scotch Baronial

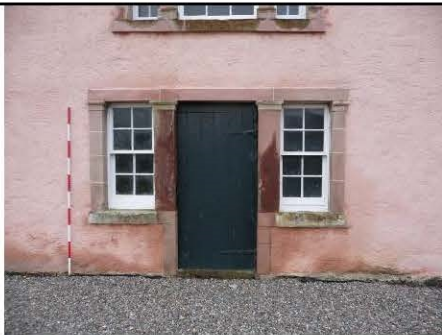
Building Element	Item	Significance	Reason		Image
	roofing styles and materials	EXCEPTIONAL	A typical mixture of the Scottish baronial ideal of pointed circular towers and crow stepped gables and roofed with slate. Finial an important feature on the tower roof		
	Door	CONSIDERABLE	Simple batten door used for less visible or functional areas and is therefore appropriate for a rear elevation. Door way of late 18 th century, outward opening door and ironwork may be original visible in photo of 1881-5

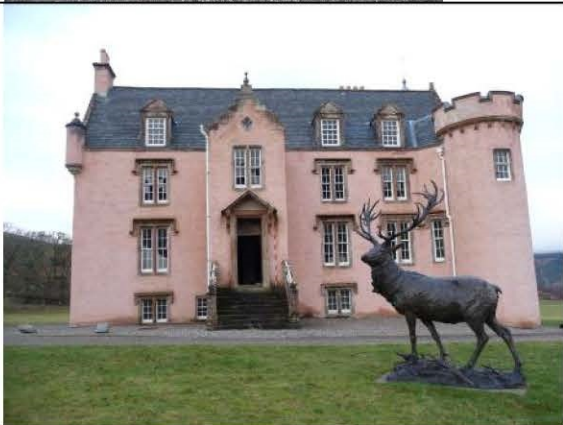
east	whole elevation	EXCEPTIONAL	The most important elevation as it is the welcoming entrance with pre-Carruthers porch and the greatest density of detailing which gives the building its architectural and historical distinctiveness. Architectural detailing which is an important element of the overall design includes hood moulding over the windows, crow stepped gables, the bartizan, the crenellated tower, quatrefoil window, the symmetrical layout of multi-pane sash windows with red sandstone surrounds, dormer windows, finial and imposing entrance porch with steps of 1820-40 extended

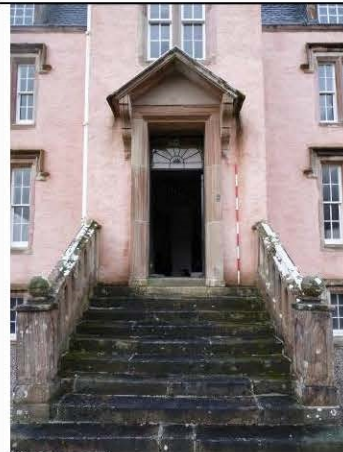
Building Element	Item	Significance	Reason		Image
	Entrance porch	EXCEPTIONAL	<p>1894 in similar style</p> <p>Stone steps, an ornate balustrade and stone porch create an imposing entrance designed to impress the visitor. The porch block is not keyed into the main structure and may represent an addition to the building in the first half of the 19th century.</p>

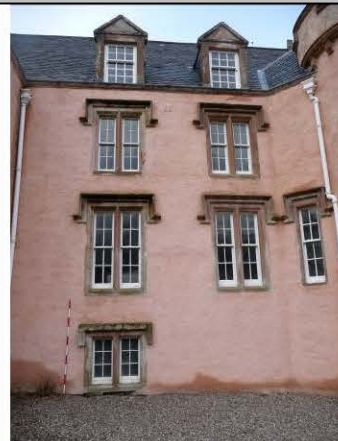
Building Element	Item	Significance	Reason		Image
	Dormer windows	EXCEPTIONAL	The bays to the immediate left and right of the porch are pre-Carruthers who sought to make the extension fit in by continuing the use of multi-pane sashes and red sandstone surrounds.

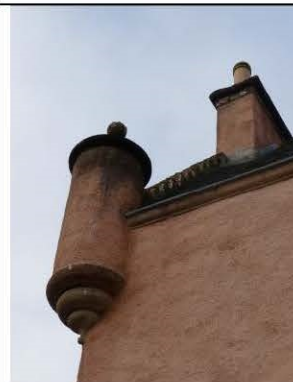
Building Element	Item	Significance	Reason		Image
			phases together, however it appears also to have been harled before his work too. The colour has varied.		
	bartizan	EXCEPTIONAL	Particularly distinctive of Scotch baronial architecture – pre-Carruthers.

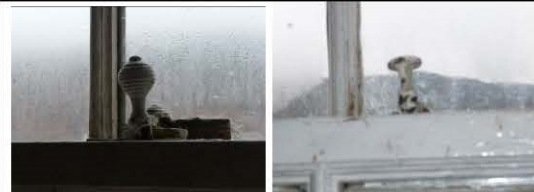
crow stepped gable	EXCEPTIONAL	A distinctive Scotch Baronial style		
	roofing types and materials	EXCEPTIONAL	A typical mixture of the Scottish baronial ideal of pointed circular towers and crow stepped gables and roofed with slate.		
Internal features - general	windows	EXCEPTIONAL	Windows express a uniformity of design and add interest and depth to the external elevation. Windows are predominantly multi-pane sash windows typical of the mid 19 th century, although there are a few casements in the more recent SW corner. Some display the original window glass which has now become attractively iridescent. Window fittings are also important. Most have a

Building Element	Item	Significance	Reason		Image
			common type of brass sash fastener called the lever catch. This helped to prevent windows rattling by drawing both sashes together and are a common 19 th century design feature.
