# West Coast Archaeological Services

## Gorthleck Mainout Route Diversion Dores, Inverness-shire

### Archaeological Desk Based Assessment and Walkover Survey

National Grid Reference	NH 56832 22848 – NH 55484 19603
Site Code	Gorthleck12
Author	Steven Birch
WCAS Report #	32/GORTH/12
Client	Scottish Water Solutions
Date	22-07-12
OASIS Report #	Westcoas1- 131177

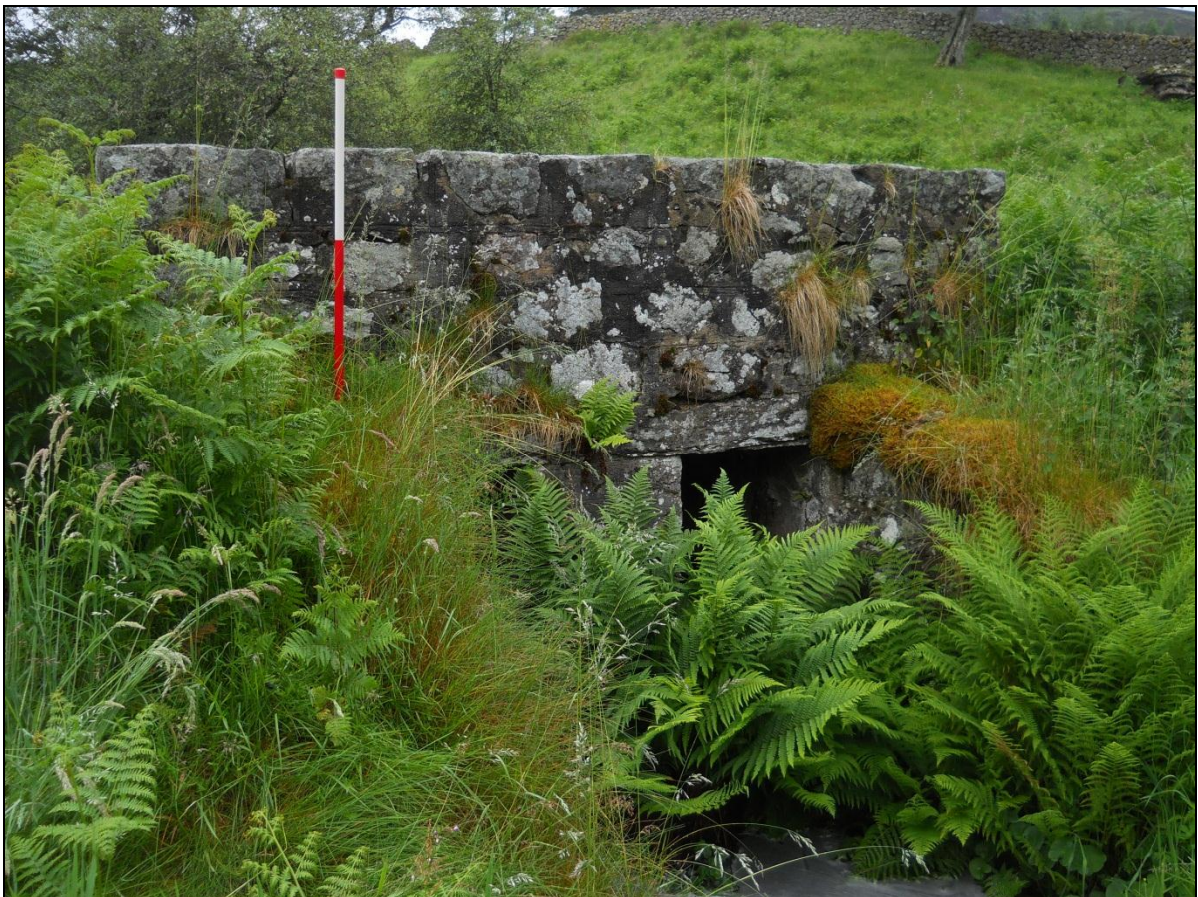
**Cover** - Stone-built bridge Site 4 near Farraline House

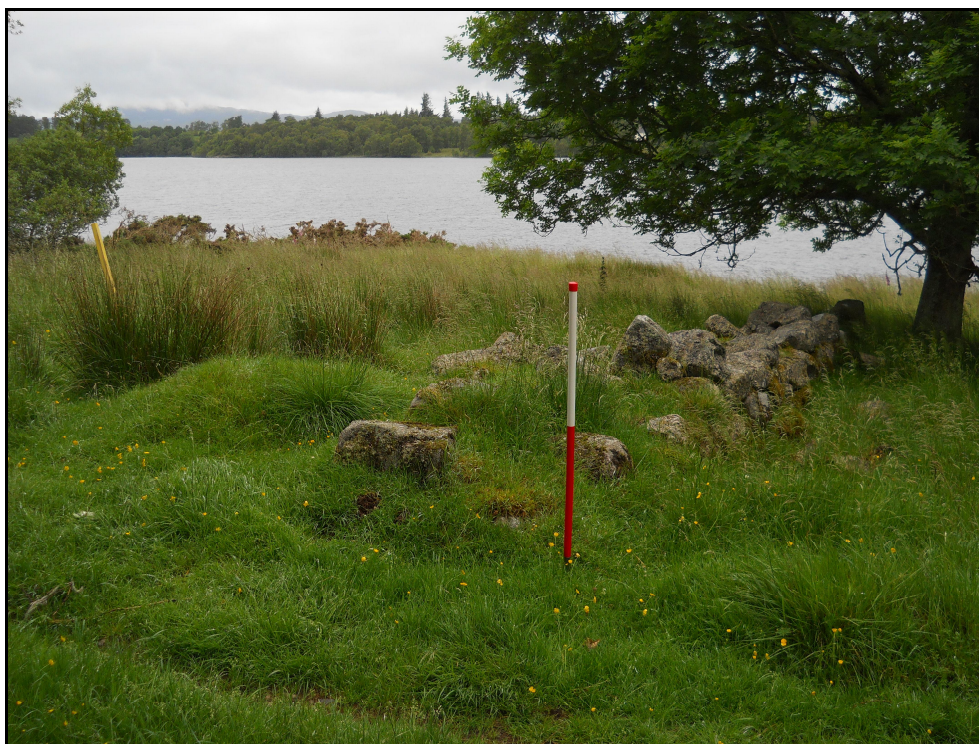
**Plate 1 – Partially robbed-out stone wall Site 3 and yellow marker of pipeline route**

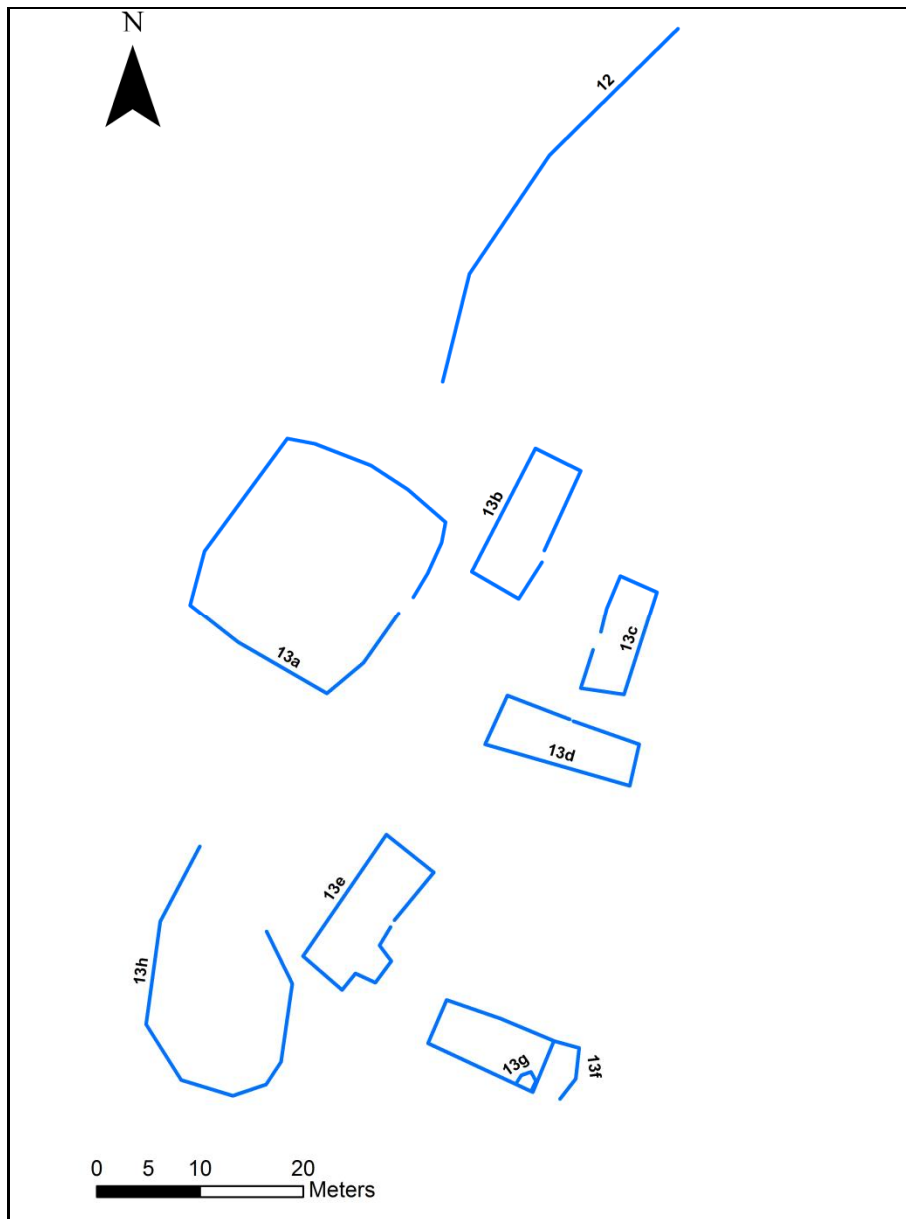
**Figure 3 – Post-medieval settlement at Ballindalloch (Site 13) and boundary dyke Site 12**

6.2.2.4 The township of Ballindalloch comprises at least four separate areas of settlement remains, as depicted on the Ordnance Survey mapping. Only one of these areas of settlement was surveyed

during the walkover survey, as the proposed pipeline route passed close to the west. Site 13 included five individual houses, one of which displayed evidence for earlier footings (Site 13f), and two enclosures. A fragment of boundary dyke was also recorded (Site 12), which may form part of a larger enclosure associated with the settlement. The houses and enclosures were primarily constructed from stone, while the identification of a twinning pen (Site 13g) within the southeast corner of house Site 13f indicates a later re-use of the building after it had passed out of use as a dwelling.

- 8.1 The following buffer zones should be retained around archaeological sites recorded during the walkover survey:
- 8.1.1 A 10 metres buffer zone should be retained around post-medieval farmsteads, individual stone and turf built structures, and small enclosures. The pipeline route passes close to the enclosure Sites 13a and 13h and the buffer zone should be retained in this area of the Ballindalloch settlement.

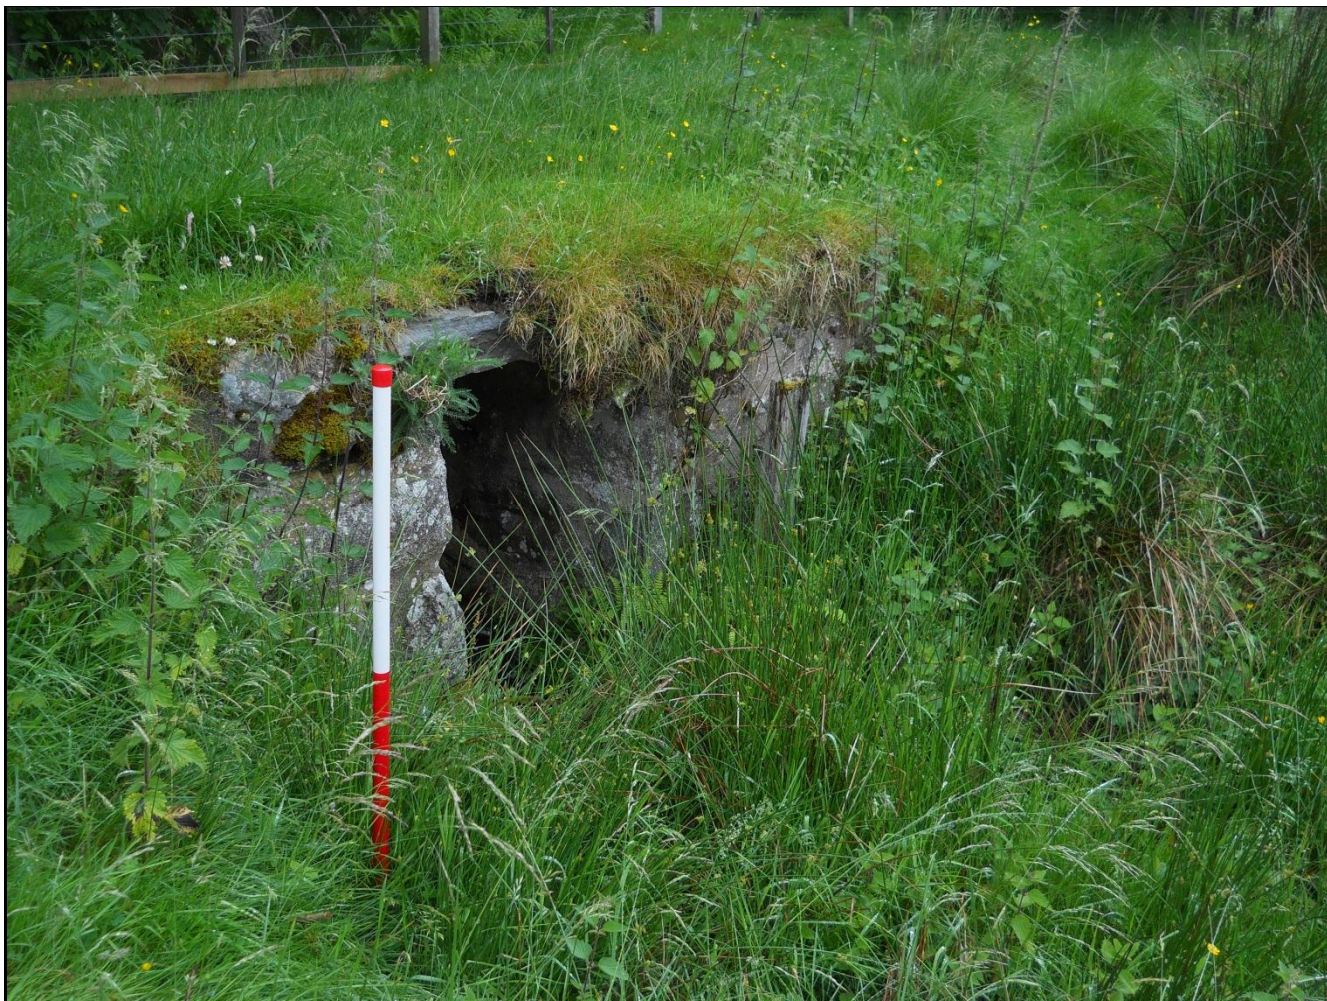
6.2.2.2 The four bridges recorded during the survey (Sites 1, 2, 4 and 7) are most likely associated with the access track (Site 5) leading past Farraline House to the settlements at Farraline, Balnoe and Ballindalloch. Two of the bridges (Sites 1 and 2) now carry the metalled road to Farraline House and may have been modified for this purpose, but it appears that the track originally took a route closer to the loch shore and bridges Sites 4 and 7 are still located on this former access route.

**Plate 2 – Bridge Site 4 carrying access track Site 5**

- 8.1.3 The route of the water main pipeline will have to be cut within the recommend 10 metres buffer zone to the northwest of track Site 5 and stone-built bridge Site 4. This should not impact on any associated archaeological deposits as the route passes through wet, low-lying ground.

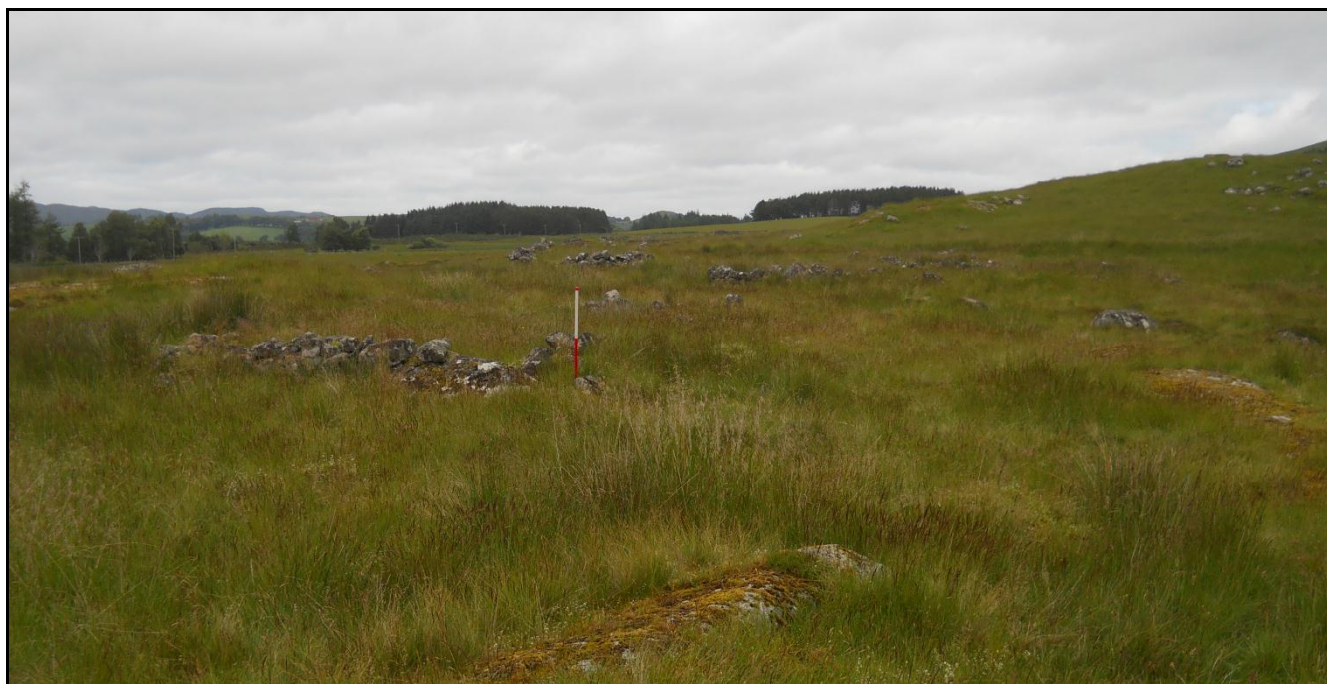
**Plate 3 – Post-medieval settlement at Ballindalloch Site 13**

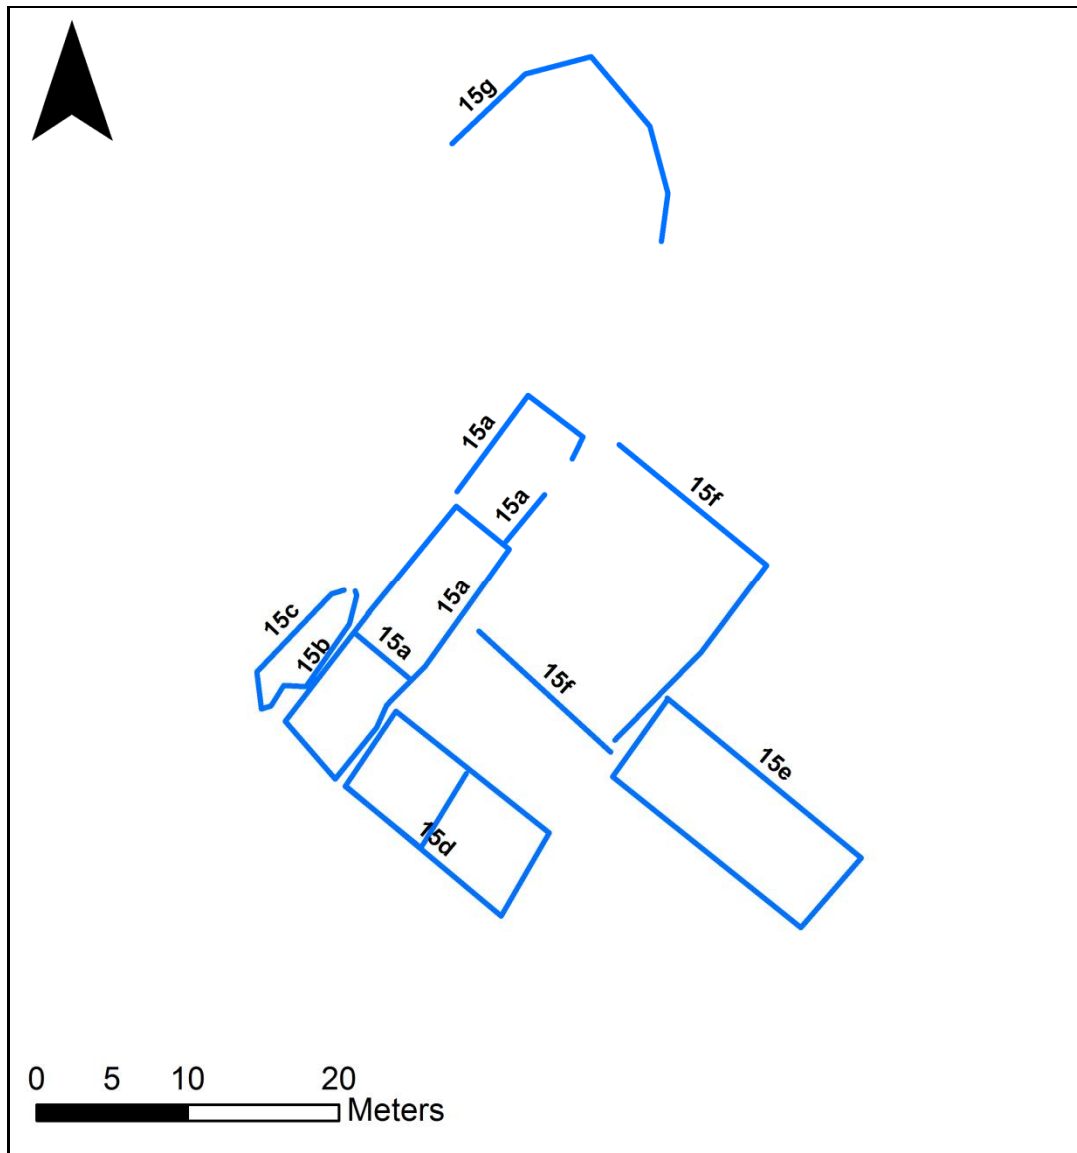
6.2.2.6 The final settlement remains recorded during the walkover survey are located to the north of the stream at Wester Abercalder (Site 15). This complex of structures with evidence of mortared walls, have been heavily robbed for their stone with some of the structures reduced to their foundation courses. Additional structures were noted, but not recorded, on the sloping ground to the north of Site 15. The structures comprising Site 15 appear to represent a former steading complex, with possible evidence for a water-wheel pit. However, only the southern structure, a single farmstead with attached enclosure, is shown on the Ordnance Survey 6 inch mapping. Therefore, the site must have undergone later alterations to convert it into a group of steadings which were not depicted on the early mapping.

**Figure 4 – The farmstead and enclosure Sites 15e and 15f shown on the OS First Edition mapping and later steading complex with possible water-wheel pit 15c**

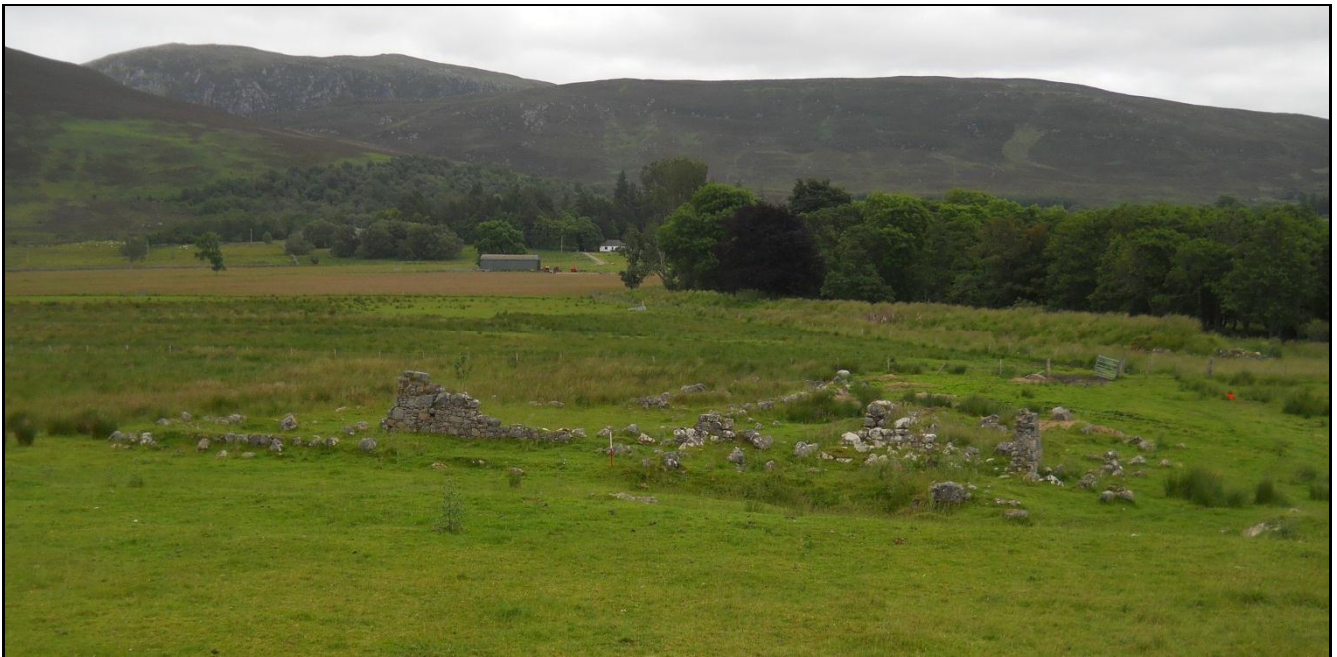
**Plate 4 – Farmstead and steading complex Site 15 looking east with the sunken stone-lined pit in the foreground, possible built to house a water-wheel**

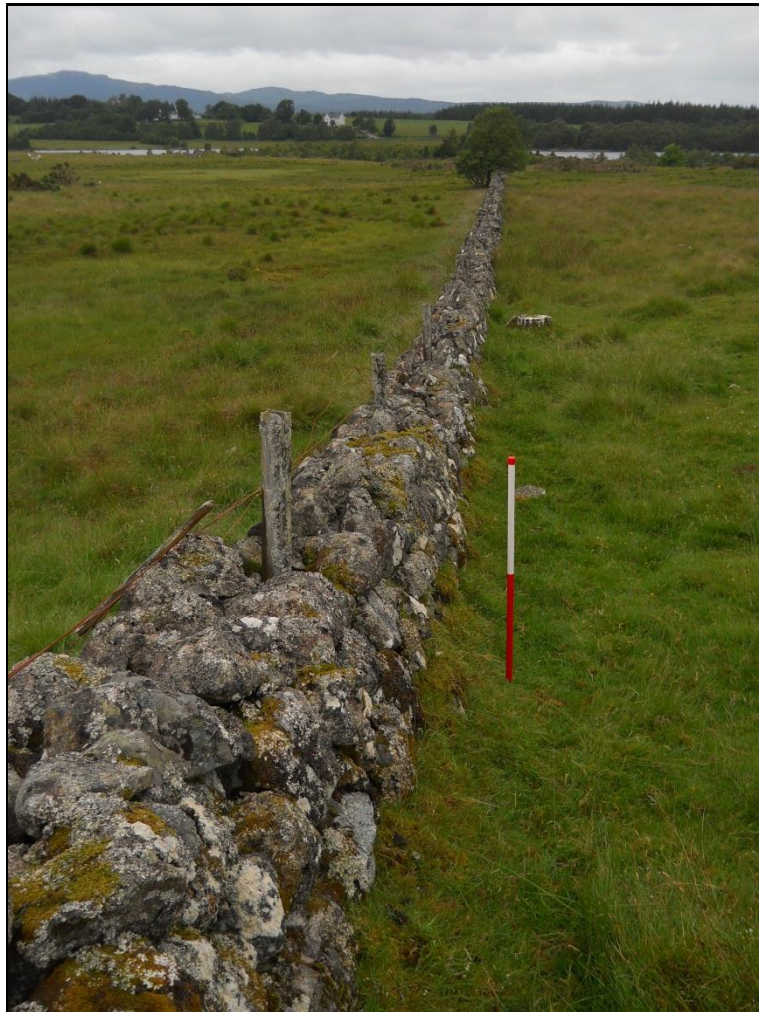
**Plate 5 – Drystone dyke Site 11 looking WNW**

- 8.1.6 Where the pipeline runs in parallel with turf or stone boundary dykes, a 5 metres buffer zone should be retained to each side of the dyke.
- 8.1.7 Where the pipeline cuts through boundary dykes and walls, the minimum amount of impact is encouraged. In particular, tracking by the excavator undertaking the cutting of the pipeline trench over boundary dykes and walls should be kept to a minimum.
