# CASTLE SINCLAIR GIRNIGOE

## ARCHAEOLOGICAL EVALUATION

WICK  
CAITHNESS

REPORT  
MARCH 2005

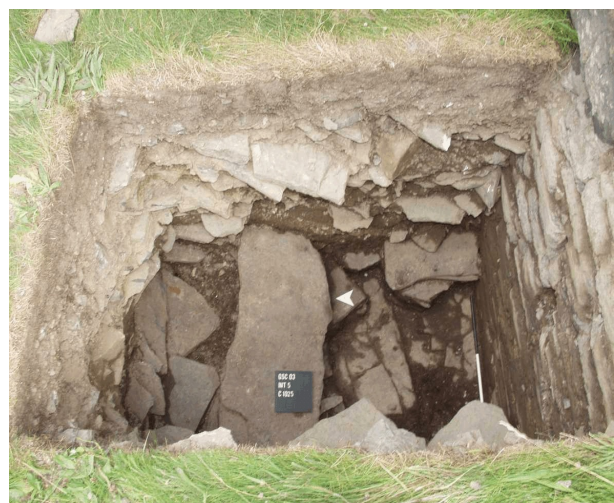
**Plate 8** Intervention 3 from the southwest

Intervention 3 was situated within the Porter's Lodge of the Outer Bailey, adjacent to the northwest elevation of the late 14th to 15th century West Gatehouse (Figure 4). The 1.0m x 1.5m trench was excavated to a depth of 1.40m, at which point a flagstone floor (F37) was encountered (16.21m AOD)(Plate 8). In addition to revealing the nature and extent of archaeological deposits overlying and abutting structural remains, the removal of deposits to this depth exposed the lower 1.5m of the northwest wall of the gatehouse. This provided access for structural assessment to be made of the foundations of this elevation, in order to inform future consolidation works, and also allowing a record to be made of stonework that had previously been concealed by accumulated deposits (Figure 5).

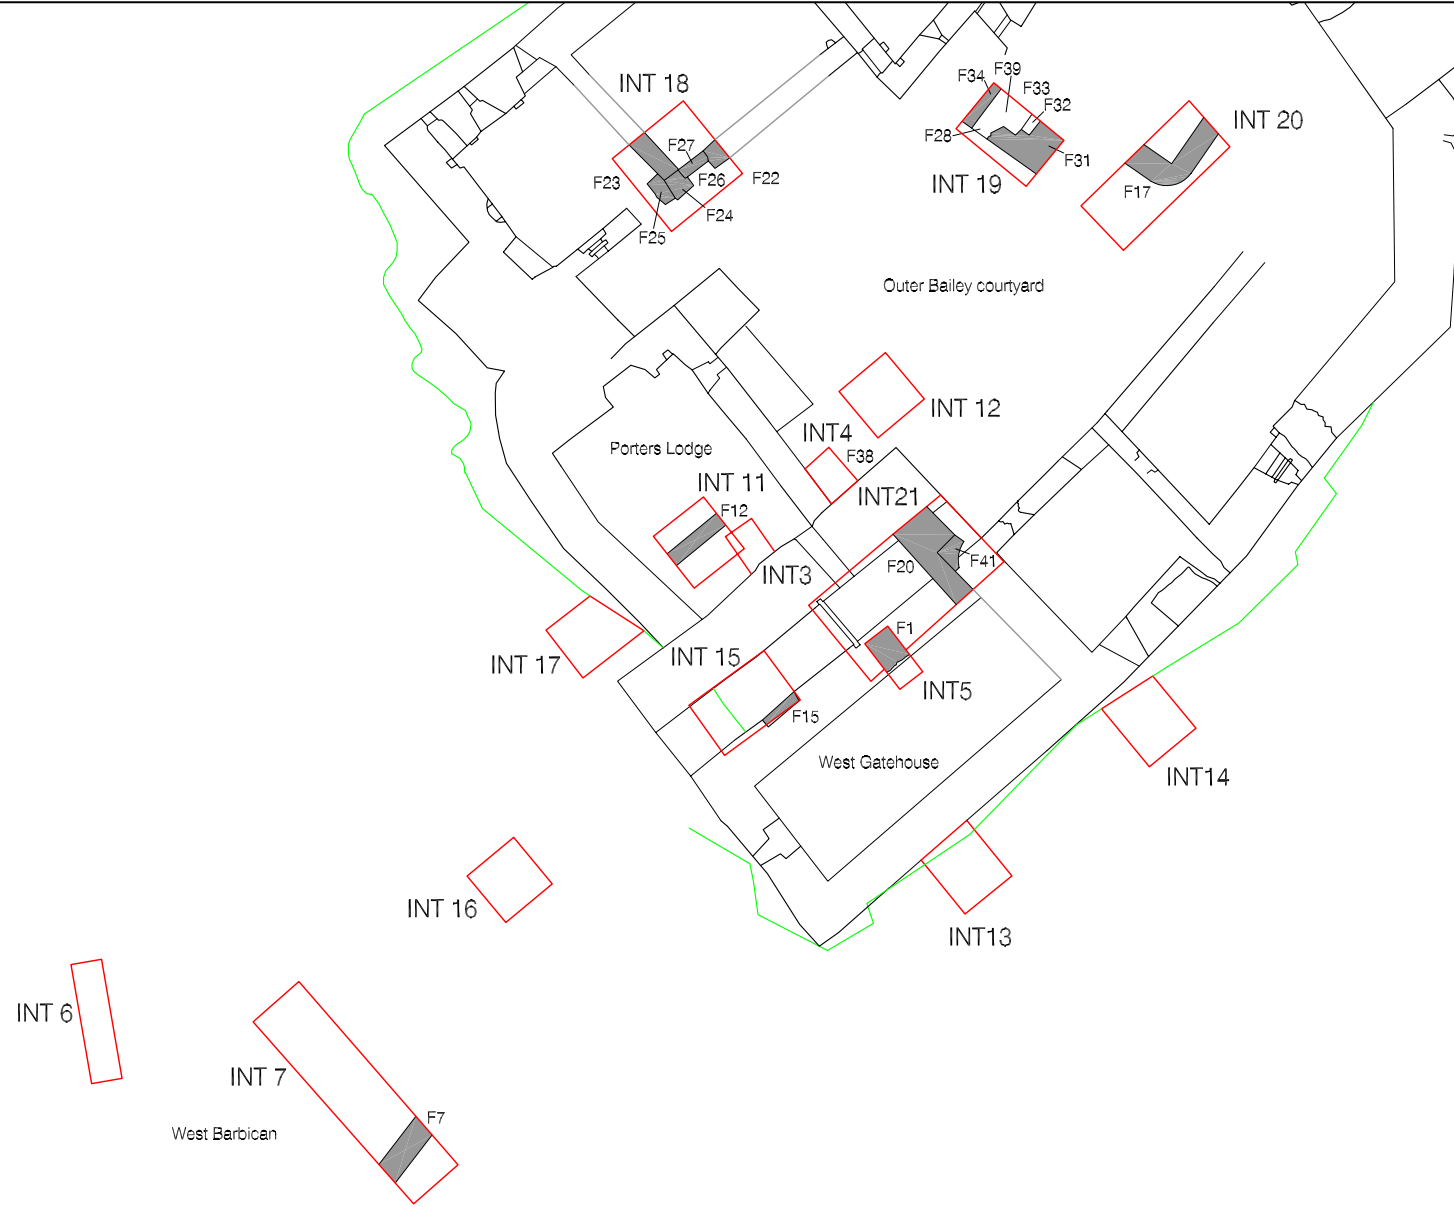
Figure 4

Detailed intervention location showing structural features revealed during the evaluation

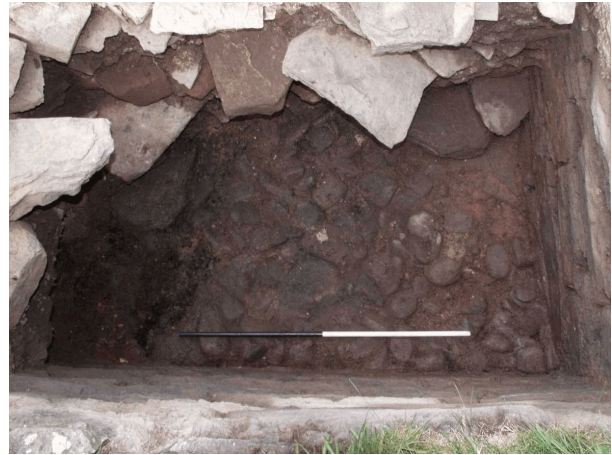
**Plate 10** Cobble layer (C1016)

The cobble layer (F38 C1016), identified at 16.25m AOD, covered all but the northwest part of Intervention 4, abutting both adjacent elevations (Figure 9; Plate 10). This level surface consisted of tightly packed waterworn cobbles. A sondage was excavated adjacent to the southwest edge of the Intervention, and revealed that the cobble surface represented the earliest structural activity in this area, overlying bedrock and natural clay subsoil. A single, sub-rectangular flagstone was noted overlying C1016, which suggested the cobbles formed a preparation layer for a slabbed surface that was later disturbed or robbed out.

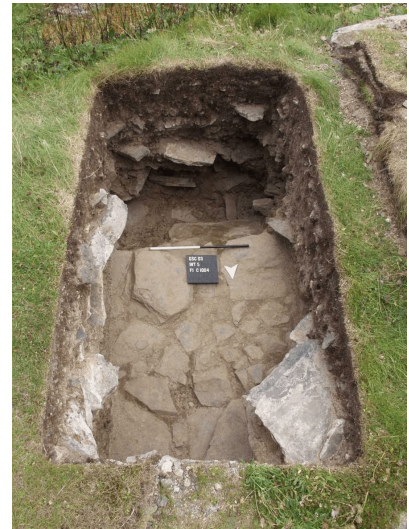
**Plate 14** Wall F1, C1004

F1 C1004 was identified in plan as a NE-SW aligned wall, running across the western end of Intervention 4, measuring over 1.10m wide (Plate 14). The construction of the wall was visible, comprising two faces of roughly squared slate slabs, between which a core of slate rubble was identified (Figure 11). Excavation of overlying deposits exposed the wall to a height of 0.15m, but did not continue further; it is assumed that F1 represents the upper courses of the wall dividing the vaulted passage and adjacent room within the Gatehouse, and as such, overlying deposits will have accumulated throughout the internal areas of the underlying storey.

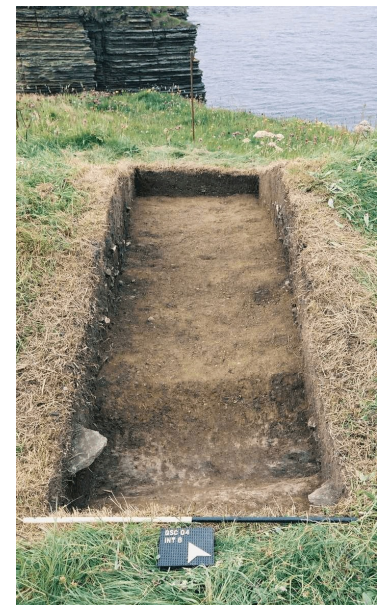
**Plate 15** Bank (F4) and ditch (F5)

The bank (F4) was not substantial, reaching only 0.33m in height, and measuring 2.11m wide, with gently sloping sides. The make-up of this structure comprised a friable sandy clay (C1031), which appears to have been quarried from the adjacent and parallel ditch (F5). The ditch, which measured 0.90m wide, was found to measure at least 0.25m in depth, backfilled with a light greyish-brown sandy clay with sandstone and mortar inclusions (C1032).

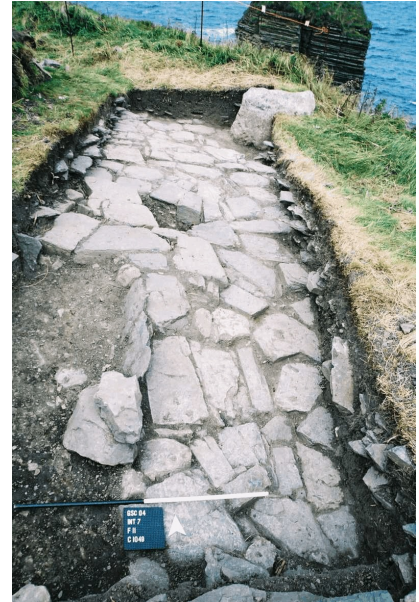
**Plate 16** Slab floor (F11) with pit (F18) to the left

A flagstone surface (F11 C1049) was found to cover much of the northwestern part of the intervention (Plate 16). F11 overlay a rubble and sandy clay layer which was recorded, but not excavated further. The floor surface comprised irregular but tightly fitted slabs, generally Caithness slate, but with occasional rounded cobbles (C1049). Generally, the surface was found to be level, although sloping gently from southeast to northwest, possibly representing changes in levels associated with erosion of the cliff.

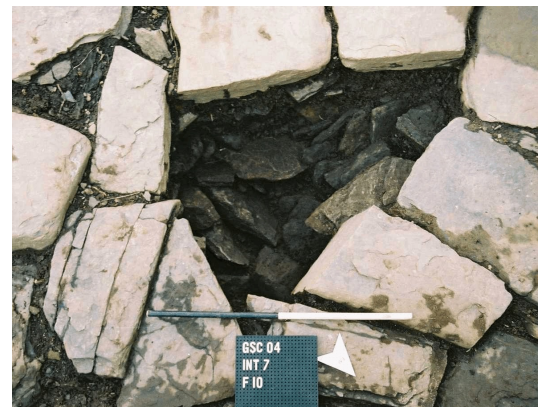
**Plate 17** Intervention 7 posthole F10

The triangular posthole, F10, was clearly defined against the slab surface, backfilled with C1048, a dark greyish-brown silty clay, with flecks of mortar and large stone slabs, which may represent displaced packing material. The alignment of slabs around the upper edge of F10 may suggest that the feature was either in place (or intended) when the floor was constructed. The feature, measuring 0.69m by 0.48m in plan, was excavated to a depth of 0.35m, and was found to cut into the rubble layer below, resulting in an irregular profile (Plate 17).

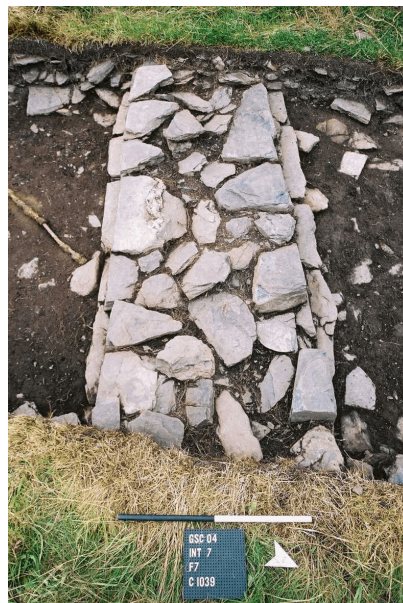
**Plate 18** Wall F7 C1039

The flagstone floor, posthole and rectangular pit were all found to have been sealed by C1047, a very dark grey silty clay with mortar flecks and slate inclusions. This layer was found to predate a NE-SW aligned stone wall (F7), running across the intervention at its southeastern end. The exposed length of wall measured 2.0m long and 0.80m wide, and was found to have been constructed from slate slabs, with roughly squared facing stones and a rubble core (C1039). The wall survived to only two courses; removal of overlying and abutting deposits revealed that the lower course formed a footing (Plate 18).

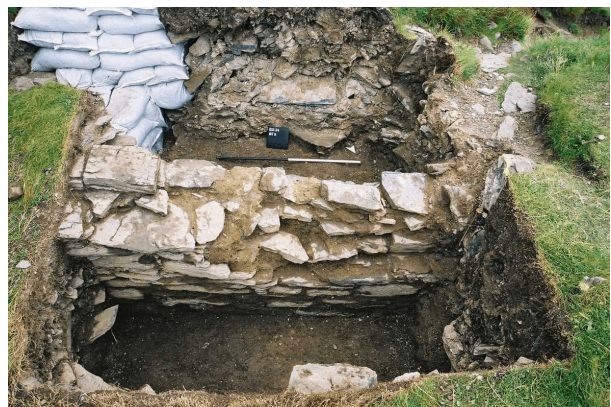
**Plate 20** Intervention 11 wall F12

Intervention 11 was bisected by a wall running NE-SW, of which a length of 2.0m was exposed (F12)(Figure 18). The wall was found to measure 0.55m wide, and was constructed from roughly shaped blocks of slate (C1062), with yellowish-brown clay bonding (C1063). Upon removal of abutting and overlying deposits, F12 was found to survive to ten courses (0.78m)(Plate 20). The wall was not anticipated by earlier research into the layout and plan of the castle, and appears to represent an internal wall within the Porter's Lodge. Without examination of the relationship between this feature and the external walls of the Lodge, it is not possible to

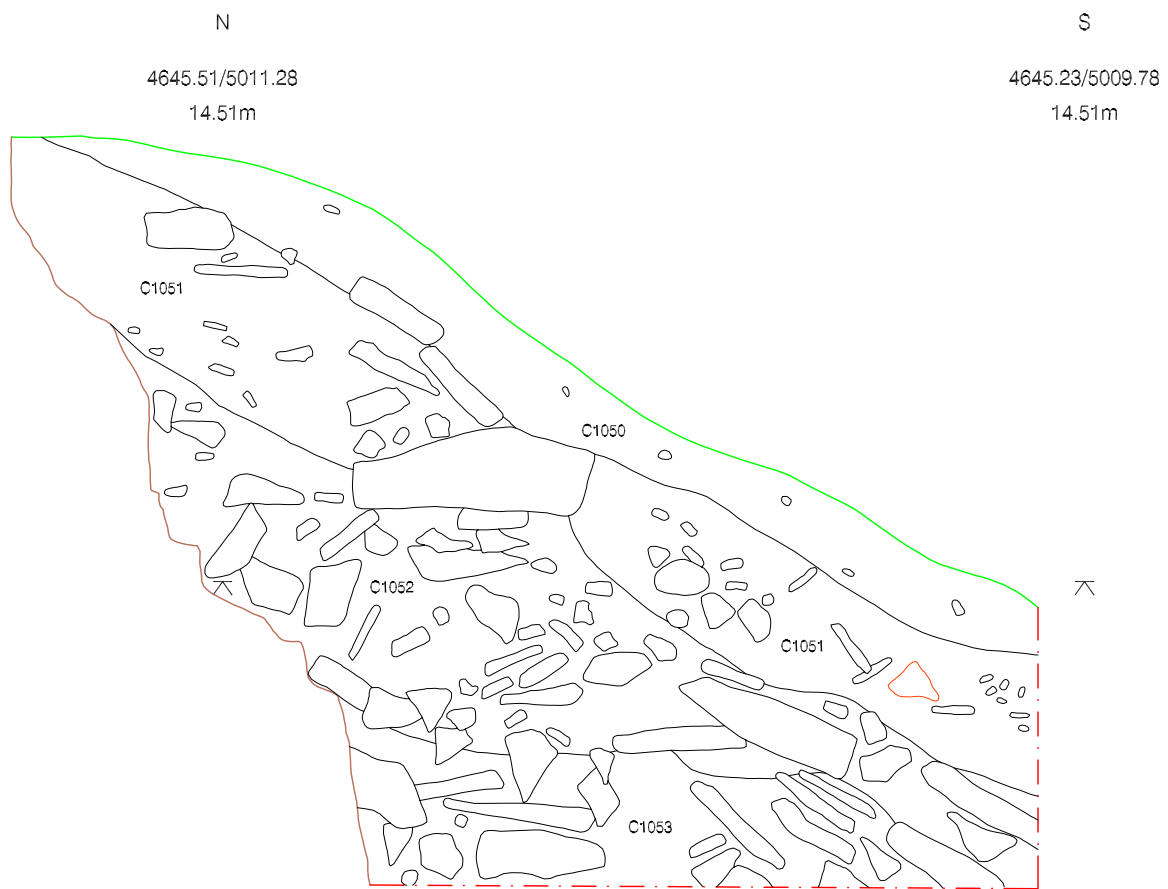
Intervention 13 west facing section

The intervention encountered a total of four contexts, which contained slate, mortar and sandstone, all representing the build up of rubble collapse within the dry moat, against the near-vertical, stepped slate bedrock (Figure 22). The earliest context to be identified, C1053, was found to measure at least 0.35m in depth, but was not fully excavated. C1053 comprised approximately 75% angular slate blocks, within a matrix of dark yellowish-brown clay with rare charcoal flecks.

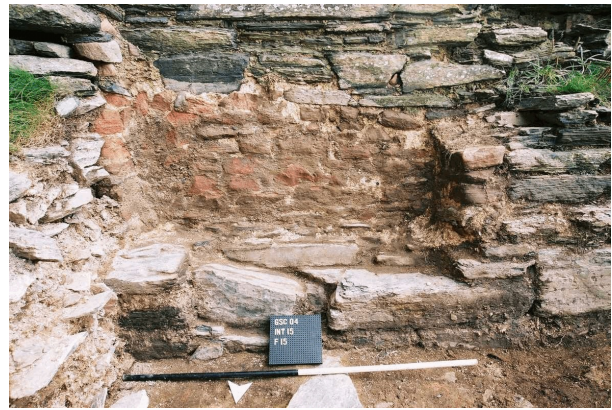
**Plate 25** Bench F15

The walls of the passage, as with the remainder of the castle, are constructed from roughly coursed slate slabs. Set into the southeastern wall (F14), the removal of abutting rubble deposits revealed a recessed bench, clearly integral to the original construction of the wall, with Old Red sandstone detail (F15; Plate 25). The seat itself, measuring 1.05m wide and 0.30m deep, was set at a height of 0.45m above the identified occupation deposits. Located in a hollowed area in the centre of this seat, an organic deposit (C1070) was tentatively identified as decayed wood. F15 has been interpreted as a 'visitor's seat', associated with the Gatehouse and with entry to the castle.

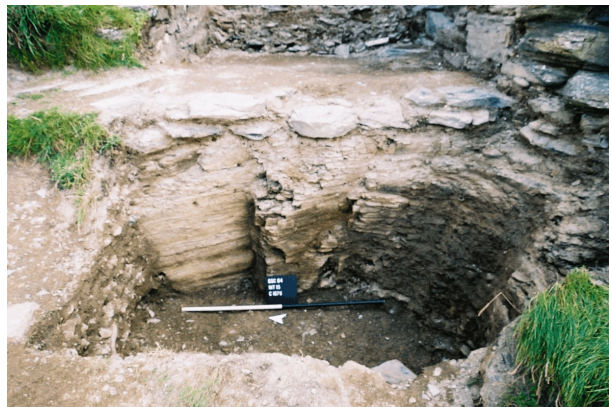
**Plate 26** Shaped bedrock and F36, Intervention 15

The removal of rubble revealed that, 0.95m from the southwestern edge of Intervention 15, the underlying bedrock stepped downwards at least 1.0m, and appeared to follow the circuit of the overhead wall (Plate 26). The full extent of this contour was not visible, since excavation reached the required depth.

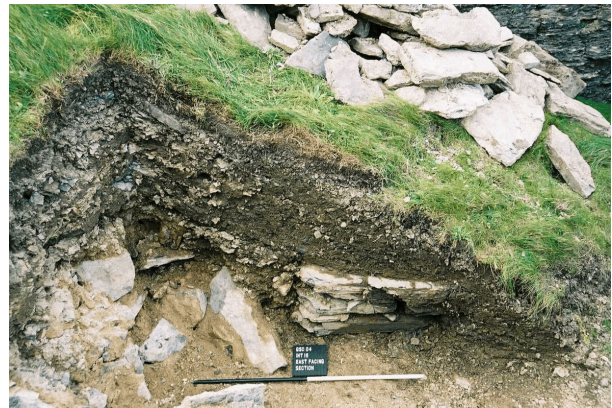
**Plate 27** Intervention 16 northwest facing section

F16 (C1077) was allocated to a short section of masonry at the southwestern edge of Intervention 16, visible only in section. Four courses of slate were visible, measuring 0.70m in length, and 0.40m in height and bonded with a light yellowish-brown clay. As only one part of the elevation was visible, it was not clear whether this feature represented an *in situ* structure, although the horizontal position of the coursed masonry was suggestive of such (Plate 27).

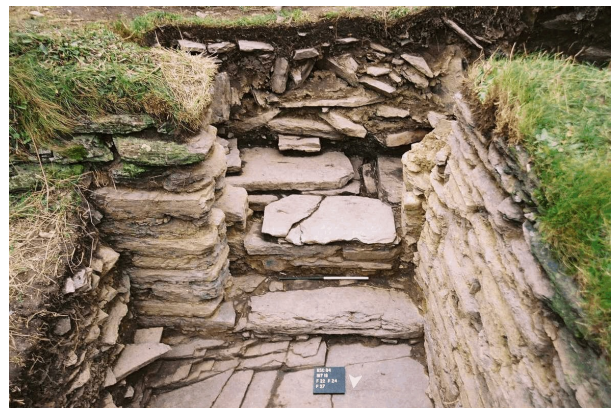
**Plate 30** Intervention 18, F22 and F27

The rough edges of F22 suggest that this wall was subsequently cut through to form access points into both internal areas. The construction of a central door jamb (F24), abutting the end of F23, would have consolidated these doorways. Again, this feature was made up of slate slabs (C1108), measuring 0.56m x 0.44m in plan, and surviving to a height of 0.90m. Evidence for a rebate for a doorway can be seen on the southwestern edge of the feature, and a vertical break in its northeastern edge might have been associated with the fitting of a doorway to the northeast. It is likely that the construction of a series of steps (F27) leading from the external courtyard into the building would have part of the same phase of alteration (Plate 30). The upper of the two steps appears to have been constructed from slate slabs; there is a possibility that the lower step was cut directly from the bedrock that forms the floor surface of the internal area.

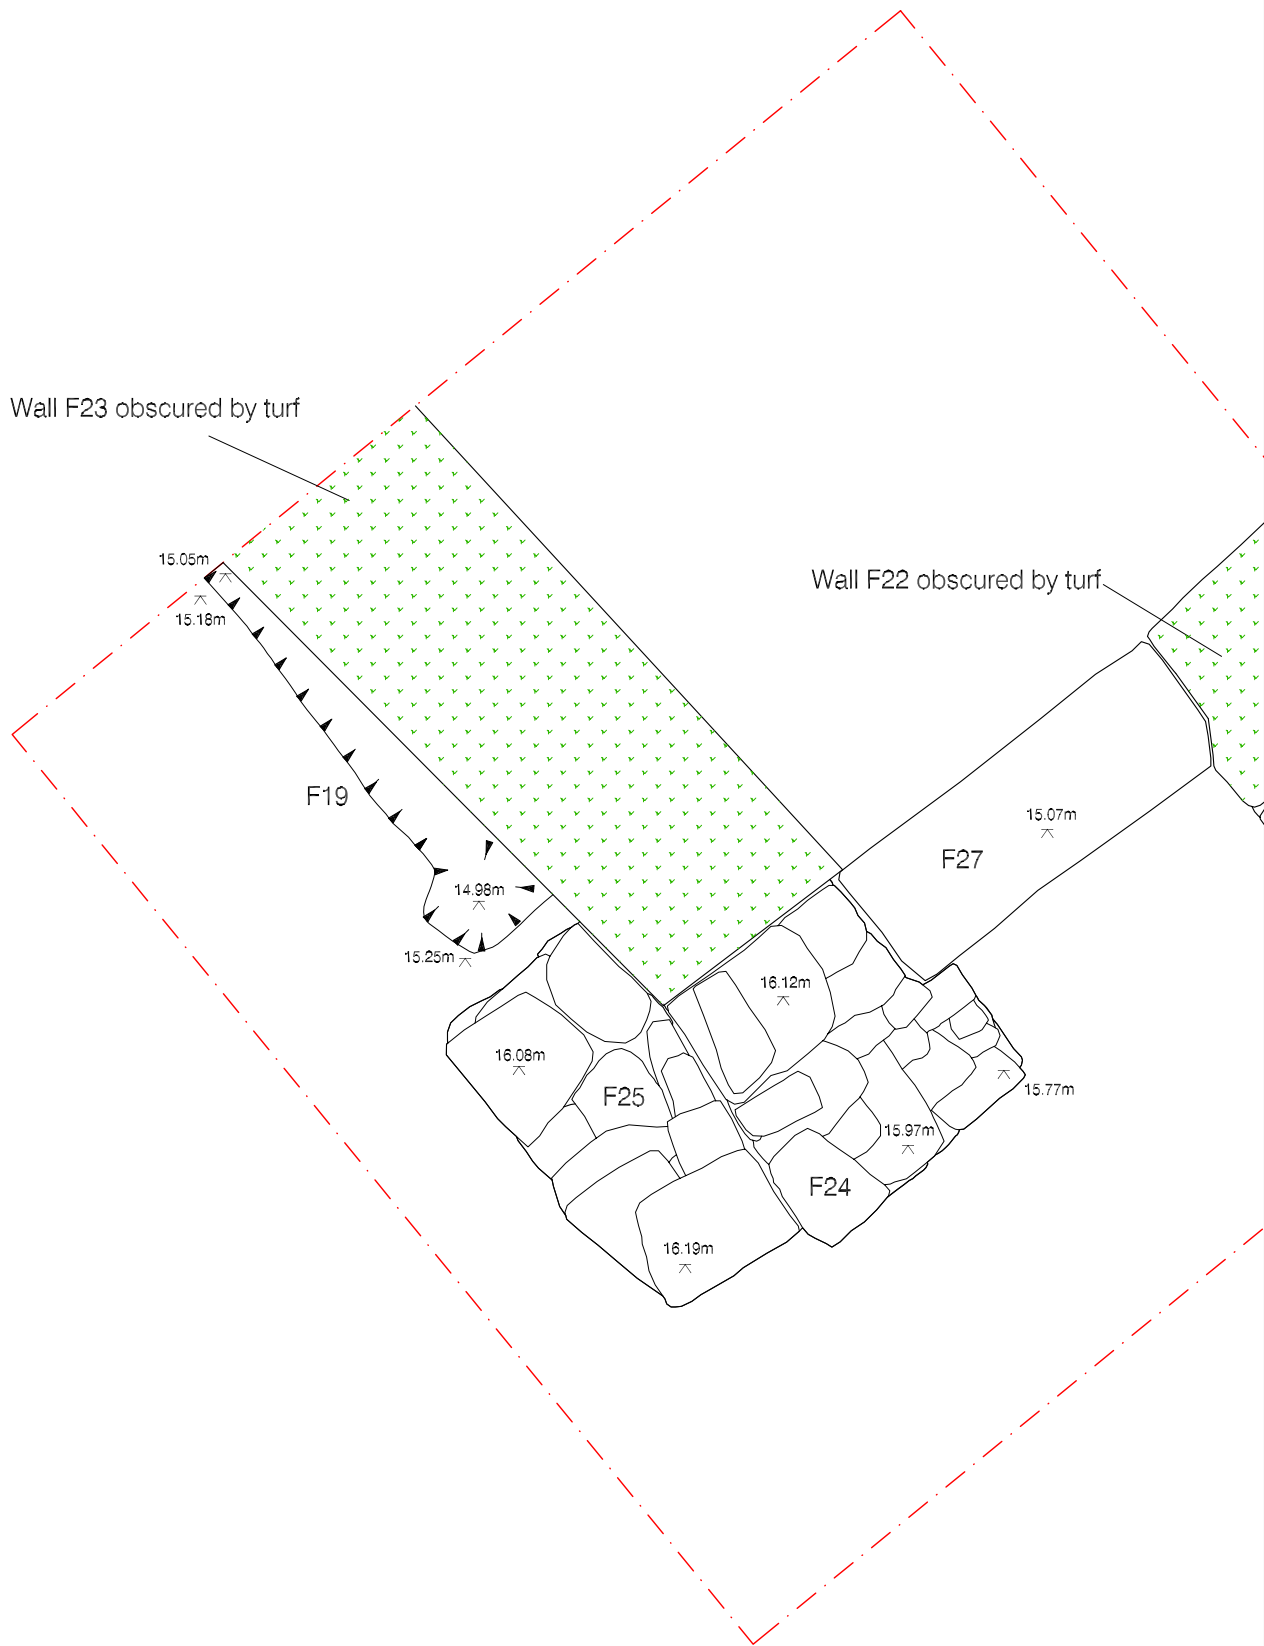
Intervention 18 plan of features

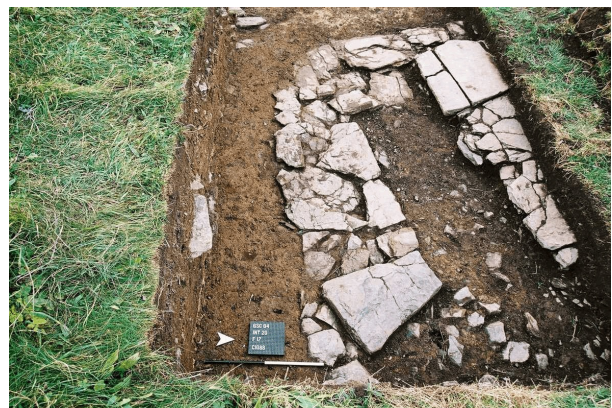
**Plate 34** Intervention 20, F17 and F40

There is some evidence for slabbed surfaces both within and without this structure. Partly overlying the make-up of F17, a series of irregular slate slabs was identified along the northwestern edge of Intervention 20, apparently representing an incomplete stone surface (F40 C1126)(Plate 34). If contemporary with F17, it is possible that the large, smoothed slab which overlies the wall represented a threshold.
