Unknown Wreck, Drumbeg, Highlands

Undesignated Site Assessment Report

UNDESIGNATED SITE ASSESSMENT REPORT

Ref: 83800.15.04

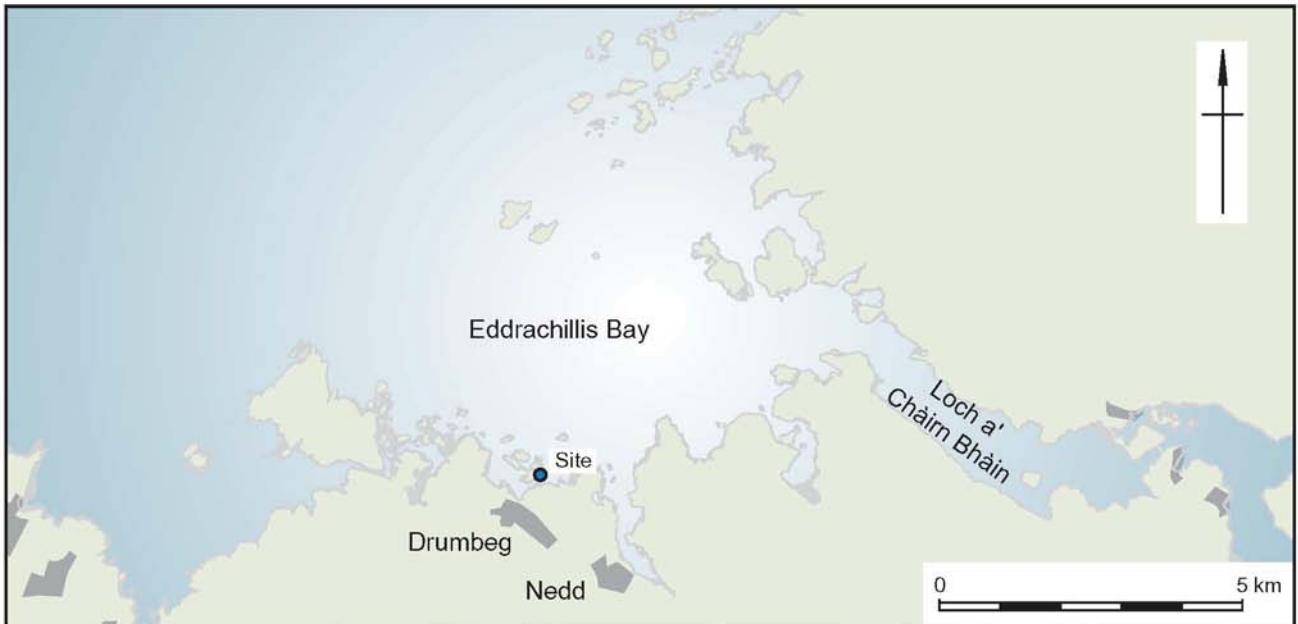
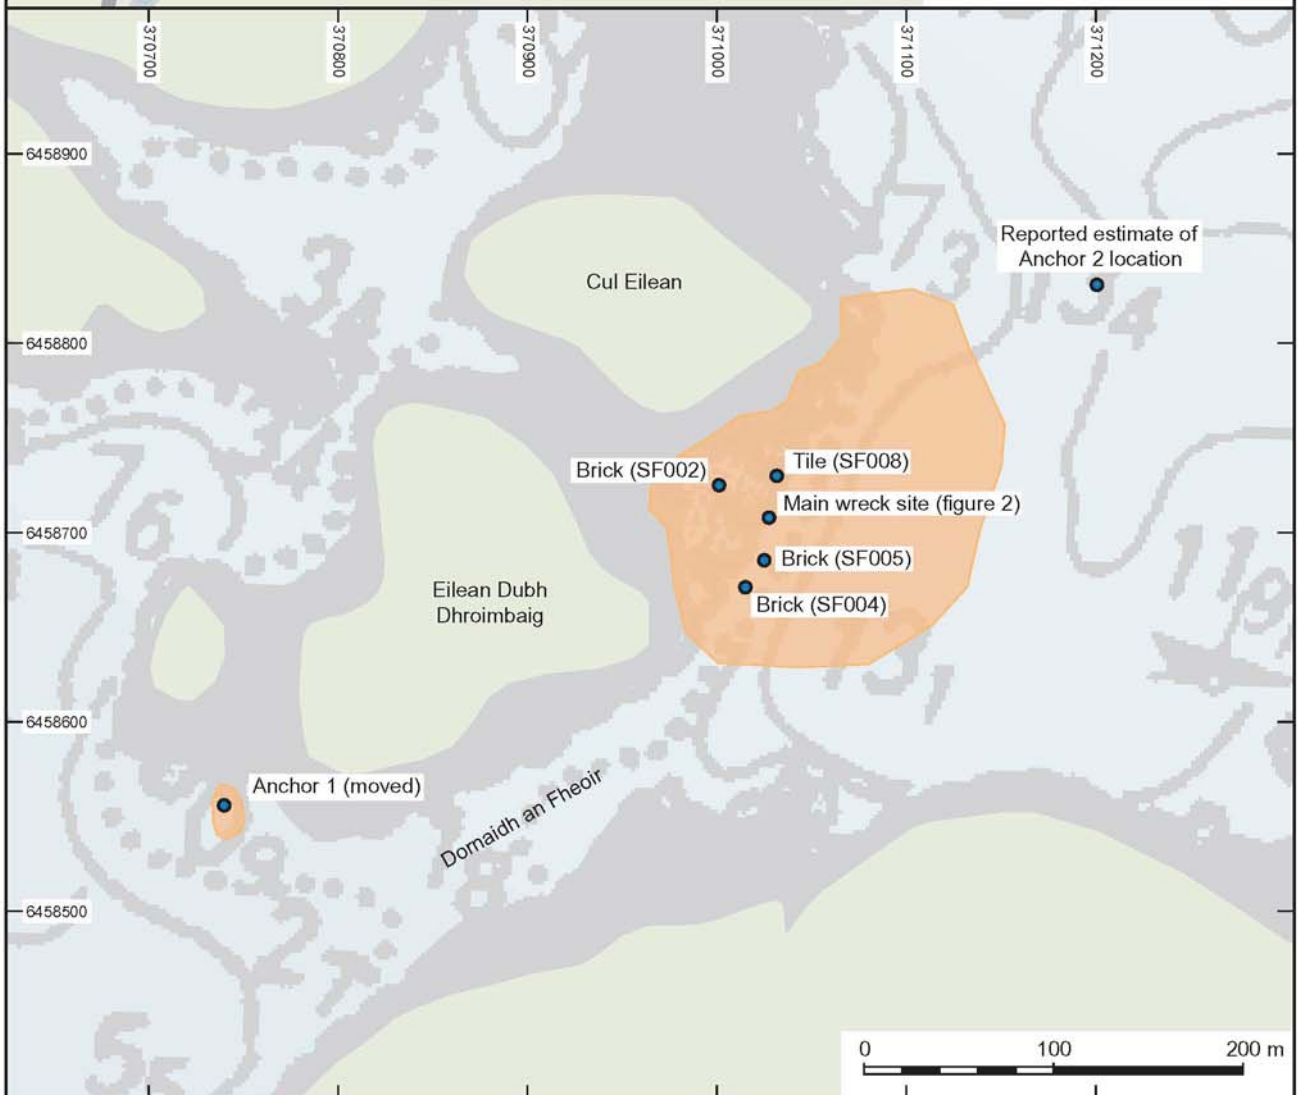
Figure 1

- 5.1.1. The position given above is based on the centre point of the cannons.
- 5.1.2. The wreck site is located in Eddrachillis Bay (**Figure 1**) a small bay at the mouth of the sea-loch Loch a' Chàirn Bhàin. It lies within 500 m of Drumbeg village to the east of a group of small rocky islets which sit in the bay off Drumbeg. The wreck lies to the immediate east of the easternmost islands. In the 18th century these islands were known as *Eilan-in-du* (Black Islands) (Sinclair 1799, 175). These are now marked on the Ordnance Survey maps as 'Eilean Dubh Dhroimbaig' (Black Island of Drumbeg) and lying further back from the village, 'Cul Eilean' (Back Island). The wreckage is just on the northern side of a narrow channel cutting between the islands and the mainland. The channel is named as 'Dornaidh an Fheoir' (which roughly translates to narrow sea-channel of the hay). This channel is around 60 m at its narrowest point and widens out to around 200 m by the wreck site where it meets the wider loch.

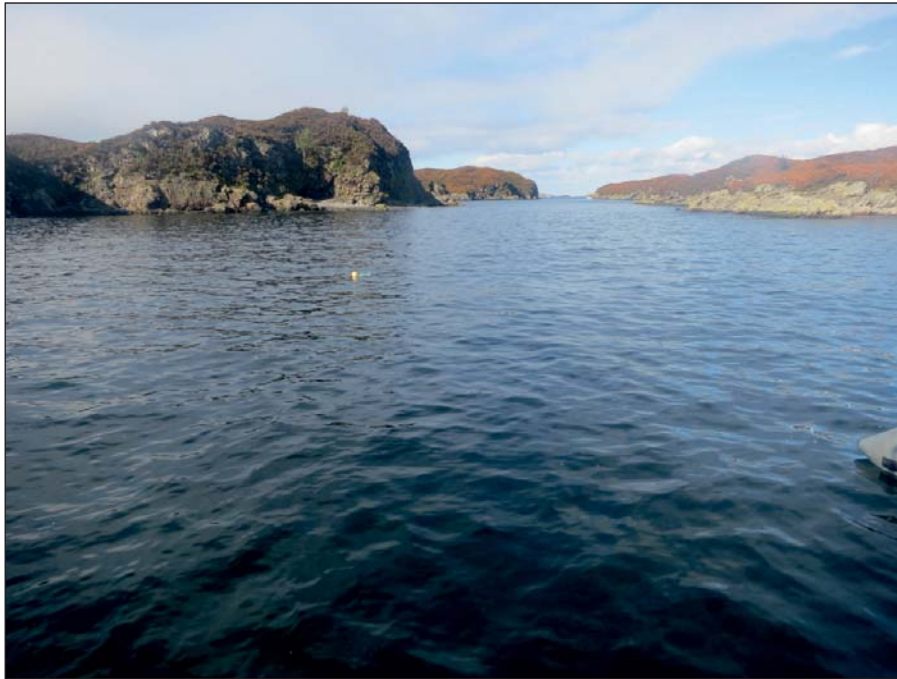
Plate 1: Photograph of Dornaidh an Fheoir looking North

- 5.2.1. As a result of its position among narrow islands, Dornaidh an Fheoir is highly sheltered (**Plate 1**) and almost no tide was discernable during any of the survey dives. The bridge between the two islands to the west of the site does appear to become inundated at high tide but only briefly. The channel appears exposed to the wider Eddrachillis Bay to the north-east but the Admiralty maps show that even this side is sheltered due to the presence of two or more reefs which are awash at Low Water.

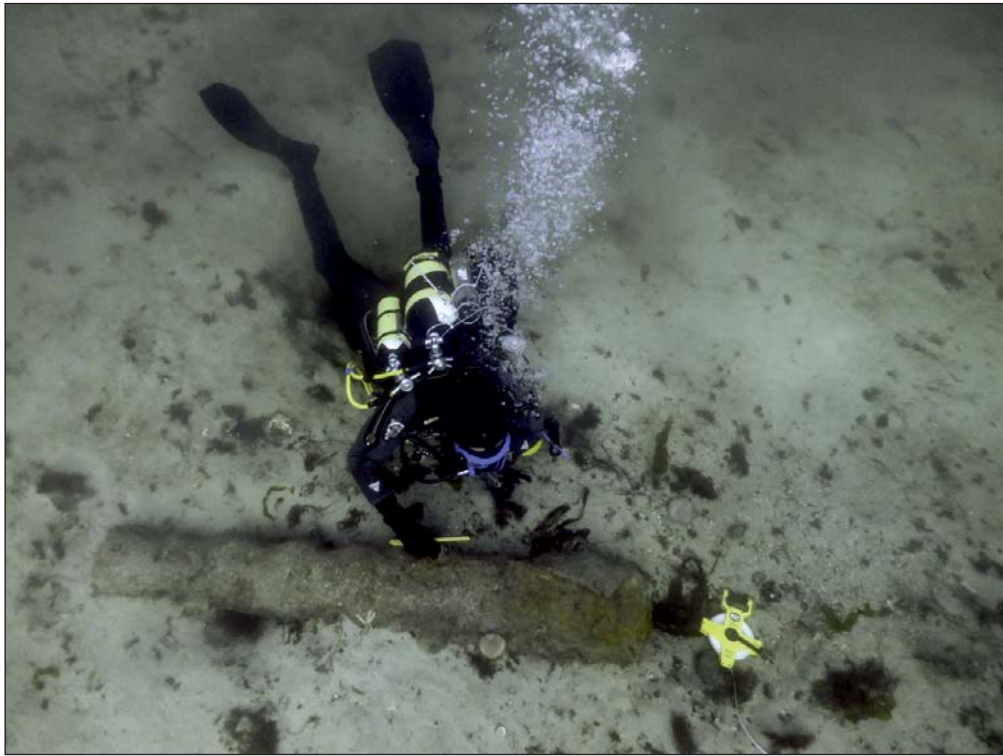
- 5.3.8. Independent cannon expert Charles Trollope was given the opportunity to examine photographs of all three cannons and the above measurements. He stated that, in his opinion, the cannon were 'clearly cast in Sweden' (e-mail dated 26/09/2012). He noted the diagnostic features of the 'straight neck run, followed by the late starting and pronounced swell which even in the concretion shows up well'. Cannon founding was a major industry in Sweden. For example the Swedes supplied most of the Dutch requirements for iron guns from the 1620s onwards. The French and Danes were also major purchasers of Swedish guns. The size of the cannons also provided some evidence in favour of this interpretation. Two of the three cannons are of a very similar size. Trollope also noted that the distances between the base ring and muzzle of Cannon 1 and 3 worked out well in Swedish feet, with Cannon 2 possibly being over length by about an inch (although as mentioned above this inch could be purely concretion).

Plate 3: Photograph of cannon 3

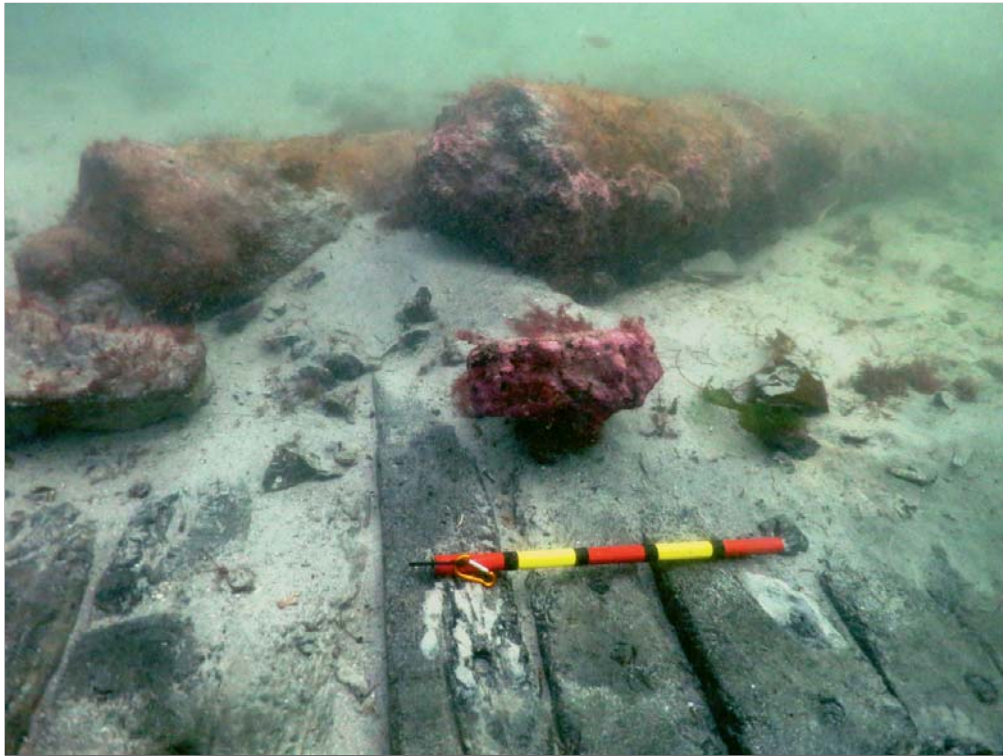
Plate 5: Concreted object beside Cannon 1

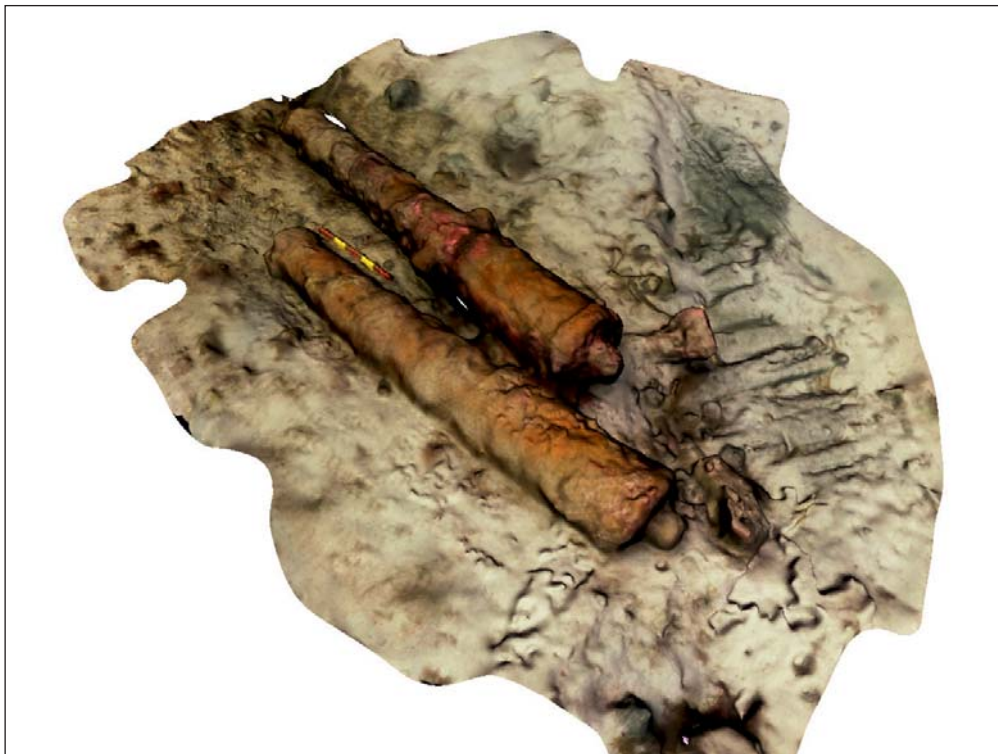
Plate 6: Photogrammetric Model of Cannon 1 and 2

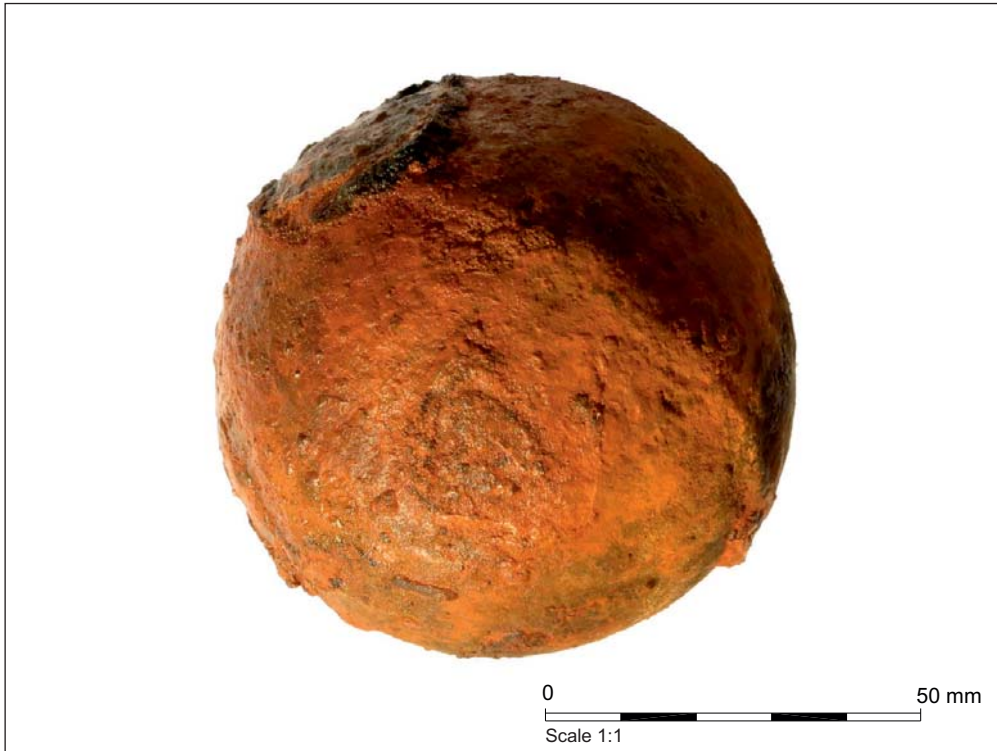
- 4.2.6. The divers recovered approximately six cannonballs in total, all from sediments in the immediate vicinity of the cannons. These were found to be of two distinct sizes, three of approximately 75mm (2.95 inches) and three of approximately 100mm (3.93 inches). All but one of these was in a degraded state and disintegrated shortly after recovery. One of the 100mm cannonballs was in good condition and was stored in fresh water at Mr. Mackay's home. A well-preserved but fragile rigging block and galley brick were recovered by Mr. Errington at the same time and also stored in fresh water at Mr. Mackay's home.

Plate 7: Cannonball recovered by local divers, with a diameter of 75mm

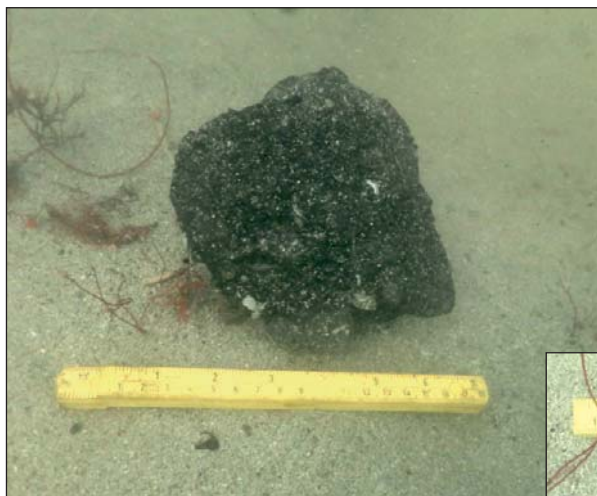
- 5.3.10. A number of cannonballs have been recorded on the site, both during previous excavation by the local divers and during the WA survey. As described above a total of six cannonballs were removed from the site by the local divers although only one was in good enough condition to survive for long out of the water (**Plate 7**). These were found in a cluster adjacent to, or just below one of the cannons and may have been stored together. This cannonball has been passed to conservators and measures around 75mm in diameter and now weighs 641.2 grams (1.4136 pounds). It appears to be cast-iron rather than lead and in this case its original weight was closer to 4 pounds. Two further cannonballs were noted during the WA survey. These were recorded photographically (**Plate 8** and **Plate 9**) but neither was removed from the site. One of these was highly corroded and was lying in mobile sediments adjacent to the cannons. Cannonball 2 was much better preserved and was found on the seabed several metres to the south. This had a diameter of approximately 100mm.

Plate 8: Cannonball 1, recorded *in-situ*

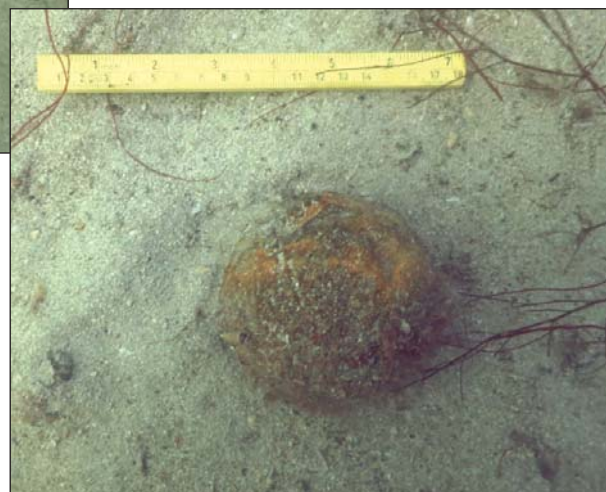
Plate 9: Cannonball 2 recorded *in-situ*

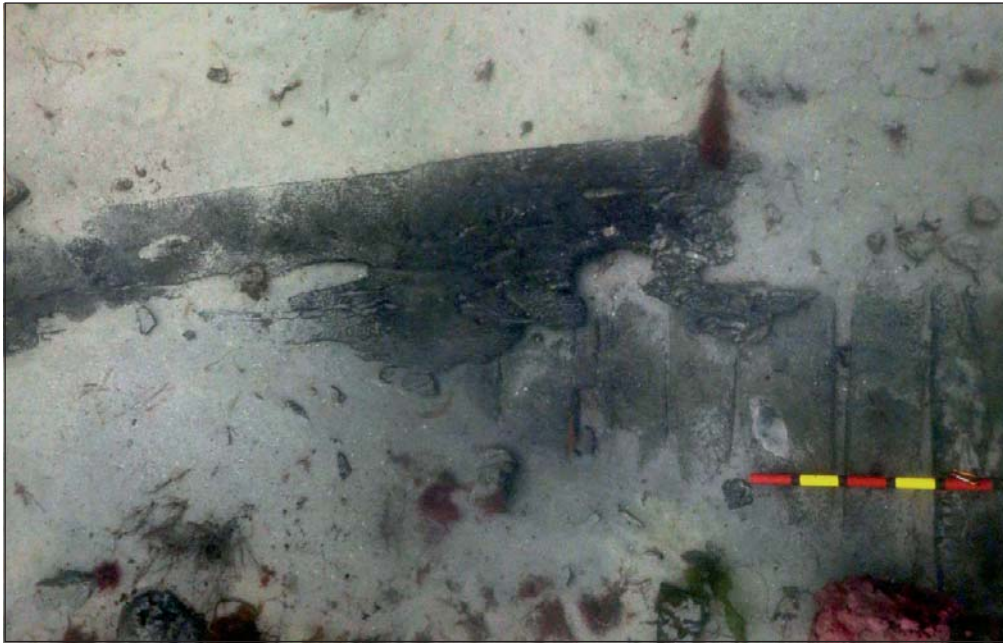
Plate 10: Photograph of ceiling timber framing showing damage by shipworm

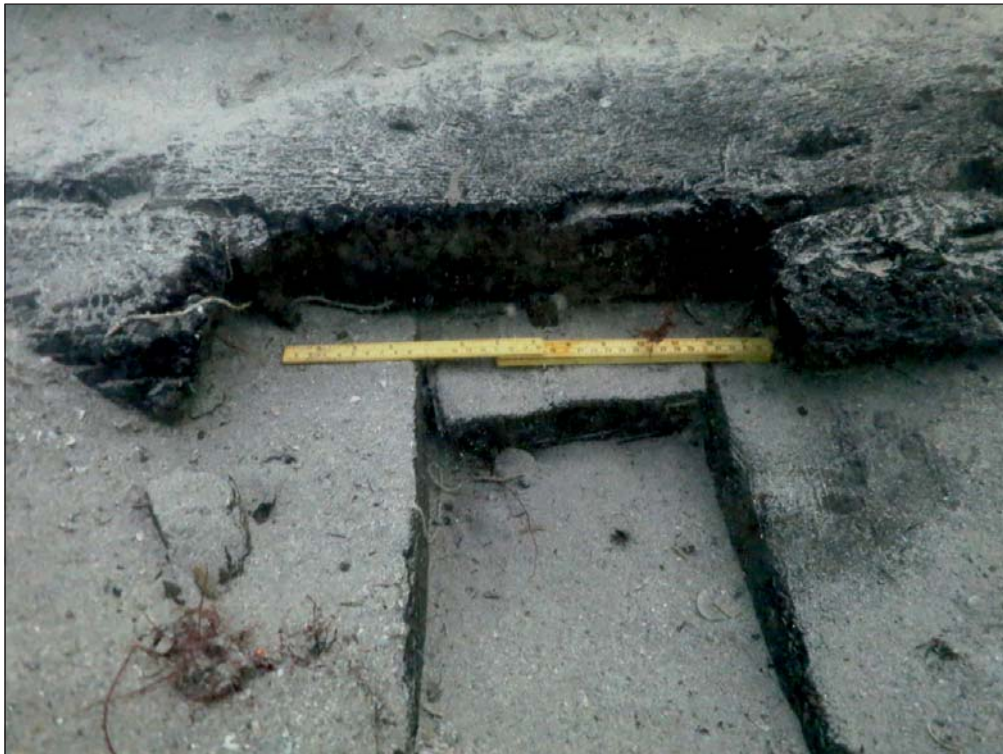
Plate 11: Section of timber framing

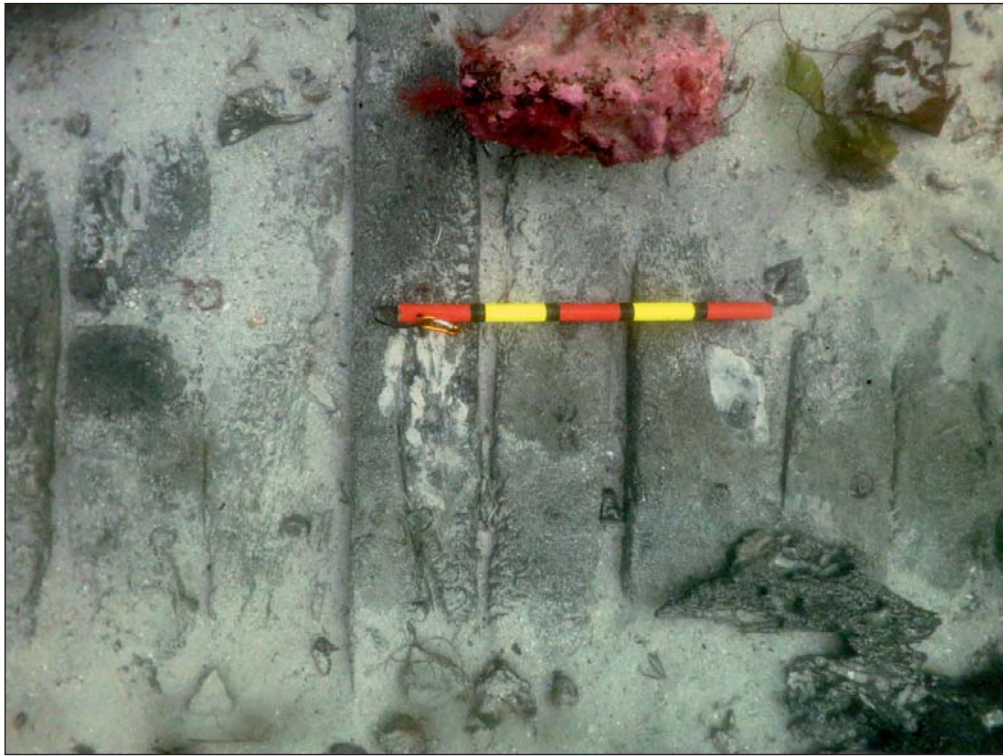
Plate 12: Close-up of futtocks

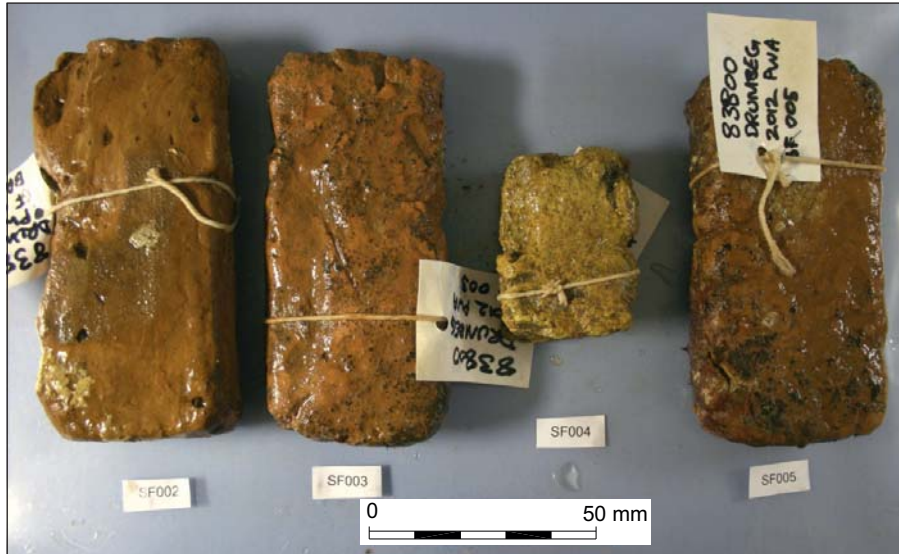
- 5.3.15. A total of five bricks were recovered in total, one of which was passed on by the local divers and four of which were recovered during the WA survey (**Plate 14**). Four of the bricks are broadly similar, measuring approximately 20 x 10 x 5 cm and of orange colour. The fifth is only a half brick and was found amongst the rocks to the north of the site. It is far more yellow in colour than the others. After their location was recorded these were recovered from the site in order to allow for the possibility of thin-section analysis.

- 5.3.16. Similar bricks have been found in other wrecks of this period in Scotland but are more commonly described as yellow. Parallels from 17th/18th-century wrecks of international origins include the *Adelaar*, the *Kennemerland*, the *Lastdrager* and the Fuday wreck. Those found in the *Kennemerland* measured 18 x 8 x 3.5 cm (Forster and Higgs 1973, 296); the *Lastdrager* 17 x 7 x 3.4cm (Sténuit 1974, 255) and Fuday, 20 x 12 x 6cm. The Fuday bricks resembled those on the *Kennemerland* and were interpreted as being typical of Dutch origin 'overij sselse steen' (Prescott *et al.* 2008, 11). In other cases these bricks have been interpreted as galley bricks, particularly where evidence of burning on the face of a brick permits such an interpretation (e.g Kinlochbervie). The bricks lack a frog (ie.e a hollow on their upper and lower faces) and as this was relatively common on bricks from the mid-1800s suggests that they are probably earlier..

Plate 14: Galley-bricks (courtesy of AOC Archaeology)

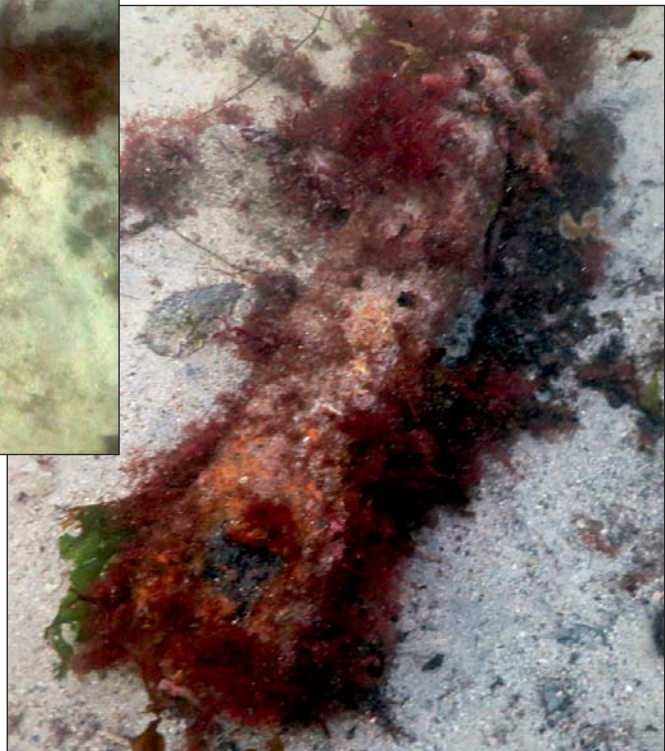
Plate 16: The stock end of Anchor 1

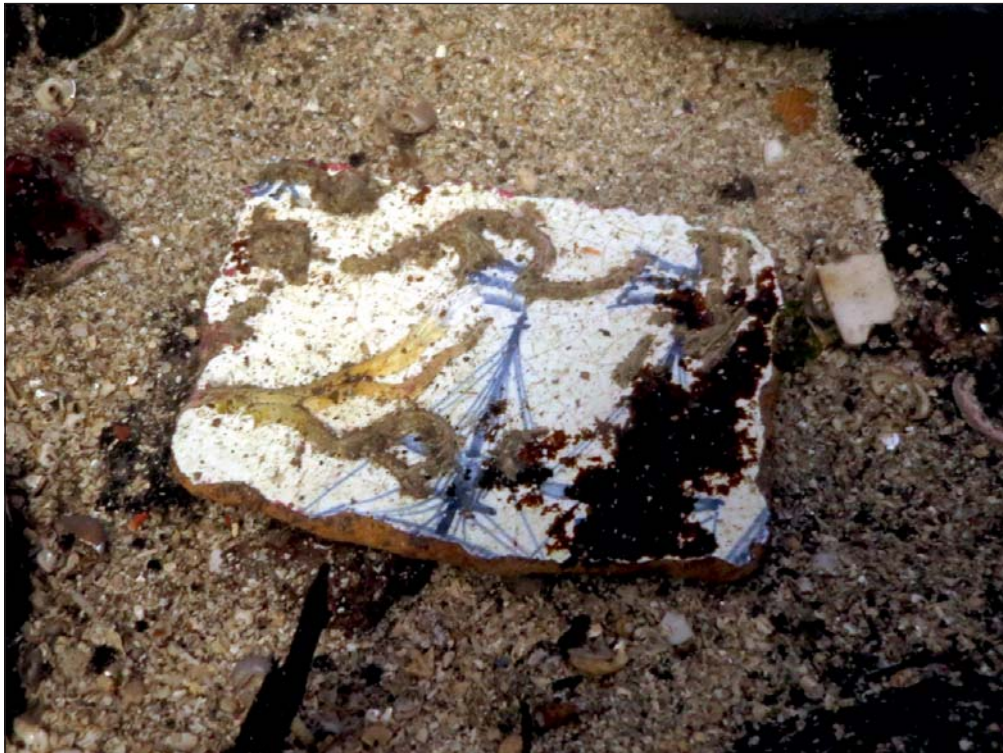
5.3.20. The broken Delft tile recovered to the north of the cannons appears to be one of the most easily dateable items recovered (**Plate 17**). It is the upper half of a Delft tile depicting a three-masted ship flying the Dutch flag. Only the rigging and upper masts are visible as well as the corner decorations of the upper right and upper left corners. There are several worm casts on both sides of the tile and the edges and back appeared eroded. The break through the centre of the tile does not appear to be fresh.

5.3.21. A local researcher in Drumbeg, Mari Mackay, was able to provide the survey team with a rough date for the tile prior to the completion of fieldwork, placing it between approximately 1650 and 1750. WA Coastal & Marine pottery specialists and Ian Betts of MoLAS were later consulted on the tile. They suggested a likely date in the second half of the 17th century and found examples of close parallels for the design which have both the ox-head corner motif and the single-tile three-masted ship design. Dr. Betts uncovered numerous references to tiles of this type, all of which date to the second half of the 17th century. These include Van Dam (1991, 80, no.s 89 and 90), Van Sabben and Hollem (1987, 54, no. 162), Schaap *et al.* (1984, 145, no. 177), and Pluis (1997, 385, A.03.07.10).

Plate 17: 17th/18th century Dutch Delft tile depicting three-masted ship *in-situ* on the seabed at the mouth of a gully

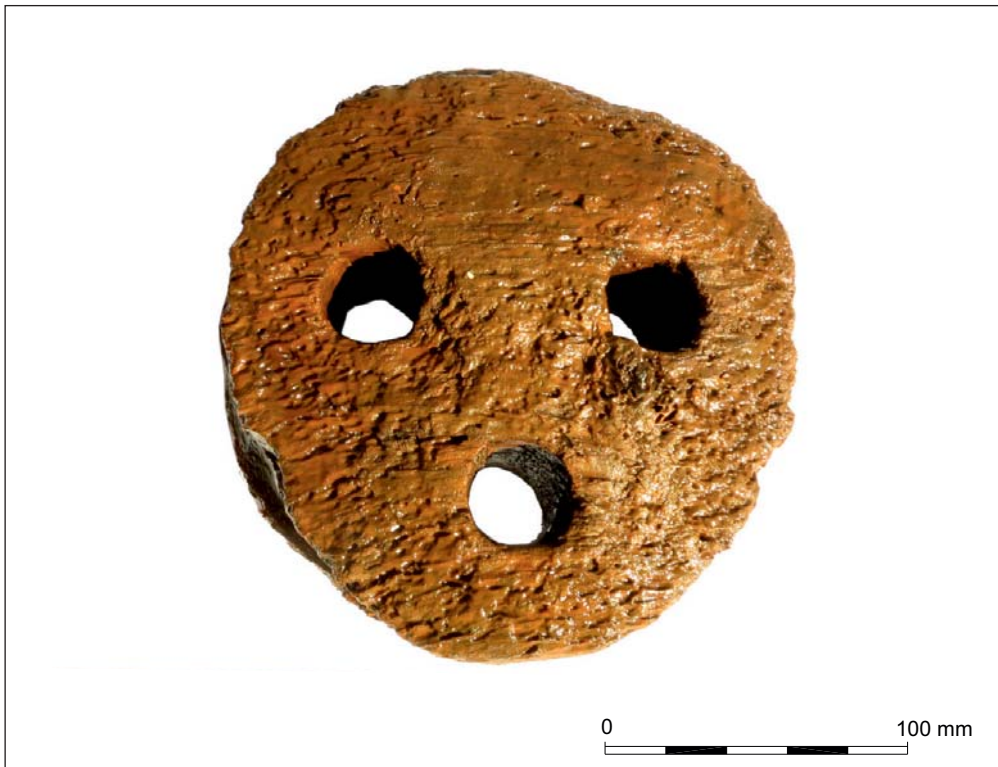
- 5.3.23. A dead-eye rigging block (**Plate 18**) of approximately 22 cm diameter was recovered by local divers while undertaking small-scale dredging around the cannons. The block was recovered and stored in fresh water at Ewen Mackay's residence and was passed to the WA dive team in Drumbeg at the end of the survey. Deadeyes are a common piece of rigging with a long and ongoing usage., commonly found in an upper and lower row near the base of the near the gunwales of a ship and are used in the hauling and fastening of rigging. They are often made of *Lignum vitae* although no analysis has yet been carried out on this example.

Plate 18: Local diver finds: Rigging block
