P570-1 Allt na Luib Hydro Scheme

Preface to Appendix B – Archaeology

An Archaeological Survey for the
Coulin Hydro Scheme, Coulin Estate,
Lochcarron, Wester Ross, Highland.

For Hydroplan UK.

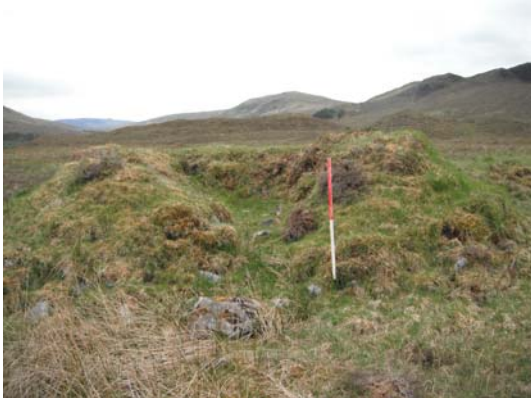
Photo No. 2, from ENE.

Site 1. Shooting stance.

A shooting stance consists of grass-covered circular banking, with an entrance to the east. A wooden target is set against the knoll to the west.

Impact assessment: This feature may be affected by the construction of the access road to the powerhouse site.

Mitigation: Identify and mark out exclusion zone to prevent accidental damage.

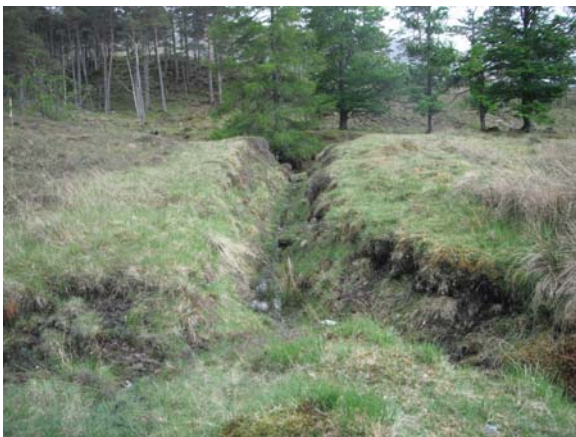
Photo No. 5, from NW.

Site 3. Water diversion.

A deep cut through the bank carries water from a ditch above the cottage into the Allt na Feithe Ruaidhe. Spread subsoil in the general area is presumed to be from this cut and suggests a relatively recent date.

Impact assessment: This feature is likely to be removed during construction of the power house and tailrace.

Mitigation: None recommended.

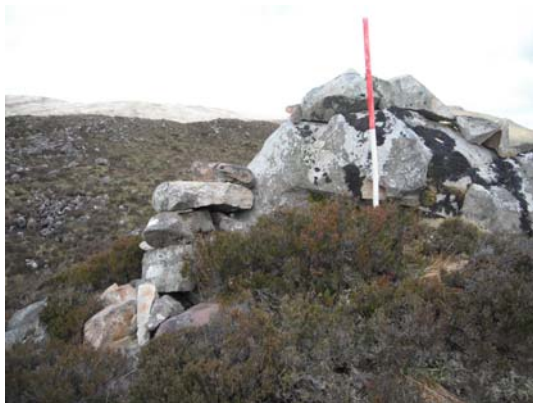
Photo No. 7, from S.

Site 6. Cairn, shelter.

On a prominent ridge end, a naturally placed boulder has been utilised to create a noticeable cairn or shelter. Rubble walling runs over the boulder and curves round to enclose an area 1m wide. The function of this is uncertain, given its exposed location it is more likely to be a marker cairn but may have been utilising the wind to dry some commodity stored within the rubble walling.

Impact assessment: As this structure occupies the summit of a ridge, it should be possible to avoid damage during construction of access and underground pipeline.

Mitigation: Identify and mark exclusion zone to avoid accidental damage

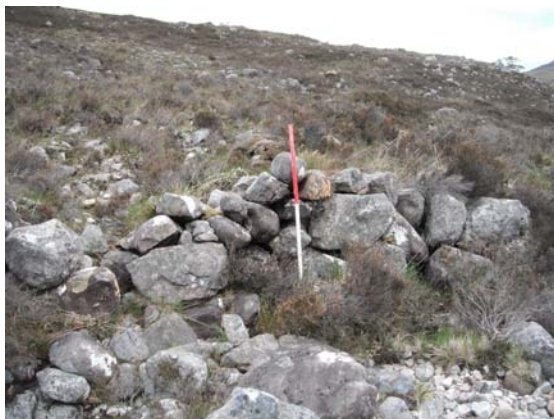
Photo No. 8, from SSW.

Site 7. Walling.

A short section of rough rubble walling, approximately 8m in length and to a maximum of 1m in height, runs along the bank of the Easan Geal. This is matched by a similar length of walling on the south bank of the stream. Neither wall continues, nor are they constructed at the only point where livestock might cross. It may be that the walls defined a rough dipping pool or sheep wash, dating to the period of sheep farming in the early 19th century.

Impact assessment: This site is not at risk.

Mitigation: No action is required.

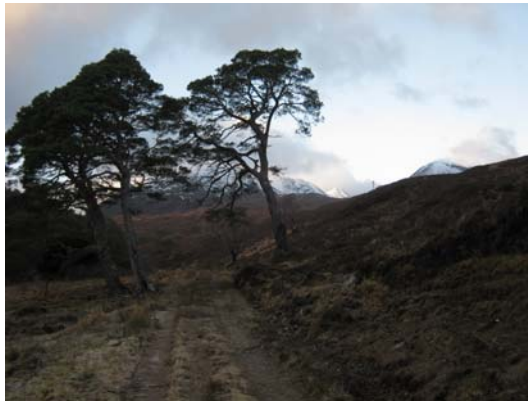
A broad, driveable track runs along the north side of the Easan Dorcha. This probably overlies an earlier stalkers path diverging from the Coulin-Achnashellach road at NH 02356 53107 and dividing at the wooden bridge over the Easan Dorcha, one branch leading up the north side of the Allt Coire Beinne Leithe, the other heading SW towards Achnashellach. The latter has been recently upgraded for walkers. The 1st edition map shows only a path leading as far as a short distance past the waterfalls. Associated with the original track are a number of borrow pits, including a large quarry just inside the SW corner of the plantation, excavated into the east end of a glacial ridge or esker.

Photo No. 10: Track, from NE.

Impact assessment: There may be a minor impact on associated features such as borrow pits during insertion of the buried pipeline

Mitigation: None recommended

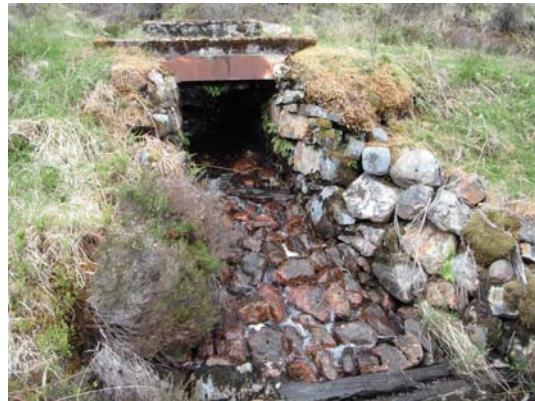
Photo No. 11: Culvert, from S.

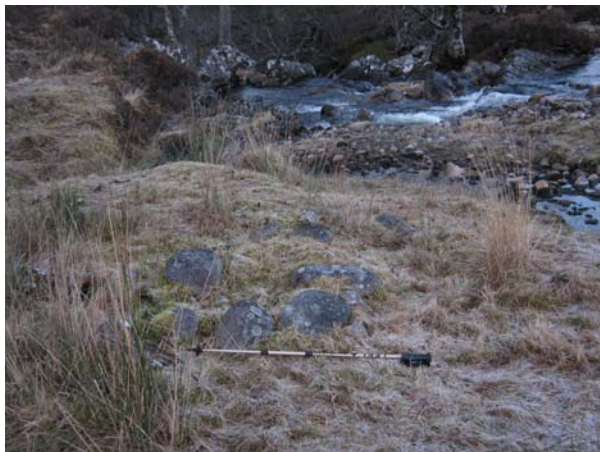
Site 10. Enclosure.

Occupying a low, level platform adjacent to the stream at the top of the waterfalls, is an enclosed area defined by low rubble walling running from NH 01895 52786 to meet the stream at NH 01894 52745. Within this enclosure, at NH 01915 52788 is a sub-oval stone setting, similar to a shieling dairy stance. This enclosure is probably similar to several similar recorded enclosures in the area.
Photo No. 12, from W.

Impact assessment: This site is not at risk.

Mitigation: No action is required. Do not use this as a lay-down area.

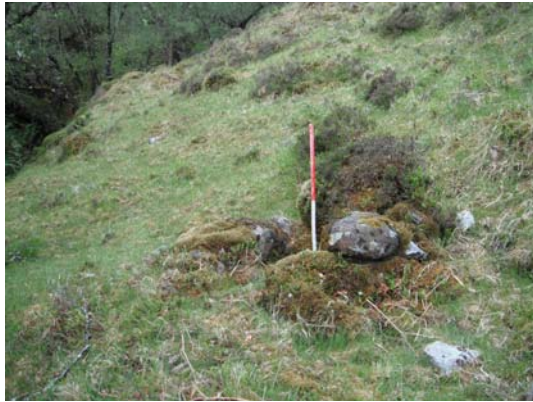
Photo No. 14, from NE.

Site 11. Structure.

Rough rubble walling encloses three sides of a sunken area measuring 0.50m across. Extending to the south, low grassy banks may be the remains of further walling forming a rectangular structure. This is of no immediately obvious function but may be associated with the track building.

Impact assessment: Any works to the south of the present track will damage this feature.

Mitigation: None recommended.

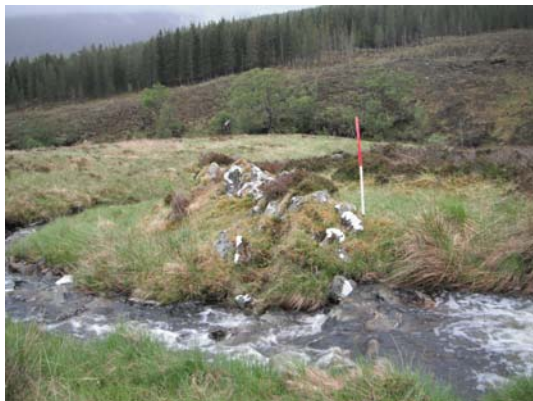
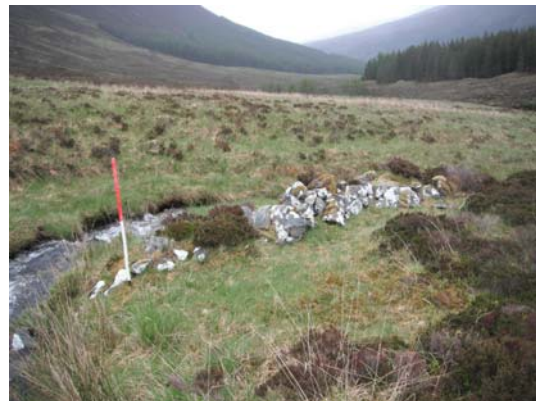
Site 13. Walling.

A short section of rubble walling runs down the west bank of the Allt Fhearchair. It extends for approximately 15m and appears to not have continued in either direction. This is located where the stream appears to have divided, as depicted on the 1st edition OS map, and may have been associated with the containment of livestock.

Impact assessment: This feature is vulnerable to damage during construction of the intake and upgrade of access

Mitigation: identify and mark to avoid accidental damage

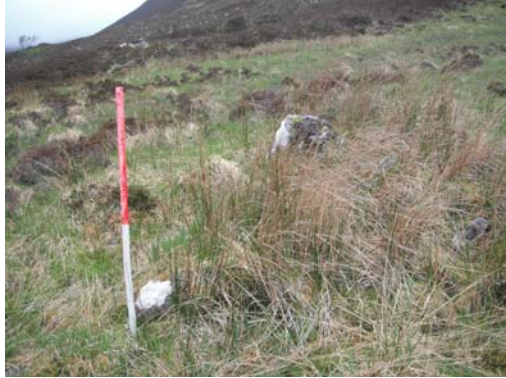
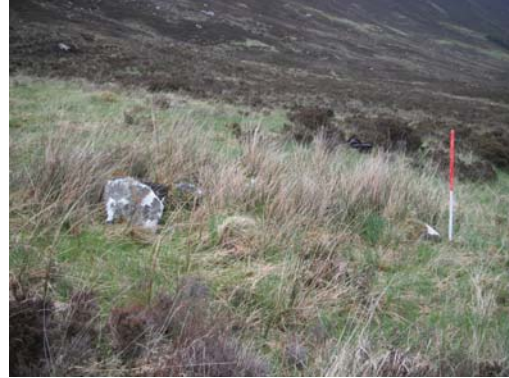
Site 14. Shieling hut (possible).

Low and indistinct footings of what may be an oval shieling hut. A row of six stones are set into the bank on the north, uphill side, aligned E-W. Other stones form the other sides of a rough oval or rectangle measuring 2m by 1m internally.

Impact assessment: This feature should be far enough up the hill slope to avoid being affected during construction of the intake.

Mitigation: None recommended.
