30 PRINCES STREET
THURSO

CONSERVATION
STATEMENT

ANDREW PK WRIGHT
Chartered Architect & Heritage Consultant

HIGHLAND BUILDINGS
PRESERVATION TRUST

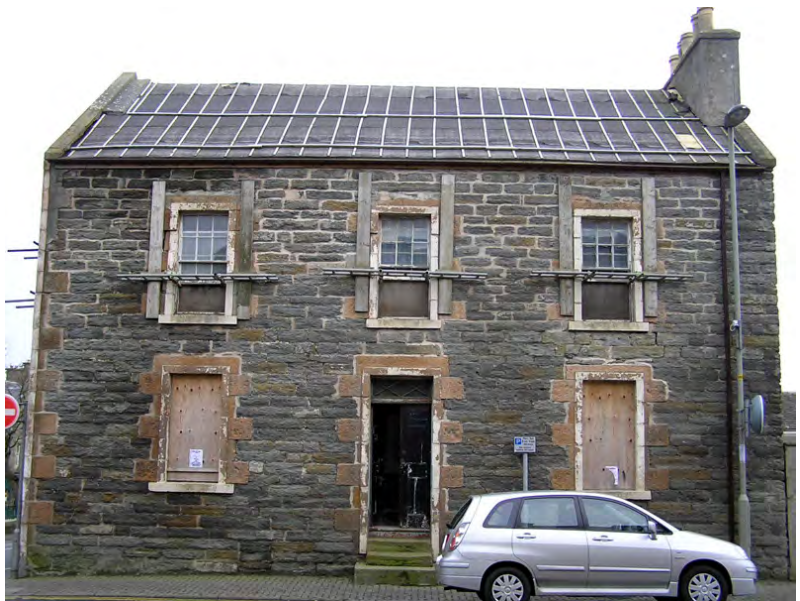
Elevation to Princes Street

The dwelling erected at 30 Princes Street occupies, therefore, an important site in relation to the planned street grid. Its importance is heightened by the topography of the site and by the open aspect from

being located next to the central square of the new town plan. Contrary to what the listing notes suggest it is unlikely to be part of the earliest development of the grid plan, and is most likely to date from the period 1825-1840. It may lack some of the grace and architectural sophistication of the houses on Janet Street, but it is nonetheless an imposing house with refined architectural detailing not found in the fabric of the earlier houses at the east end of the same street. Compared with them it is of a larger scale altogether and the forerunner of later houses on Princes Street as it extended westwards. The depth of the masonry above the window lintols of the first floor may suggest that dormers were incorporated originally, the front face of which might have been brought forward to meet the wallhead of the main elevation. This arrangement appears on later houses on the same street, but no dormers can be made out on the earliest photographs. It can be seen that a single straight-sided dormer of this type, with a piended (hipped) slated roof had been in existence at the elevation facing Sir John Square until it was removed when the recent emergency repair works were undertaken.

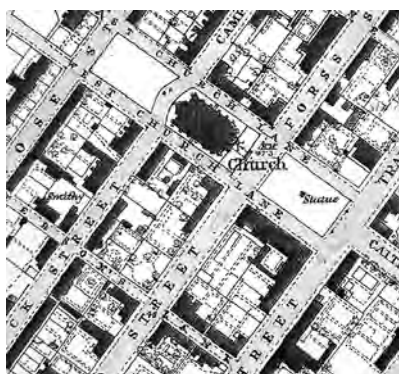
Detail of the 1877 OS map © NLS

It is tempting to conclude from the slightly uncertain evidence of the 1844 map that the house had been erected originally as a simple rectangle to match the house on the opposite corner of the square, with the jamb to the rear being a later addition. However, neither the cartographic evidence, nor the evidence of the building itself, supports this supposition. The plan layout is clearly shown as being L-shaped on the 1872 map while the evidence of the masonry coursing, now that it has been exposed to view, all points to a single build. The earlier map of 1844 is difficult to decipher with any certainty, but it appears that the building was L-shaped originally, and that the stair tower to the rear could only have been a later addition. Confirmation of the original L-shaped arrangement can be seen from the masonry of the east elevation facing Sir John's Square where the windows of the upper storey are set out within the wall with equal spacing, a decidedly amateurish arrangement considering that there is a gable within the composition. Correspondingly the middle window clashes with the internal dividing wall and has been left as a blind window in the façade.

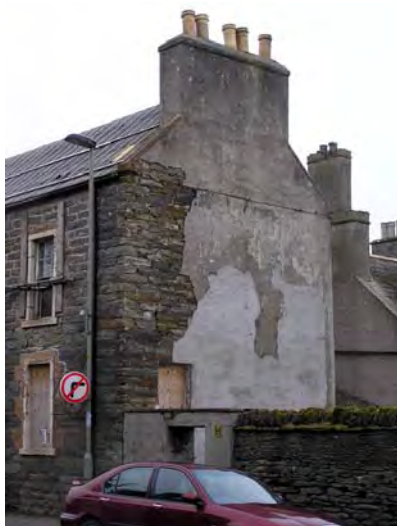
West gable

Windows are well proportioned, positioned on the principal façade in accordance with classical principles based on the established pattern books. The satisfying proportions are reinforced by the twelve-pane sash and case windows with slender astragals, and there is a good diamond-patterned fanlight to the front door assembly. The original roof had been slate, and it is inconceivable that this could have been other than the same West Highland blue slate by which the roofs of the principal dwellings and public buildings of Thurso of the nineteenth century are finished. The chimneyheads are bold, and of generous width at each gable, which again points to a construction date not much later than 1840. Similar to the chimneyheads of the early nineteenth century store-houses of Telford's Pulteneytown, having plain copes they are not particularly refined in detail. The principal elevation to Princes Street is odd in one respect: at the west gable there are no quoins of sandstone built in, unlike the south gable, which gives an imbalance to the elevation. The explanation for this may be a simple one: when the property was erected it had been envisaged that there would have been properties immediately to the east, continuing the terrace. In fact, this length of Princes Street, to the west of Sir John's Square, had never been developed in this manner. This may also explain also why, originally, there had been no windows on the west gable.

- CP15 Analyse the constituent parts of the historic early cement render applied to parts of the west gable; if this, or other walls require to be coated for reasons of preventing water penetration or the further deterioration of the flagstone walling, rendered surfaces should match historic finishes in terms of appearance and the performance of the render having regard to the permeability, strength and appearance of the coating

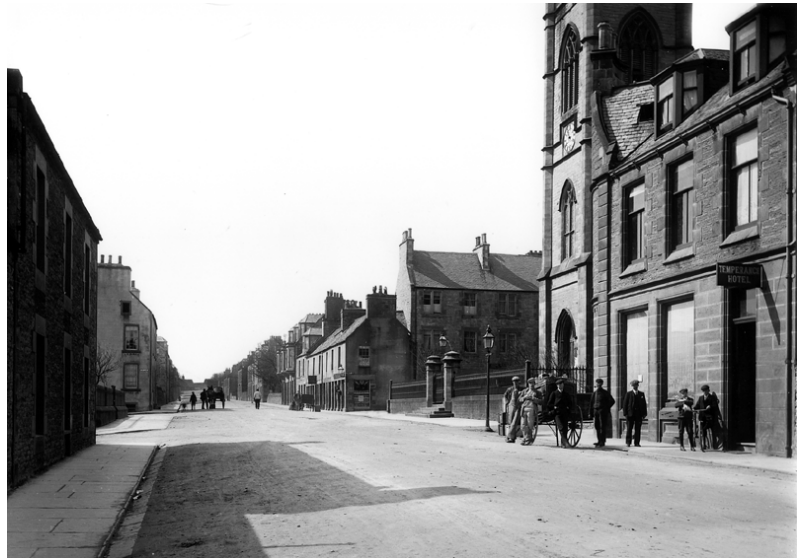
George Washington Wilson photograph of c1900 of Princes Street looking west; the property has been cement rendered by this time © University of Aberdeen

on the northern side of Rose Street having front gardens. The arrangement at 30 Princes Street results in three steps being formed to the principal door, with the bottom step of a different height, faced up in cement which may suggest that some minor changes in level have occurred. This is confirmed when the George Washington Wilson photograph looking up Princes Street is examined carefully, which shows two equal steps leading to the front door from the pavement of Caithness flagstone. There is also evidence that a small window aperture corresponding to pavement level on the principal elevation to Princes Street had been blocked up at some stage. The setting out of the streets of the grid plan would have involved cutting and filling operations to ensure that the street surfaces were kept reasonably level across their width, and to avoid having major falls towards the south side of each street. That the ground on the pavement line has been built up can be seen in the steps leading from the back of the pavement down to the garden ground. On Sinclair Street the problem of changes in level had been more marked, to the extent that it could only be overcome by building up the kerb edge on the south side of the road from which steps lead down to the pavement which must correspond roughly to the original ground level. From the photographic evidence it can be stated with certainty that the level of the pavement has been dropped by approximately 0.25m from around the beginning of the twentieth century. The pavement finish is currently of interlocking concrete blocks.

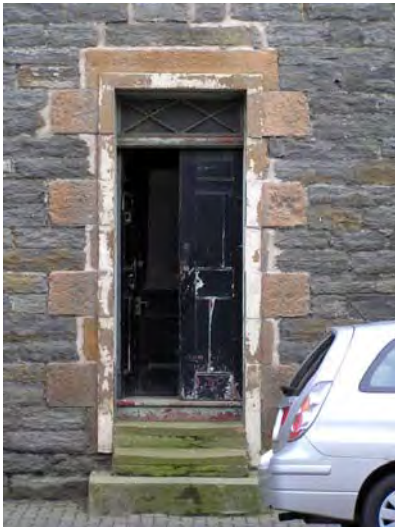
Front door to Princes Street

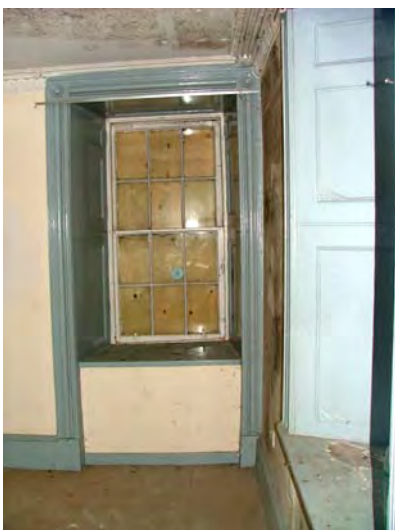
Interior of first floor room (west), courtesy of The Highland Council

Without having access to the interior of the property it is difficult to be precise about the internal finishes and the layout to assist with dating. However, it is clear from archival images from the 1940s, and from those supplied by the Highland Council, that the principal rooms had been finished to a high contemporary standard, with reeded architraves and blocking pieces with roundels where the architraves met at door and window openings. There are subtleties to be seen in the joinerwork: some of the architraves have convex reeded mouldings whereas others are concave. Shutters were set deep within the window openings, and there seem to have been decorative plaster cornices well suited to a high status early nineteenth century dwelling. The stairwell had been a particularly elegant feature, laid out on a half-spiral with a gentle rise between storeys, and with cast-iron balusters.

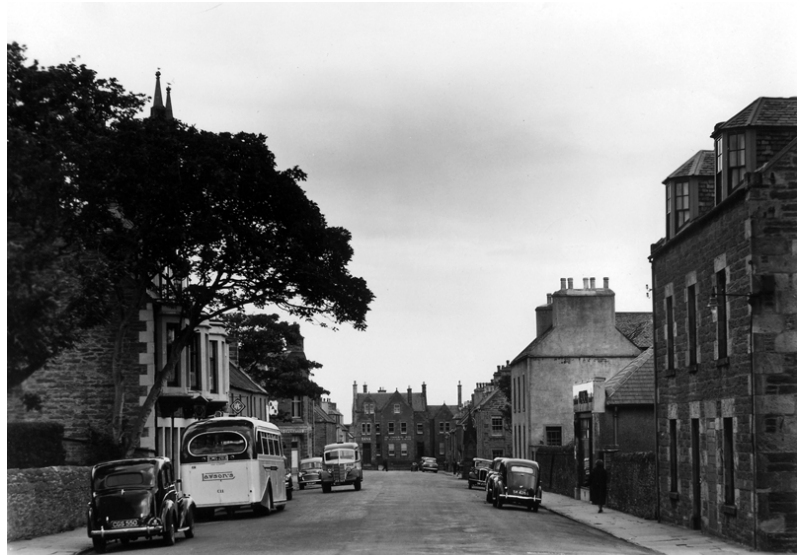
Valentine's of Dundee photograph of Princes Street looking west c1958 © University of St Andrews

The late 1950s Valentine image appears to indicate that the render was beginning to wear thin on the east gable, and at some stage the upper parts of the gable were renewed in a modern dense cement mortar which is very dull in appearance when compared with the original material, the appearance of which was enlivened through the use of a seashell aggregate which was common in Caithness, and which may imply the use of a beach sand. From the George Washington Wilson photograph it can be seen that the sash and case windows were painted white or off-white, while in later photographs they are painted a dark colour. From examining the door and door frame of the front door the original colour had been crimson, followed by light green, and then it was painted black, the present colour. More detailed investigation will no doubt provide further clues.

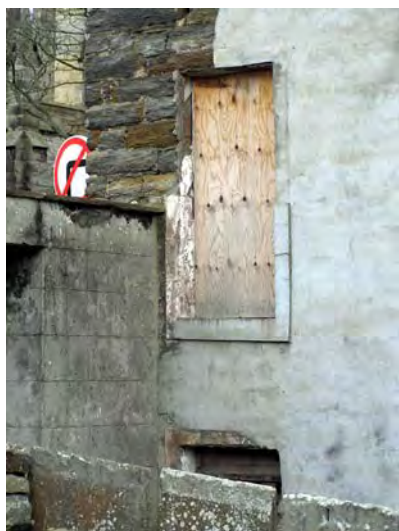
Windows inserted at the west gable

There is evidence that the windows on the west gable serving the ground floor and basement are later insertions, and may relate to when the rendered finish was applied as the raised margins have been added in cement work, and then coloured to match the exposed masonry rybats. As noted above it is probable that the windows had been left out for the same reason that the sandstone quoins were omitted, in that it was considered that the property was intended to be at the end of a terraced row of houses. The rendered finish applied

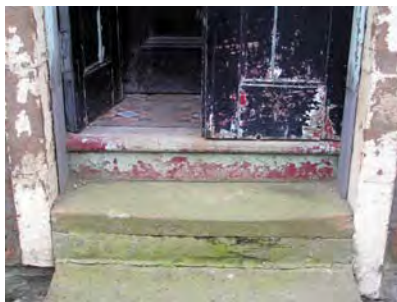
The door threshold and lobby floor

SS09 Although many of the original features have been damaged, there is still much early fabric that survives externally that is historically authentic, even if from different construction phases; features include external joinery such as the front door and fanlight, 12 pane sash and case windows with historic glass, yellow chimneycans with a beaded moulding, and the encaustic tiled floor to the entrance lobby

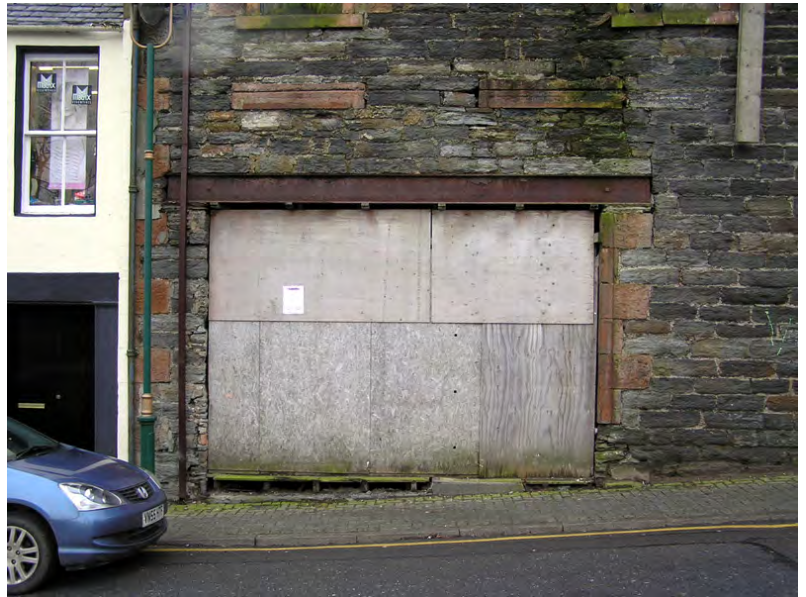
Detail of the shopfront inserted at ground floor on Sir John's Square

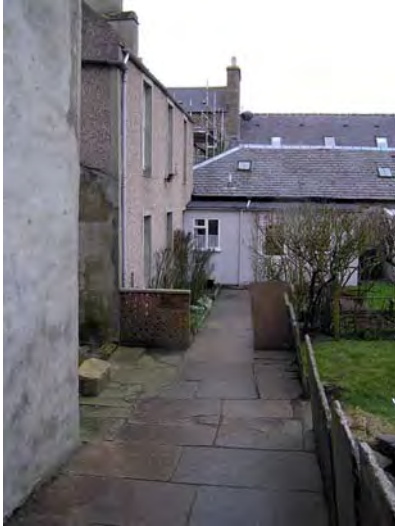
Shared access to the rear of 7 Sir John's Square and to Rose Cottage

- CP18 Restore the significance of the garden ground and of the mutual access to the rear of the property and to Rose Cottage; repair steps and relay paving slabs as required in matching materials, and restore the fence of vertical flagstones in accordance with established photographic evidence

- CP19 Ensure that the boundary wall and entrance portal to the mutual access path are conserved as part of a scheme of repairs; as early fabric there should be a presumption against making major change to these features which are presumed to be early and possibly original

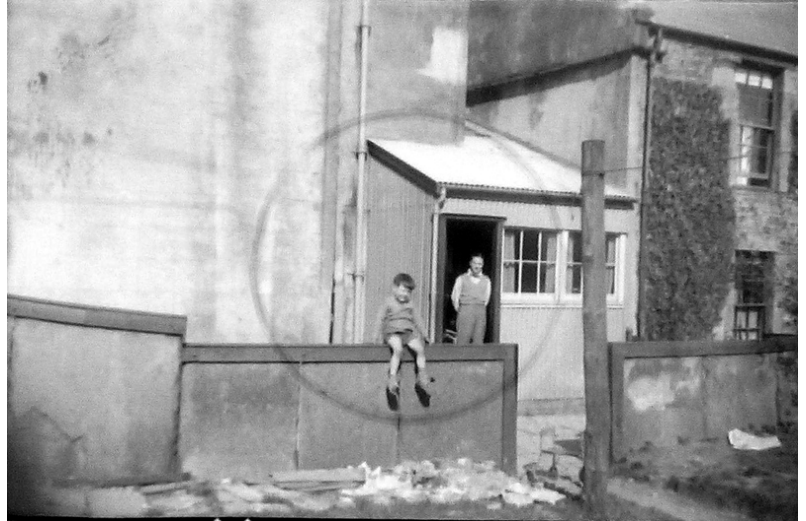
View c1940 of the rear of 30 Princes Street showing the timber edging to the flag dyke and rear of the shop at 7 Sir John's Square © Manson Collection

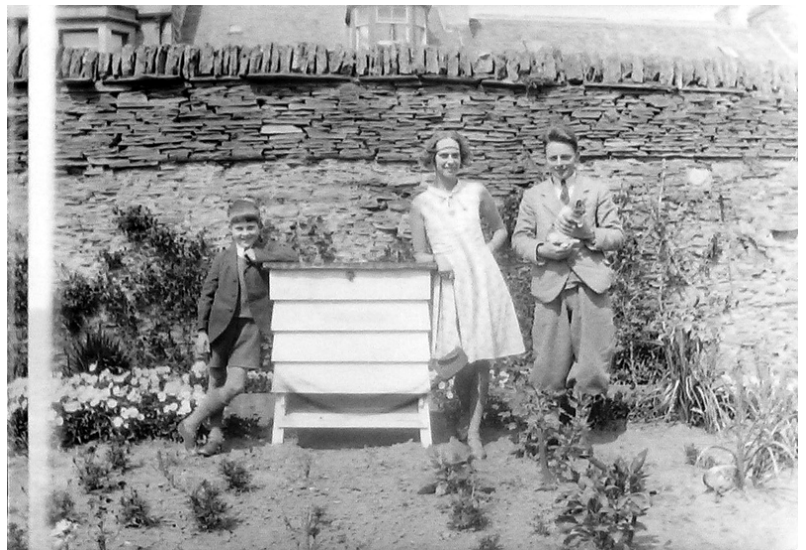
Photograph taken within the garden of 30 Princes Street showing the extension to the height of the wall © Manson Collection

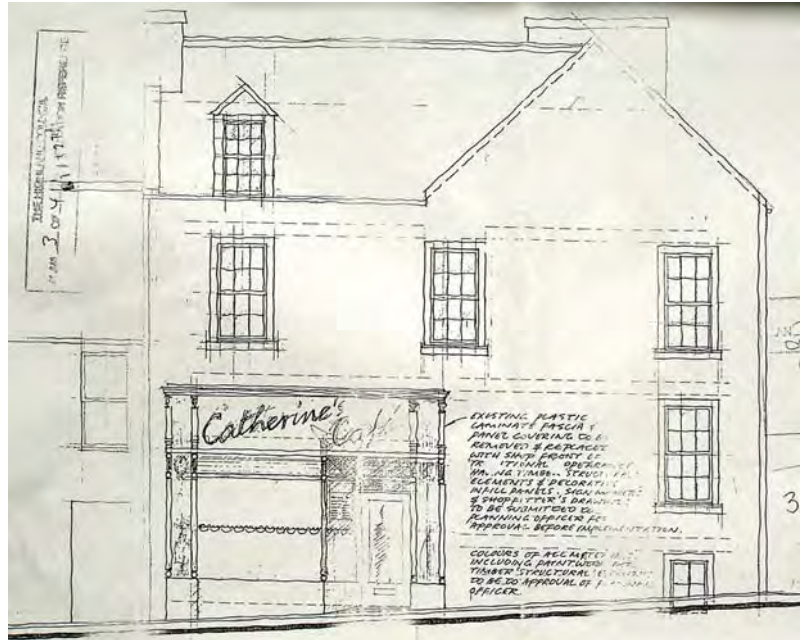
Drawing prepared by Duncan J Fraser of Inverness for the conversion of 7 Sir John's Square (1996): the elevation shows the hipped dormer remaining in position but the east chimneyhead has been removed at the gable

- CP06 Reinstatement the missing chimneyhead at the east gable to match the original detail of the two surviving chimneyheads and chimneycans
- CP07 Ensure, wherever it is possible to do so, that historic woodwork is salvaged and repaired in preference to being replaced

- CP10 The original piended dormer facing Sir John's Square should be reinstated based on the evidence surviving within the building, or upon the surviving pictorial evidence in photographs and drawings

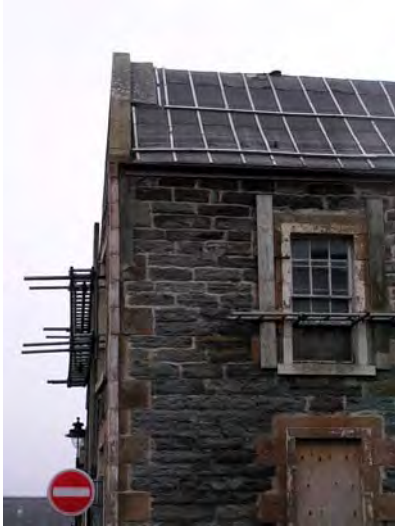
Bulging masonry at the southeast corner

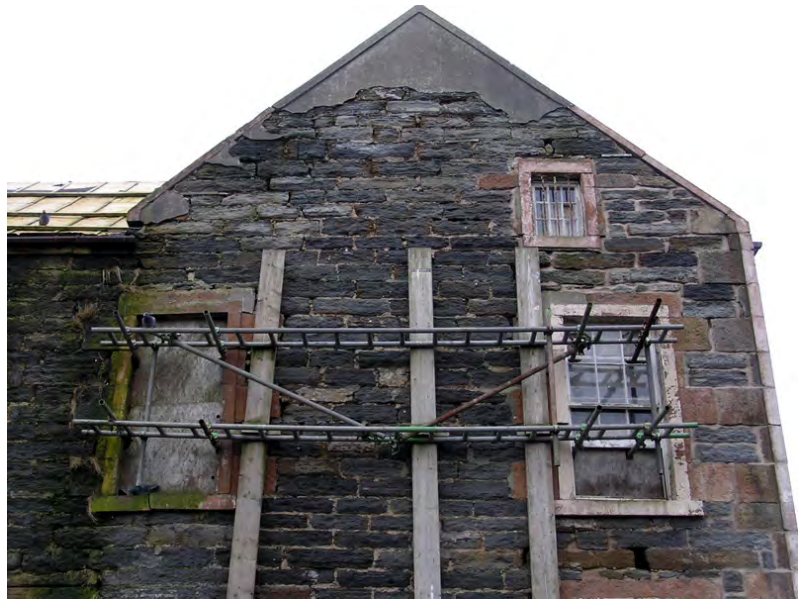
Temporary stabilisation works at the east gable

DS04 The temporary measures put in place to secure the long term future of the property – these include structural scaffolding to prevent structural collapse and to restrict further movement of the external walls; breakages to historic glass; boarding up of windows; the removal of cast iron rainwater goods and the original roofing slates; the loss of the hipped dormer facing the square; and the application of felt to the roof sarking

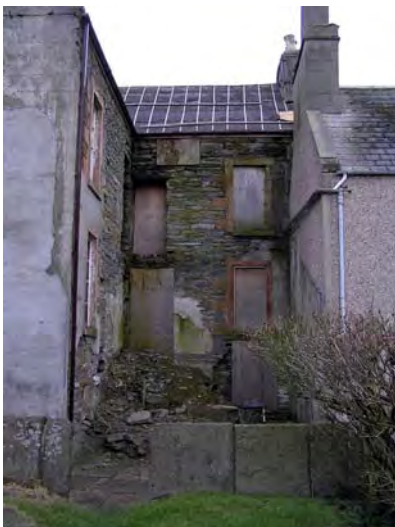
The re-entrant to the rear of the property following the demolition of the stair tower

DS03 The destruction of the stair tower: even though it had been an addition to the original house it was an early one and part of its history

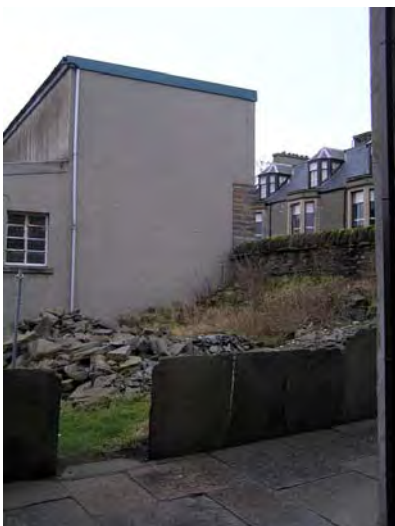
Spoil from demolitions within the garden
