Rebecca Shaw Archaeological Services

Rosal Township, Strathnaver, Sutherland: Archaeological Survey Works

by Rebecca Shaw, Dr Ben Edwards and Andrew Wilson
28th March 2014

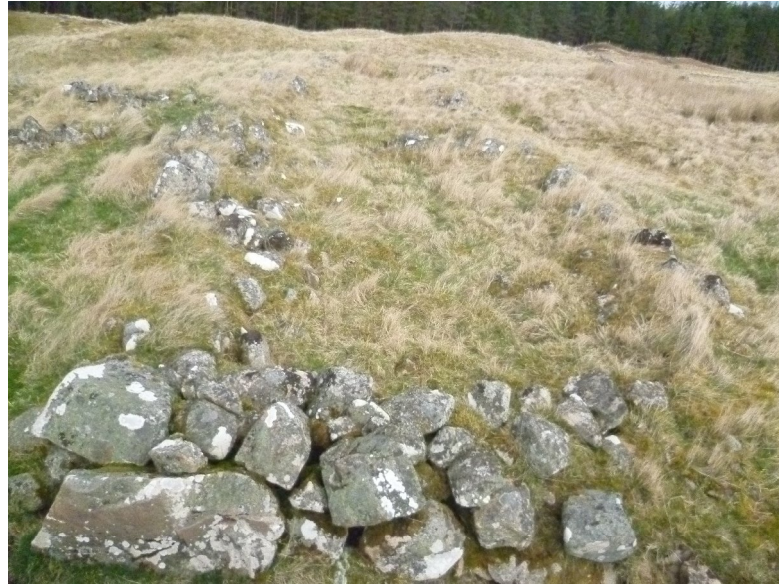
Figure 6a – Longhouse / dwelling (D1)

(1) long rectangular sub-divided structure, aligned north / south (Figure 6a). The structure measures 26m in length with the sub-dividing wall sited at 7.10m (internally) from the south end, the width of the structures measures between 2.7m to 4m (averages 3.5m) – narrows at northern end. There is an entrance to the main compartment in the east wall with a further possible entrance in the northern wall of the smaller compartment – there is a possible access in the sub-dividing wall. The structure is rounded at both ends and the walls are of a drystone construction measuring between 0.70m to 0.80m in width and between 0.20m to 0.80m in height.

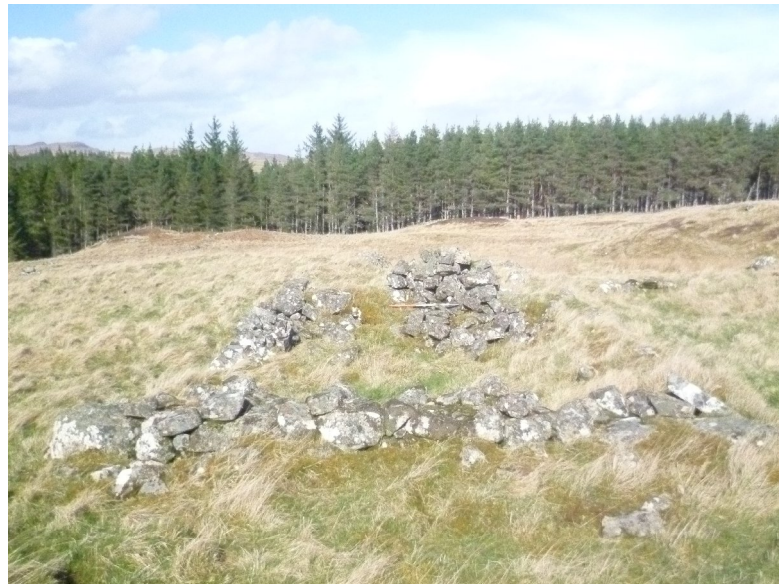
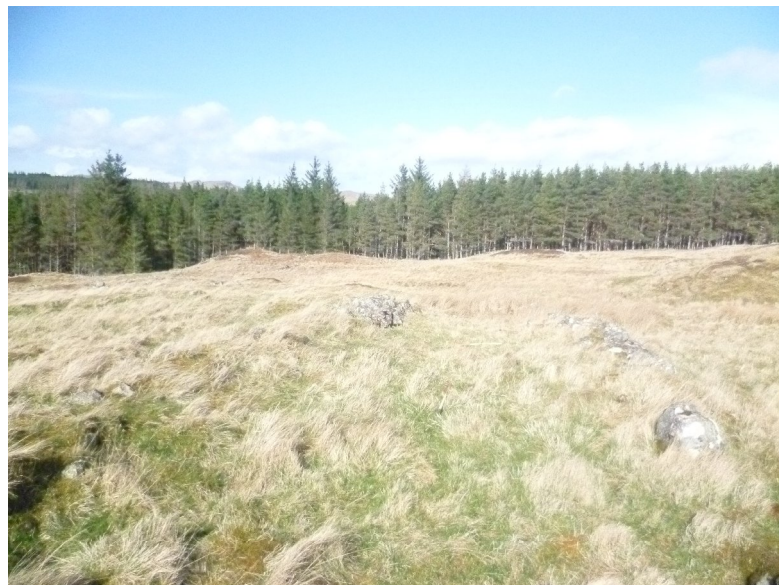
Figure 6b – Longhouse / dwelling (D2) – upper end

(2) long rectangular structure, aligned north / south and divided into two compartments (Figures 6a & 6b). The structure measures 34.30m in length with the dividing wall sited at 6.20m (internally) from the southern end, width varies between by 3.30m to 3.60m in width in the larger compartment and averages 3.7m in the smaller compartment. There is a definite entrance to the main compartment in the eastern wall with a further possible entrance in the western wall of the smaller compartment – there is also a possible opening at the very northern end of the eastern wall in the main compartment. There is no visible access between the two compartments. The structure is rounded at the northern end and the walls are of a drystone construction and in general measure between 0.70m to 1m in width and between 0.50m to 0.55m in height – though the dividing wall is more substantial upstanding to 1.20m (at most) and measuring 0.90m in width. There is a small section of curved walling, comprising one course of fairly large stones and measuring 1.20m in width sited to the immediate north of the entrance in the larger compartment (Figure 7a).

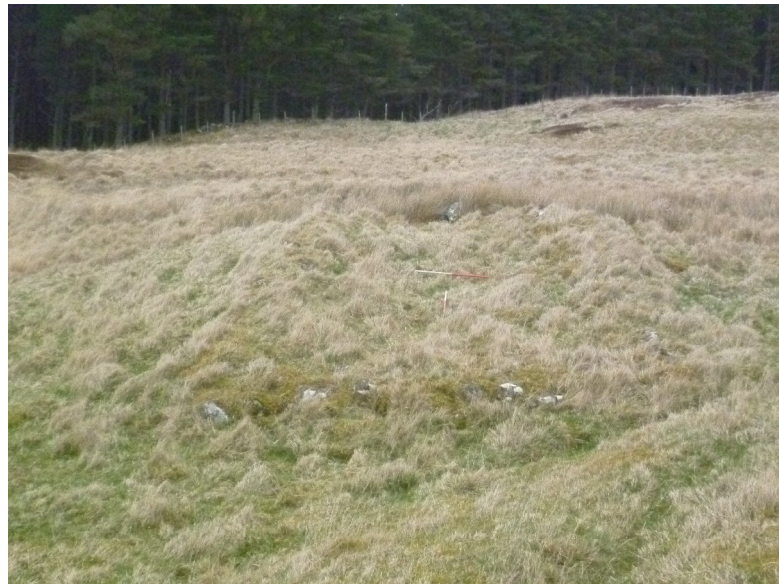
Figure 7b – Longhouse / dwelling (D4)

(4) long rectangular structure, aligned southwest / northeast, measuring 15m in length by 3.30m in width (Figure 7b). There is a single entrance in the southeast wall. The walls of the structure are of a drystone construction and in general average 0.70m in width and between 0.20m to 0.30m in height.

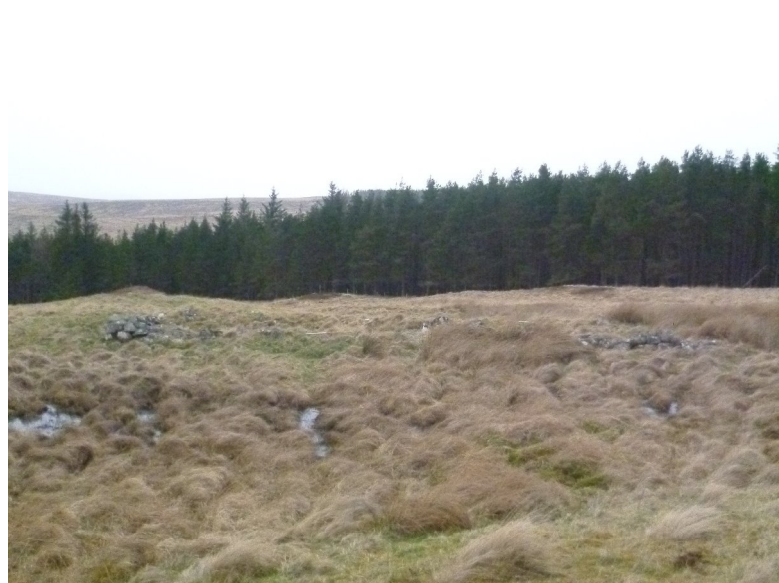
Figure 7c – Longhouse / dwelling (D5)

(5) long rectangular structure, aligned southwest / northeast, measuring 13.7m in length by 3.30m in width (Figure 7c). There is an entrance in the northwest wall with a further possible opening in the southwest end. The walls of the structure are of a drystone construction and in general average 0.60m in width and 0.40m in height – the wall at the northeast end more substantial measuring 0.80m in width.

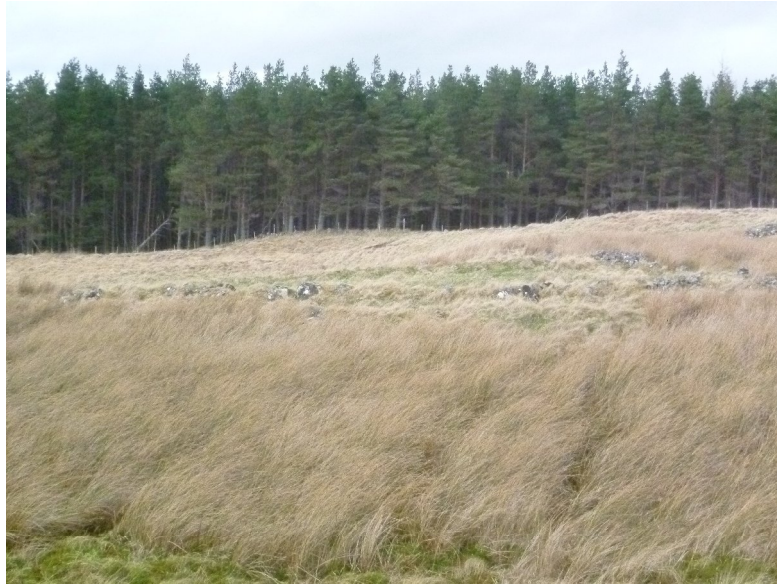
Figure 8a – General of Longhouse / dwelling (D6) and enclosure (E7)

(6) long rectangular structure, aligned roughly east / west (attached to E7) (Figure 8a) and measuring 22.30m in length and averaging 3.10m in width. There is a single entrance in the

southern wall. The walls are of a drystone construction and in general average 0.70m in width and 0.50m in height. Both ends of the structure comprise very large stones with marsh / bog at the exterior.

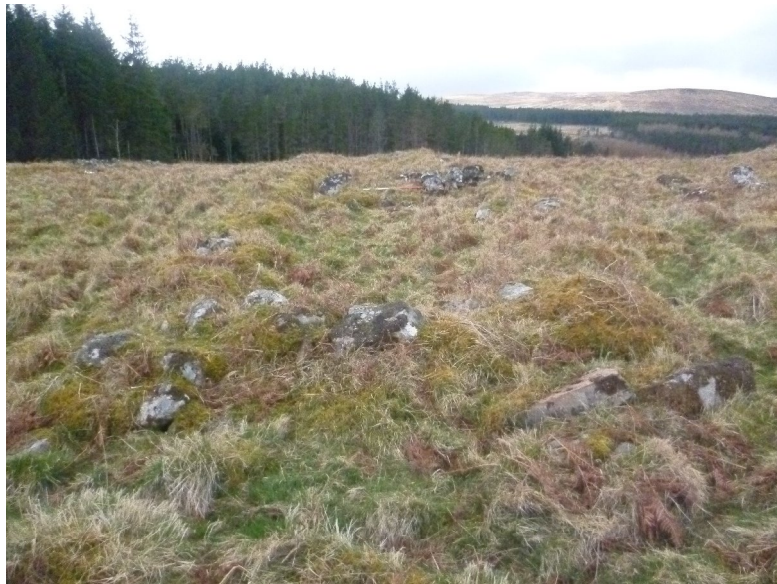
Figure 8b – Longhouse / dwelling (D7)

(7) long rectangular structure, aligned east northeast / west southwest and divided into two, the larger of which is subdivided (Figure 8b). The structure measures 24.20m in length with the dividing wall sited at 6.10m (internally) and the sub-dividing wall at 19m from the eastern end, the width of the structure averages 3.30m. There is an entrance to the main compartment in the south southeast wall with a further entrance in the south southeast wall of the east northeast compartment – there is access in the sub-dividing wall. The walls are of a drystone construction and in general average 0.60m in width and between 0.30m to 0.50m in height – the easternmost dividing wall is more substantial averaging 0.80m in width and up to 0.60m in height.

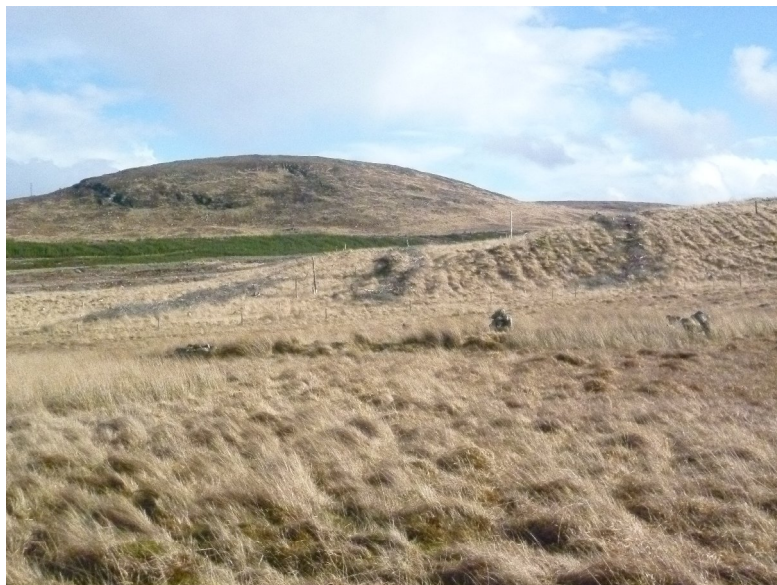
Figure 8c – Longhouse / dwelling (D8)

(8) long rectangular sub-divided structure, aligned east northeast / west southwest (Figure 8c). The structure measures 29m in length with the sub-dividing wall sited at 4m (internally) from the west southwest end, the width of the structure averages 3.20m. There is a single entrance in the south southeast wall and an access in the sub-dividing wall. The walls are of a drystone construction and in general measure average 0.70m in width and between 0.30m to 0.40m in height – the sub-dividing wall is more substantial upstanding to a height of 1m in height.

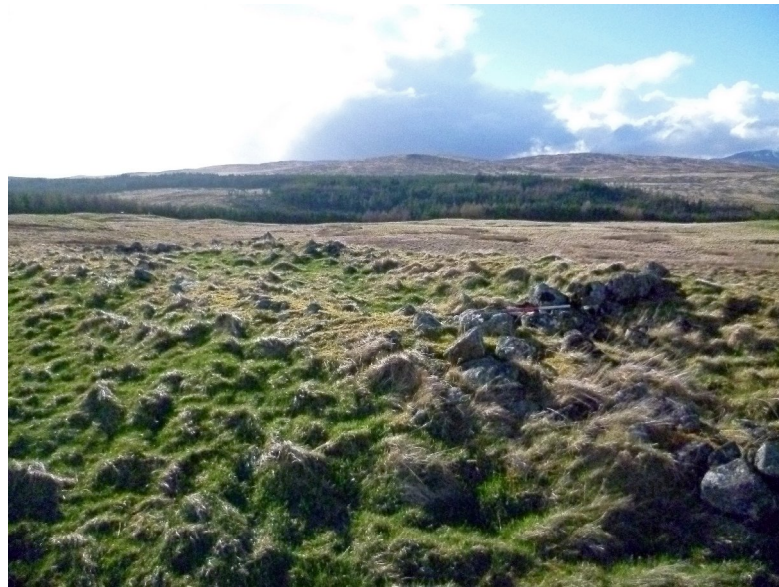
Figure 9a – Longhouse / dwelling (D9)

(9) long rectangular structure, aligned northeast / southwest and divided into two compartments (Figure 9a). The structure measures 17.50m in length with the dividing wall sited at 4m (internally) from the northeast end, the width of the structure averages 3.30m. There is an entrance to the main compartment in the southeast wall with a further possible (opposing) entrance in the northwest wall – there is also a further entrance in the southeast wall of the smaller compartment. There is no visible access between the two compartments. The walls are of a drystone construction and in general measure between 0.60m to 0.80m in width and between 0.10m to 0.40m in height.

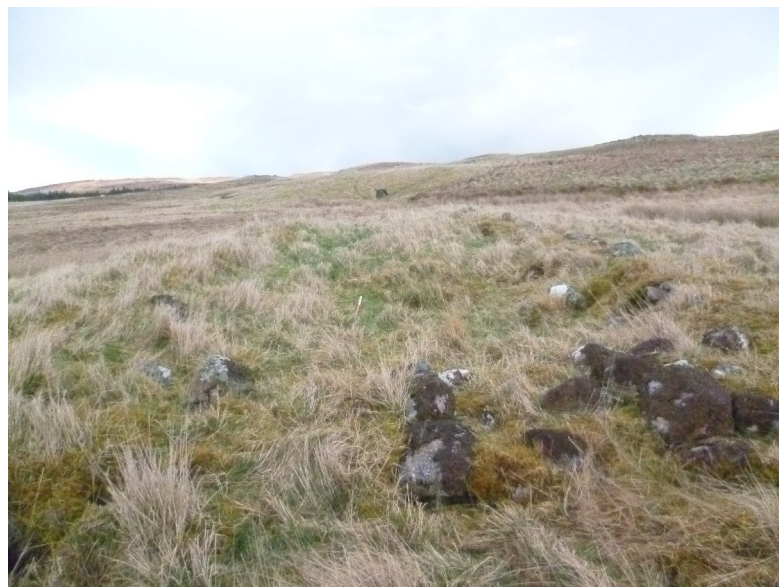
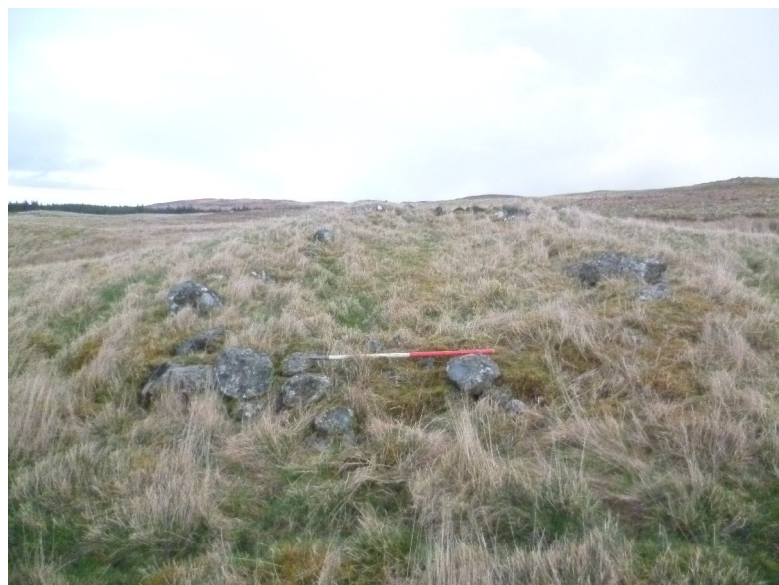
Figure 9b – Longhouse / dwelling (D10) – ENE half

(10) long rectangular structure, aligned west southwest / east northeast and divided into two compartments (Figures 9b & 9c). The structure measures 27.80m in length with the dividing wall sited at 11.90m (internally) from the west southwest end, the width of the structure averages 3.20m. There is an entrance in the south southeast wall of the west southwest compartment with opposing entrances in the south southeast and north northwest walls of the east northeast compartment. There is no visible access between the two compartments. The structure is rounded at both ends and the walls are of a drystone construction with the walls averaging between 0.60m to 0.70m in width and 0.40m (at most) in height – the west southwest wall is more substantial upstanding to a height of 1.20m. A hollow measuring roughly 0.90m in diameter and 0.30m in depth was visible within the base of the east northeast compartment.

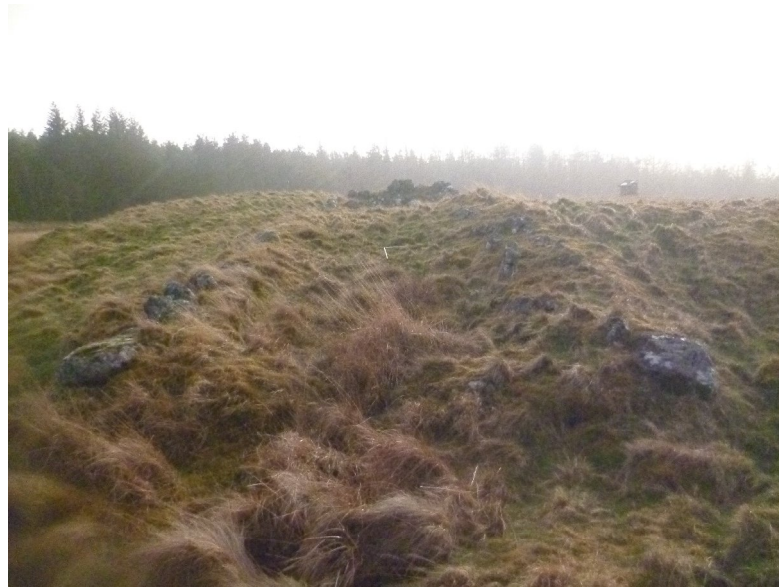
Figure 10a – Longhouse / dwelling (D11)

(11) long rectangular subdivided structure, aligned west southwest / east northeast (Figure 10a). The structure measures 29.80m in length with the sub-dividing wall sited at 20.90m (internally) from the northeast end, the width of the structure averages 3.40m. There is a single entrance in the south southeast wall and an access in the sub-dividing wall – there is a further opening in the west southwest end. The walls are of a drystone construction and in general measure average 0.70m in width and between 0.30m to 0.40m in height.

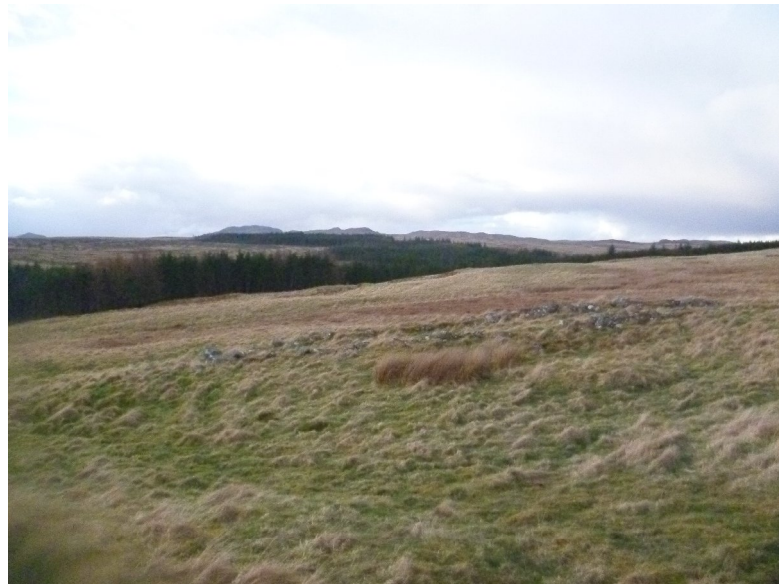
Figure 10b – Longhouse / dwelling (D12)

(12) long rectangular structure, aligned north northeast / south southwest measuring 25.30m in length by 3m in width (Figure 10b). There is an entrance in the east southeast wall with a further possible opening in the north northeast end. The structure is rounded at both ends and the walls are of a drystone construction and in general average 0.70m in width and between 0.40m to 0.50m in height.

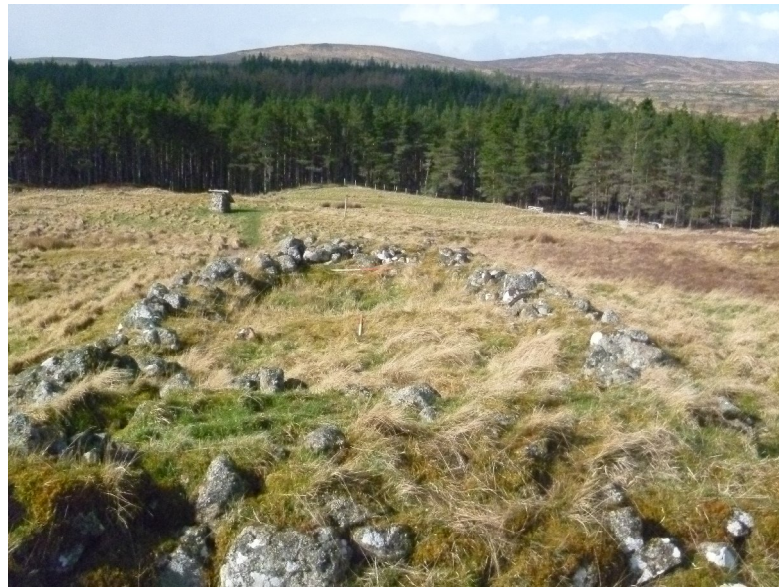
Figure 11a – Ancillary structure (A1)

(1) small rectangular structure attached to western side of longhouse / dwelling structure (1). The structure is aligned east / west measuring 10.40m in length by 3.4m in width (Figure 11a) with an entrances in the south wall and an opposing opening in the south wall (Figure 25a). The walls are of a drystone construction and in general average 0.90m in width and between 0.20m to 0.80m in height.

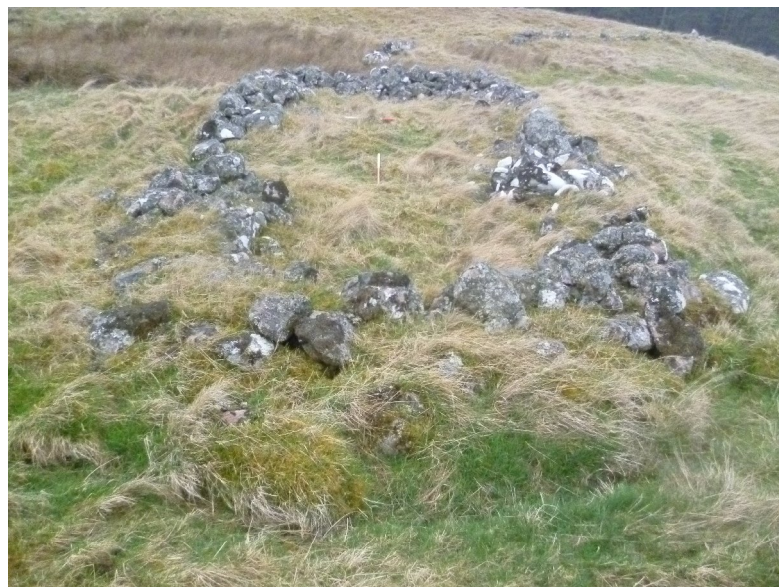
Figure 11b – Ancillary structure (A2)

(2) small oval structure, aligned northwest / southeast and measuring 8.90m in length by 2.90m in width (Figure 11b). There is a single entrance in the southwest wall. The walls are of a drystone construction and in general averaged 0.70m in width and 0.30m in height (0.60m at most) - walling wider at northeast end.

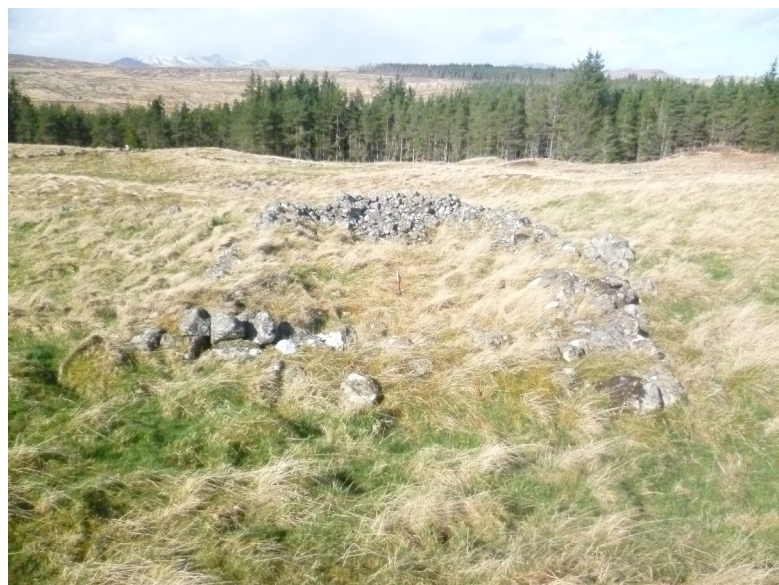
Figure 11c – Ancillary structure (A3)

(3) small rectangular structure, aligned northwest / southeast and measuring 10m in length by 3.40m in width (Figure 11c). There is a single entrance in the southwest wall. The walls are of a drystone construction and in general measure between 0.90m and 1.20m in width averaged 0.70m in height – walling wider at northwest end. There was a sunken area within the base at the northwest end of the structure.

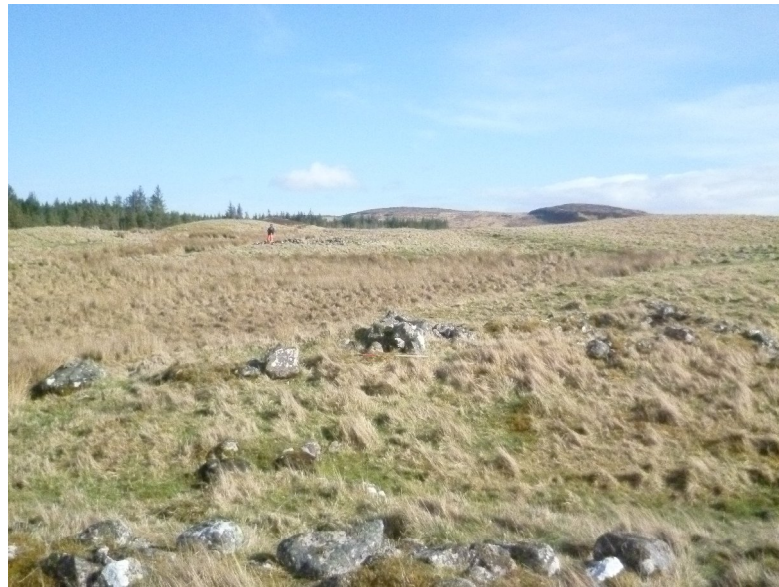
Figure 12a – Ancillary structure (A4)

(4) small rectangular structure, aligned north / south, divided into two compartments. The structure measures 8.10m in length by 2.90m in width with the dividing wall at 2.5m (internally) from the northern end (Figure 12a). There is an entrance in the western wall of both compartments. The structure is rounded at the northern end and the walls are of a turf & drystone construction and averaged 0.70m in width and between 0.20m to 0.40m in height – the dividing wall 0.60m in height (at most).

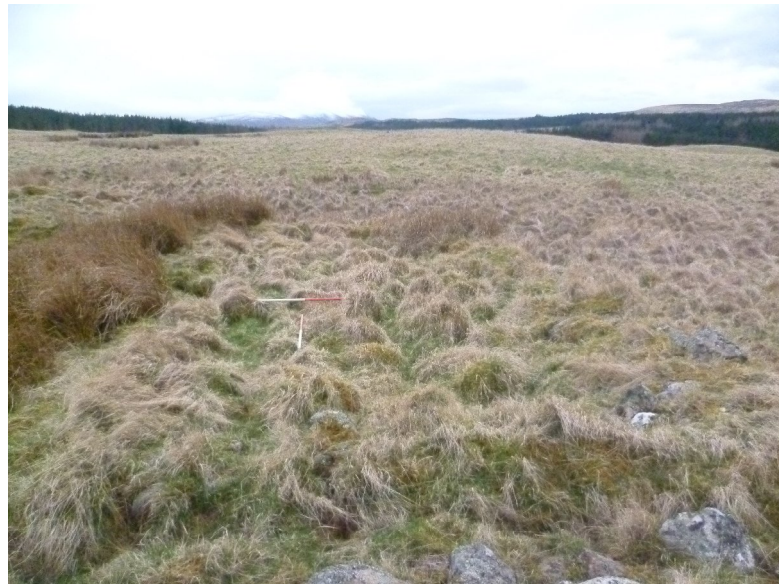
Figure 12b – Ancillary structure (A5)

(5) small rectangular structure, aligned southwest / northeast and measuring 10m in length by 3.40m in width (Figure 12b). There is an entrance in the southeast wall with a further possible opposing narrow opening in the northwest wall. The walls are of a drystone construction and averaged 0.70m in width 0.40m in height.

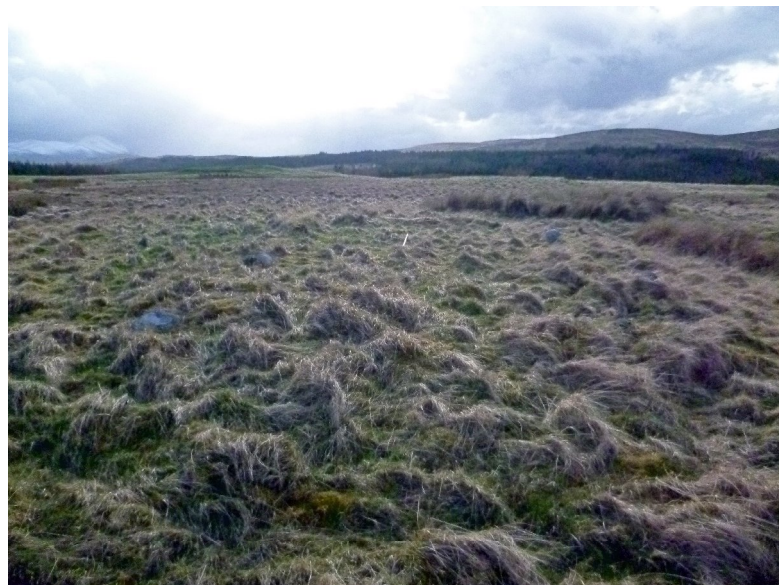
Figure 12c – Ancillary structure (A6)

(6) very denuded remains of a small rectangular structure, aligned southwest / northeast and measuring 8m in length by 2.9m in width (Figure 12c). There is a possible entrance in the northern corner. The walls are of a drystone construction and in general average 0.70m in width and 0.20m in height (at most)..

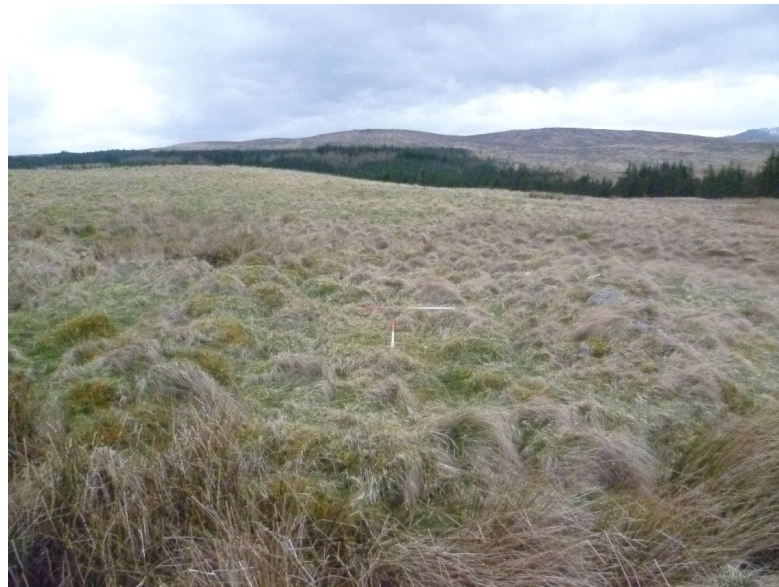
Figure 13a – Ancillary structure (A7)

(7) small oval structure, aligned east / west and measuring 7.9m in length by 3.10m in width (Figure 13a). There is a possible entrance in the southern wall. The walls are of a drystone construction and in general average 0.80m in width and 0.30m in height.

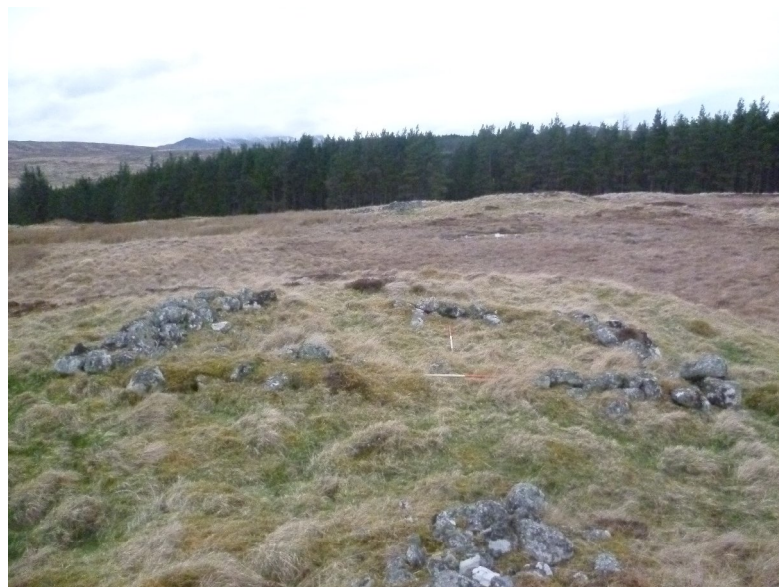
Figure 13b – Ancillary structure (A8)

(8) very small rectangular structure, aligned southwest / northeast and measuring 5.6m in length by 2.80m in width (Figure 13b). There is a single entrance in the northwest wall. The walls are of a drystone construction and in general average 0.70m in width and 0.60m in height (at most).

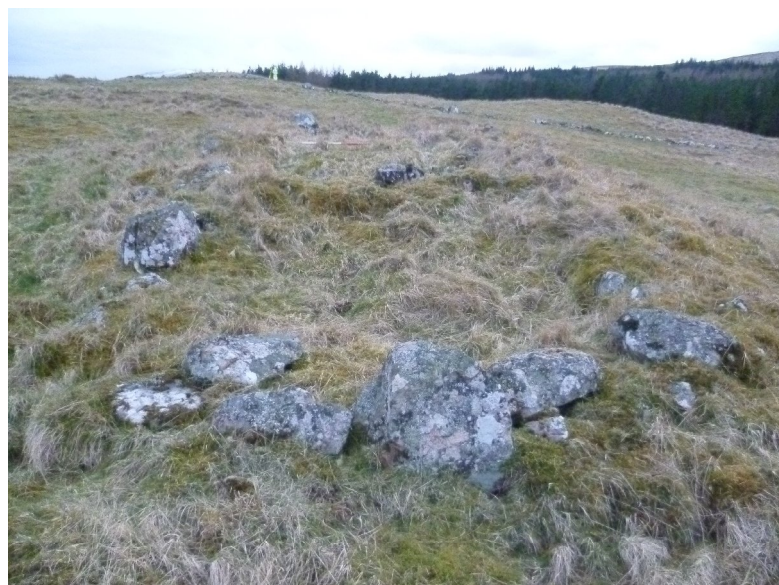
Figure 13c – Ancillary structure (A9)

(9) small oval structure, aligned northeast / southwest, divided into two compartments (Figure 13c) measuring 10.30m in length by 2.30m in width. There is an entrance in the northwestern wall of both compartments. The walls are of a drystone construction and average between 0.70m to 0.90m in width and average 0.30m in height.

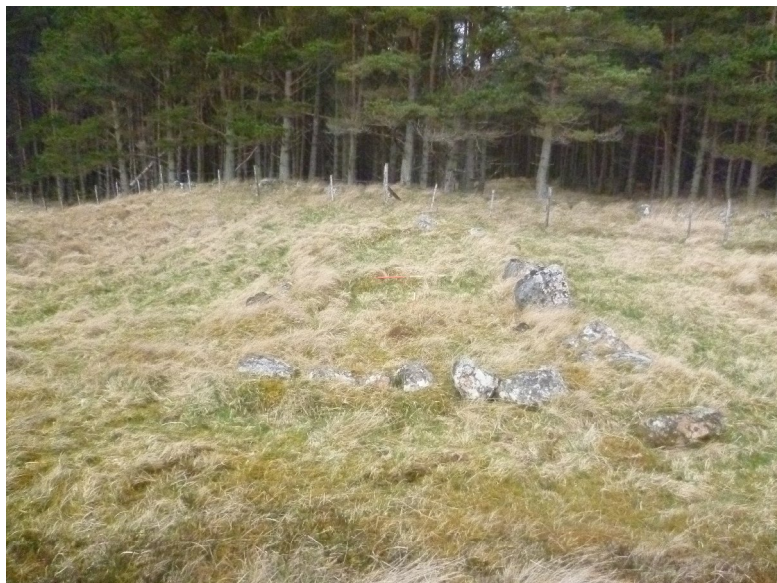
Figure 14c – Ancillary structure (A12)

(12) small rectangular structure, aligned northwest / southeast, possibly divided into two compartments (Figure 14c). The structure measures 9.3m in length by 2.40m in width. There is an entrance in the southwest wall of the southeast compartment with a further possible opposing narrow opening in the northwest wall. There is a further possible entrance in the southern corner of the structure. The structure is rounded at the northwest end and the walls are of drystone construction and average between 0.60m to 0.70m in width and 0.50m in height (at most).

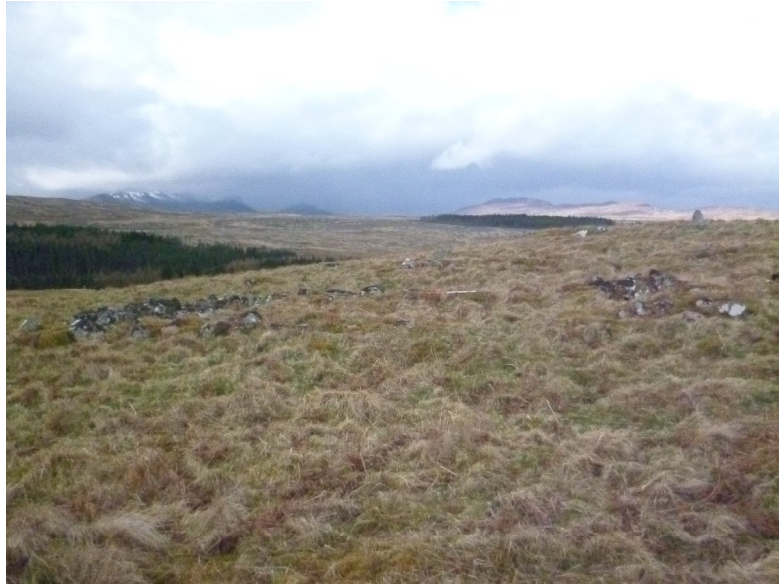
Figure 15a – Ancillary structure (A13)

(13) small rectangular structure, aligned northeast / southwest and measuring 8.6m in length by 3m in width (Figure 15a). There are opposing entrances in the southeast and northwest walls. The walls are of a drystone construction and in general average 0.80m in width and between 0.20m to 0.90m in height – the wall appears very wide at the western end (1.40) almost like an inner skin.

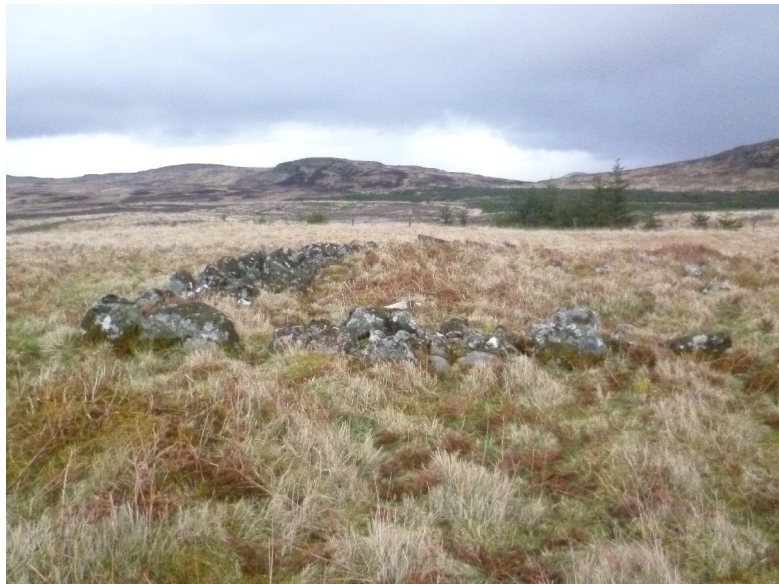
Figure 15b – Ancillary structure (A14)

(14) very small rectangular structure, aligned east northeast / west southwest and measuring 6.40m in length by 3.40m in width (Figure 15b). There is a single opening / entrance in the southern wall. The walls are of a drystone construction (most very large stones) and in general average 0.70m in width and 0.50m in height (at most).

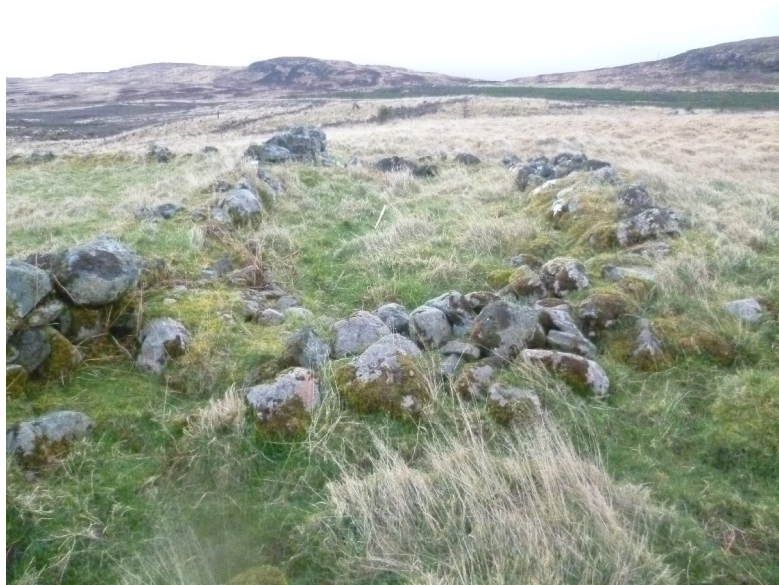
Figure 15c – Ancillary structure (A15)

(15) very small rectangular structure (attached to a section of walling), aligned east southeast / west northwest and measuring 6.20m in length by 2.30m in width (Figure 15c). There is a single entrance in the southeastern corner. The walls are of a drystone construction (most very large stones) and in general average 0.70m in width and measure between 0.20m to 0.40m in height.

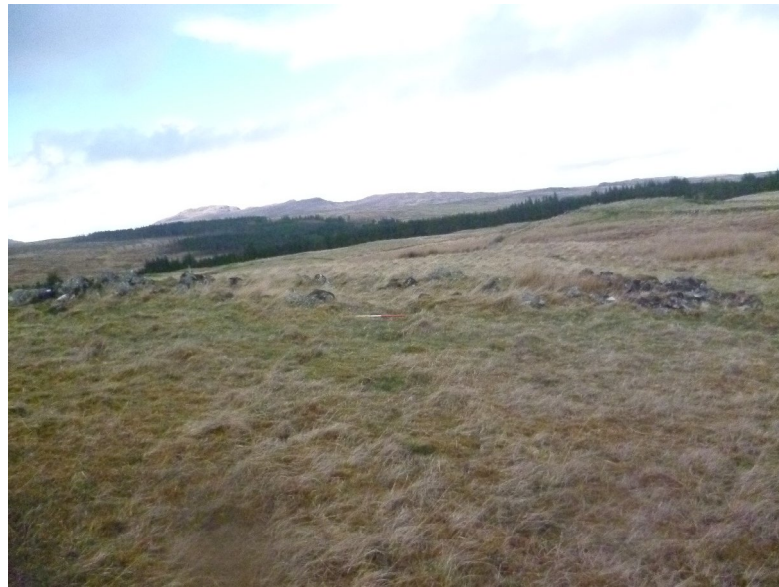
Figure 16a – Ancillary structure (A16)

(16) small oval structure, aligned east northeast / west southwest and measuring 9m in length by 3m in width (Figure 16a). There is an entrance in the south southeast wall with a possible opposing entrance in the north northwest wall. The walls are of a drystone construction and in general measure between 0.70m to 0.90m in width and between 0.10m to 0.65m in height.

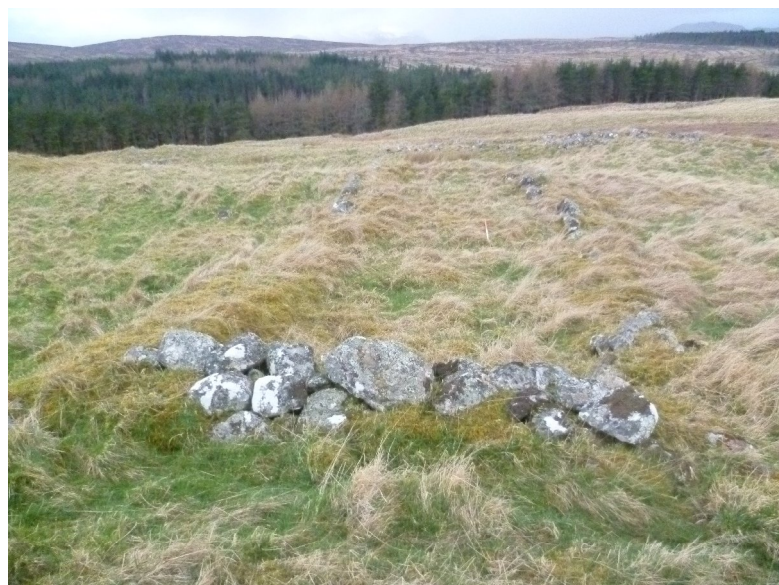
Figure 16c – Ancillary structure (A18)

(18) small oval structure, aligned northwest / southeast and measuring 12.40m in length by 2.70m in width (Figure 16c). There is an entrance in the southwest wall with a further

possible entrance in the northeast wall (not opposing). The walls are of a drystone construction and in general measure between 0.60m to 0.80m in width and 0.50m in height (at most)

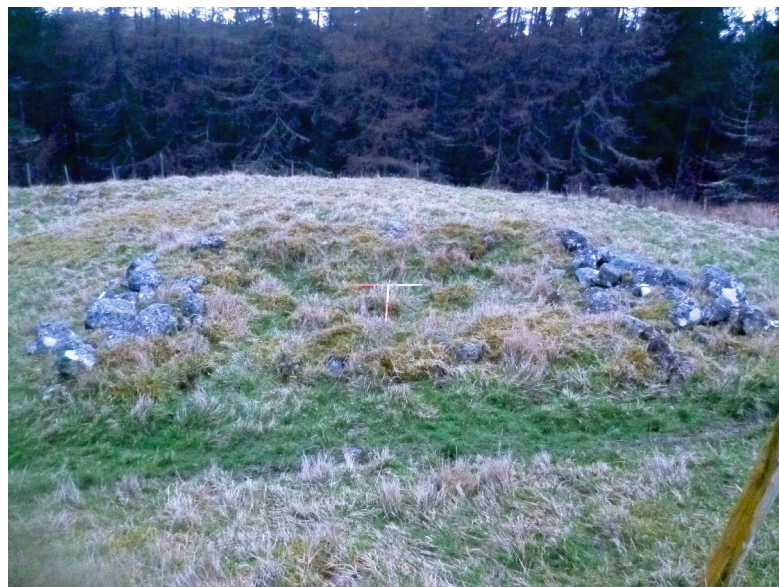
Figure 17b – Ancillary structure (A20)

(20) small rectangular structure, aligned south southwest / north northeast, and measuring 4.5m in length by 3m in width (Figure 17b). There is a single entrance in the south southeast corner of the structure. The walls are of a drystone construction and average 0.80m in width and 0.50m in height (at most).

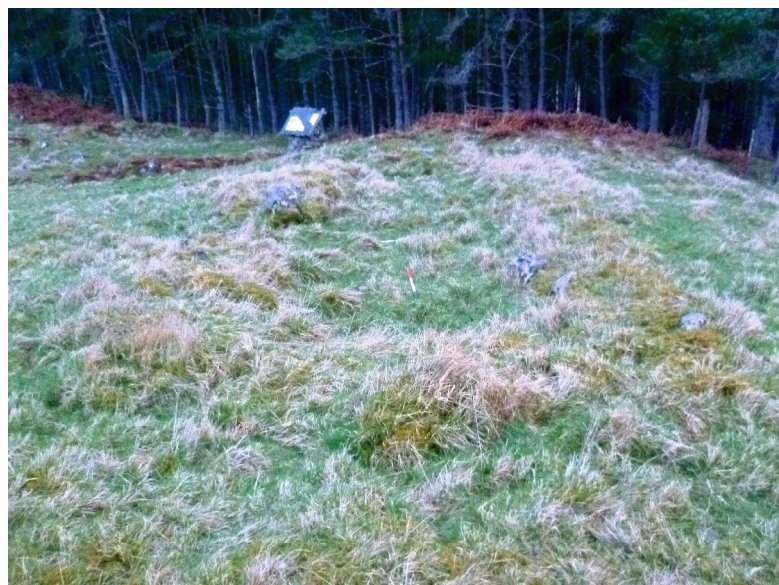
Figure 17c – Ancillary structure (A21)

(21) small oval structure, aligned northeast / southwest and measuring 9.2m in length by 2.70m in width (Figure 17c). There is a single entrance in the southeast wall. The walls are of a drystone construction and average between 0.70m in width and 0.30m in height.

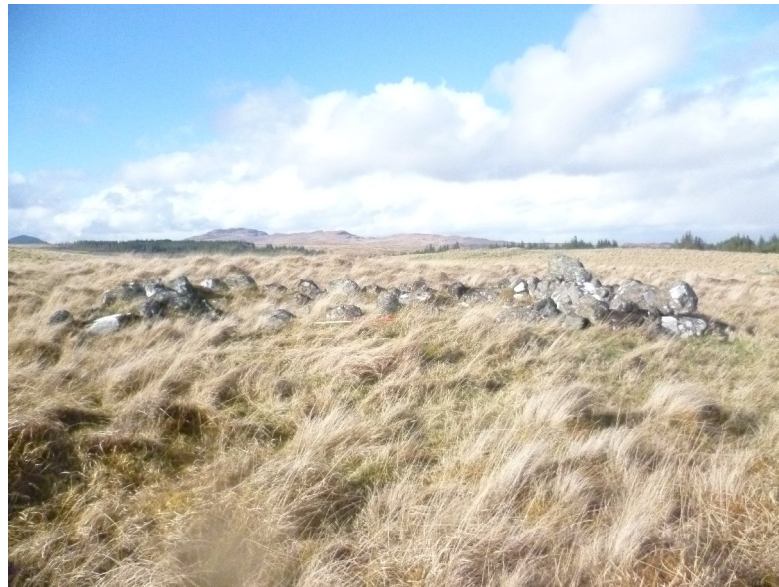
Figure 18a – Ancillary structure (A24)

(24) very small rectangular structure, aligned west southwest / east northeast and measuring 5.10m in length by 2.50m in width (Figure 18a). There is a possible entrance in the south southwest. The walls are of a drystone construction and in general measure between 0.60m (side walls) to 0.80m (end walls) in width and between 0.20m to 0.80m in height.

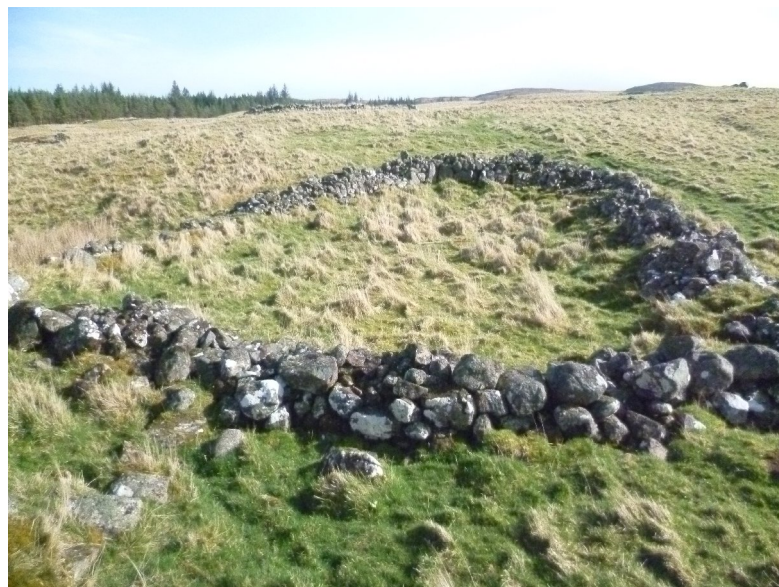
Figure 18b – general of enclosure (E1)

(1) roughly sub-rectangular shaped enclosure aligned roughly east / west, measuring between 13.60 and 7.20m. There was an entrance in the northwest corner (Figure 18b) comprises drystone walling measuring between 1m to 1.50m in width (due to spread) and upstanding to a height of 0.90m

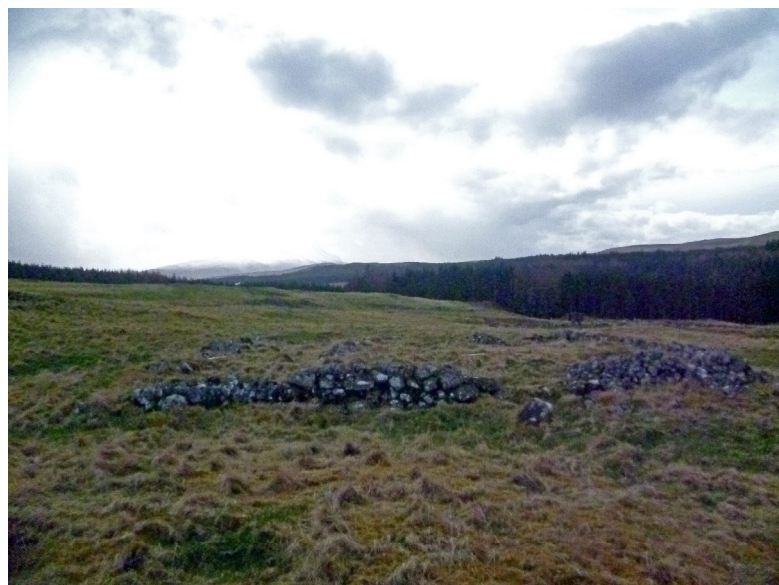
Figure 18c – General of enclosure (E2)

(2) subdivided enclosure aligned northwest / southeast, comprising a roughly square structure measuring 6.50m by 6.30m and a rectangular structure measuring 10m by 2.8m (Figure 18c). The walls in the square structure average 0.80m in width (though some have spread more) and 0.60m in height – the walls in the rectangular structure average 0.70m in width (Figure 25b) and 0.30m in height. There was an entrance in the northwest wall of the square structure but no other obvious entrances. A small sunken rectangular shaped pit-like feature measuring 1.80m by 1.20m and 0.50m in depth was noted in the floor area of the square structure (Figure 19a).

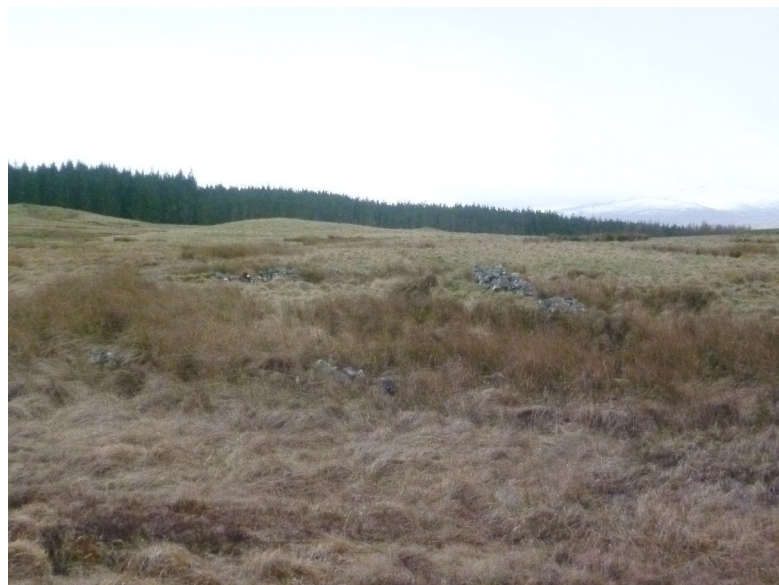
Figure 19b – General of enclosure (E3)

(3) rectangular shaped enclosure aligned roughly north northeast / south southwest measuring 21.70m by 9.70m (Figure 19b). There was an opening / entrance in the east northeast corner. The walls comprise drystone walling measuring between <0.10m to 0.70m in width and 0.90m to 1.20m in height.

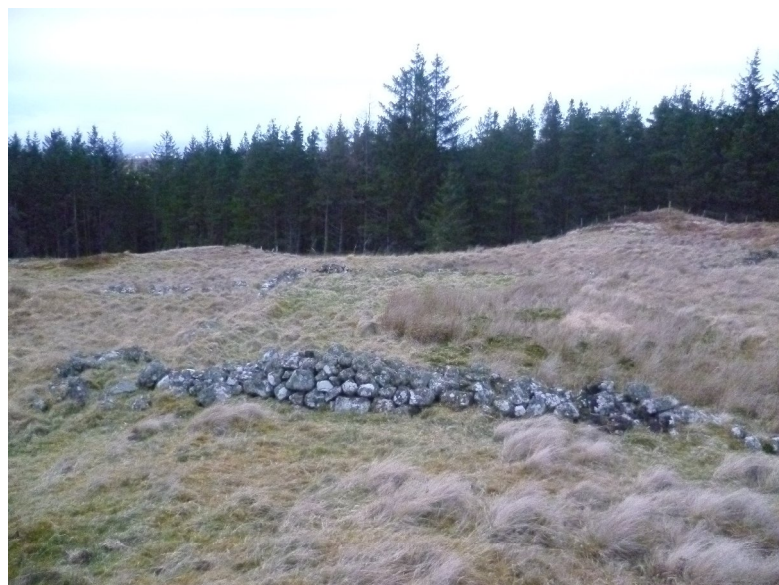
Figure 19c – General of enclosure (E4)

(4) rectangular shaped enclosure aligned roughly north northeast / south southwest

measuring 17.70m by 10.50m (Figure 19c). There was a possible entrance in the eastern corner. The walls comprise drystone walling measuring between 1m to 1.50m in width (due to spread) and upstanding to a height of 0.90m

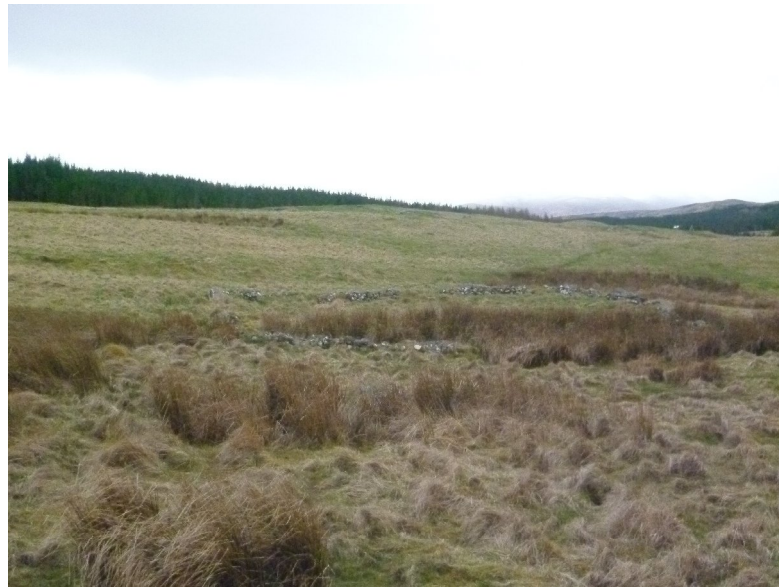
Figure 20a – General of enclosure (E5)

(5) roughly square shaped enclosure aligned roughly east southeast / west northwest, measuring 13m by 11.80m (Figure 20a). There was a possible entrance in the east northeast corner. The walls comprise drystone walling averaging 0.80m (some more spread) in width and 0.20m to 0.40m in height.

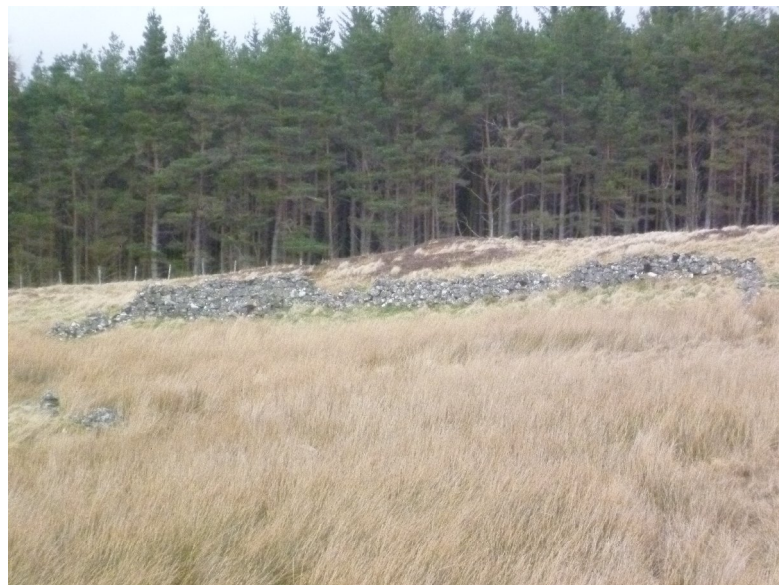
Figure 20c – General of enclosure (E7)

(7) triangular shaped enclosure (attached to D6) measuring at most 14.70m (west southwest / east northeast)(Figure 20c). There was a possible entrance in the east northeast corner. The walls comprise drystone walling measuring between 0.70m to 1.40m in width and 0.10m to 0.60m in height.

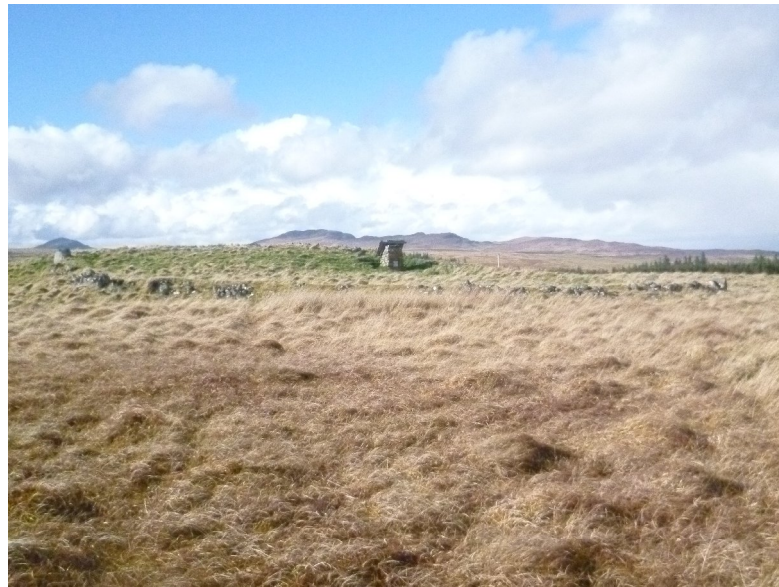
Figure 21a – General of enclosure (E9)

(9) roughly square shaped enclosure (rounded at east northeast side) (attached to D9) aligned west southwest / east northeast) (Figure 21a). There is no easily visible entrance.

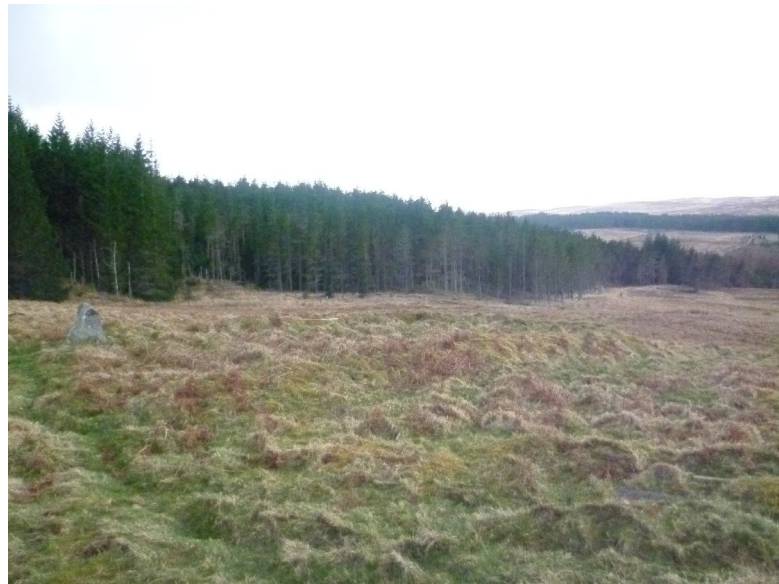
Figure 21b – General of enclosure (E10)

(10) sub-rectangular enclosure (rounded in the west), aligned roughly east / west (Figure 21b) measuring 12m by 7m (at most). There is a single entrance in the southeast corner.
