Rebecca Shaw Archaeological Services

Rosal Township, Strathnaver, Sutherland: Archaeological Survey Works

by Rebecca Shaw, Dr Ben Edwards and Andrew Wilson
28th March 2014

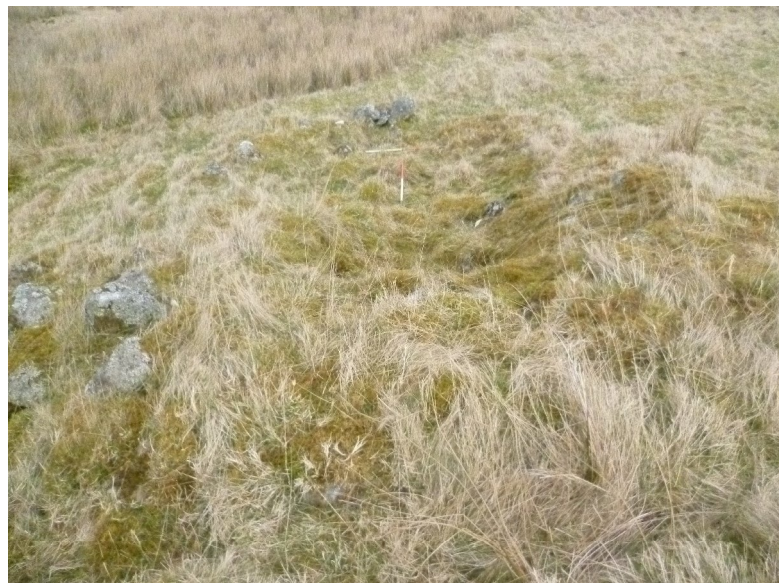
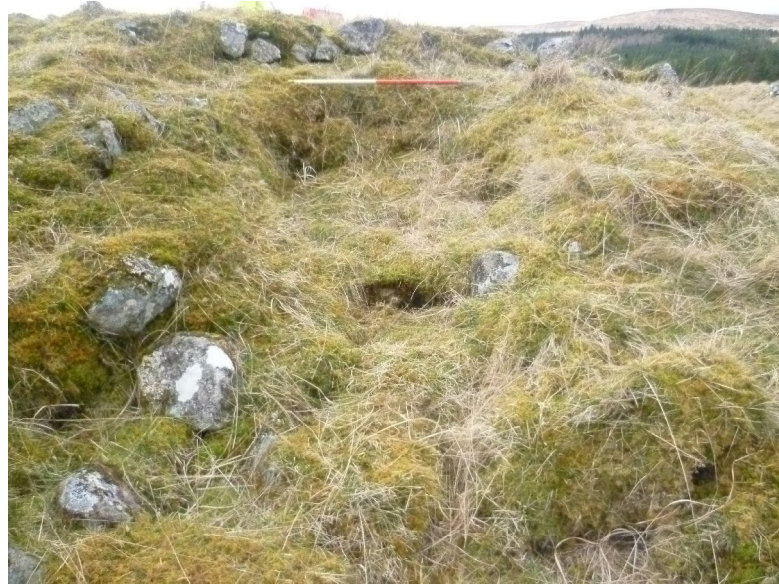
Figure 21c – General of CK1

(1) built into a slope are the remains of a corn kiln comprising an oval stone structure, aligned east northeast / west southwest (Figure 21c). The structure measures 7.10m by 2.70m (internally) and there is a possible entrance in the eastern corner. The walls are drystone built and average 0.70 to 0.80m in width and 0.30m in height. There are the remains of a bowl, which measures 1.6m in diameter, at the west southwest end of the structure with a further small stone circular feature to the east of the (front) of the bowl (Figure 22a).

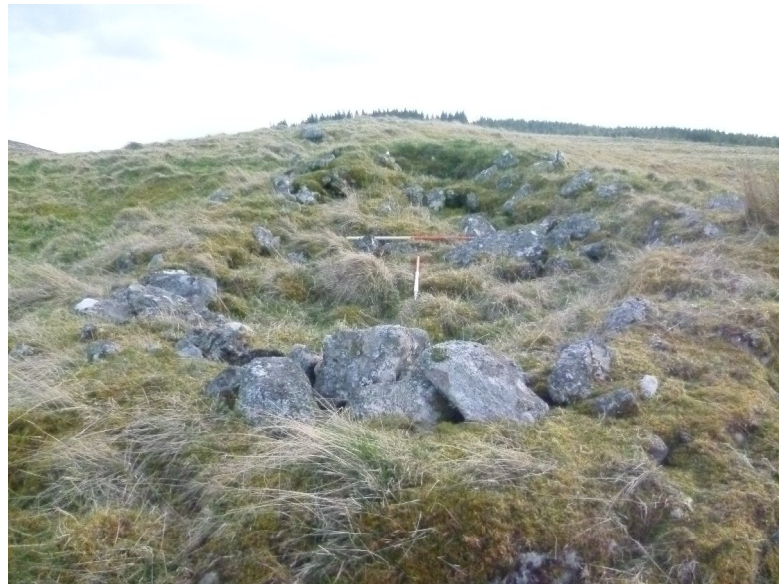
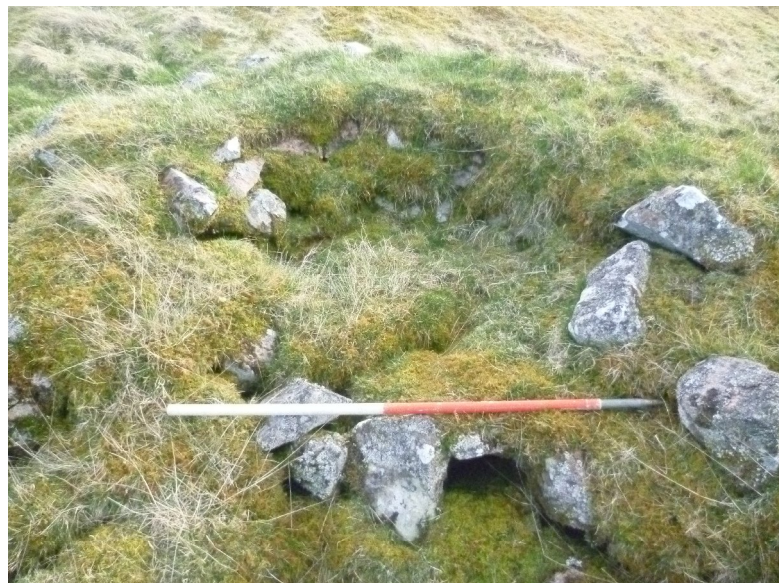
Figure 22b - Corn Kiln (CK2)

(2) built into a slight slope are the remains of a corn kiln comprising an oval stone structure aligned south southeast / north northwest (Figure 22b). The structure measures 5.50m by 2.60m (internally) with a possible entrance in the north. The walls are drystone built and average 0.90m in width and 0.30m in height – at bowl end the walling is much wider (1m at most). There are the remains of a bowl at the south southeast end of the structure (Figure 22c).

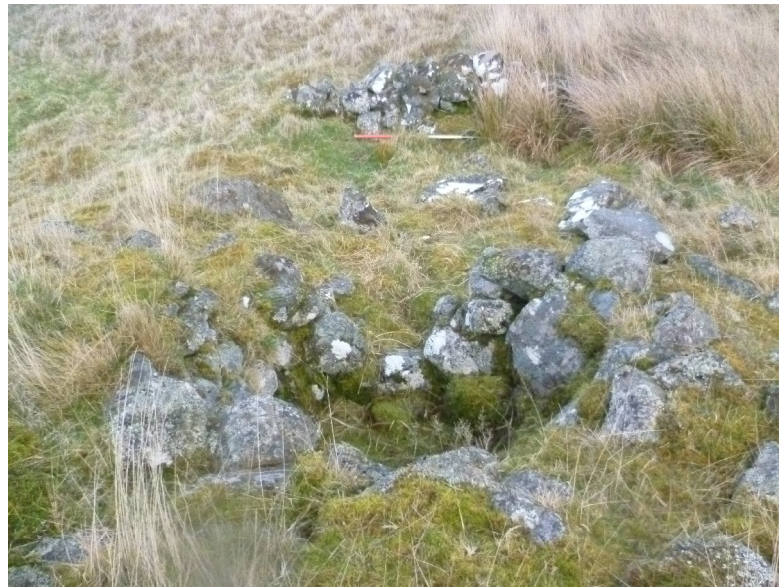
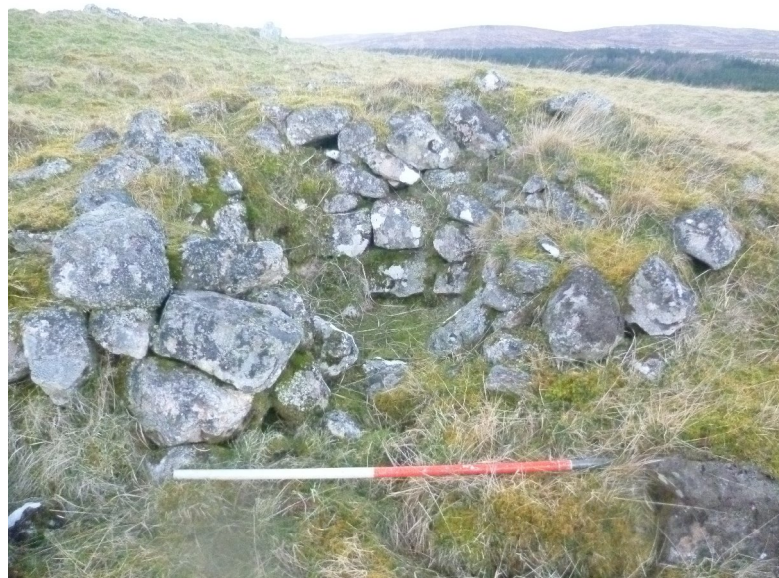
Figure 23a – General of Corn Kiln (CK3)

(3) built into a slope are the remains of a corn kiln comprising an oval stone structure, aligned west southwest / east northeast (Figure 23a). The structure measures 5.20m by 2.40m (internally) with a possible entrance in the east southeast. There are the remains of a bowl at the west southwest end of the structure which measures 1.40m in diameter and 0.90m in depth (Figure 23b).

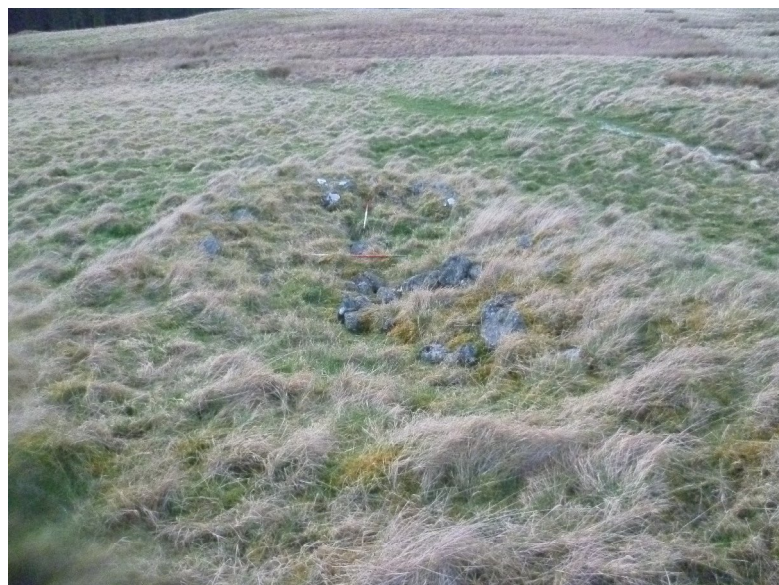
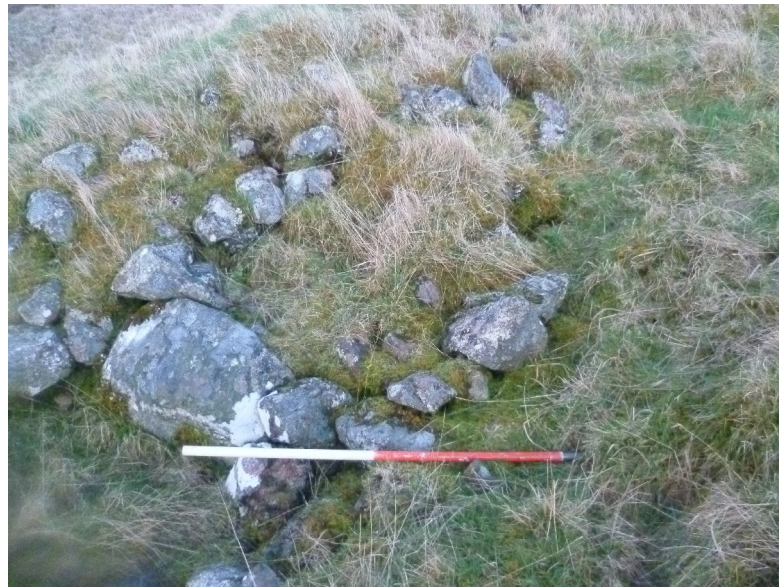
Figure 23c – General of Corn Kiln (CK4)

(4) built into a slope are the remains of a corn kiln comprising an oval stone structure, aligned west northwest / east southeast (Figure 23c). The structure measures 6.50m by 2.30m (internally) with an entrance in the north. There are the partial remains of a bowl at the east southeast end of the structure with a further small stone circular feature to the east of the

(front) of the bowl (Figure 24a).

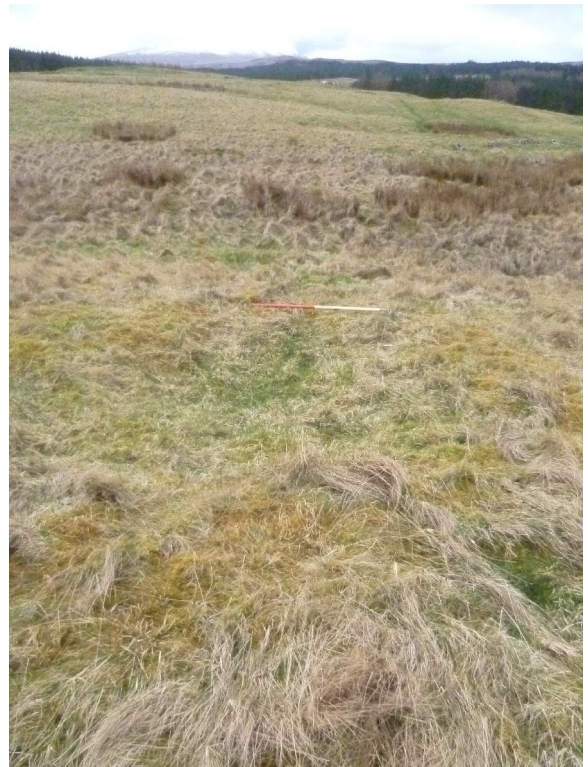
Figure 25d – Depression / Pit (P2)

(2) located on the opposing flank from CK1 are the remains of two oval depressions / pits (similar to P1) (Figure 25d).

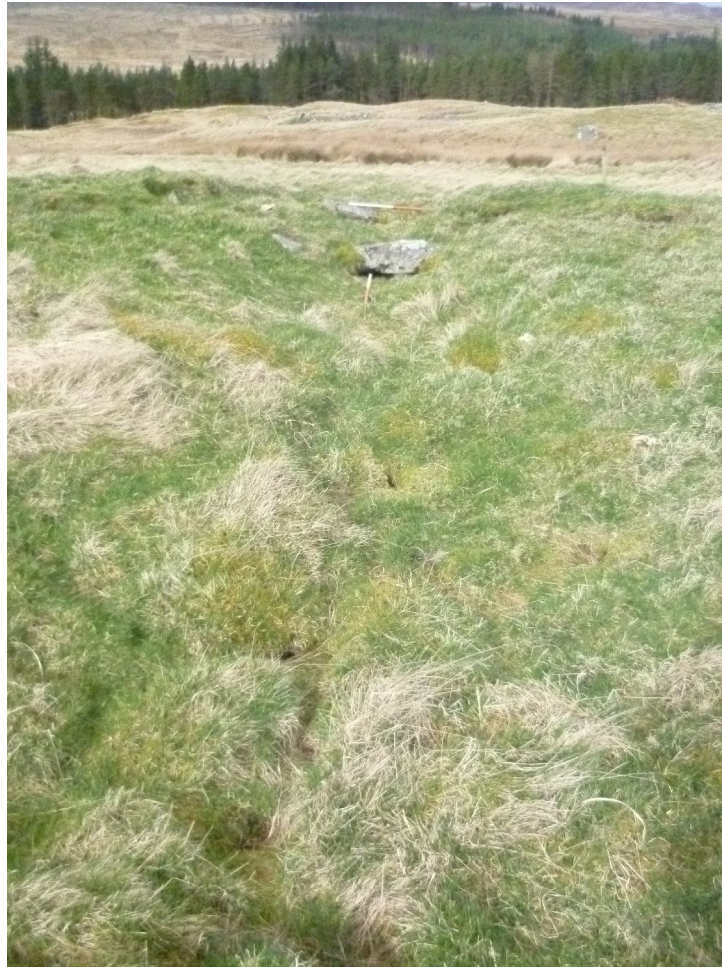
Figure 26a – General of Soutterain

A souterrain (Figure 26a) a (possible) Bronze Age cairn (Figure 26b) and a burnt mount have all also been noted within the proximity of the ring dyke that surrounds the settlement at Rosal all of which indicate possible continuous use of the site since prehistoric period – numerous hut circles, one within the ring dyke and numerous just outside give credence to this theory.

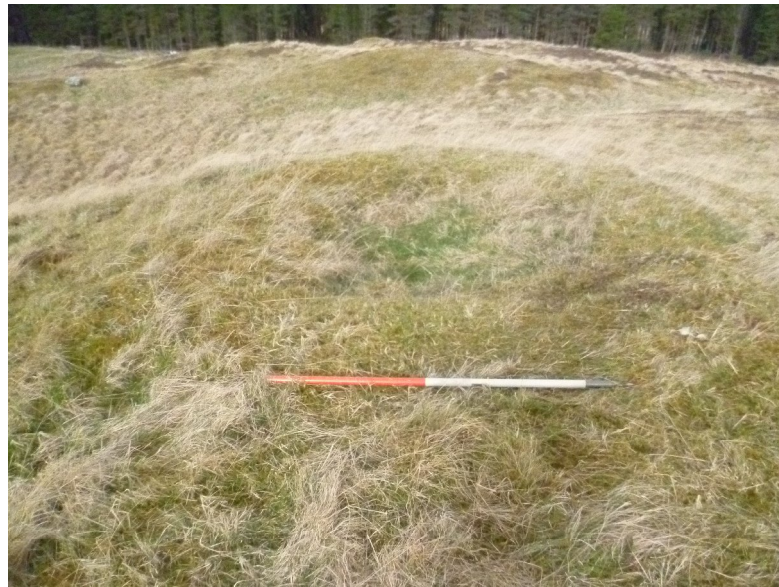
Figure 27a – Depression / Pit (P1)

(1) situated on a knoll is an oval depression / pit measuring roughly 1.90m by 1.60m – occasional stones are visible around the edge (Figure 27a). There is a further depression sited 2.7m to the east southeast.

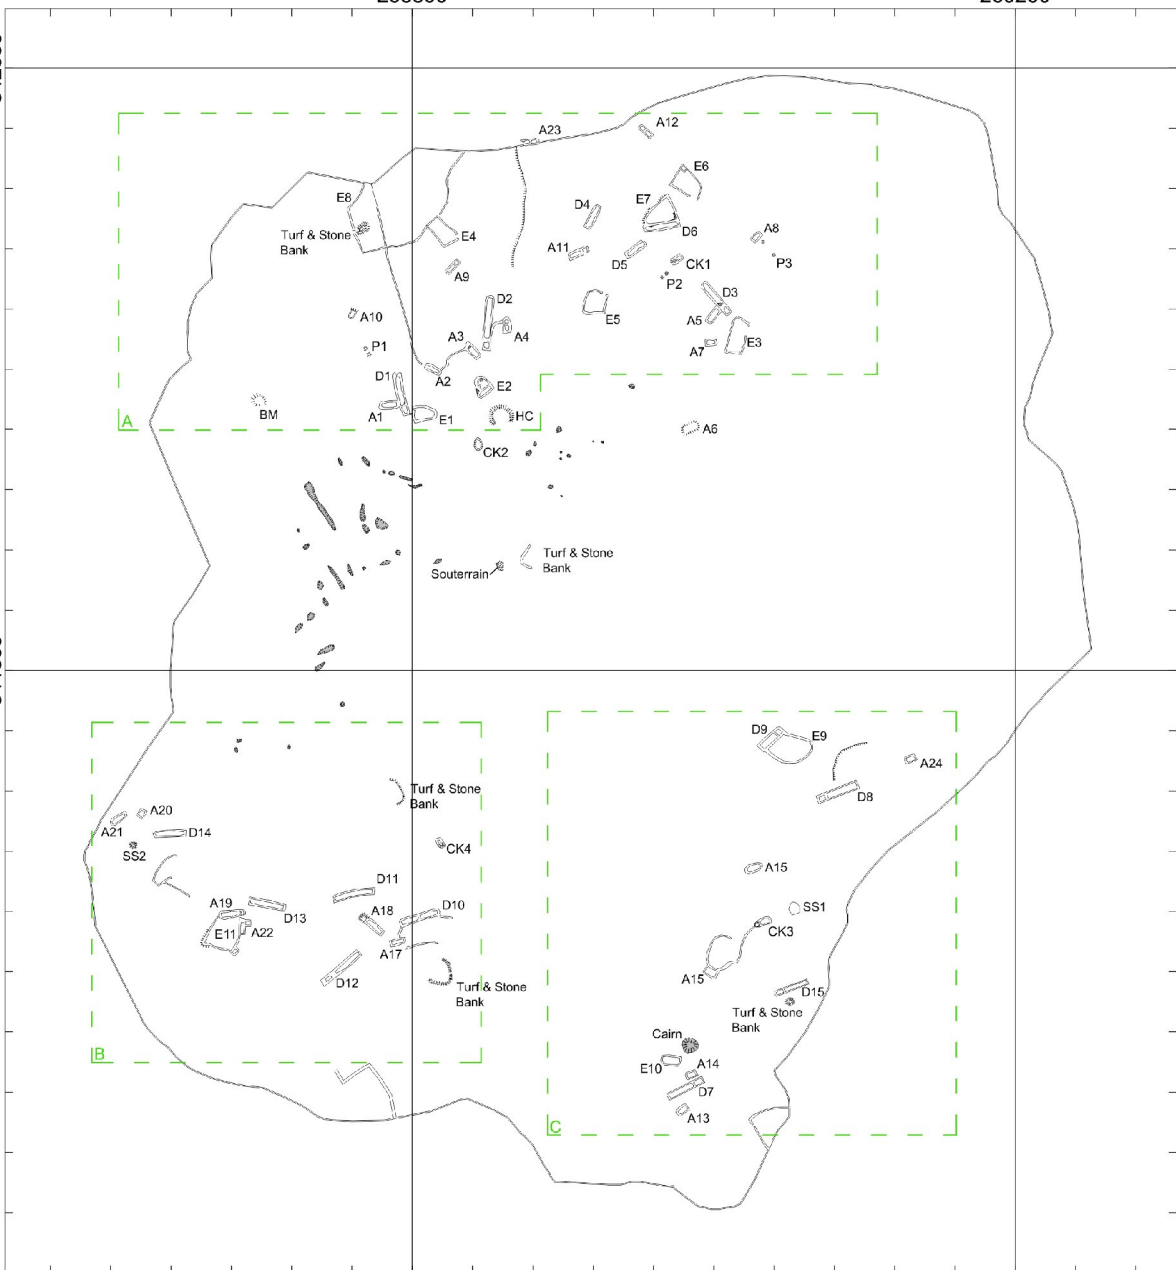
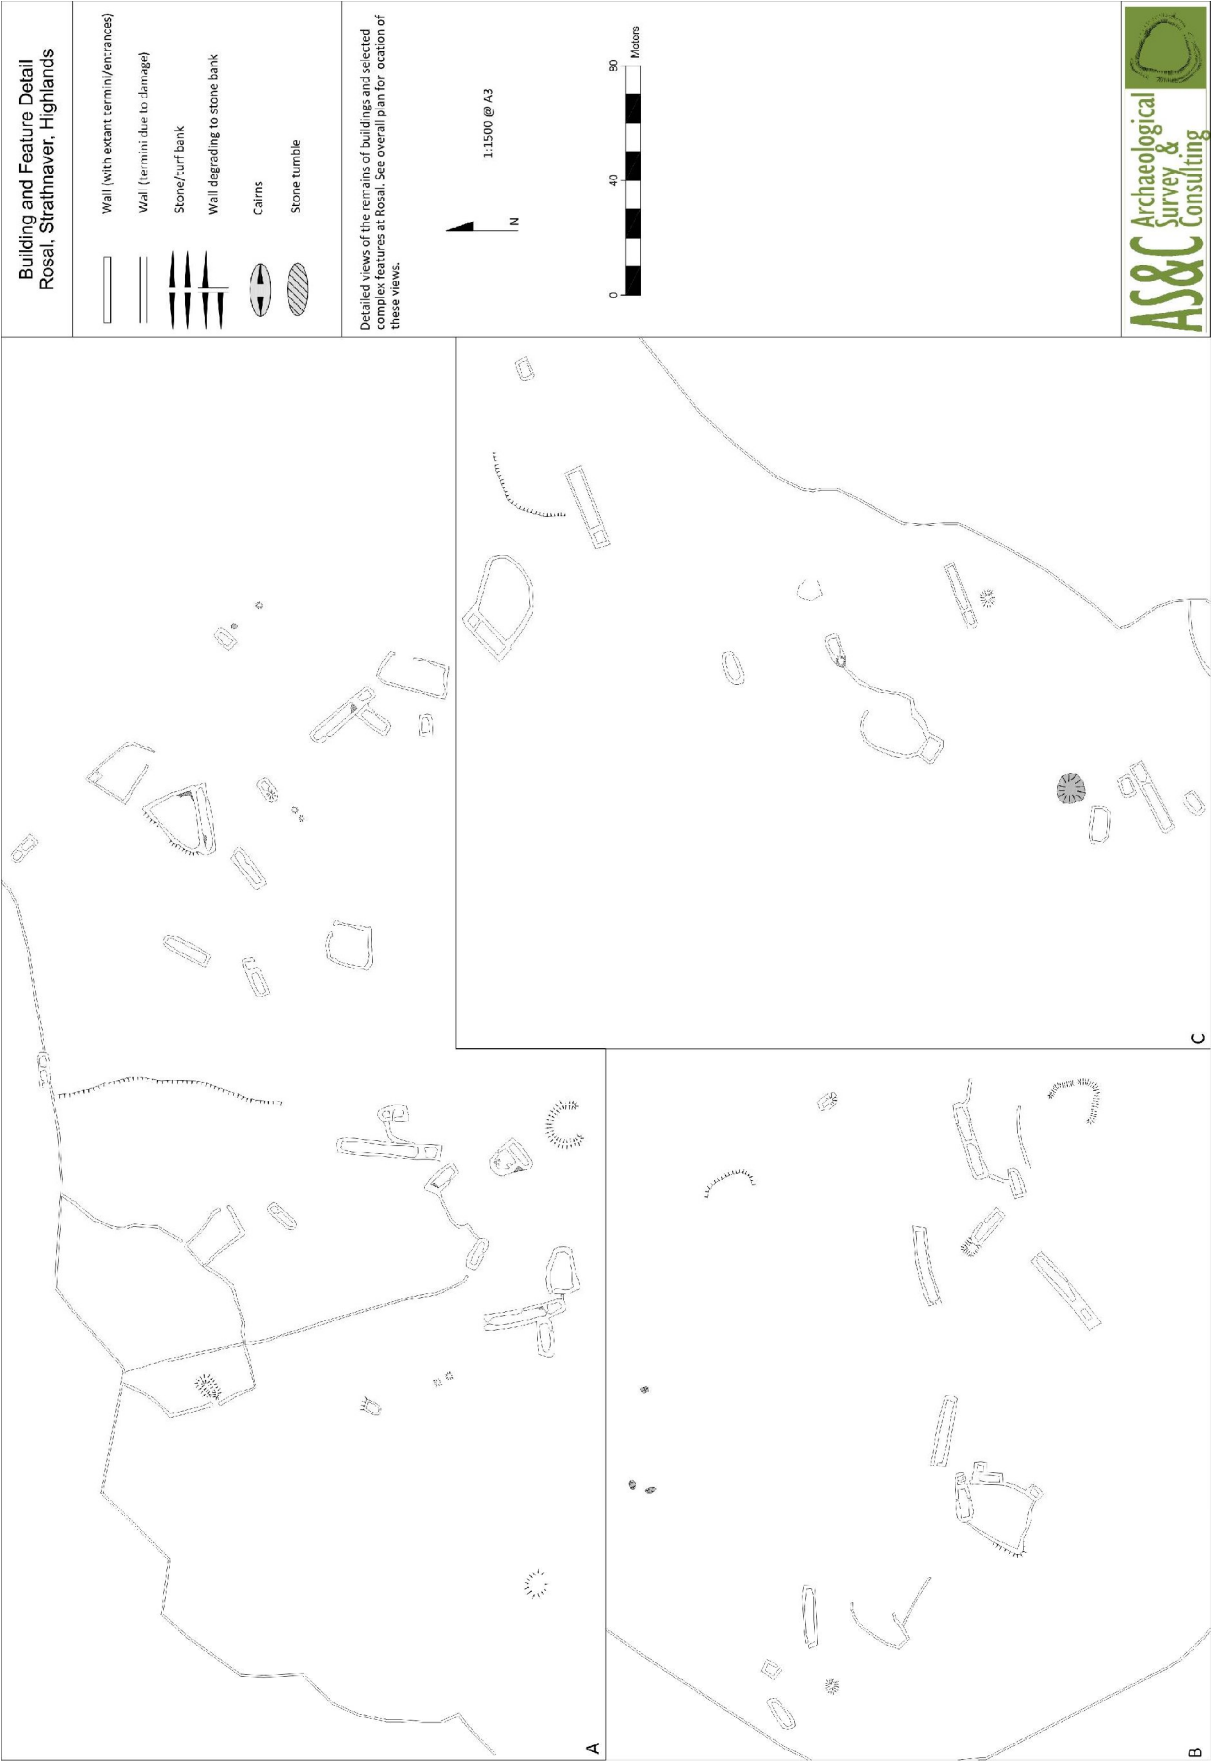
Figure 28a – overview site plan (from survey))

This current phase of works recorded the remains of fifteen dwellings (of which thirteen were longhouses); twenty three ancillary structures (of which at least six were barns – indicated by their opposing entrances used for winnowing); four corn kilns; three pit-like features (sited on knolls); eleven enclosures and two stone (circle) settings as well as numerous clearance cairns and sections of: turf / stone banks and walling (Figures 28a -28d).
